AGUA FRIA RIVER 6 LEVEE SYSTEM

**MARICOPA COUNTY, ARIZONA
NLD SYSTEM ID # 3805030001**

**PERIODIC INSPECTION REPORT NO. 1
GENERALIZED EXECUTIVE SUMMARY**

**FINAL SYSTEM RATING: MINIMALLY ACCEPTABLE
FINAL RATING DATE: SEPTEMBER 24, 2015**

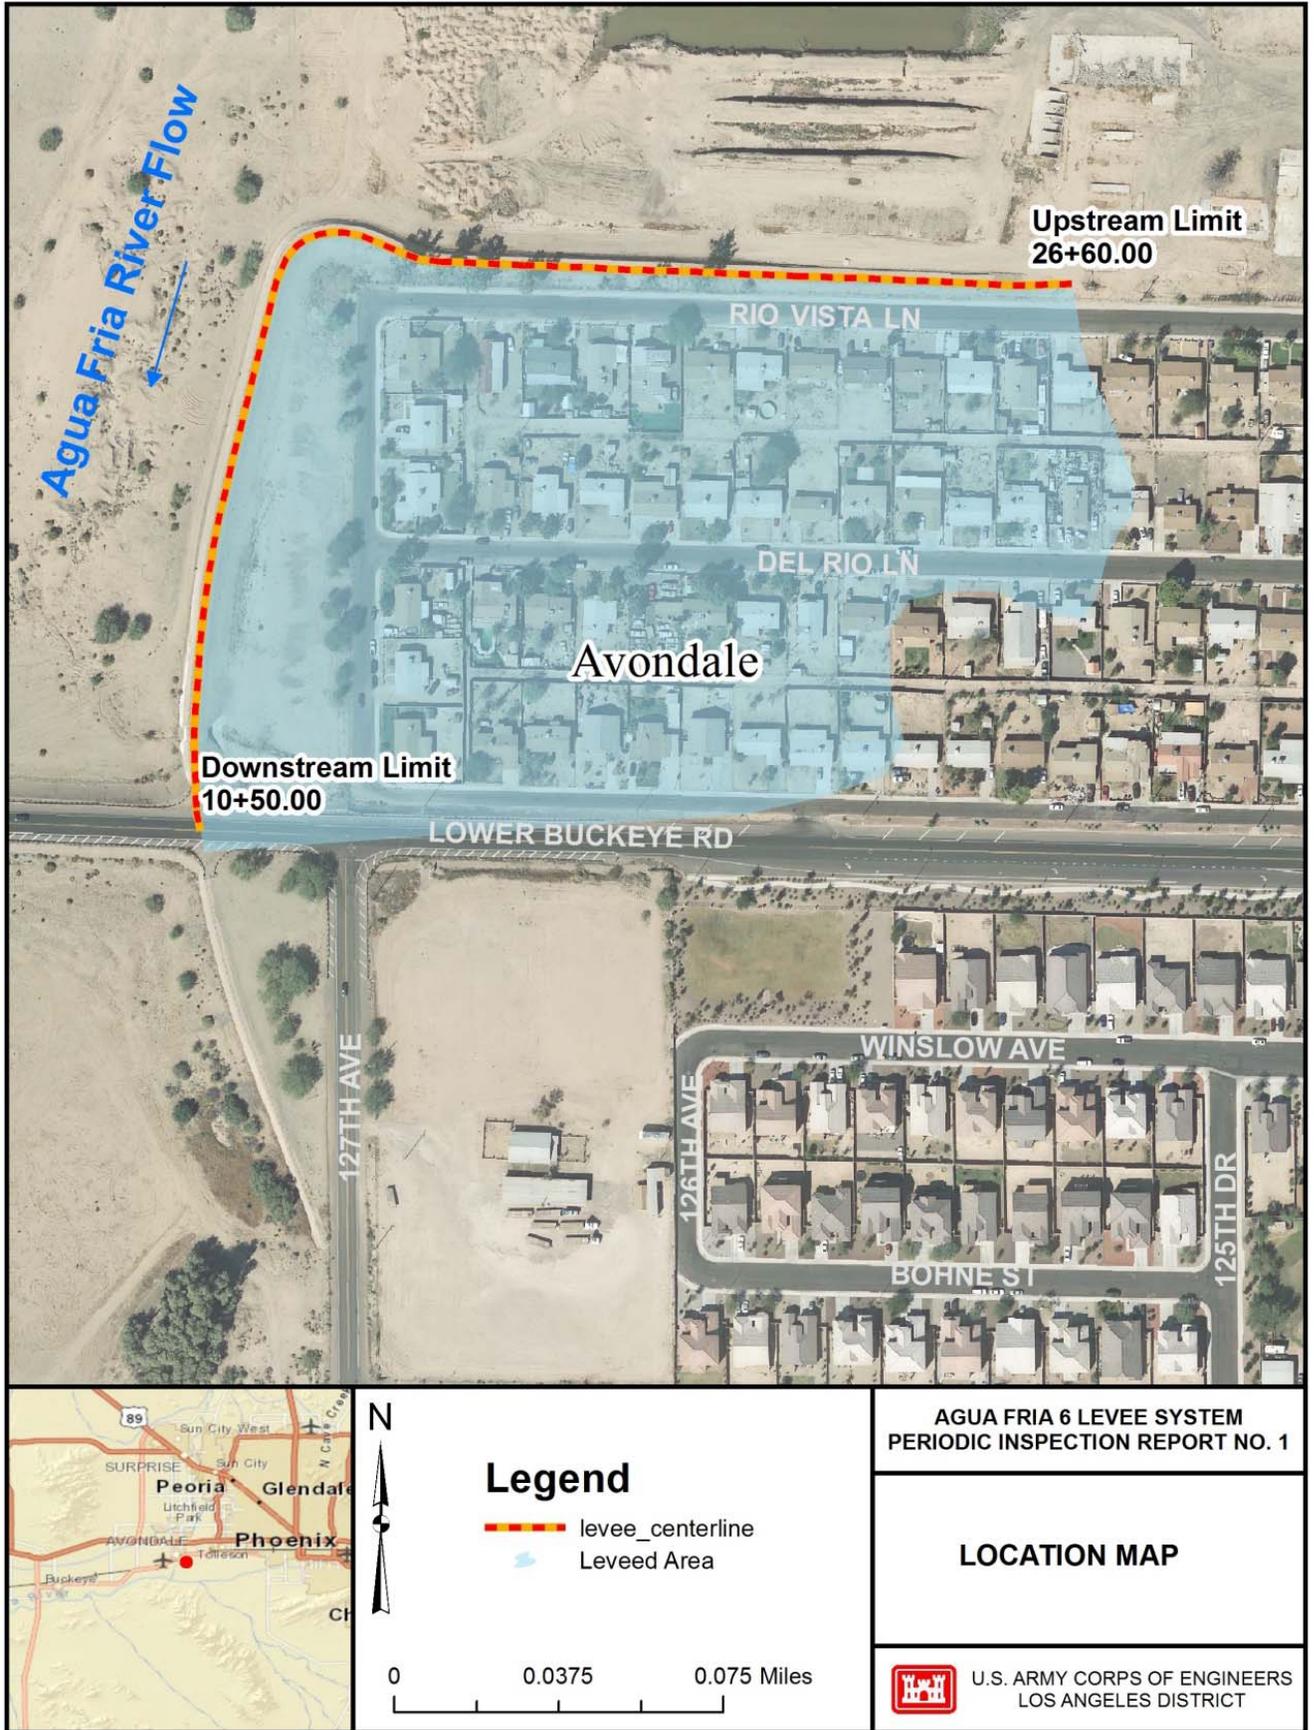
Figure 1

The AFR6 System is located in the city of Avondale, in Maricopa County, Arizona, a suburb on the west side of Phoenix. According to the National Levee Database (NLD), this levee system is referred to as the AFR6 levee system with a total length of approximately 0.31 miles. This levee system runs along the left (east) bank of the Agua Fria River, beginning at Sta. 26+60 about 1,610 feet upstream of Lower Buckeye Road and ending at Lower Buckeye Road at approximate Station 10+50 (Figure 1).
