LOS ANGELES RIVER 5 LEVEE SYSTEM

NLD SYSTEM ID # 3805010054

PERIODIC INSPECTION REPORT NO 1
GENERALIZED EXECUTIVE SUMMARY

SUBMITTED: NOVEMBER 2014
INSPECTED: MARCH 4-5, 2014

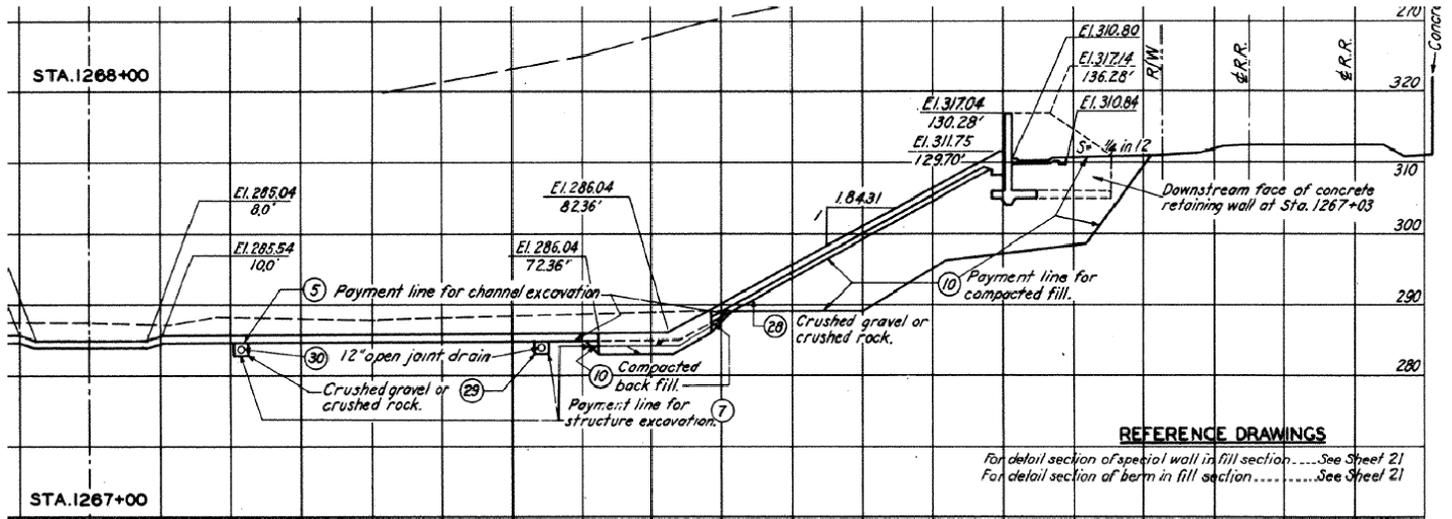
Figure 6-1: Los Angeles River Left Bank Cross-Section (Looking Upstream At Station 1267+00 [District File No. 303/13])

Upstream from Spring Street Bridge on the left bank, there appears to be a floodwall ranging from 1.8 to 9.6 ft between Station 1244+46.10 and 1267+03 [Section 6.6 (USACE 1941)]. Adjacent to the floodwall, there is a 60 to 80 ft corridor used by the railroad (Figure 6-1 and Figure 6-2). In this corridor, the ROW is generally located between the left bank floodwall and nearest railroad track. Access to this corridor is limited between Spring Street to the confluence of Arroyo Seco. For the purposes of this report, the design documentation for this apparent floodwall was not reviewed or inspected apart of this effort. If the design documentation supports a floodwall condition, it is recommended that the LAR5 System alignment be revised from Station 1202+48.43 to 1243+45.29 to the proposed system alignment (Station 1244+46.10 to 1267+03) along with revisions to the leveed area. The proposed revisions to the system alignment and leveed area are illustrated in Figure 6-3.
