Fourth Five-Year Review Report

**Former Camp Elliott-Tierrasanta, Project Number J09CA006701
Former Camp Elliott-Mission Trails, Project Number J09CA006702
San Diego, California**

Date: 7 September 2021

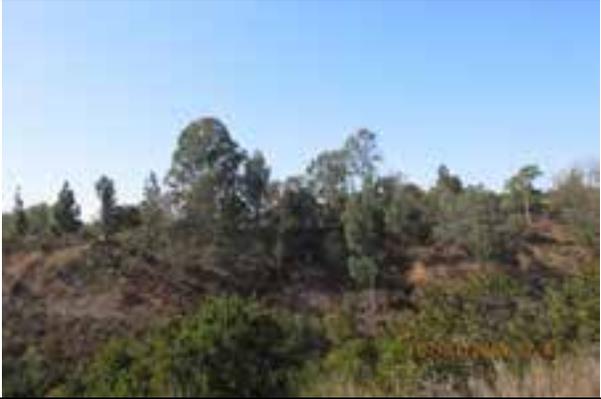
Observation ID:	TS01
Date:	07 November 2019
Latitude:	32.81963889
Longitude:	-117.1021667
Bearing (degrees):	260
Project Area:	Tierrasanta (F-1)
Description:	<p>Located north of Roadrunner Park, looking east. Field team could not find the configuration from the previous five-year review. Photo matches the configuration from the Second Five-Year Review.</p> <p>Vegetation appears drier on the canyon slope than in the previous review; minor erosion also noted.</p>

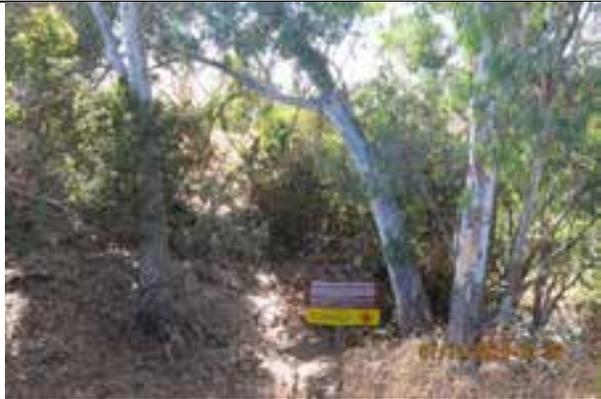
Photo/Observation ID:	TS02
Date:	07 November 2019
Latitude:	32.81855556
Longitude:	-117.1008611
Bearing (degrees):	190
Project Area:	Tierrasanta (F-1)
Description:	<p>Located at the north end of Roadrunner Park (near school fence in trees and brush).</p> <p>Sign S-002 is bent but still legible. TS85 provides a closeup of the sign. Vegetation is very dry in the area.</p>

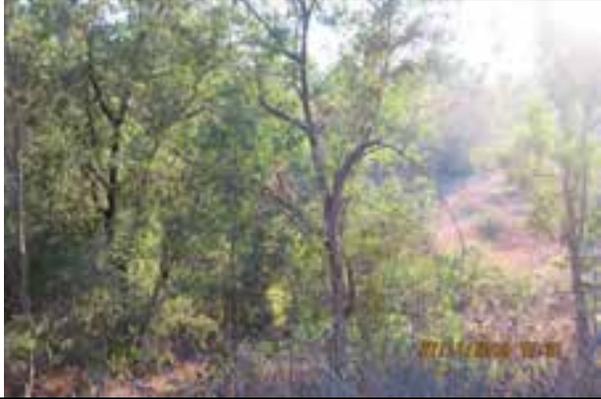
Photo/Observation ID:	TS07		
Date:	07 November 2019		
Latitude:	32.83277778		
Longitude:	-117.1133889		
Bearing (degrees):	200		
Project Area:	Tierrasanta (F-8E)		
Description:	<p>Located on the south side of Clairemont Mesa Blvd, just west of Repecho Drive.</p> <p>Good vegetation in area; no erosion noted.</p>

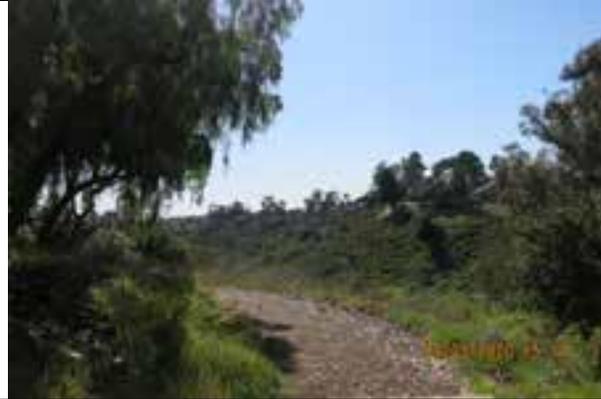
Photo/Observation ID:	TS08		
Date:	03 March 2020		
Latitude:	32.82877778		
Longitude:	-117.0884167		
Bearing (degrees):	225		
Project Area:	Tierrasanta (F-2W)		
Description:	<p>Located off of Clairemont Mesa Blvd, across the street from the Tierrasanta Recreation Center.</p> <p>Vegetation growth is heavy and appears greener/healthier than the previous review; no erosion noted.</p>

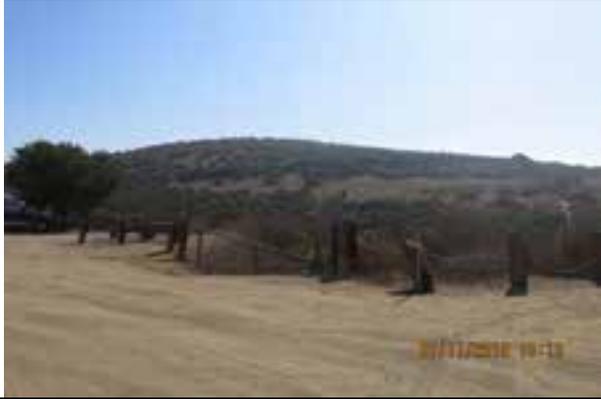
Photo/Observation ID:	TS30		
Date:	07 November 2019		
Latitude:	32.82497222		
Longitude:	-117.0761389		
Bearing (degrees):	110		
Project Area:	Tierrasanta (E-2CB)		
Description:	<p>View of Mission Trails Regional Park from the parking area at the end of Clairemont Mesa Blvd. Observation collected at 32.82501, -117.07630 with the same bearing as the previous review.</p> <p>Vegetation is much taller and thicker; no erosion noted. Looking at a trailhead with no MEC warning sign. The trail leads into the park.</p>

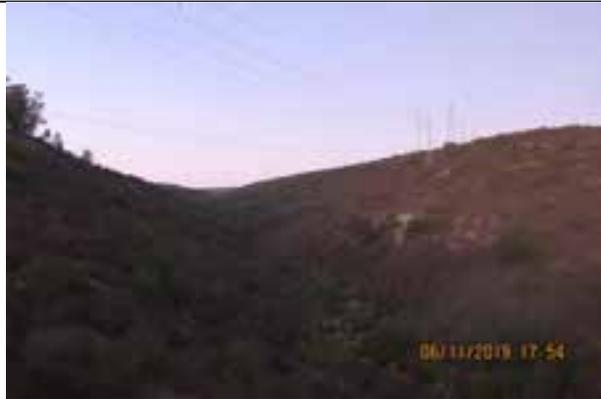
Photo/Observation ID:	TS37		
Date:	06 November 2019		
Latitude:	32.82541667		
Longitude:	-117.0753889		
Bearing (degrees):	350		
Project Area:	Tierrasanta (F-10A)		
Description:	<p>Located on a wooden bridge at the entrance to Mission Trails Regional Park from Clairemont Mesa Blvd.</p> <p>Good vegetation with some bare ground observed on the hillside.</p>

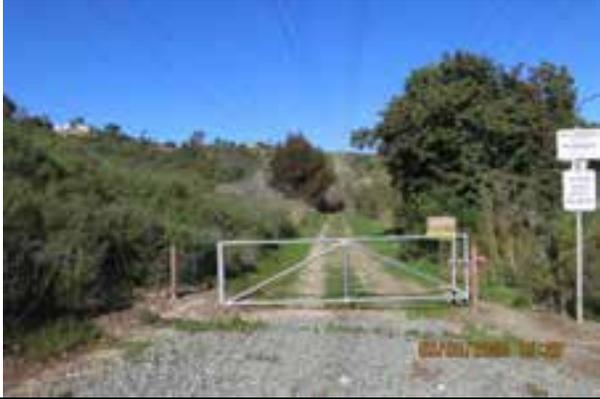
Photo/Observation ID:	TS42		
Date:	03 March 2020		
Latitude:	32.81577778		
Longitude:	-117.0869722		
Bearing (degrees):	22		
Project Area:	Tierrasanta (F-5N)		
Description:	<p>Located on Tierrasanta Blvd at the San Diego Gas & Electric (SDG&E) gate, under power lines.</p> <p>Service road includes MEC warning sign S-007. Sign is in good condition and is in a visible location. Area is vegetated with no erosion observed. Observation collected with a bearing of 35°.</p>

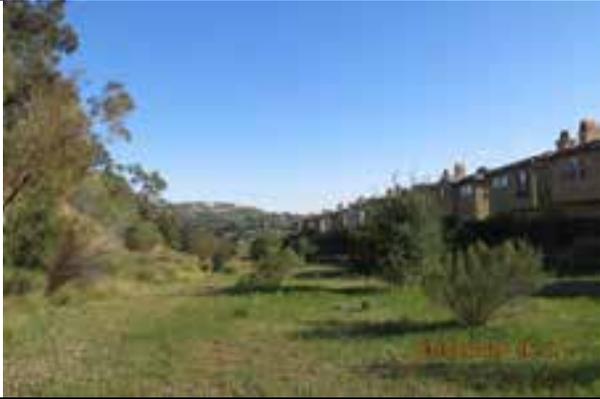
Photo/Observation ID:	TS43		
Date:	03 March 2020		
Latitude:	32.81169444		
Longitude:	-117.0829722		
Bearing (degrees):	100		
Project Area:	Tierrasanta (F-5S)		
Description:	<p>Located at western terminus of Tierrasanta Blvd.</p> <p>Area is vegetated with a graded trail; no signs of erosion. Copperleaf neighborhood (completed in 2012-2013) observed (right side of photo). No MEC warning sign observed at trailhead or down trail.</p>

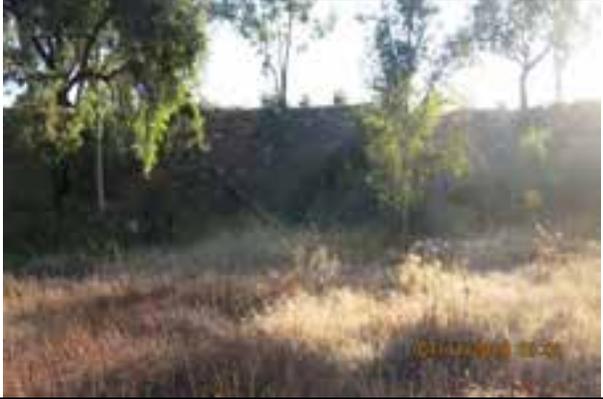
Photo/Observation ID:	TS48
Date:	07 November 2019
Latitude:	32.83088889
Longitude:	-117.1063611
Bearing (degrees):	188
Project Area:	Tierrasanta (F-7)
Description:	<p>Located on the north side of Clairemont Mesa Blvd, between Antigua Blvd and Santo Road.</p> <p>Vegetation appears dry. Serious erosion observed, and erosion control measures appear to be failing on the hillside. See also TS47, TS49, and TS89.</p>

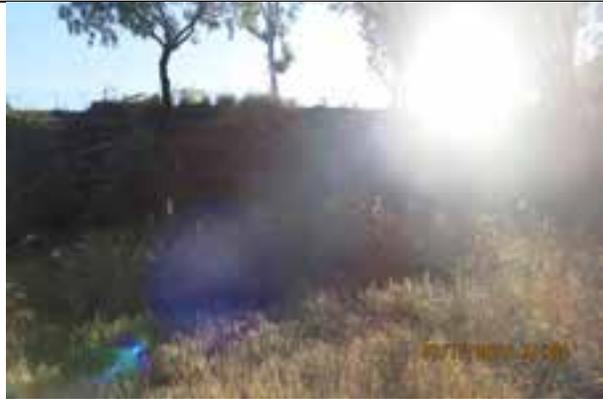
Photo/Observation ID:	TS49
Date:	07 November 2019
Latitude:	32.83086111
Longitude:	-117.1065
Bearing (degrees):	220
Project Area:	Tierrasanta (F-7)
Description:	<p>Located on the north side of Clairemont Mesa Blvd, between Antigua Blvd and Santo Road.</p> <p>Vegetation appears dry. Serious erosion observed, and erosion control measures appear to be failing on the hillside. See also TS47 to TS49.</p>

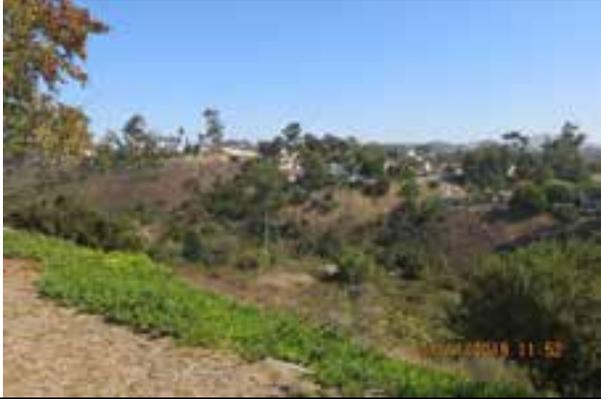
Photo/Observation ID:	TS60		
Date:	07 November 2019		
Latitude:	32.82030556		
Longitude:	-117.0954167		
Bearing (degrees):	55		
Project Area:	Tierrasanta (F-2W)		
Description:	<p>Located behind apartments near the intersection of Ducos Place and Tierrasanta Blvd.</p> <p>MEC warning sign no longer present; bench and concrete pad have also been removed. Some erosion noted down the slope.</p>

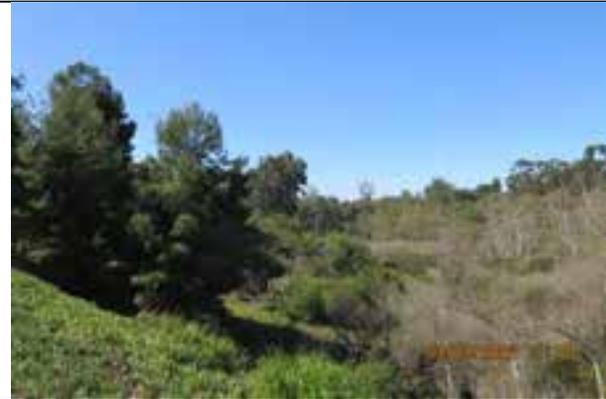
Photo/Observation ID:	TS65		
Date:	03 March 2020		
Latitude:	32.83141667		
Longitude:	-117.10275		
Bearing (degrees):	240		
Project Area:	Tierrasanta (F-7)		
Description:	<p>Taken from sidewalk off of Santo Road, north of intersection with Remore Street.</p> <p>Heavy vegetation with no signs of erosion. A faint (social) trail observed going into the canyon.</p>

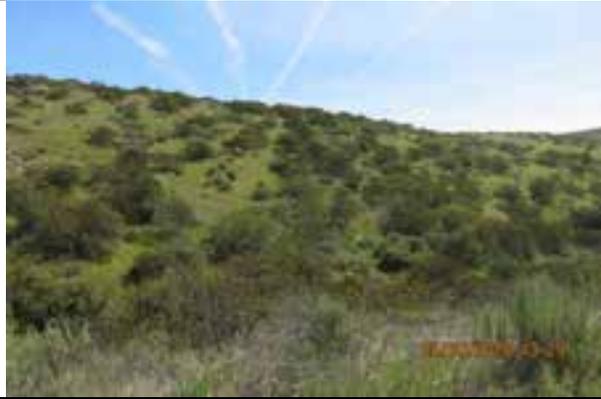
Photo/Observation ID:	MT08		
Date:	05 March 2020		
Latitude:	32.84844444		
Longitude:	-117.0735		
Bearing (degrees):	128		
Project Area:	Mission Trails		
Description:	Good vegetation on sloped hillside; no erosion noted.
