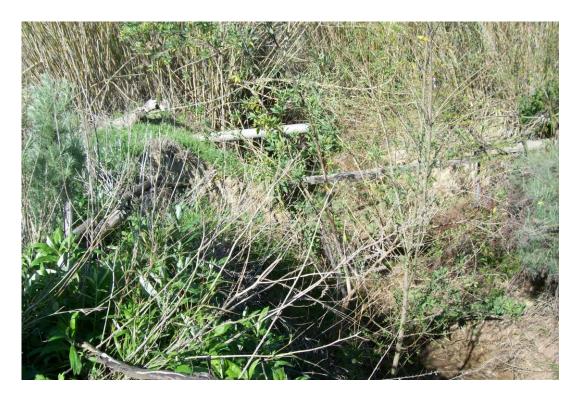
• Outfall near confluence – Downstream near outfall to SCR looking downstream

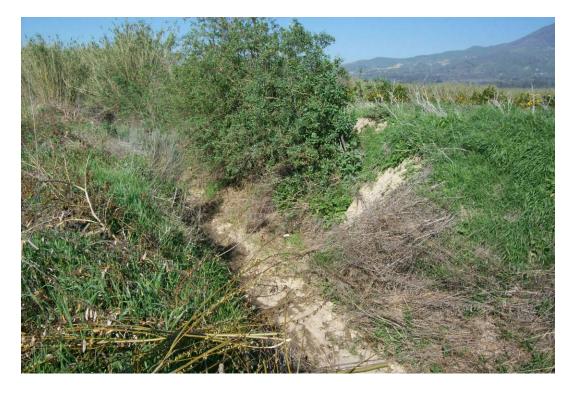
• Outfall near confluence – 200' upstream photo 96 looking downstream

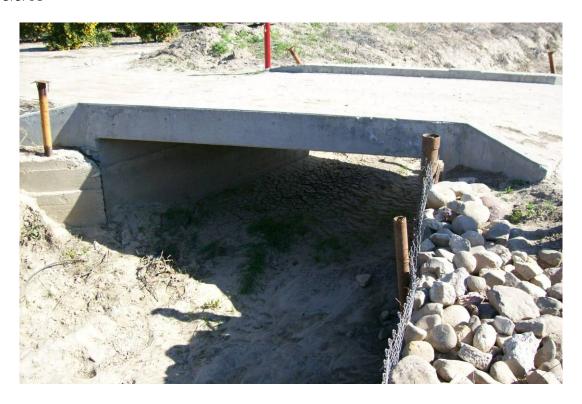
• Service Road 18A – Downstream side of bridge looking upstream

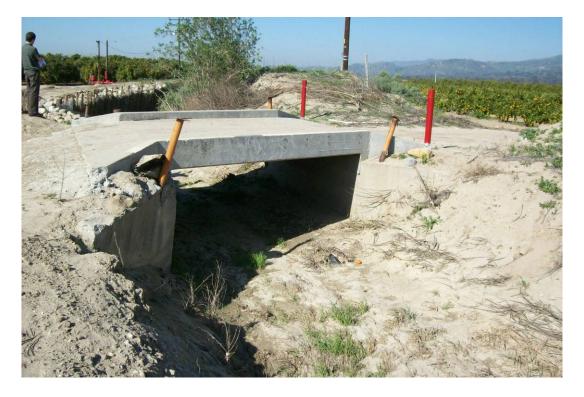
• Service Road 18A – Upstream side of bridge looking downstream

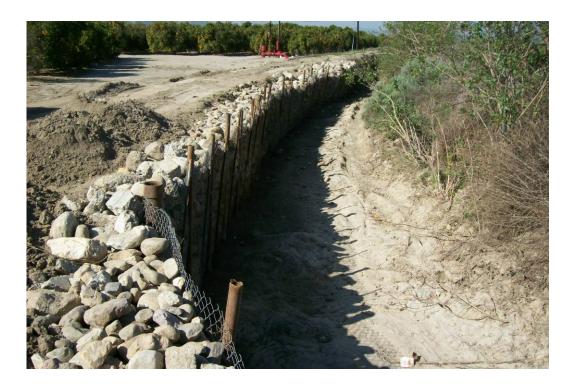
Service Road 18A – Downstream side of bridge looking downstream at rock filled wall

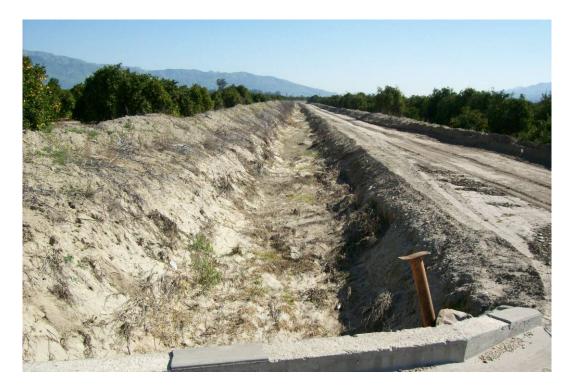
• Service Road 18A – Upstream side of bridge looking upstream

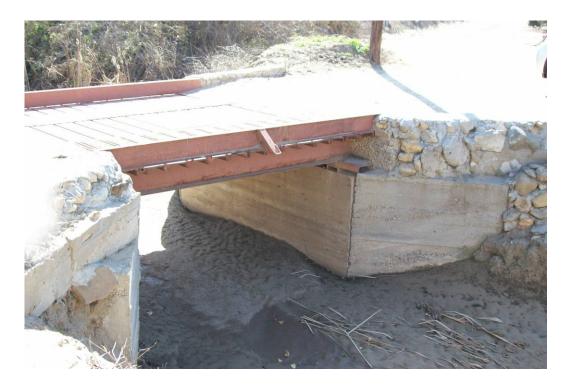
• Service Road 18B – Downstream side of bridge looking upstream

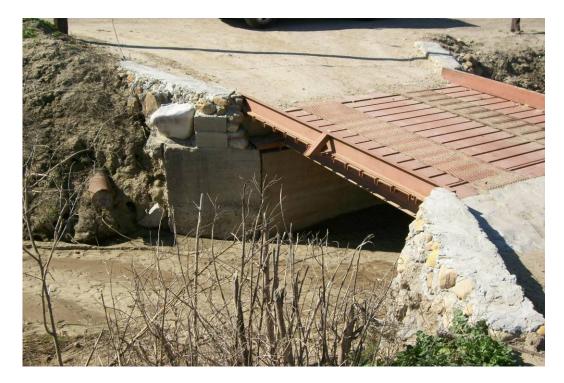
• Service Road 18B – Upstream side of crossing looking downstream

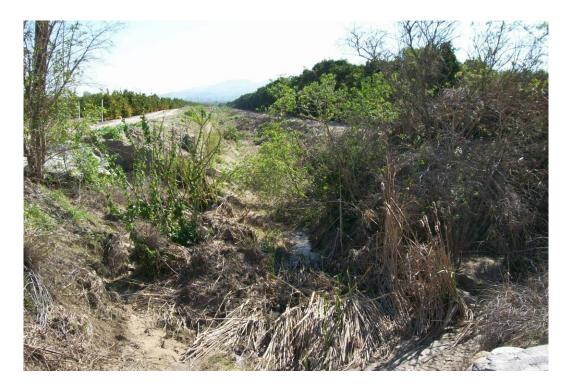
• Service Road 18B – Upstream side of crossing looking upstream

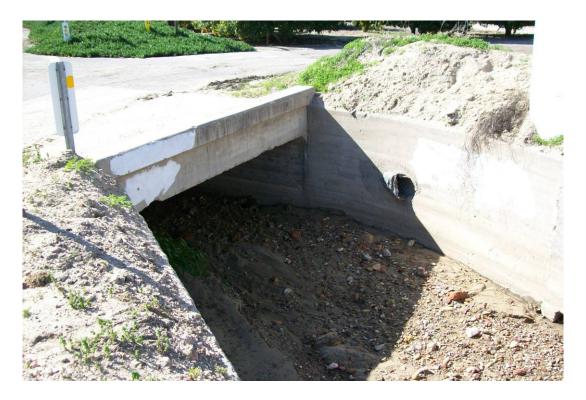
• Los Angeles Road – Downstream side of crossing looking upstream

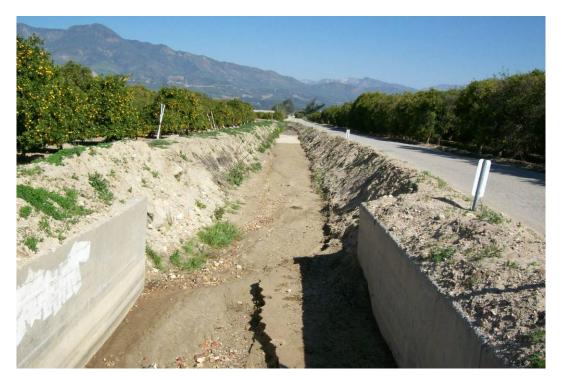
• Los Angeles Road – Downstream side of crossing looking downstream

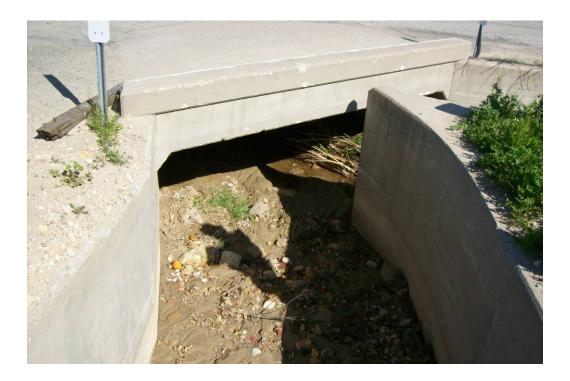
• Los Angeles Road – Upstream side of crossing looking downstream

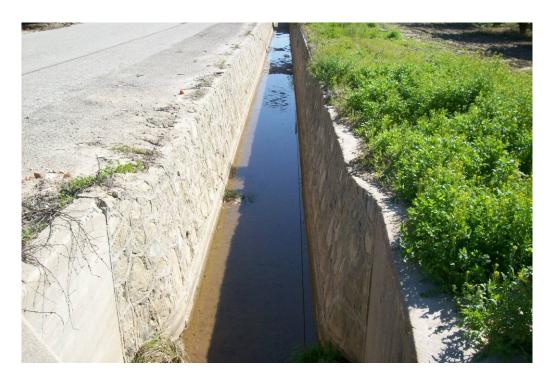
Los Angeles Road – Upstream side of crossing looking upstream at tributary channel

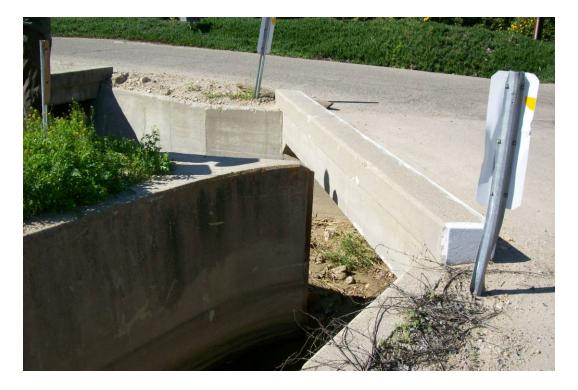
Los Angeles Road – Upstream side of crossing showing tributary and RD confluence looking North

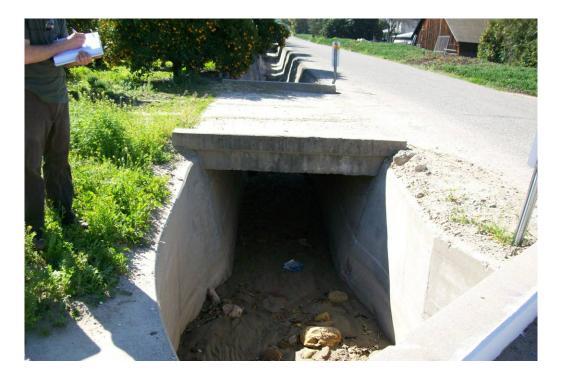
• Service Road 18D – Downstream side of crossing looking upstream

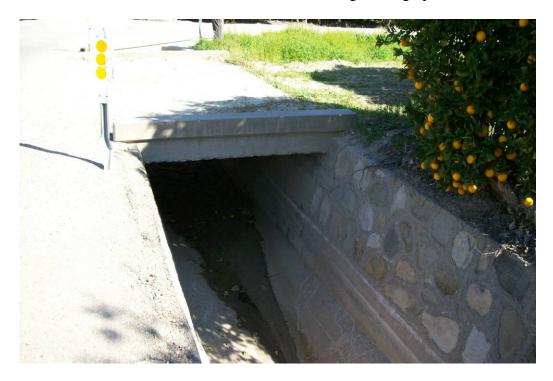
• Service Road 18D –Upstream side of crossing looking downstream

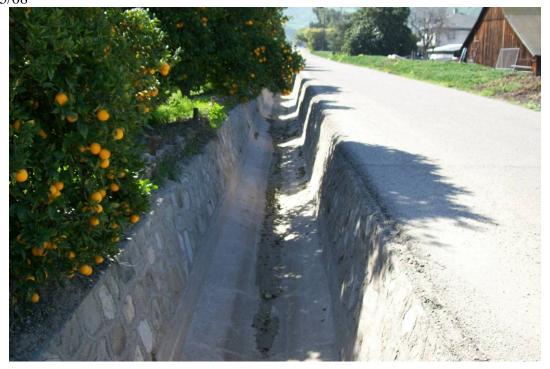
• Service Road 18D – Upstream side of crossing looking upstream

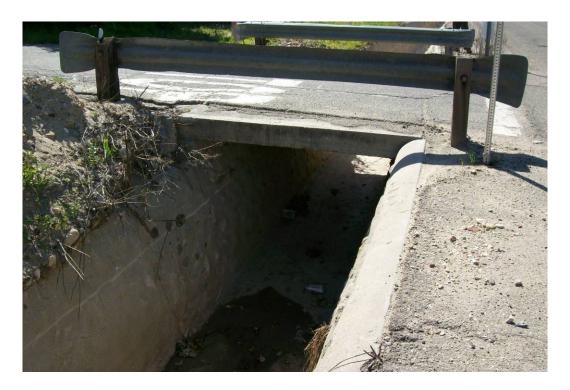
• California Avenue – Downstream side of crossing looking upstream

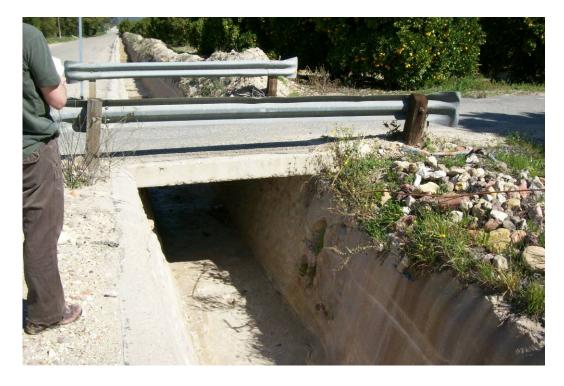
• California Avenue – Upstream side of crossing looking downstream

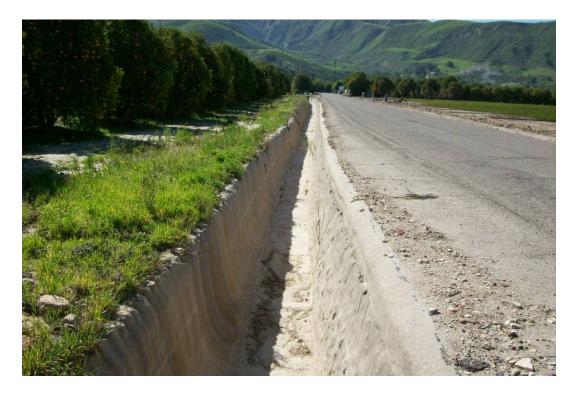
• California Avenue – Upstream side of crossing looking upstream

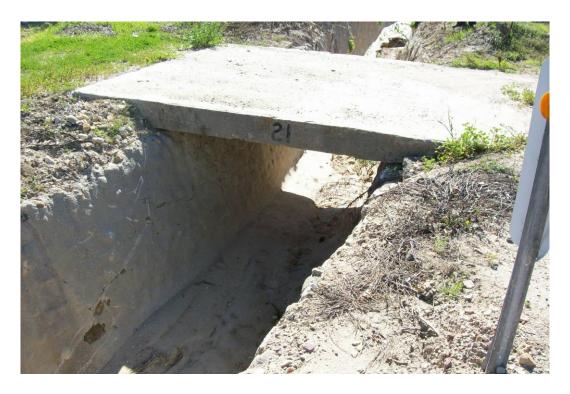
• North of South Mountain Road – Downstream side of crossing looking upstream

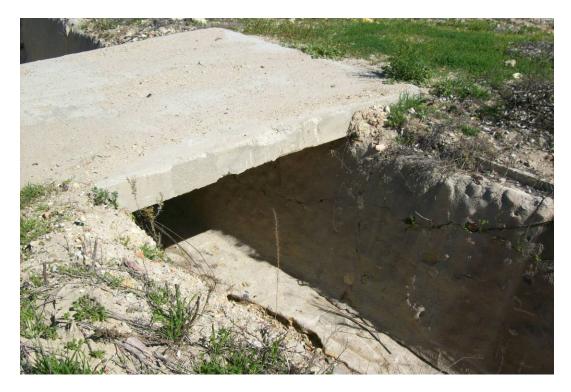
• North of South Mountain Road –Upstream side of crossing looking downstream

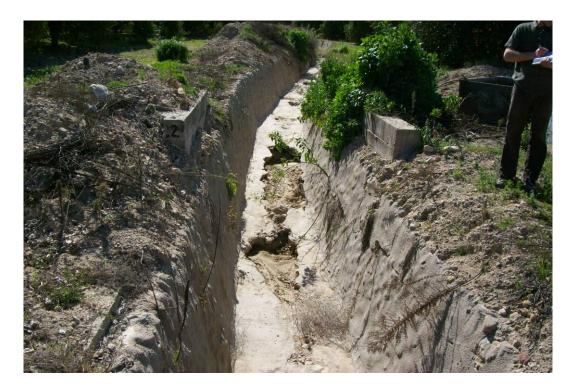
• North of South Mountain Road – Upstream side of crossing looking upstream concrete channel bottom is eroding

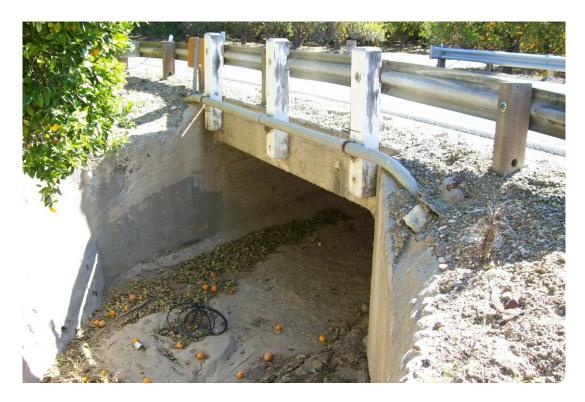
• South Mountain Road – Downstream side of crossing looking upstream

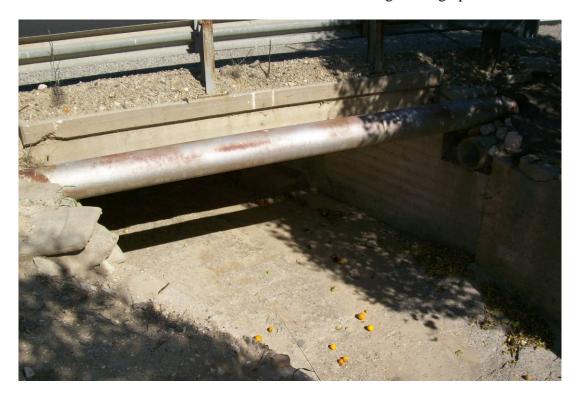
• South Mountain Road –Upstream side of crossing looking downstream

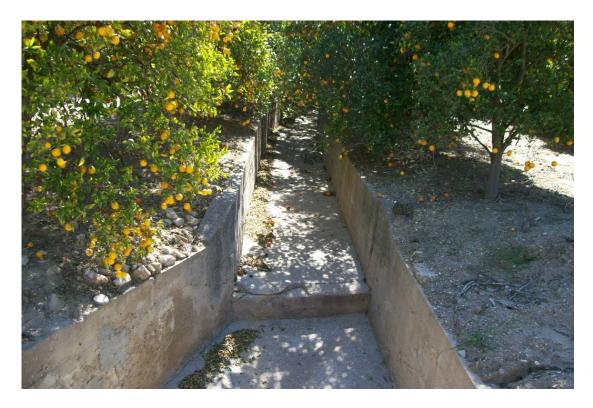
• South Mountain Road – Upstream side of crossing looking upstream
