# REMEDICATION OF HANSEN DAM LOWER LAKE FILL SITES

## I. EXECUTIVE SUMMARY

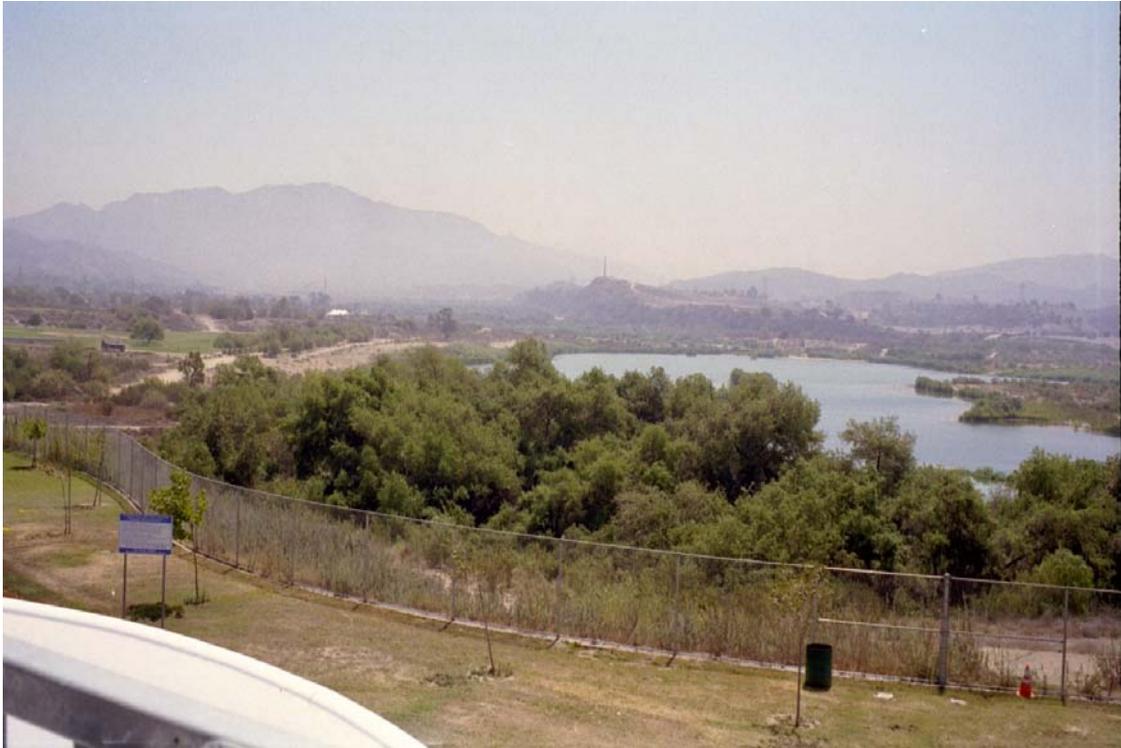
**Figure 4: View east from Recreation Lake Complex looking down toward Large Lower Lake. Note Large Lower Lake abutting active Tujunga Wash.**

These facilities include the 10.5-acre recreation swim and fishing lake complex opened in 2001. The area in which the Lower Lakes occur, below these recreation lakes, has been left to evolve as natural habitat (Figure 4).

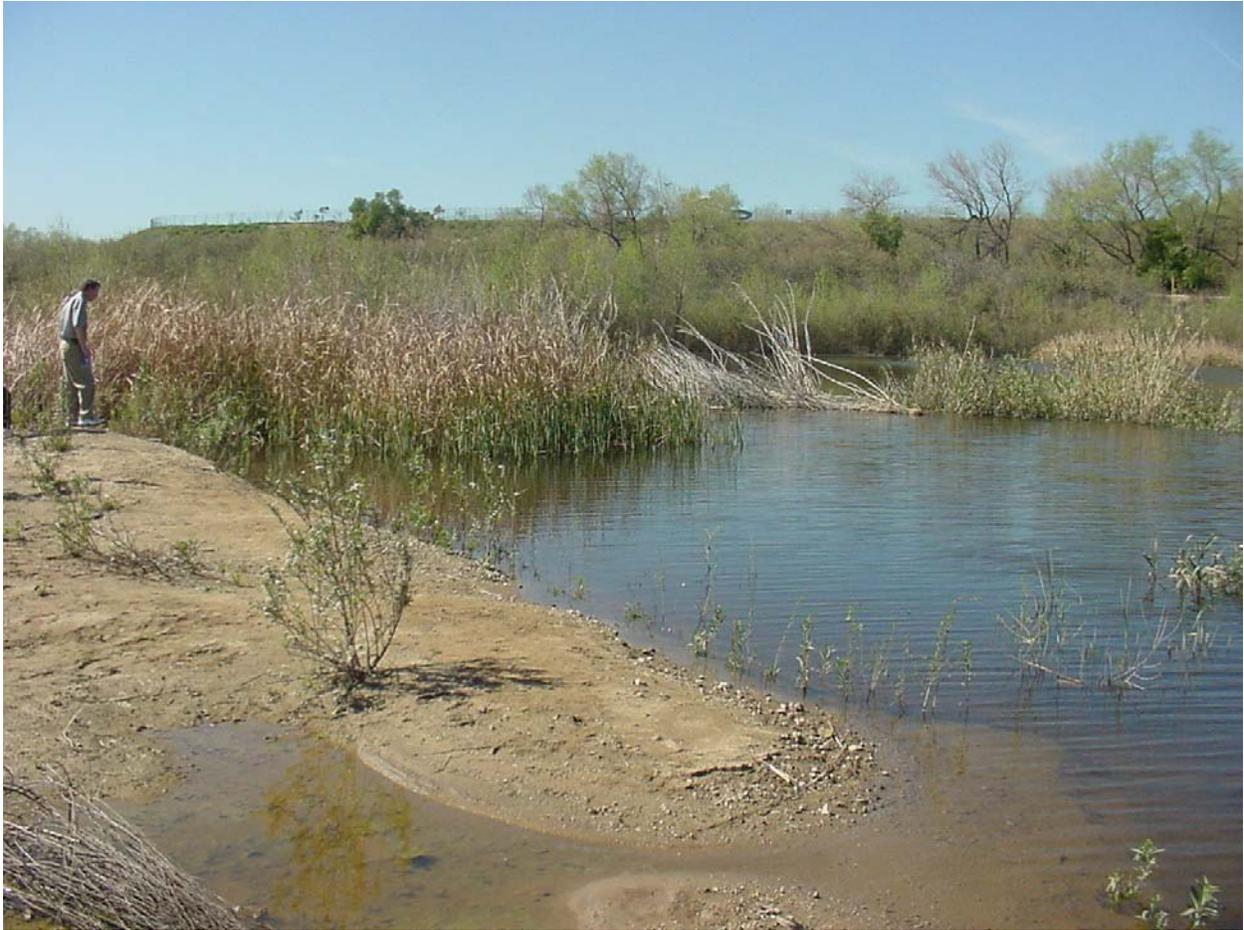
**Figure 7: View of cattails and marsh next to deposit site on Large Lower Lake. Note colonized mudflats.**

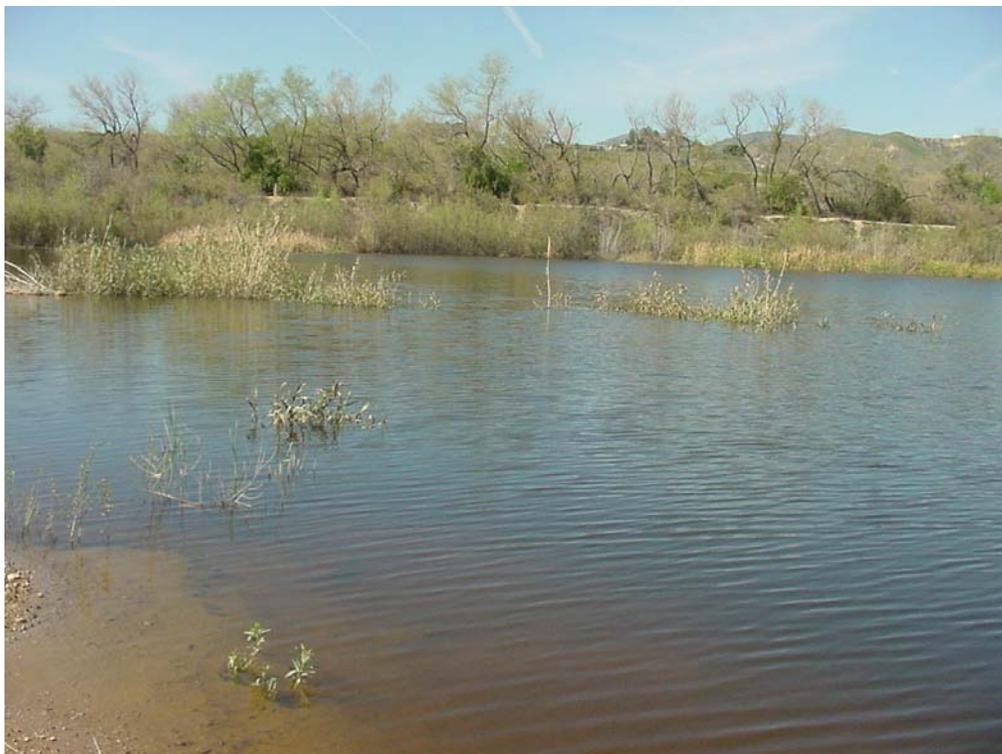
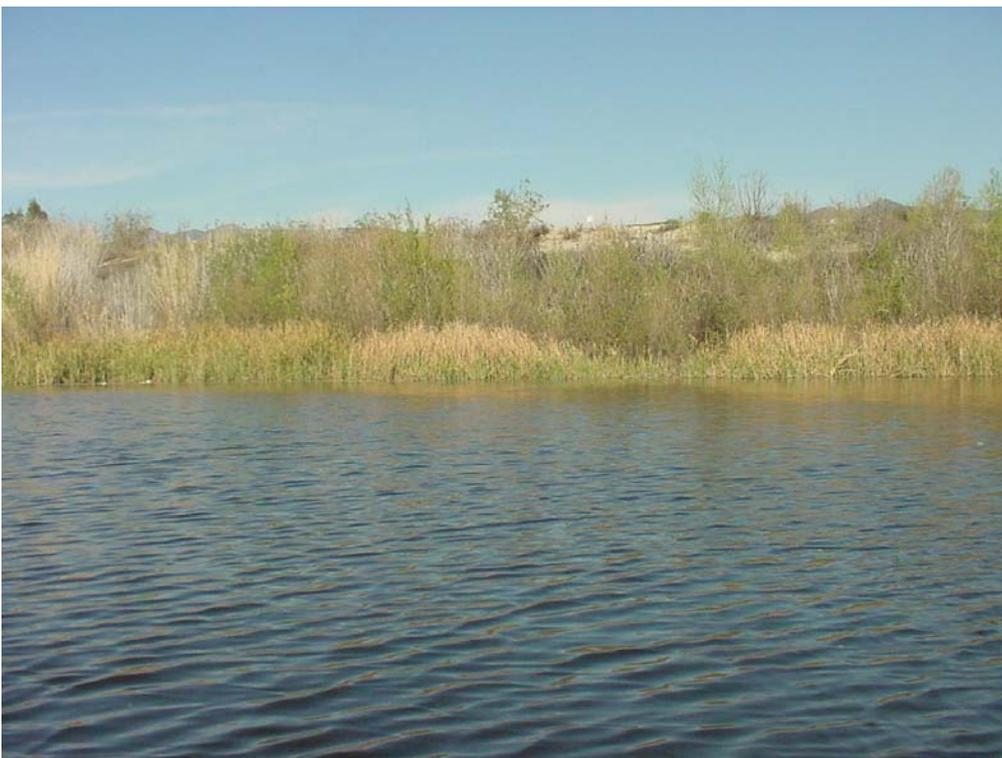
Figure 8: Views of northwest shoreline of Large Lower Lake showing tule marsh

Residents of the San Fernando Valley can now observe freshwater marsh and open water habitat above Hansen Dam. Although not a classic tule marsh, the park's wetlands harbor a diversity of aquatic plants, including tules, and a complex wildlife community that relies on these plants for food and shelter. The marsh and open water provide a window back in time of freshwater wetlands once scattered across the Valley (Figures 7, 8, 9, 10 and 11).

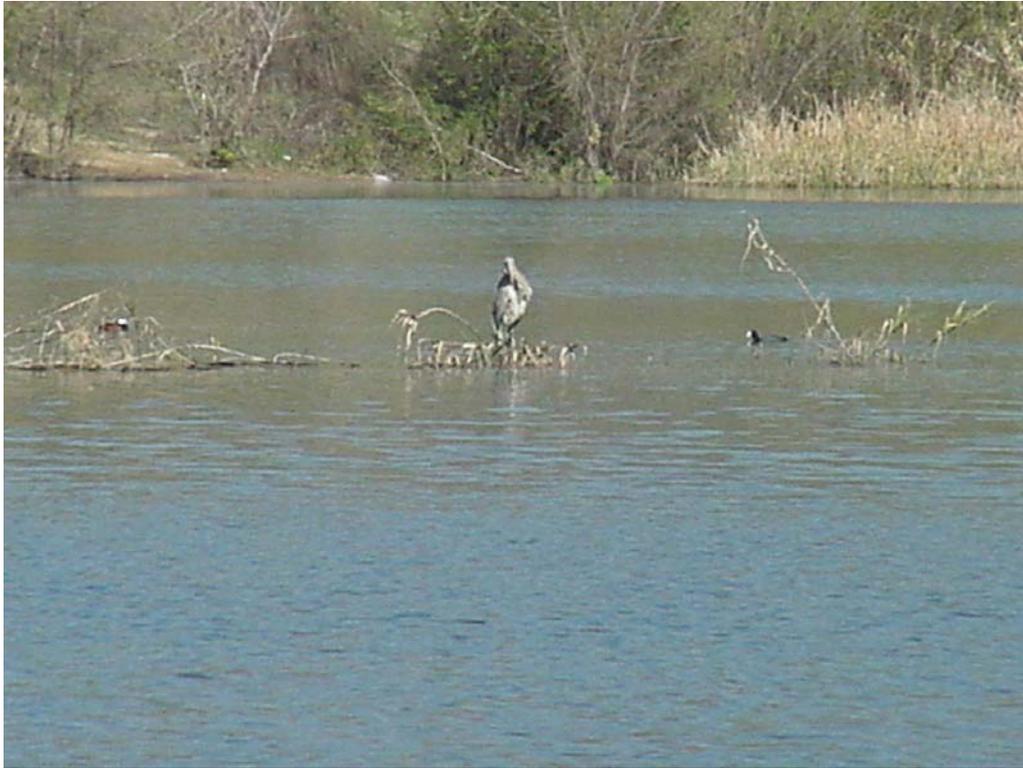
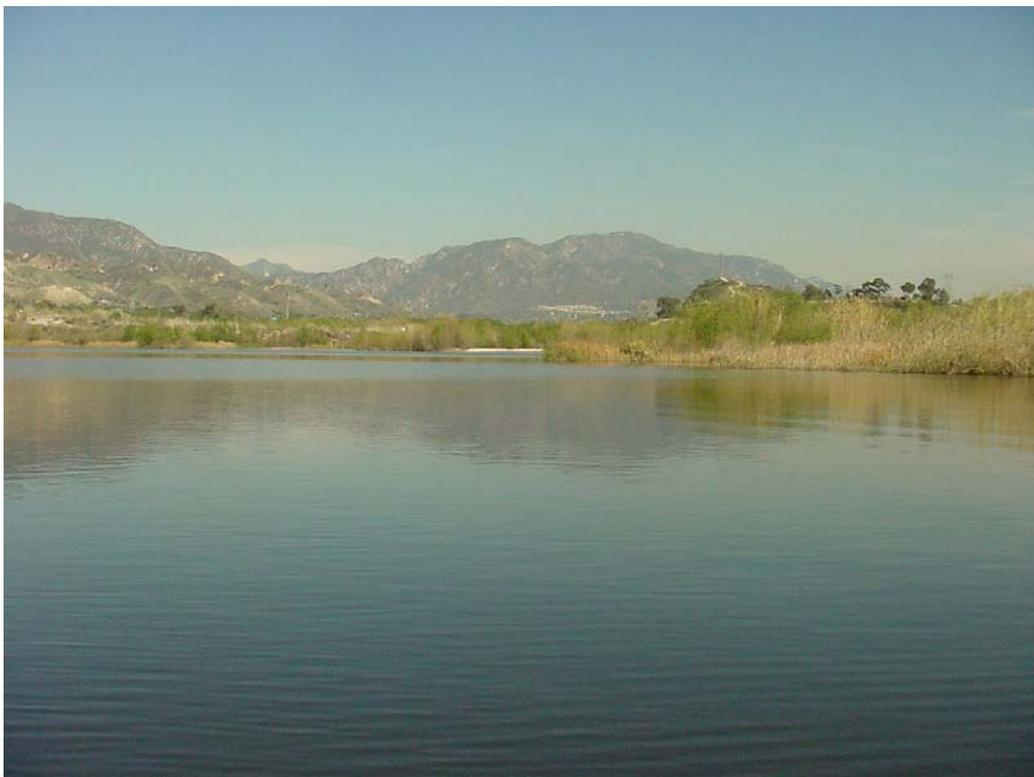
Figure 9: Views of Large Lower Lake showing tule marsh and willow margins.

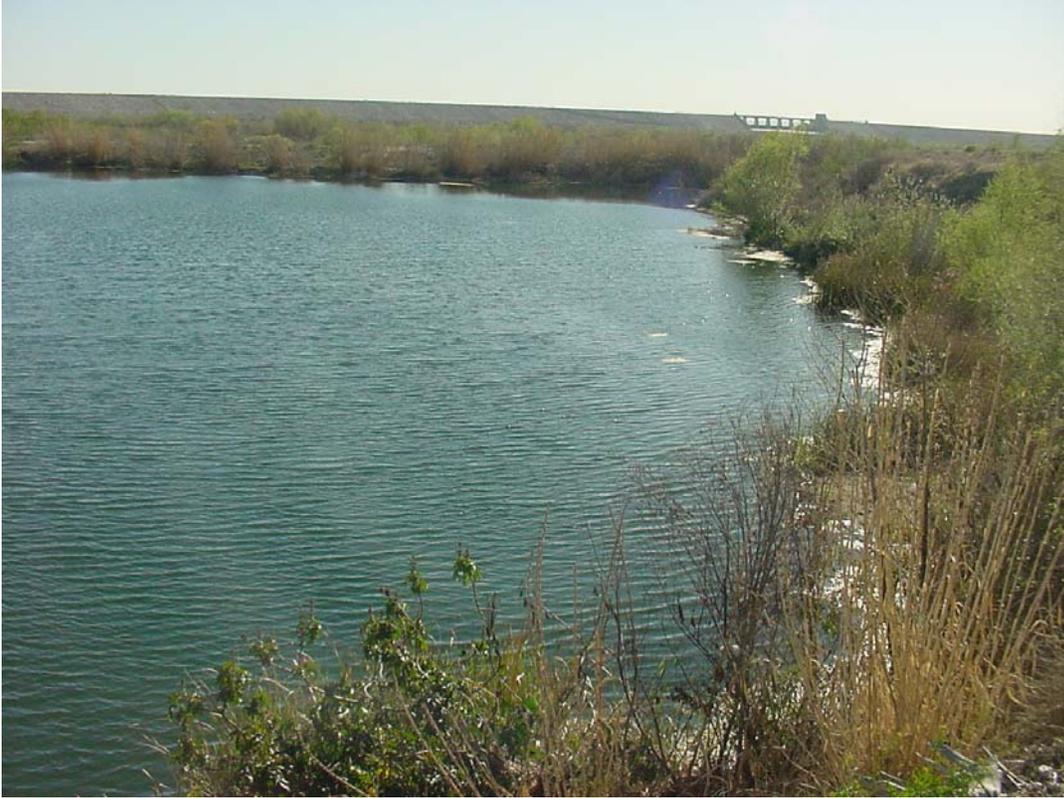
**Figure 10: View of Small Lower Lake looking south from north shore toward Hansen Dam**

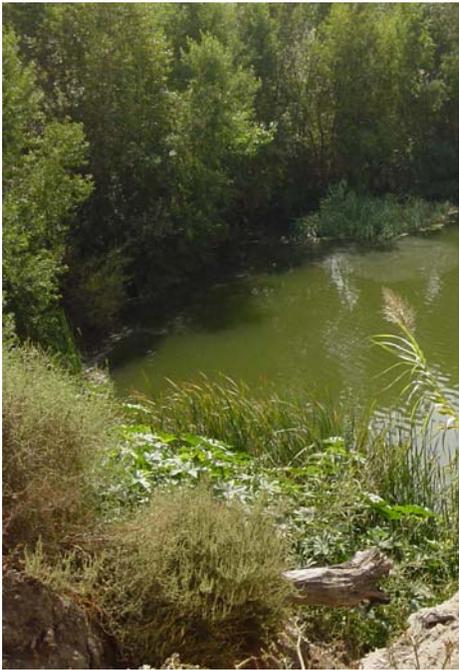
**Figure 11: Northern edge of Small Lower Lake where materials were dumped**

In the Spring of 2002, shortly after the first discharge, the Corps placed approximately 1,300 cubic yards of soil mixed with no more than 3% of dead, non-reproductive, chipped and mulched giant reed (*Arundo donax*), and a minor amount of other refuse, in the Small Lower Lake and in several piles north of the lake (Figures 15 and 16). The fill material was collected from channels in the Sepulveda and Whittier Narrows Flood Basins. The Corps cleared these flood channels as part of routine operation and maintenance measures. The fill area measures approximately 170 feet long by 100 feet wide and up to three feet deep (Figure 1). The shoreline impacted is less than 9% of the lake's entire shoreline.

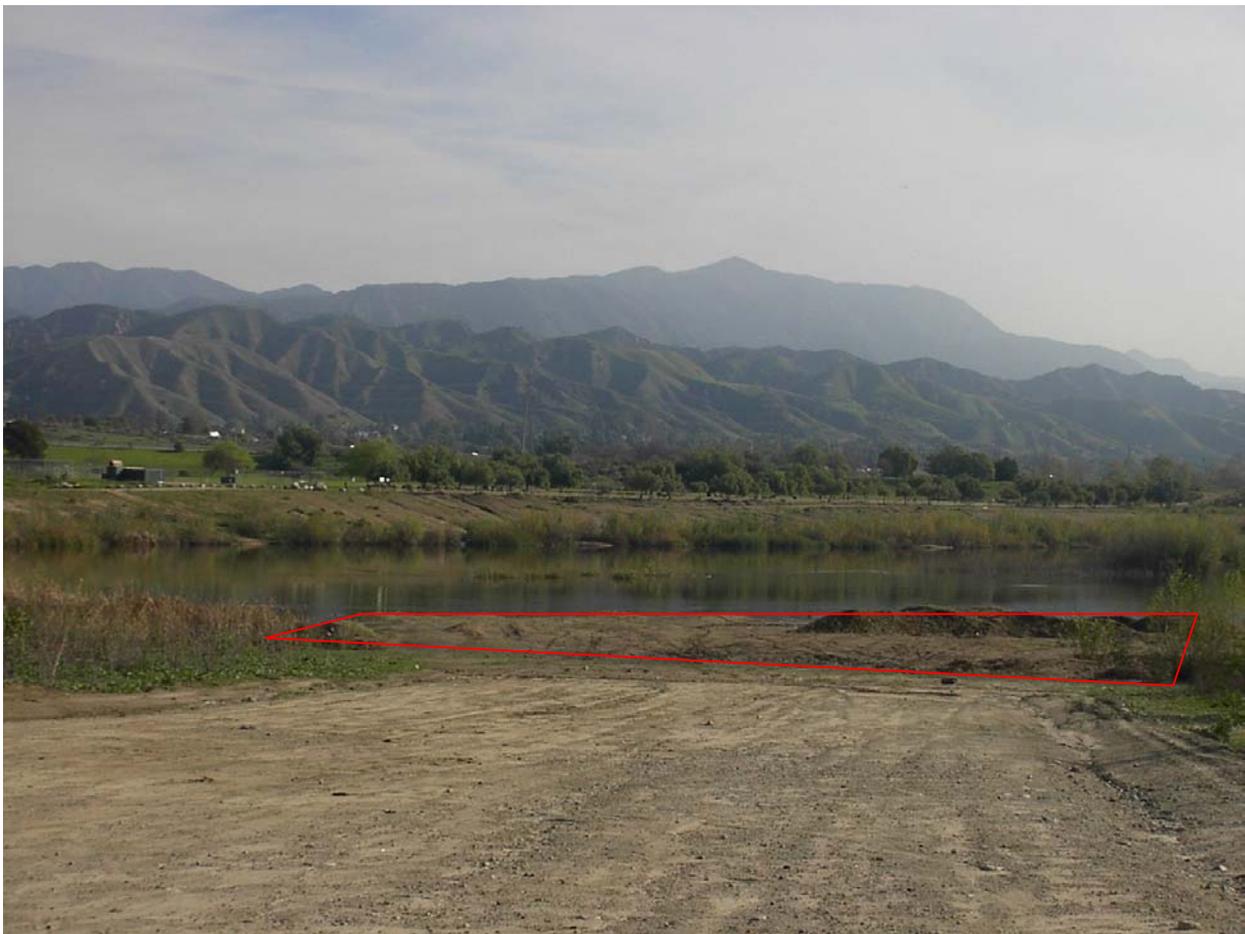
The first discharge of fill into the Lower Lakes occurred in May 2002, when approximately 1,650 cubic yards of reinforced concrete rubble were deposited in the northwestern corner (the deepest area) of the Large Lower Lake. The access ramp used to approach the lake predated the Corps' fill activities. The concrete fill material had been gathered from the bottom of the Hansen Dam Swim Lake while it was under repair. This material was capped by approximately 2,200 cubic yards of clean, native, soil from the same Swim Lake repair project. The fill area measures 150 feet long by 145 feet wide, at a maximum, and projects little more than five feet into the water (see Figures 1, 13 and 14). The shoreline impacted is less than 3% of the lake's entire shoreline.

**Figure 13: View northeast across Large Lower Lake showing deposit site at end of pre-existing access ramp, in 2002. Approximate 145 X 150 foot area of deposit outlined in red.**

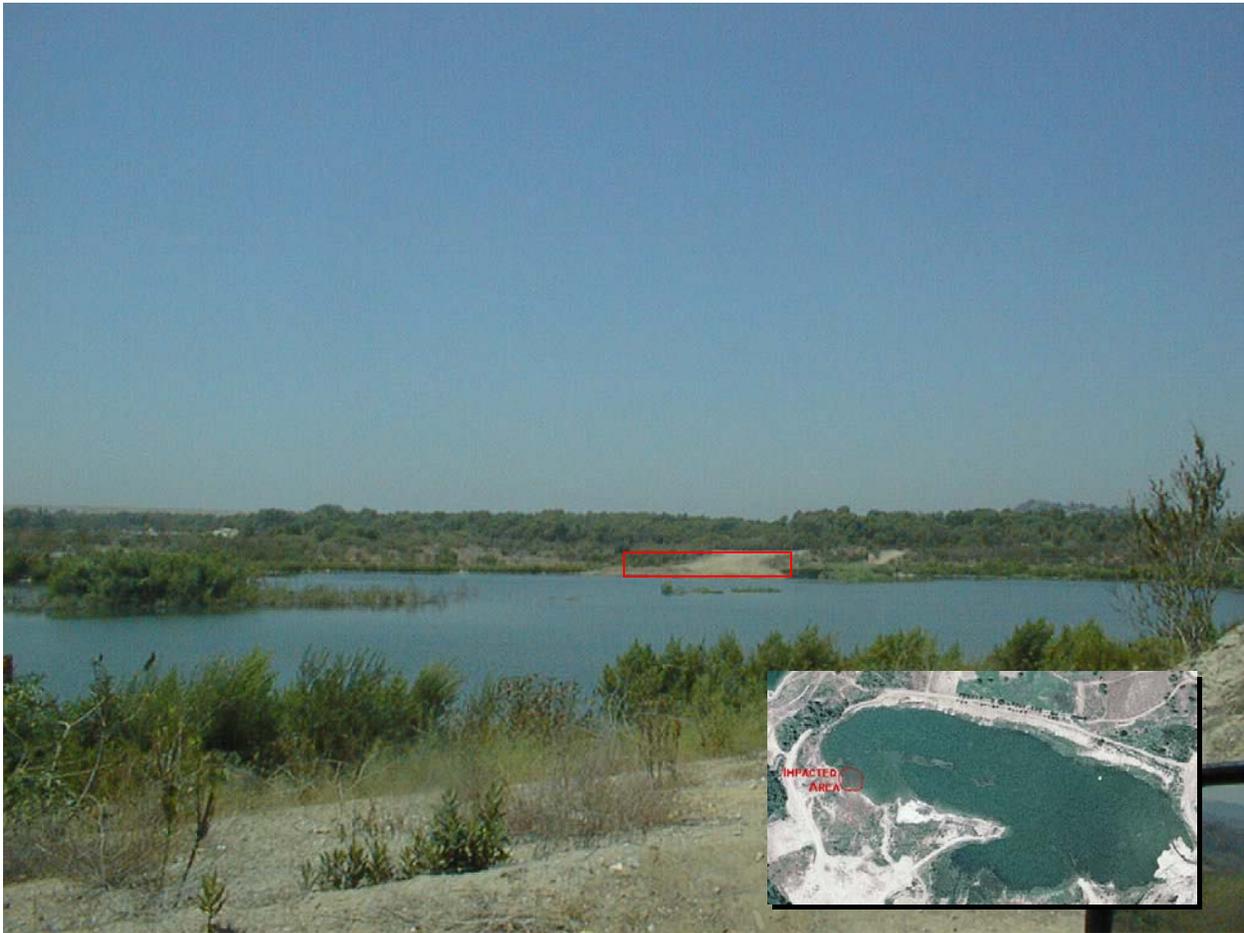
**Figure 14: View southwest across Large Lower Lake looking across toward deposit site (outlined area larger than actual disposal area).**

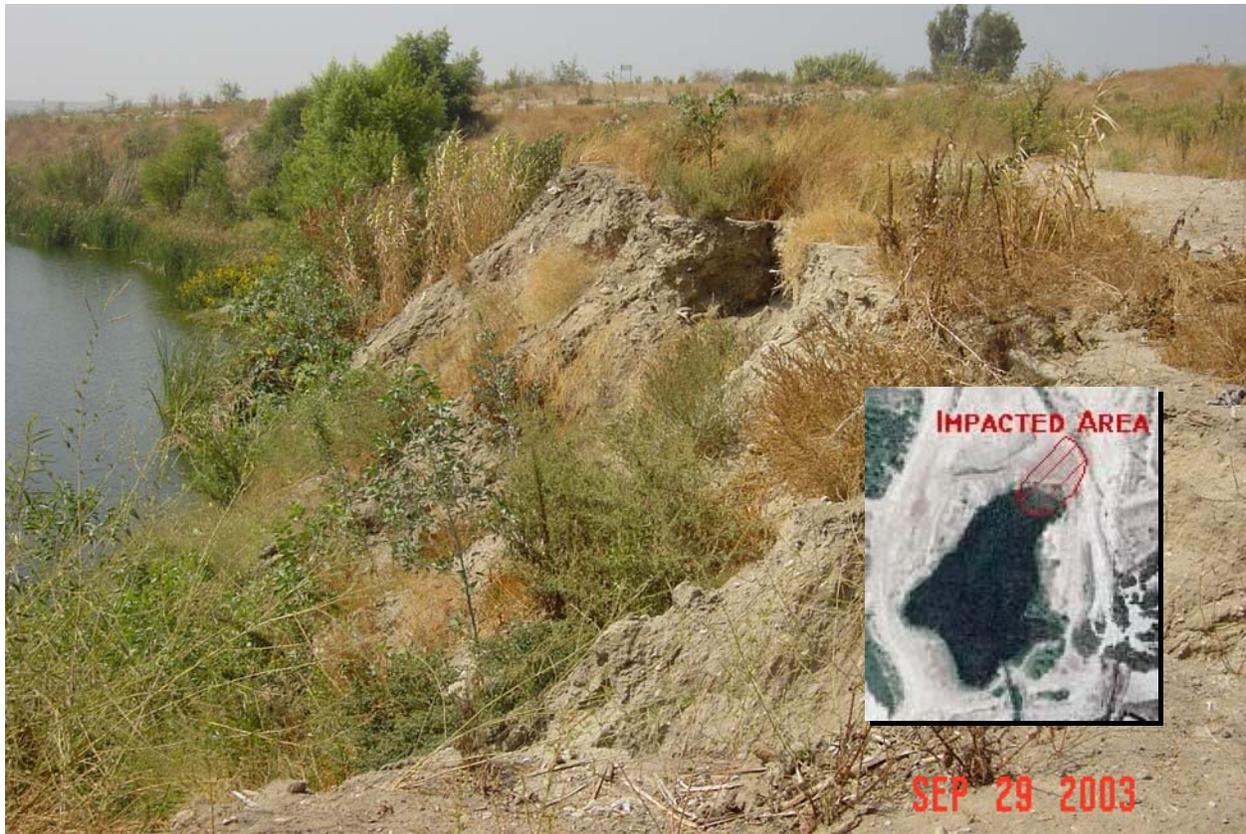
**Figure 15: Small Lower Lake. Steep, collapsing north bank. Fill deposits over bank and in piles above bank in area 170 X 100 feet (note inset aerial showing location).**

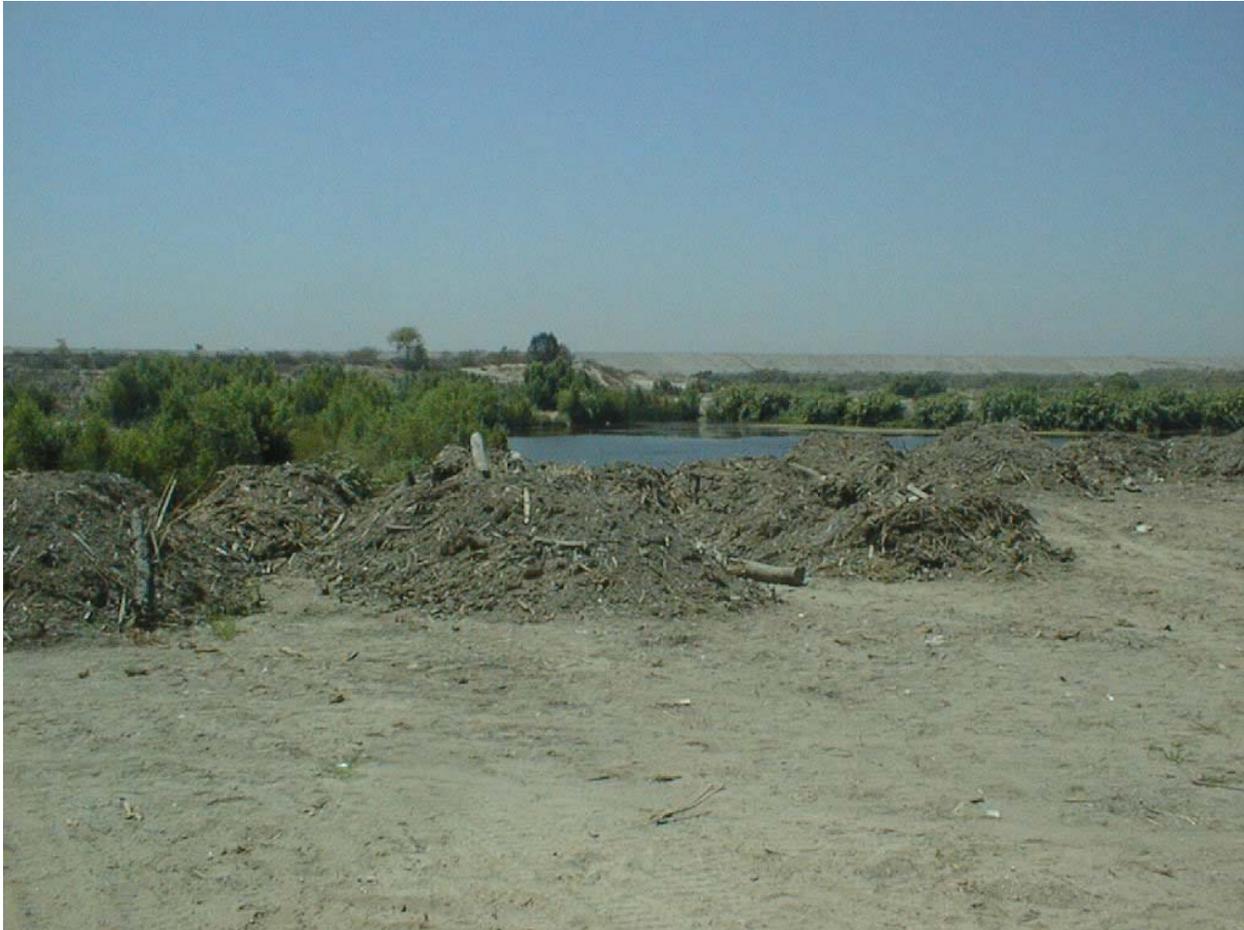
**Figure 16: Arundo deposited, and since removed, above north bluff of Small Lower Lake (view south towards Dam across lake).**

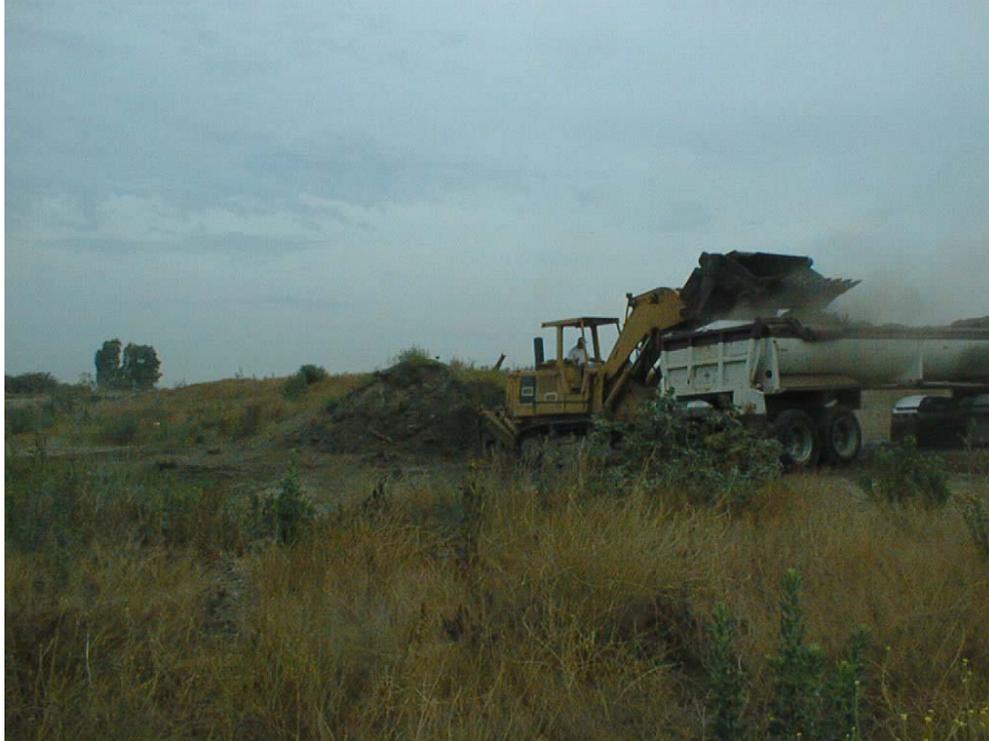
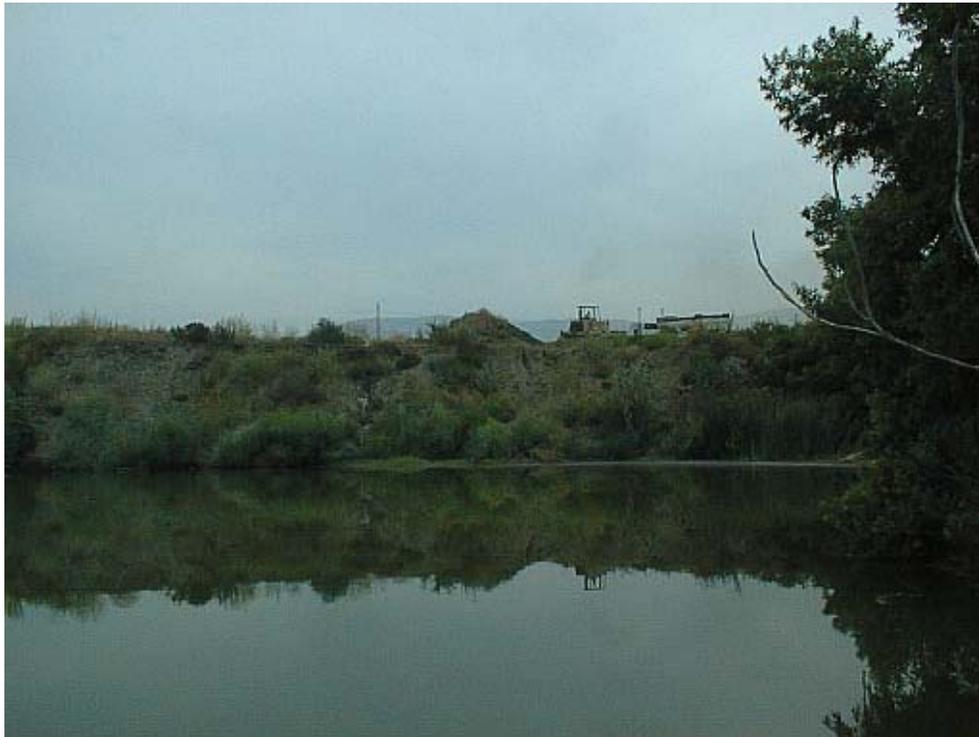
**Figure 17: Removal of fill, in July 2003, from Bluff overlooking Small Lower Lake. First view from top of lake; second looking north across lake at eroded slope and equipment on bluff.**

The Corps initiated corrective measures in the spring and summer of 2003. On July 29, 2003, approximately 150 cubic yards of material still stockpiled above and adjacent to the Small Lower Lake was removed and disposed of in a landfill (Figure 17). No material was left on the shore (Figure 18). The removal was performed with minimal disturbance to the contiguous habitat.

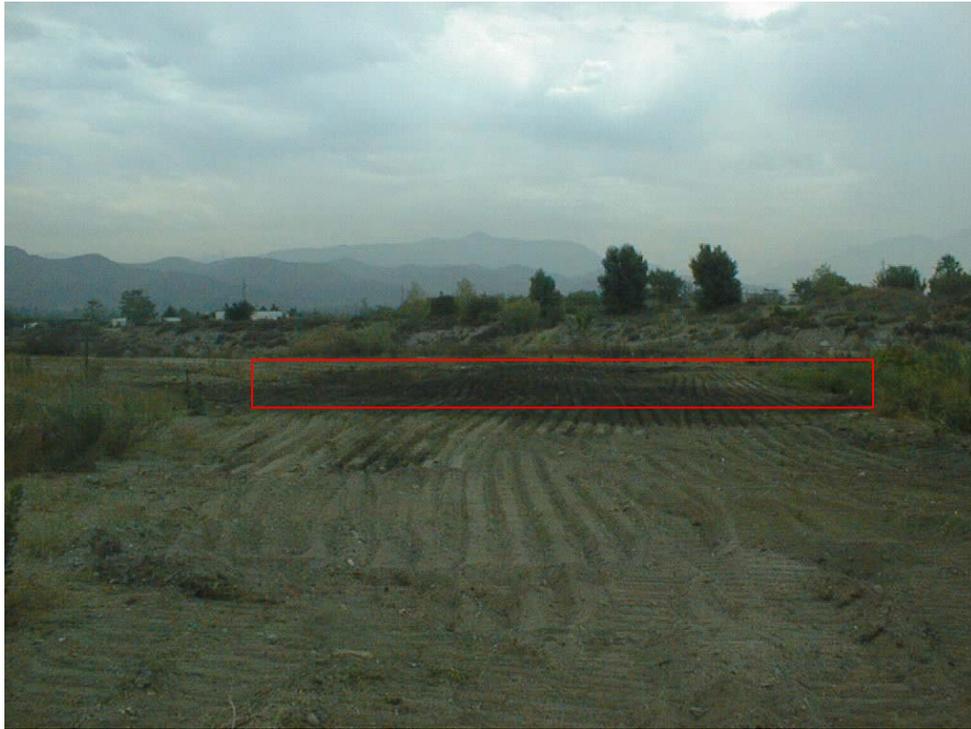
Figure 18: Cleared area above Small Lower Lake, looking northwest across area cleared of debris, and outlined in red.

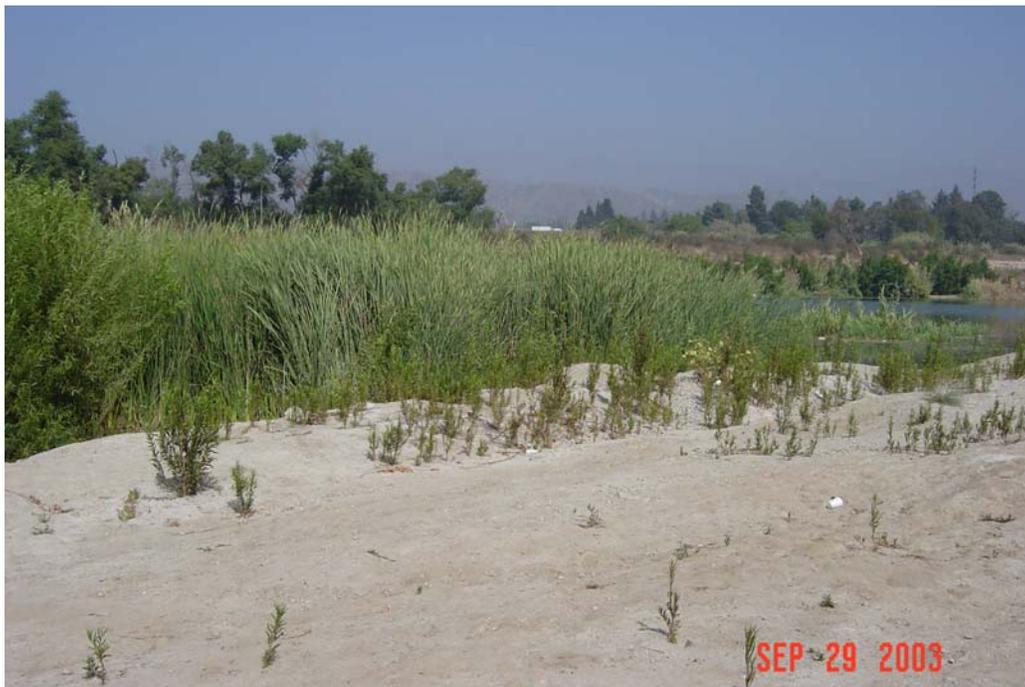
Figure 19: Note recolonized mudflat on the ramp leading to Large Lower Lake that was cleared of concrete rubble. View northwest across end of access ramp. **IV. RECENT SITE INVESTIGATIONS**

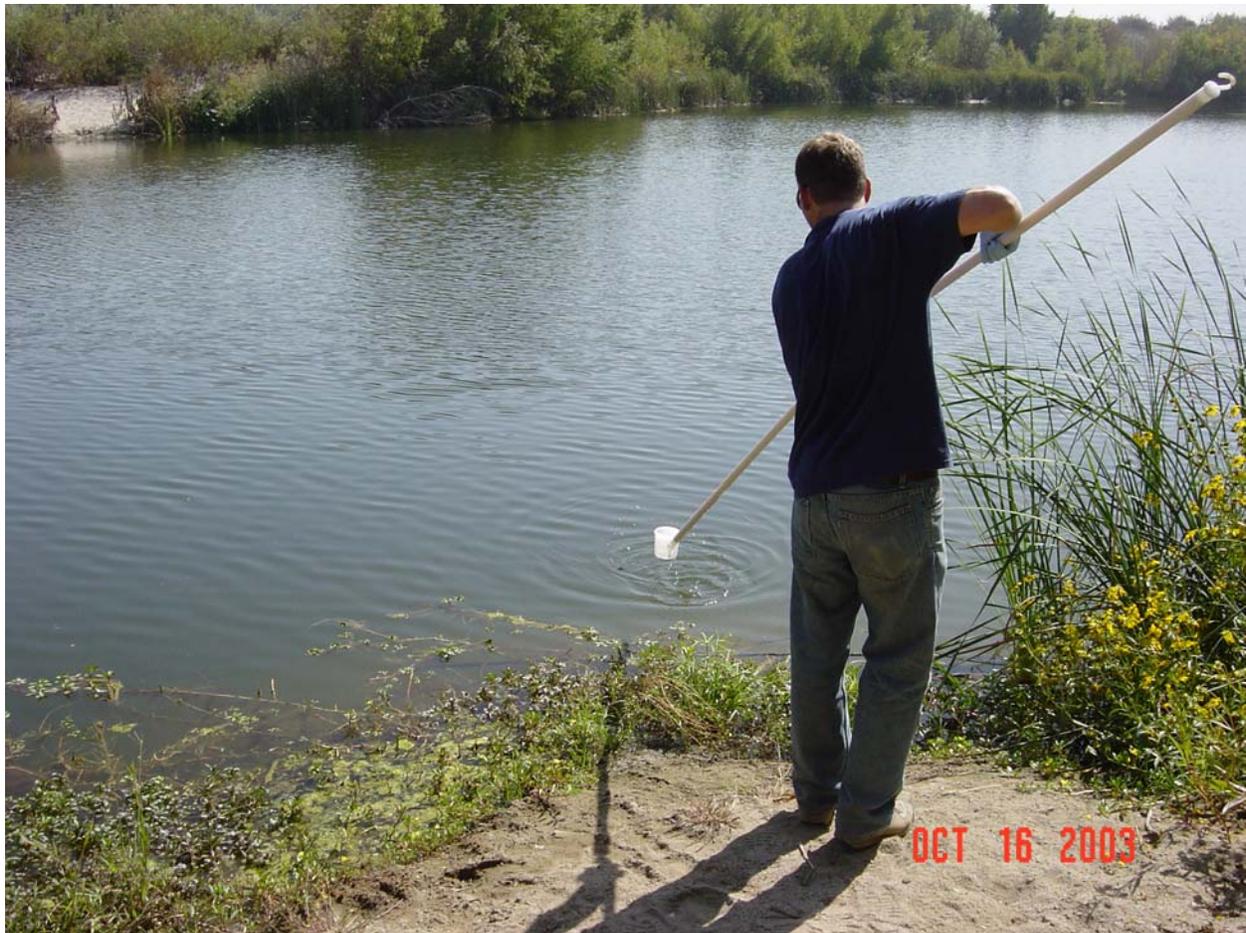
**Figure 20: Water Quality Testing**

The Regional Board's initial order questioned the results of water quality testing that the Corps submitted to the Board in its October 15, 2003 submission. In response, the Corps conducted additional water quality testing on October 16, 2003, with the assistance of SOTA, Inc. These test results were consistent with the prior test results, and indicated that levels of contaminants were no higher in the areas of the Lower Lakes where the Corps had placed fill than in upstream background water samples.

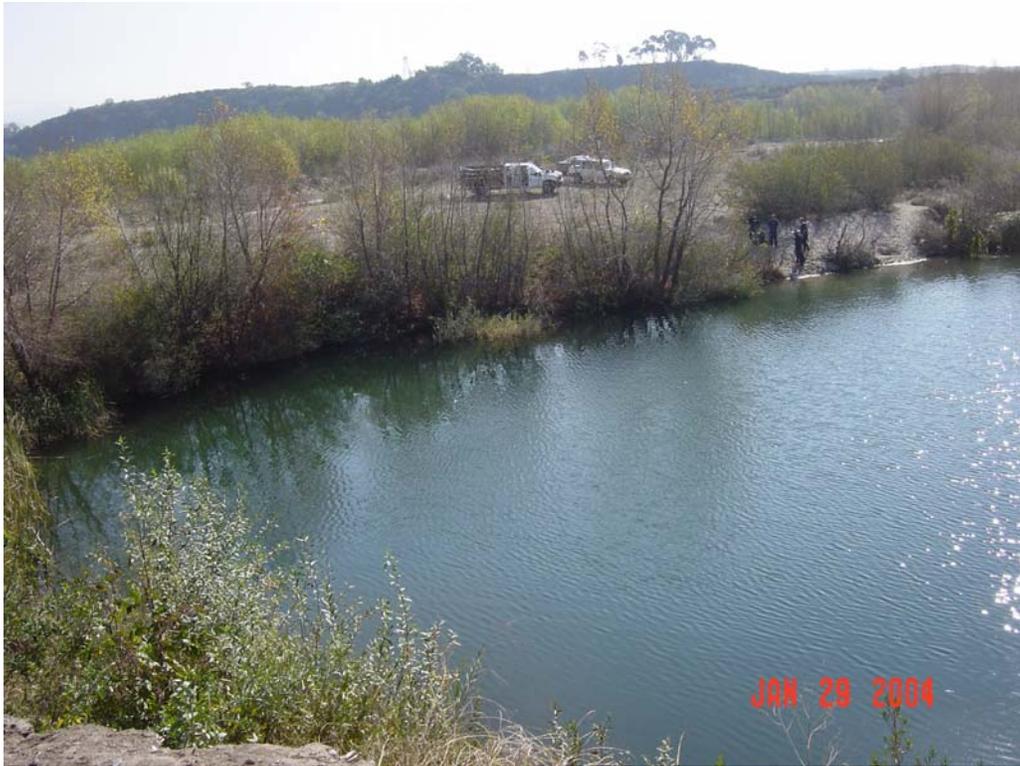
Figure 21: Views of U.S. Navy divers at Small (above) and Large (below) Lower Lakes.

On January 29, 2004, the Corps visually confirmed the extent of the areas impacted by fill activities. This visual inspection of the Lower Lakes complex was conducted with the assistance of trained U.S. Navy divers (Figure 21). Photographs of the surrounding area and of the bottom of both lakes were taken at locations that were marked with buoys to outline the extent of fill at each lake. Global Positioning System (GPS) coordinates of the buoy locations were taken to outline the fill areas. The Corps is overlaying this data on survey plots previously produced. The data collected further supports the estimates of areas impacted by filling at the Lower Lakes, as reported in the Corps' Environmental Assessment (Appendix A).

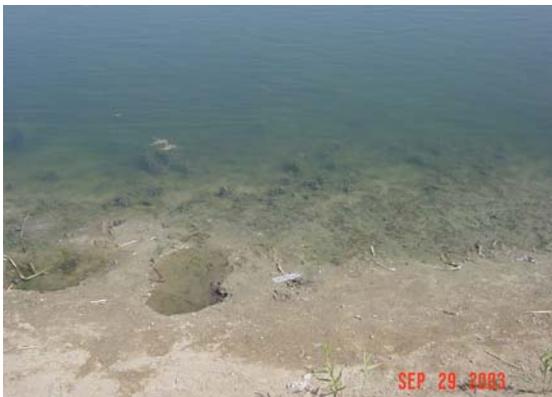
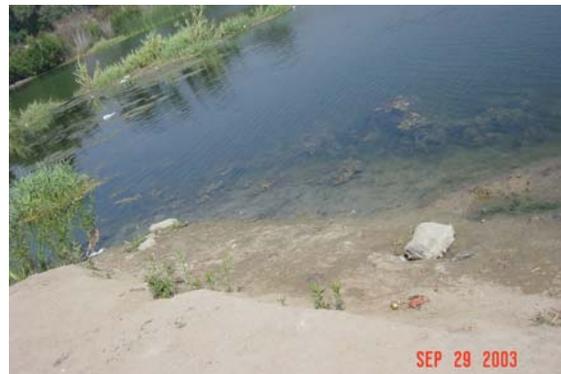
**Figure 22: Close-ups of Large Lower Lake shoreline where deposition occurred, showing colonization by algae and micro-invertebrates.**

The Corps' proposed action includes removal of up to 2,000 cubic yards of fill material from the top 3 feet of the fill area at the Large Lower Lake, and the removal of all identifiable fill material at the Small Lower Lake. Because micro-flora and fauna have colonized these shorelines and concrete rubble (Figures 22, 23), Corps and Regional Water Quality Board (RWQB) staff will work with professional biologists, on site, to determine the precise removal actions.

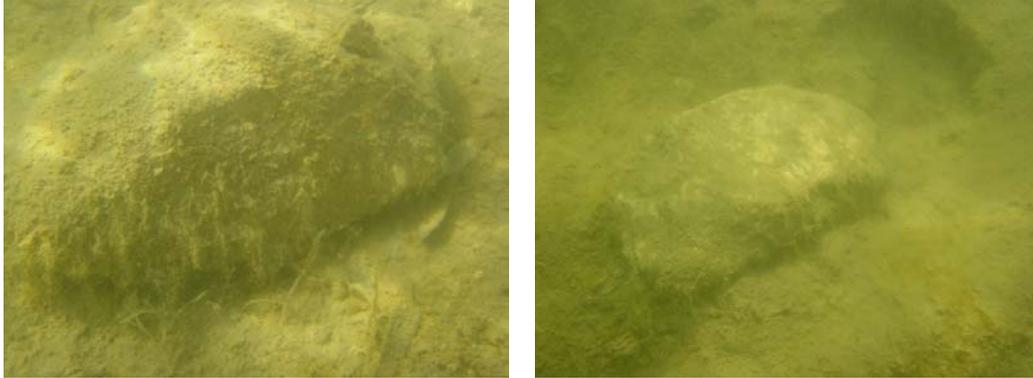
**Figure 23: Pieces of disposed concrete rubble colonized, like rocks, with algae in Large Lower Lake.**

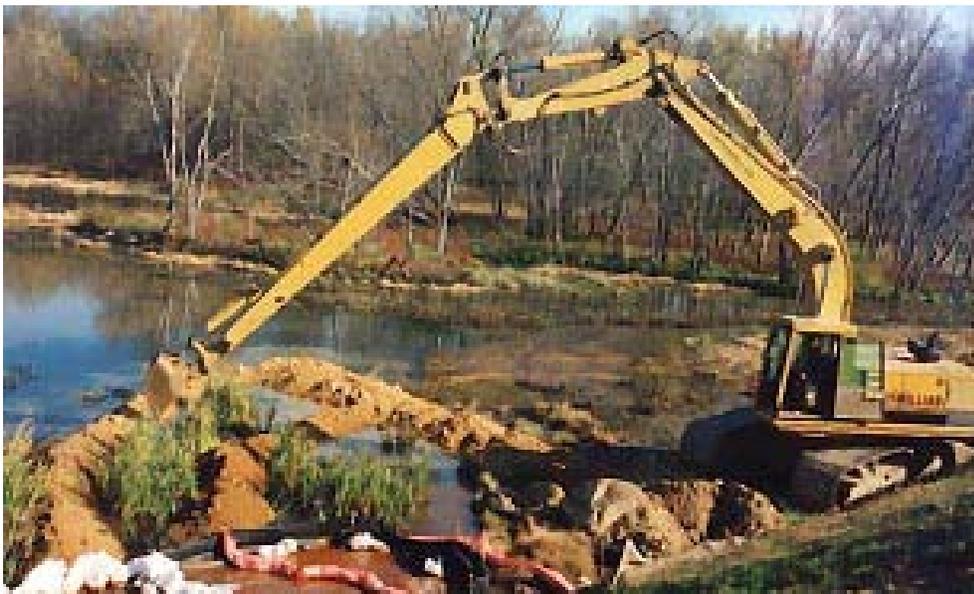
**Figure 24: Example of long-reach excavator proposed for use at Lower Lakes**

All removal actions will be accomplished using a long-reach excavator, like the one pictured in Figure 24. At each of the lakes, the excavation equipment would be positioned to minimize impacts to the surrounding habitat. Removal activities will avoid disturbing the densely vegetated fresh water marsh areas that exist at both lakes, and silt curtains will be installed during excavation to trap any suspended particulates and thus prevent adverse turbidity impacts. A tentative schedule for these activities, mitigation and follow up adaptive management measures is provided at Table 1. To ensure that the removal activities are successful, visual surveys, including photographs using the same GPS coordinates and buoy locations used for the January 29, 2004 visual survey, will be conducted. Quarterly monitoring of the water quality at both lakes would continue for one year after removal.

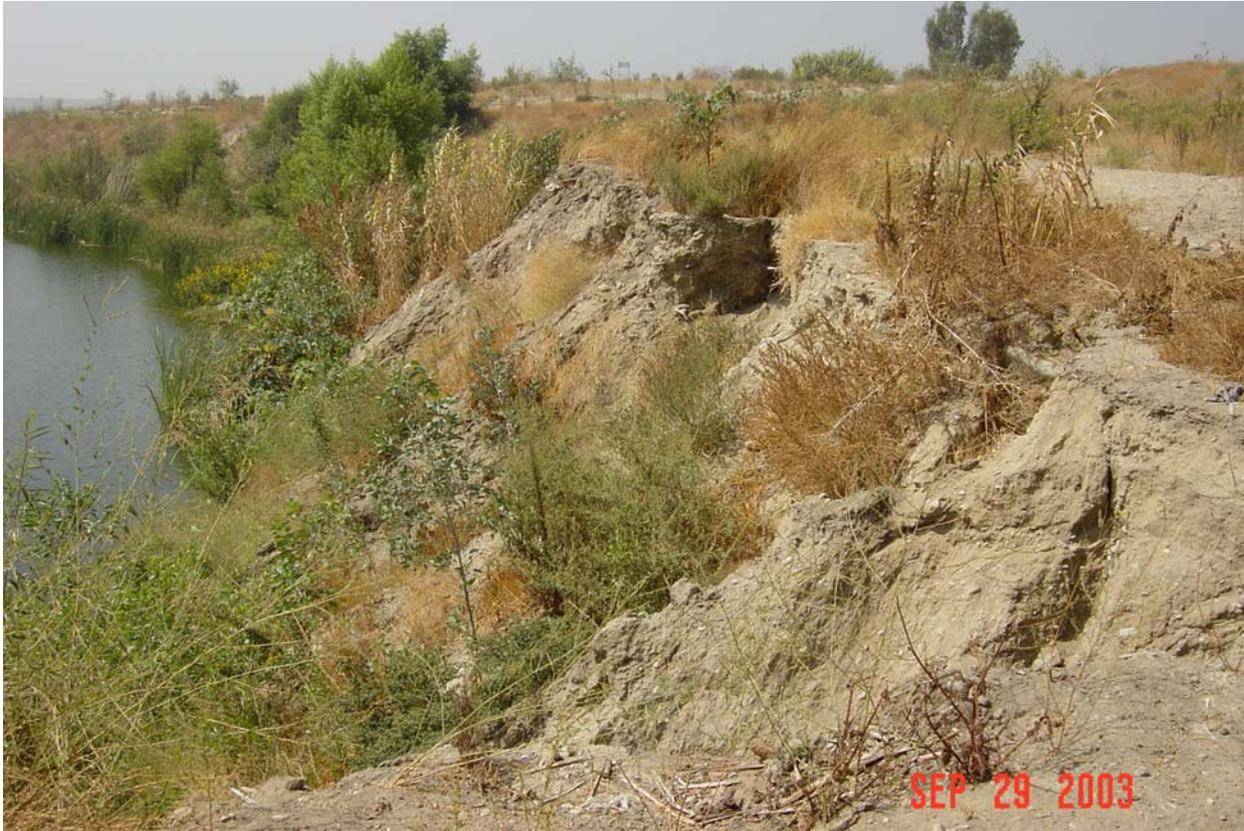
**Figure 25: Steep, collapsing north bank of Small Lower Lake and profile drawing showing proposed profile.**

At the Small Lower Lake, an access pad would be created by partially flattening the unsafely steep and eroding slope there. The bluff, now about 20-feet high, would be flattened to a slope no steeper than 3H:1V (Figure 25). A 10-foot wide bench would be created 2-feet above the waterline toe of the regraded slope, to provide for any future underwater slope adjustment. This would be accomplished through the removal of

about 1,200 CY of material from about 100 feet of shoreline. Laying back the slope would alleviate both the safety concern and promote vegetation growth.
