Channel Islands Jetty Repair Preconstruction Seagrass Survey

Pre-construction Seagrass and Canopy Kelp Surveys Report
In Support of the Channel Islands Harbor Breakwater and Jetty Repairs Project

2017-2018 CHANNEL ISLANDS HARBOR GEOTECHNICAL AND ENVIRONMENTAL INVESTIGATION PROJECT

SUPPLEMENTAL ENVIRONMENTAL ASSESSMENT FOR THE MODIFICATIONS TO THE CHANNEL ISLANDS HARBOR BREAKWATER AND JETTY REPAIR PROJECT VENTURA COUNTY, CALIFORNIA

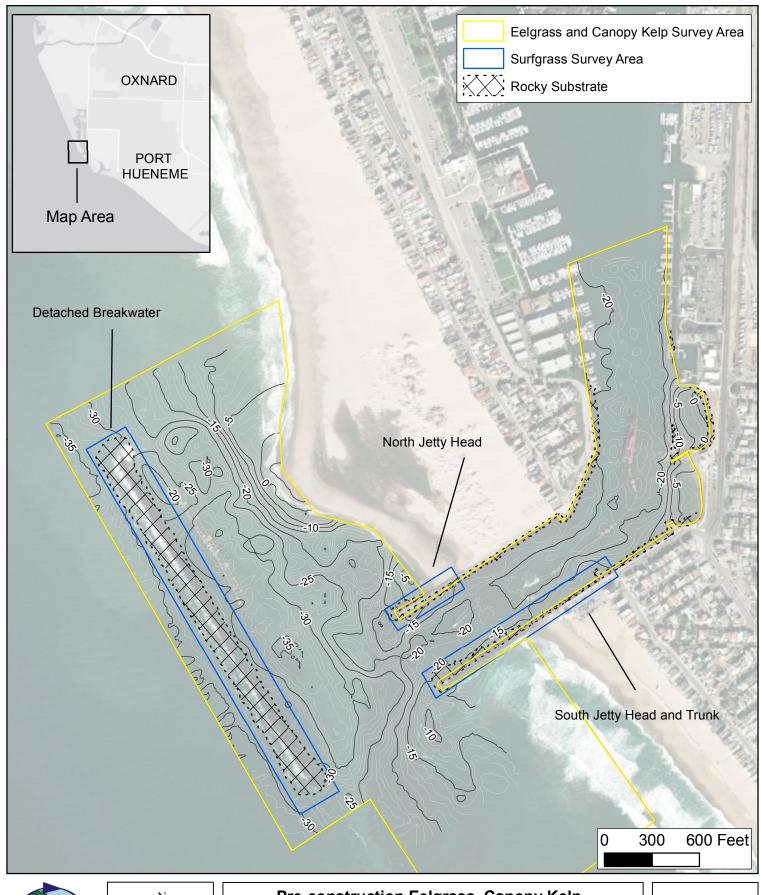
Channel Islands Harbor Breakwater and Jetty Repairs Ventura County, CA Figure 1

Pre-construction Eelgrass, Canopy Kelp, and Surfgrass Survey Areas

- **Eelgrass Survey**: A focused pre-construction eelgrass survey and mapping is to occur within the Area of Potential Effects (APE) within the Channel Islands Harbor and immediate vicinity as illustrated in Figure 1;
- **Canopy Kelp Survey**: A pre-construction canopy kelp survey, mapping, and characterization is to be completed within the APE as shown in Figure 1;
- Surfgrass Survey: A focused pre-construction surfgrass survey and mapping of the intertidal
 and subtidal areas of the detached breakwater, north and south jetties in the following
 areas: Detached Breakwater (leeward, seaward, radius of North and South heads: Station

0+00 to Station 23+00) North Jetty Head Section (channel, seaward, radius of head: Station 9+50 to Station 12+70) South Jetty Head and Trunk Section (channel, seaward, radius of head: Station 2+75 to Station 13+00). All surfgrass survey areas have been expanded to include buffers beyond the defined survey requirements. The surveyed areas are illustrated in Figure 1.

Surveys were completed within the outer federal channel areas, channel jetties and detached breakwater of Channel Islands Harbor, Ventura County, California (Figure 1).

Surfgrass surveys were completed in more discrete areas located around the individual repair areas identified within the Project. The survey areas were located at the north jetty head, the south jetty head and trunk, and over the entirety of the detached breakwater (Figure 1).

The interferometric sidescan sonar provided an acoustic backscatter image of the seafloor within the project area concurrent with collecting high-density swath bathymetric data. Interpretation of the backscatter data allowed for an assessment of the distribution of eelgrass, mapping of rocky and sandy habitats, identification of debris and structures on the bottom, and identification of bottom disturbance and hydrodynamic energy patterns on the bayfloor. Sidescan backscatter data were acquired at a frequency of 468 kHz scanning out 31 meters on both the starboard and port channels for a 62-m wide swath. ISS surveys covered the entirety of the eelgrass survey area (Figure 1).

For surfgrass surveys, the ROV was run within the surfgrass survey areas (Figure 1). Surveys were conducted by navigating the ROV in contour parallel paths along the rock starting at the jetty toe and working up the jetty face with the vessel tracking along with the ROV. Horizontal visibility during surveys was approximately 4-9 feet ahead of the ROV being visible during the transect runs. On the outside of the detached breakwater horizontal visibility was as high as 12 feet.

No surfgrass (*Phyllospadix*) was located within the surveyed areas (Figure 1) and no surfgrass was noted anecdotally outside of the surveyed areas. The survey area ranged as deep as -33 feet up to middle intertidal elevations. The survey area generally supported typical intertidal zonation patterns with a mussel and barnacle zone. At the lower intertidal zones, rock supports a combination of turf, foliose, and coralline algae. Within the more protected portions of the survey

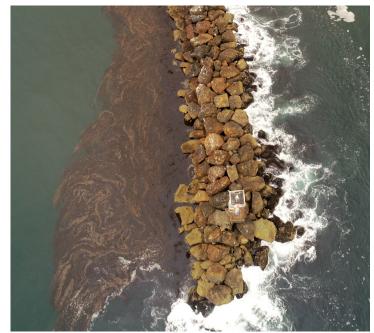
Low altitude photo of the detatched breakwater showing a dense monotypic bed of feather boa kelp (Egregia menziesii)

zone are monotypic beds of feather boa kelp (*Egregia menziesii*).

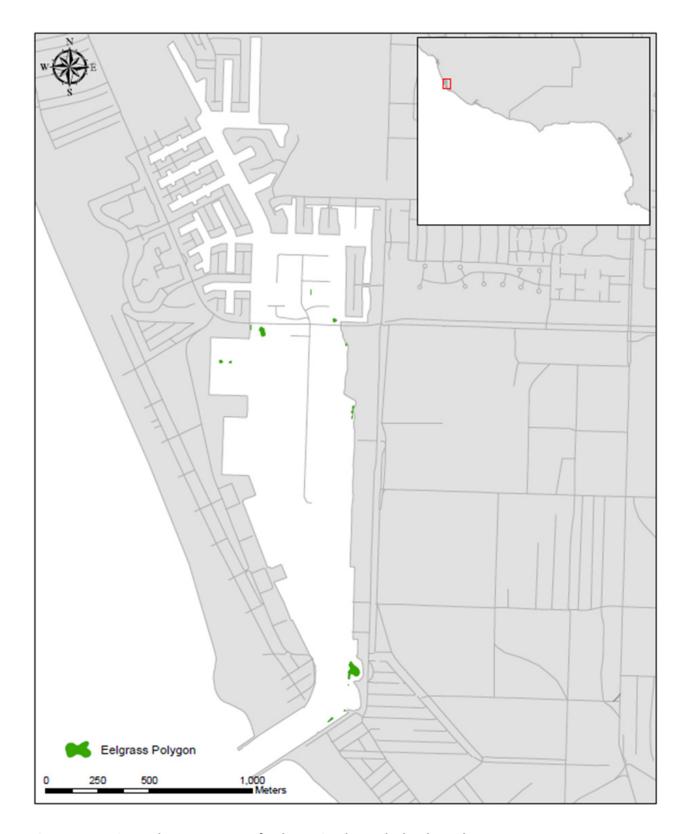
Figure 2. Maximum known extent of eelgrass in Channel Islands Harbor 2005

No eelgrass (*Zostera marina* or *Zostera pacifica*) was found within the eelgrass survey area. These results follow those noted during April 2020 surveys for U.S. Coast Guard Station Channel Islands Harbor (Merkel & Associates 2020). However, the results in the 2020 surveys differ from a prior harborwide survey completed in 2005 which found scattered eelgrass in the harbor, including eelgrass within the coves occupied by Hobie Beach and Kiddie Beach (Figure 2).

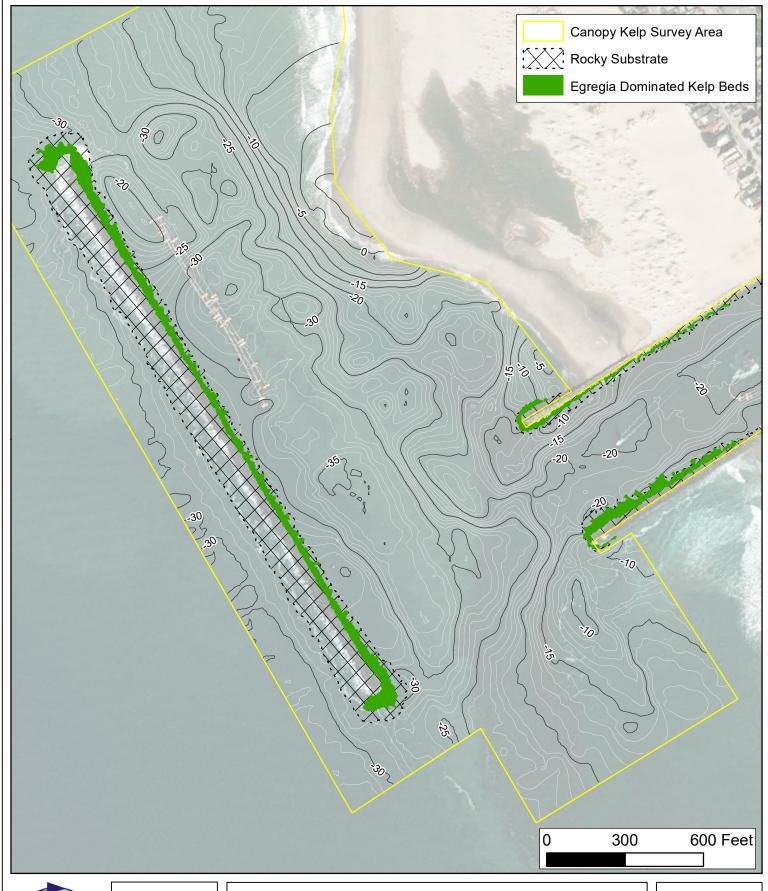
Channel Islands Harbor Breakwater and Jetty Repairs Ventura County, CA Figure 3

Pre-construction Canopy Kelp - September 2020

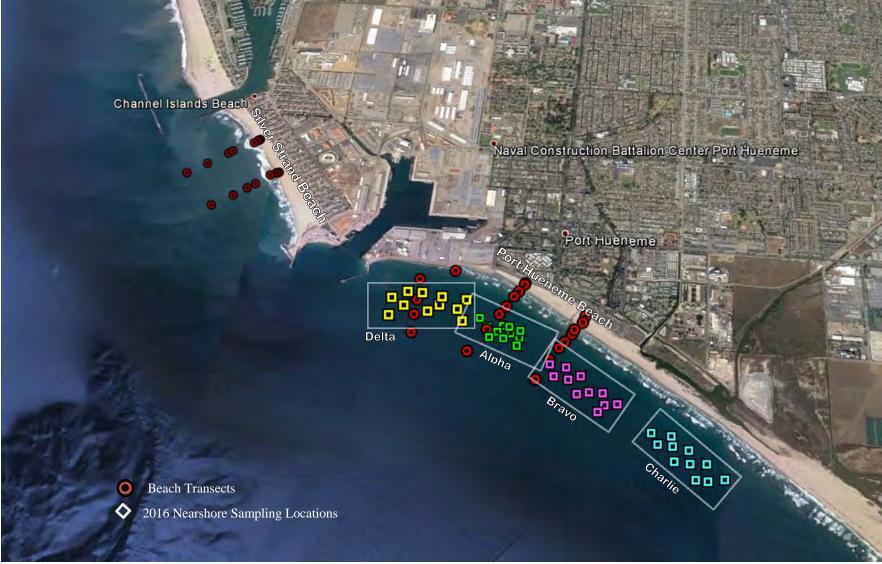
Figure 6. Location of Silver Strand Beach Sampling Transects and the 2016 Hueneme Beach Sampling Transects and Nearshore Sampling Locations.
