**SUPPLEMENTAL
ENVIRONMENTAL ASSESSMENT

CHANNEL ISLANDS HARBOR
BREAKWATER AND JETTY REPAIR PROJECT
Ventura County, California**

U.S. ARMY CORPS OF ENGINEERS
SOUTH PACIFIC DIVISION
LOS ANGELES DISTRICT**

February, 2021

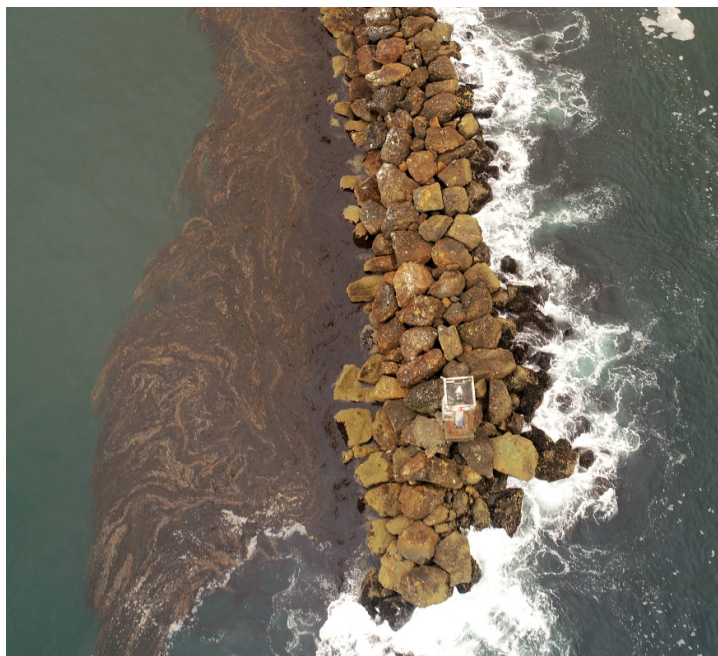
Low altitude photo of the detached breakwater showing a dense monotypic bed of feather boa kelp (*Egregia menziesii*)

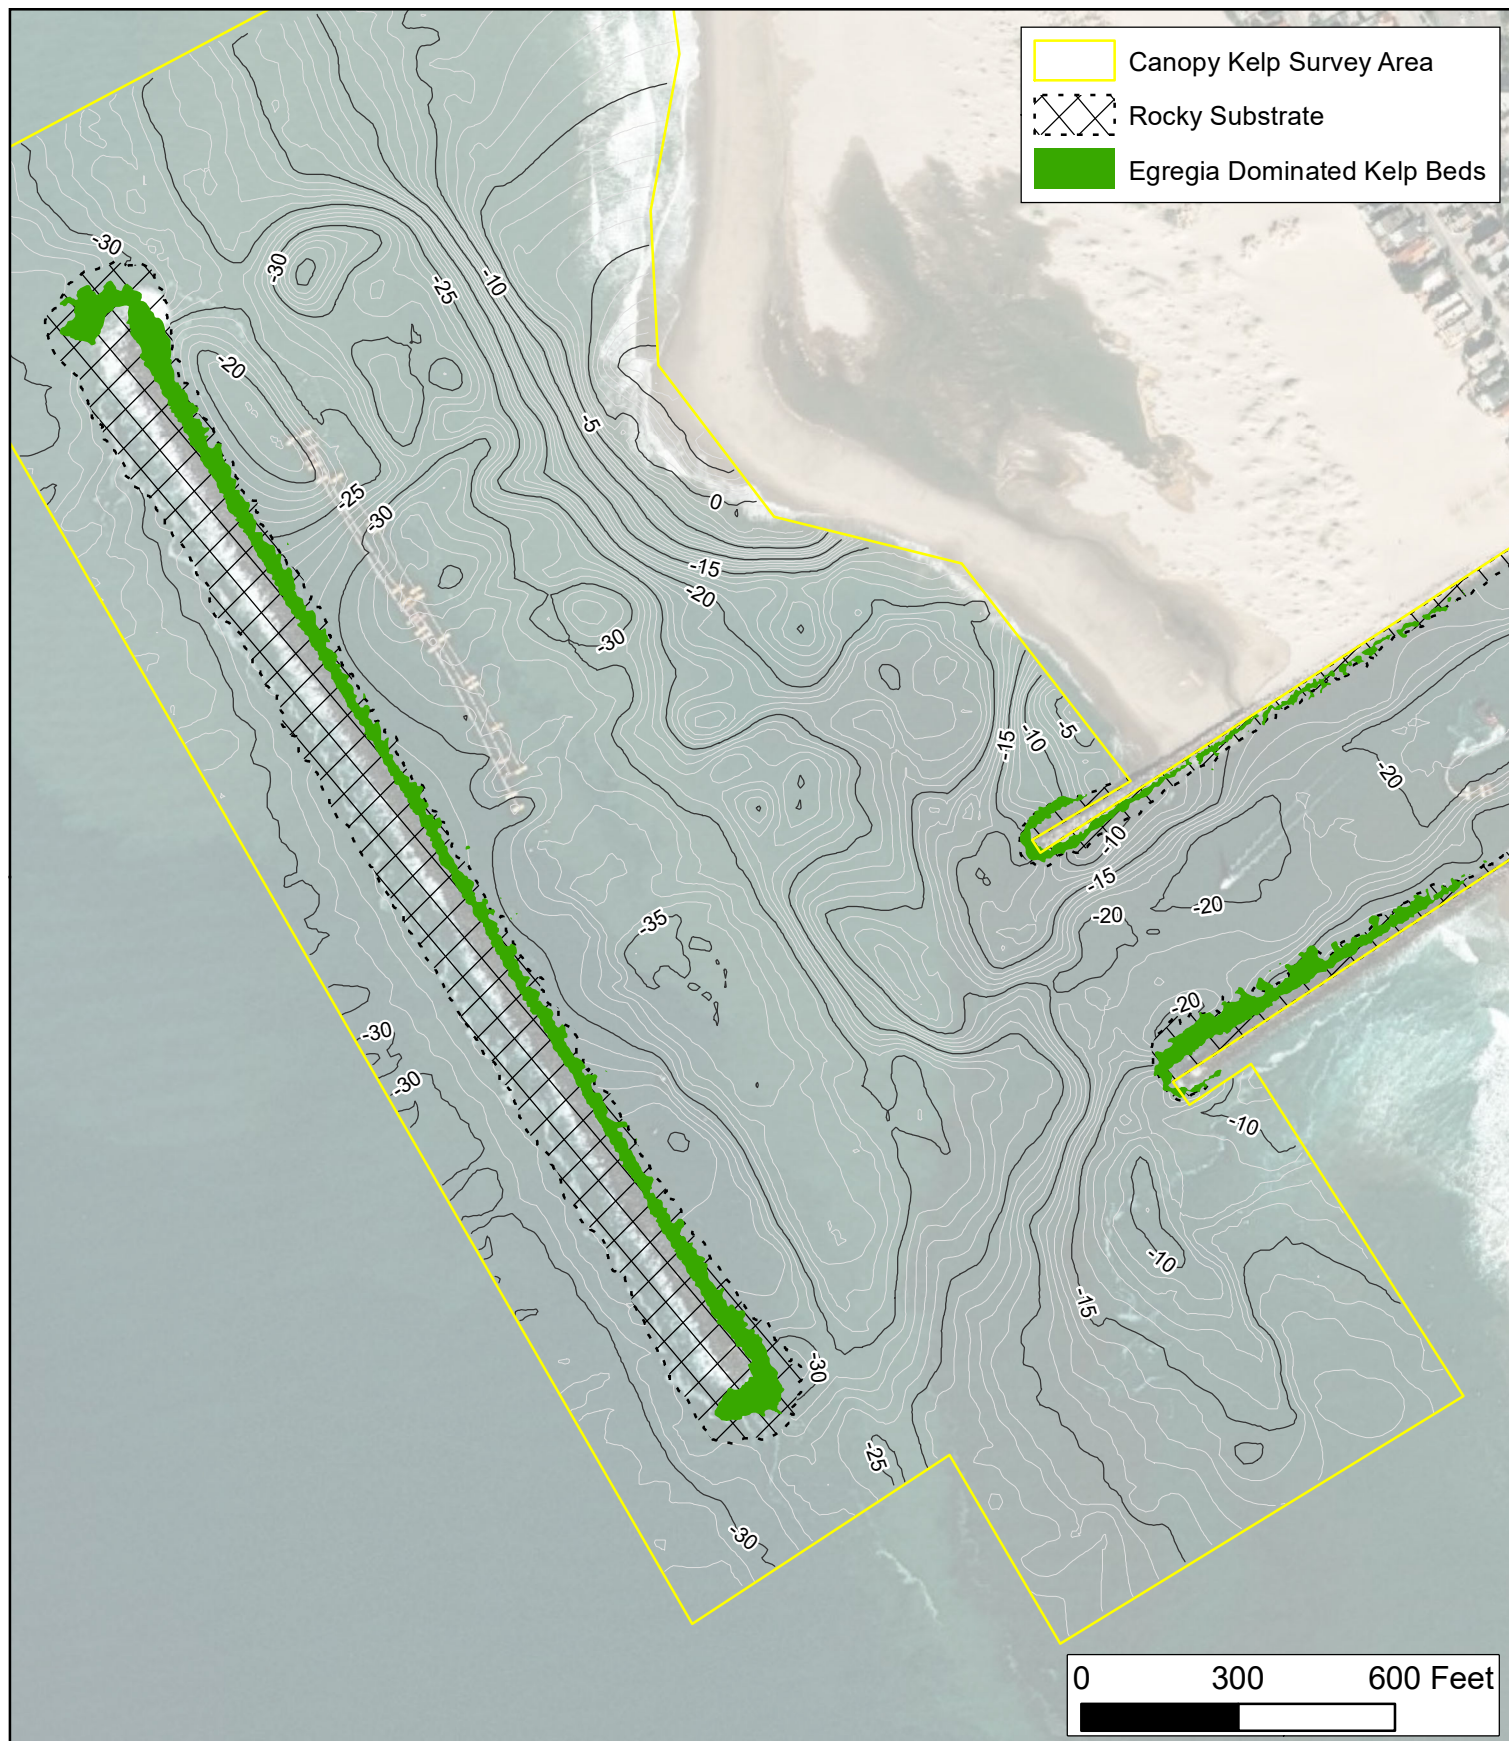
Figure 3

Pre-construction Canopy Kelp - September 2020

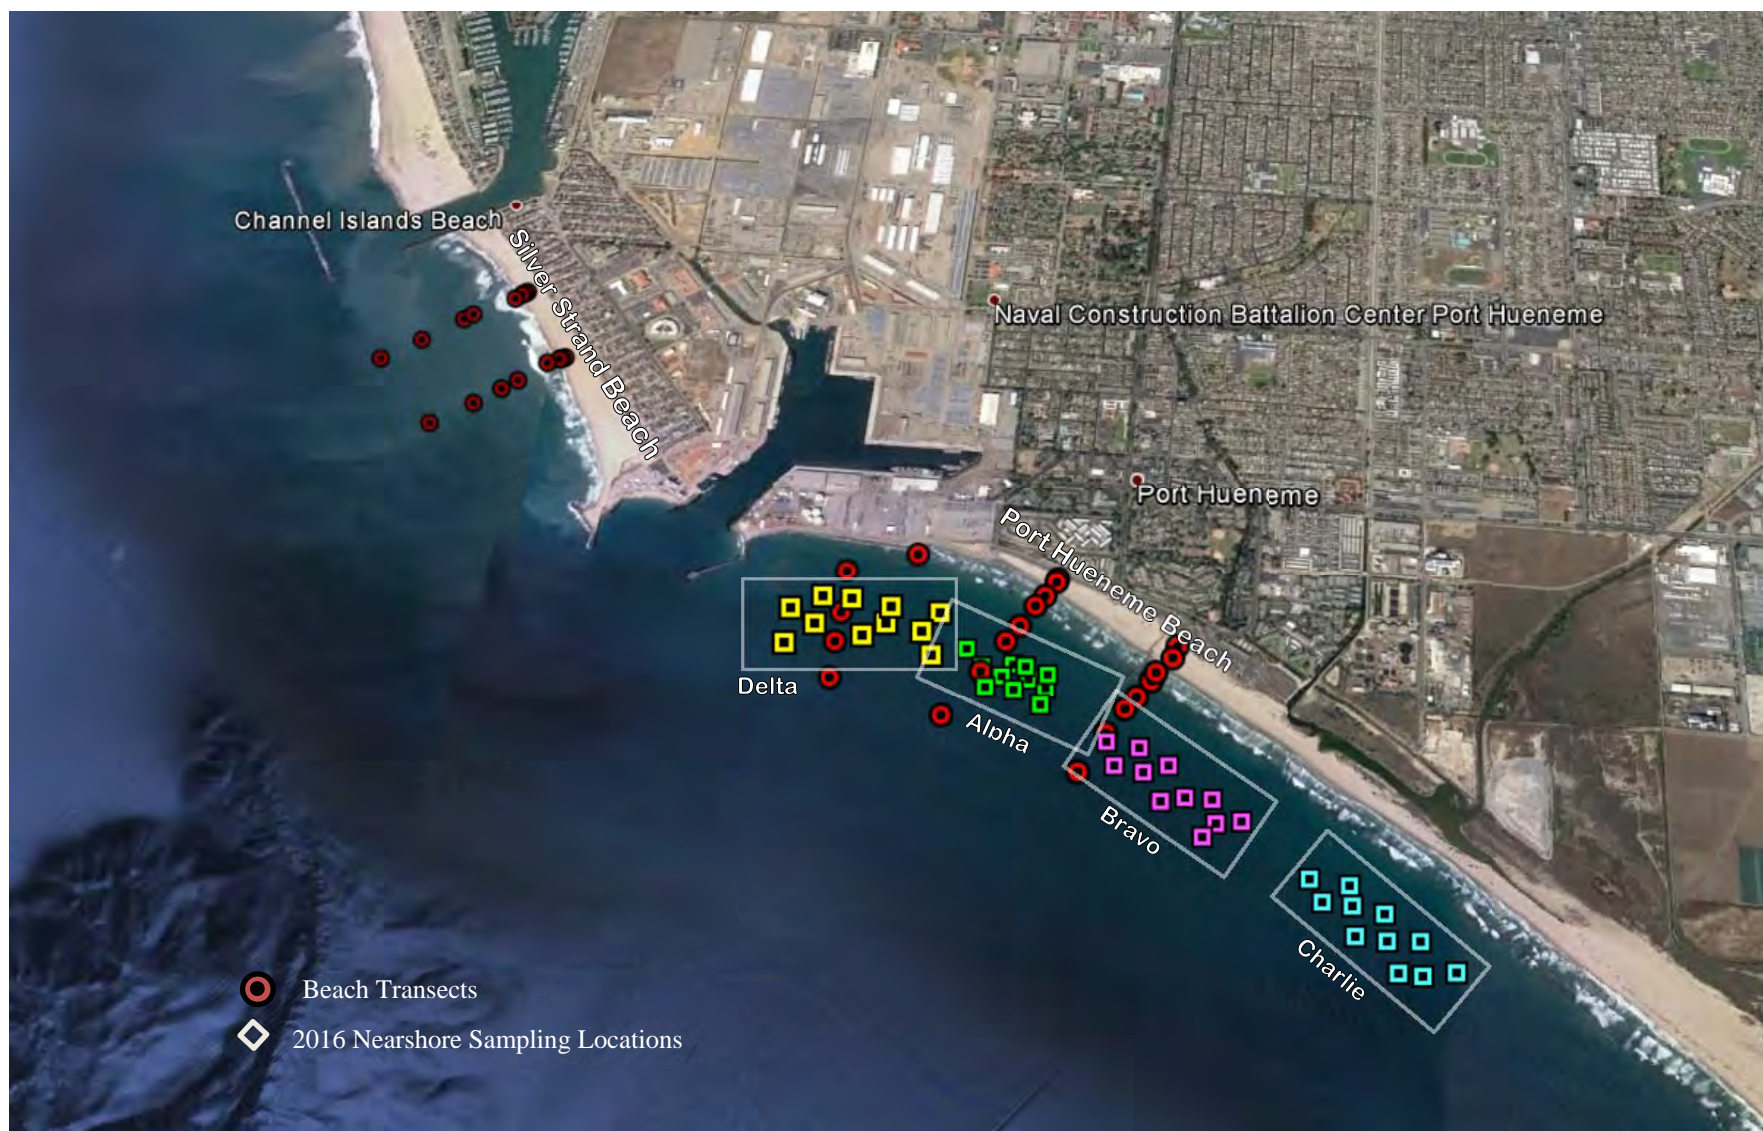
Figure 6. Location of Silver Strand Beach Sampling Transects and the 2016 Hueneme Beach Sampling Transects and Nearshore Sampling Locations.
