Figure 1-1. The San Diego Creek Watershed Special Area Management Plan area in Orange County, California.

Figure 1-2. Subwatersheds comprising the San Diego Creek Watershed.

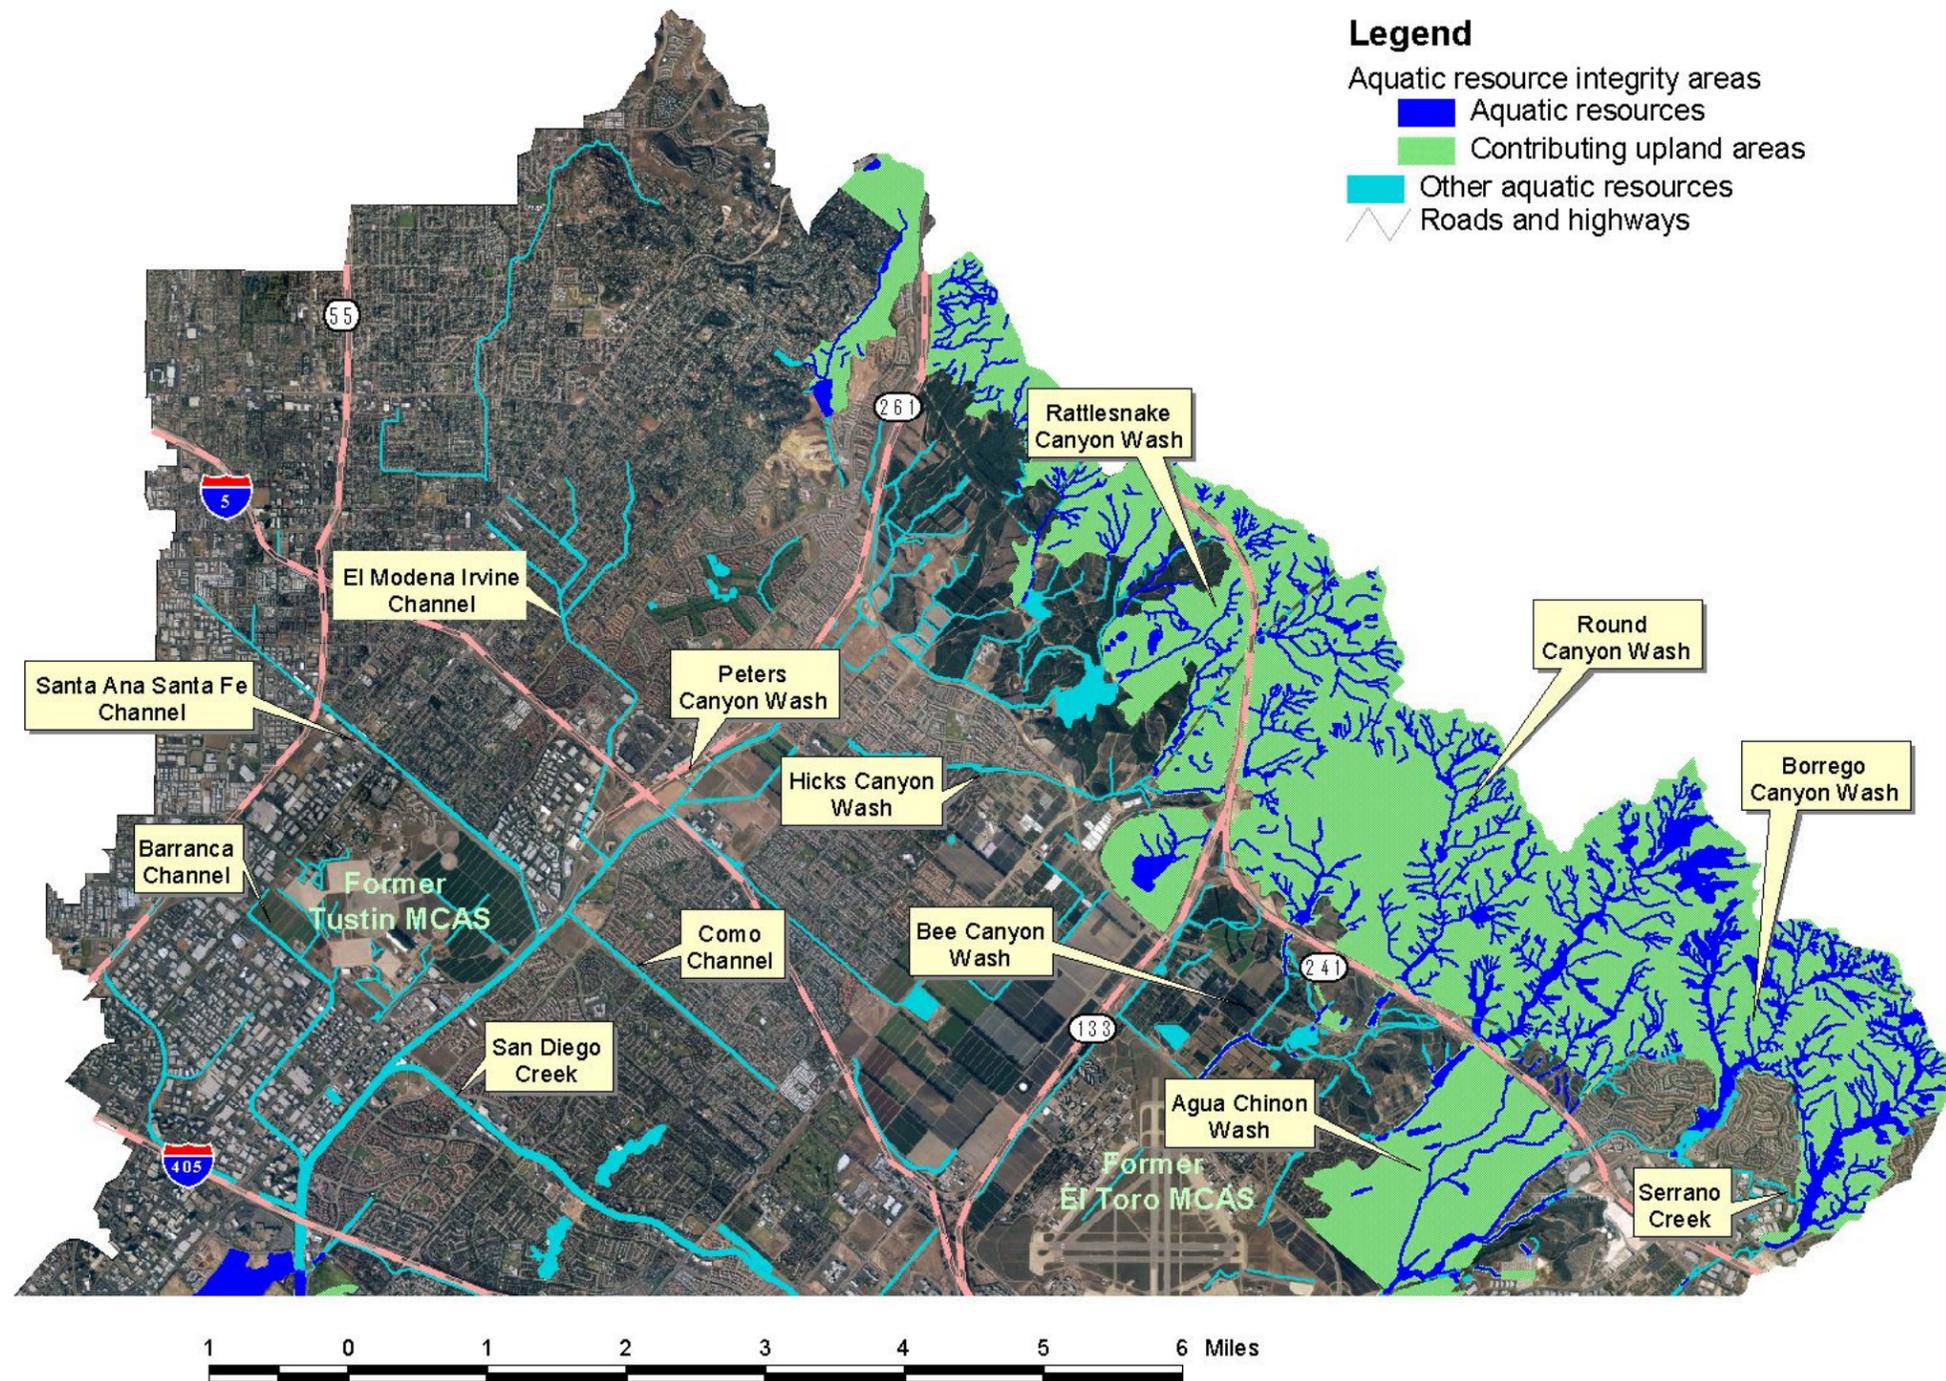
Figure 2-1. SAMP Analytical Framework was applied to identify aquatic resource integrity areas, including aquatic resources and their contributing upland area, in the northern portion of the Watershed.

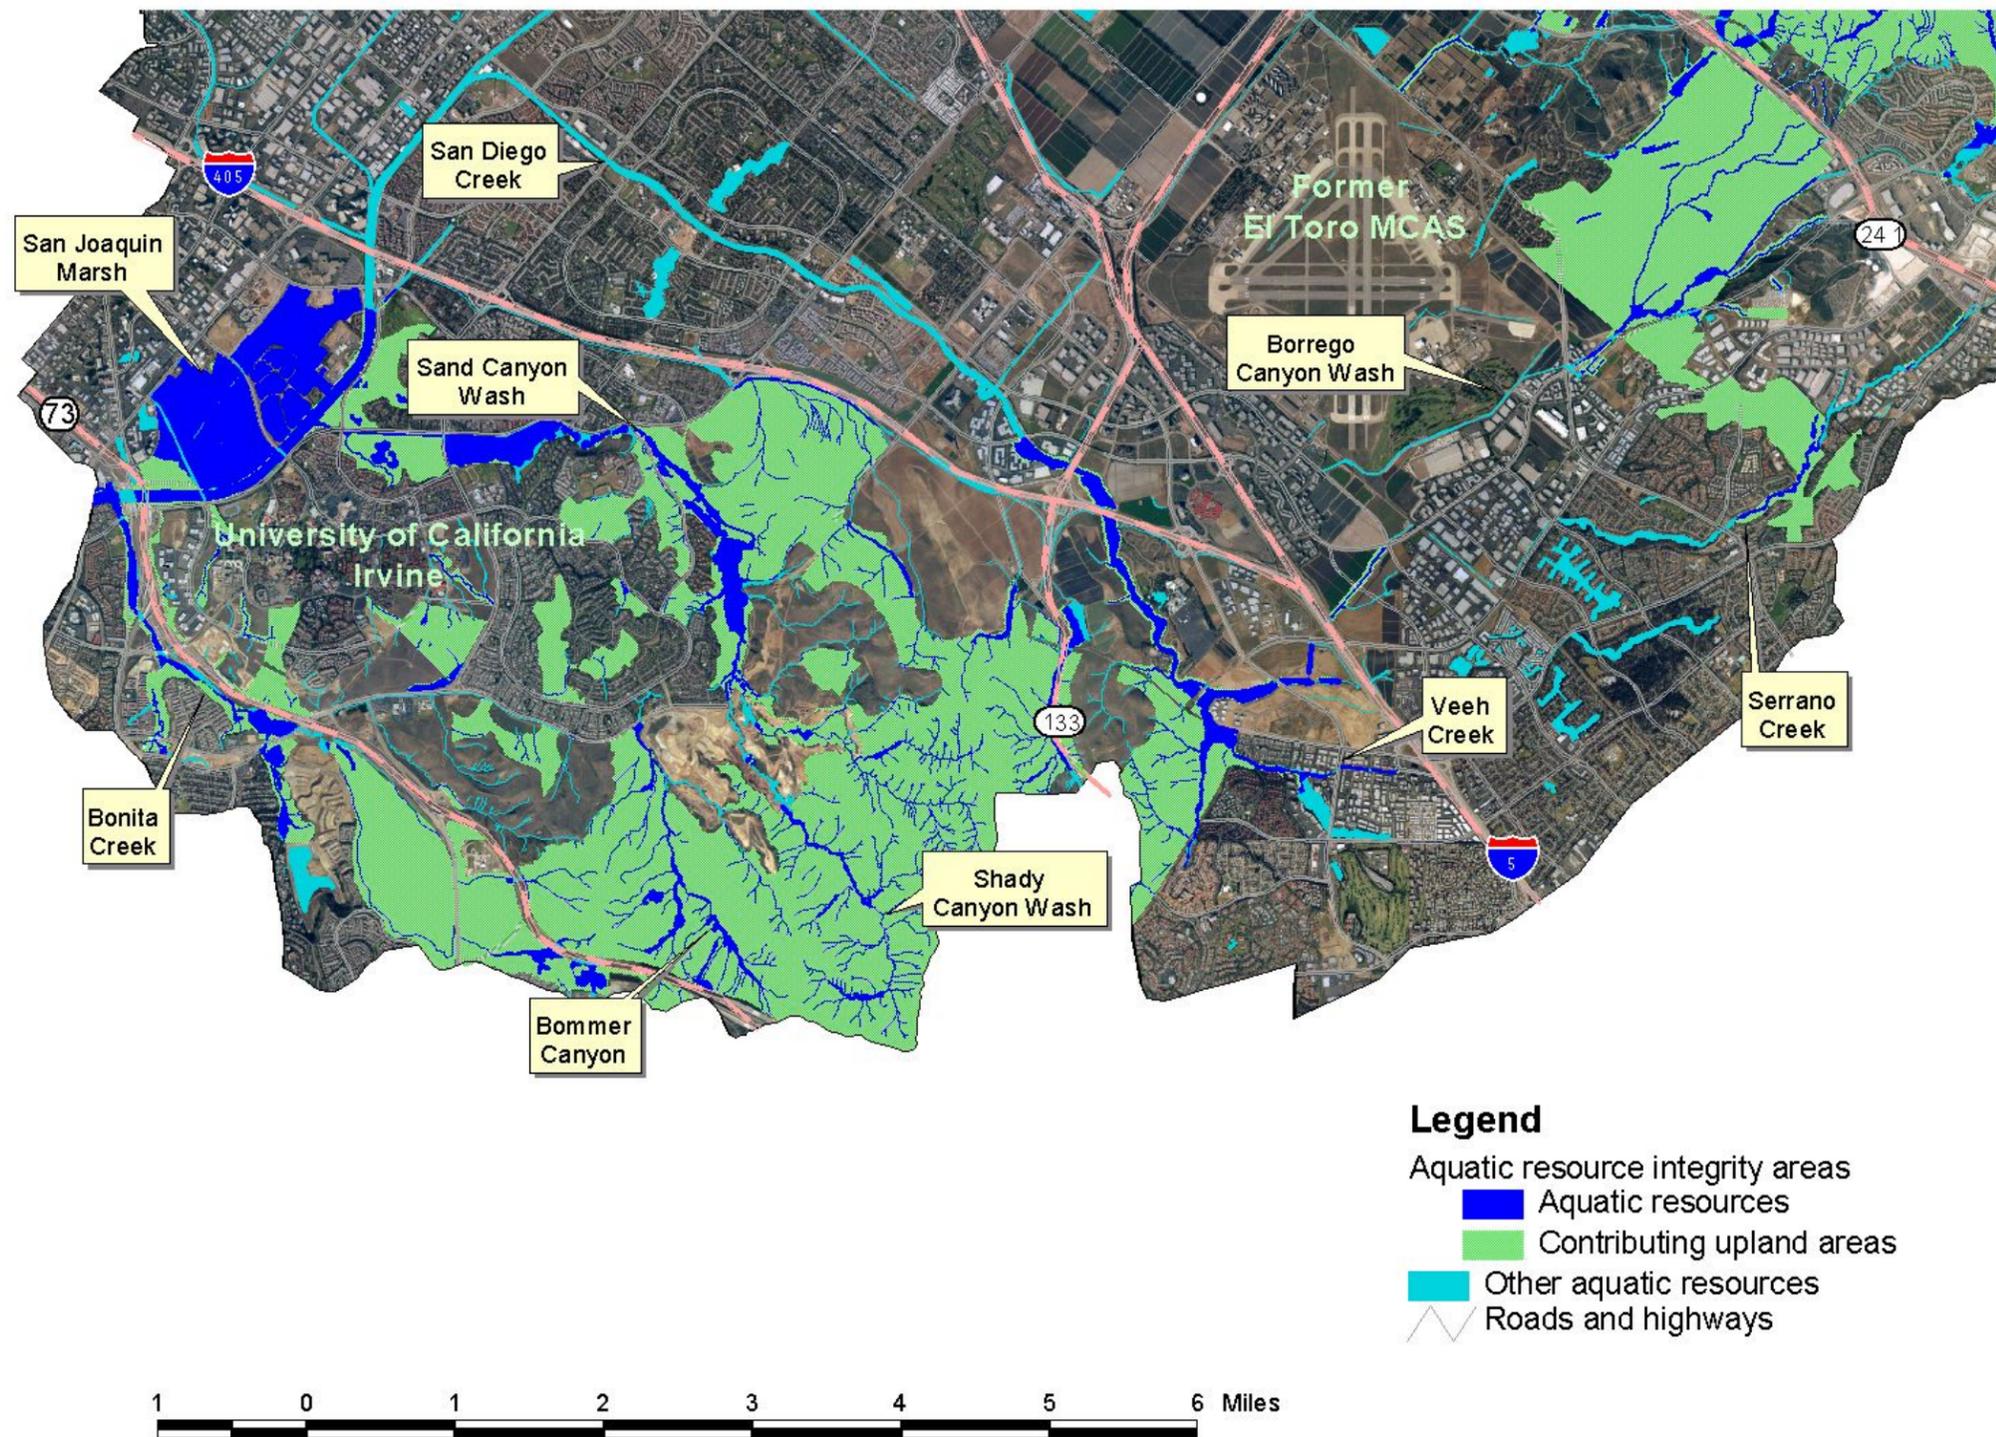
Figure 2-2. SAMP Analytical Framework was applied to identify aquatic resource integrity areas, including aquatic resources and their upland areas of influence, in the southern portion of the Watershed.

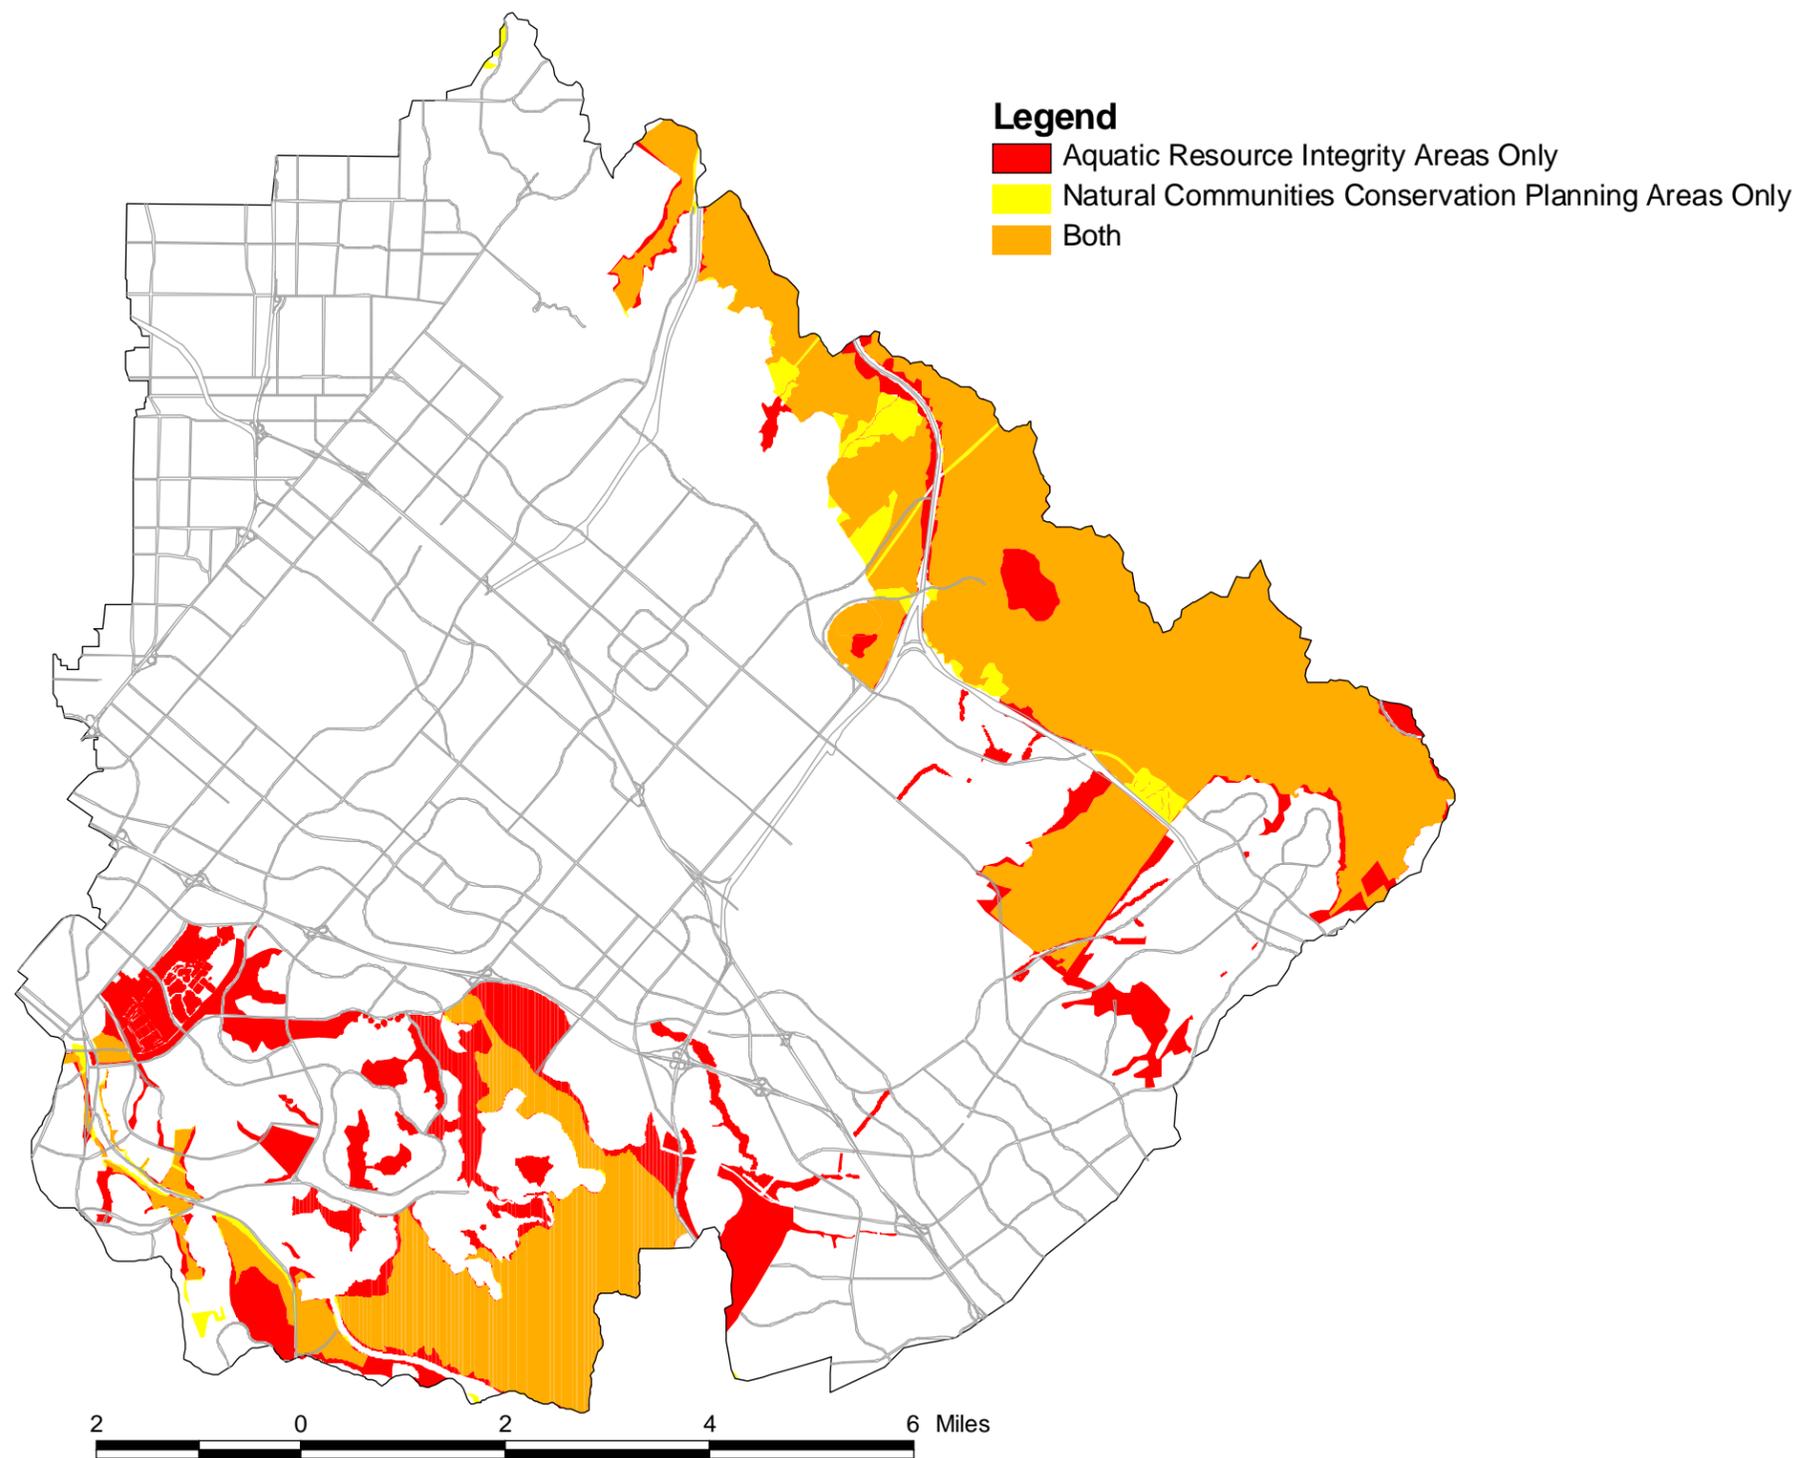
Figure 2-3. Relationship between the SAMP aquatic resource integrity areas and the Central-Coastal NCCP Subregional Reserve System planning areas.

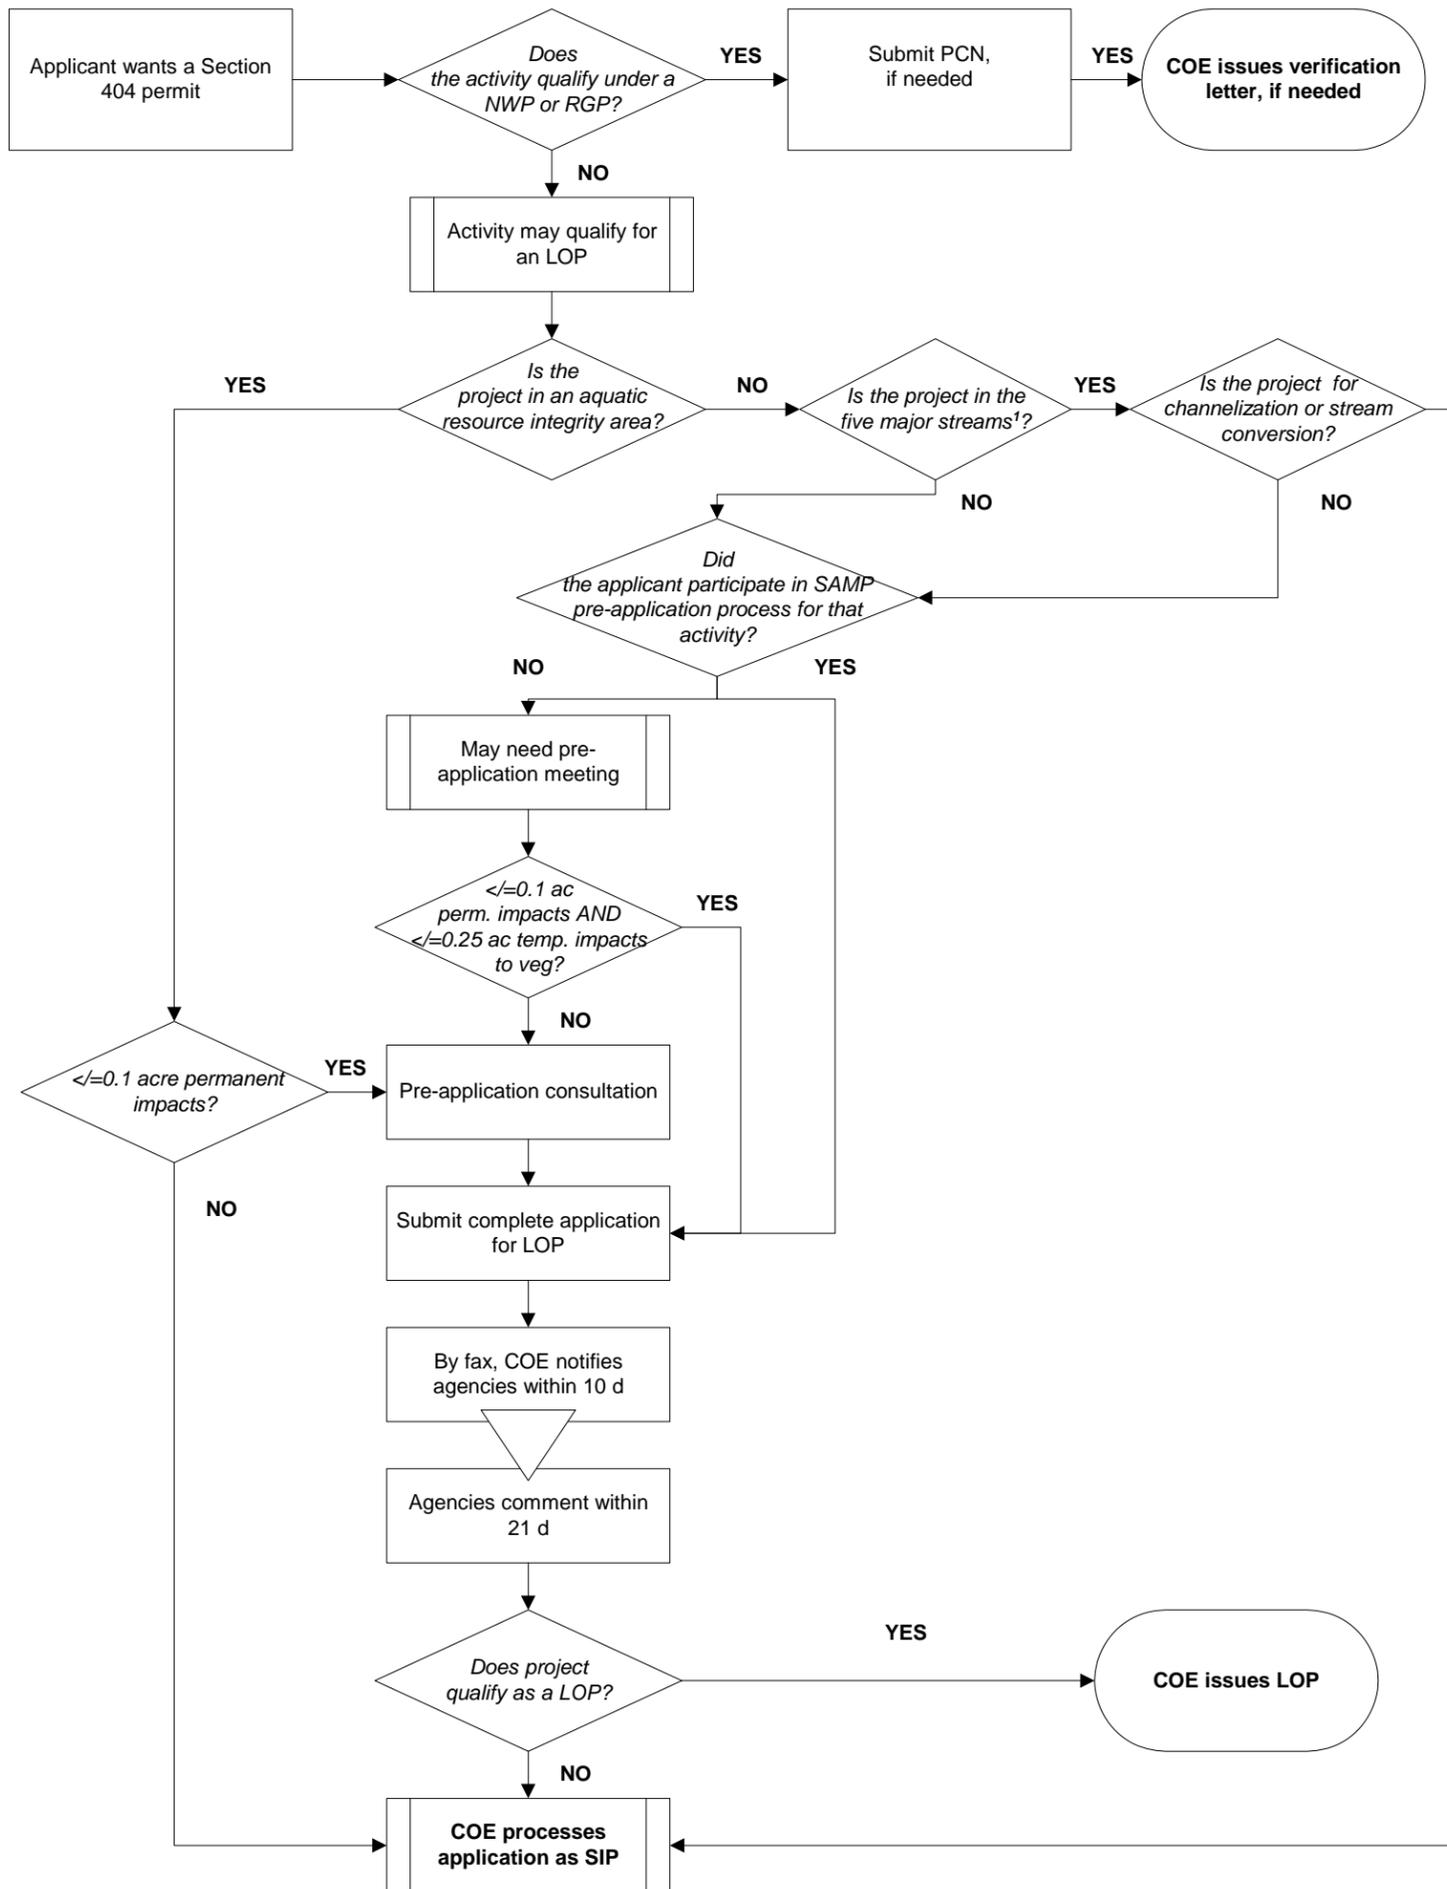
¹ Five streams: Borrego Canyon Wash, Hicks Canyon Wash, Peters Canyon Wash, San Diego Creek, and Serrano Creek

Figure 3-1. Flow diagram for Corps proposed SAMP permitting procedures in the San Diego Creek Watershed.

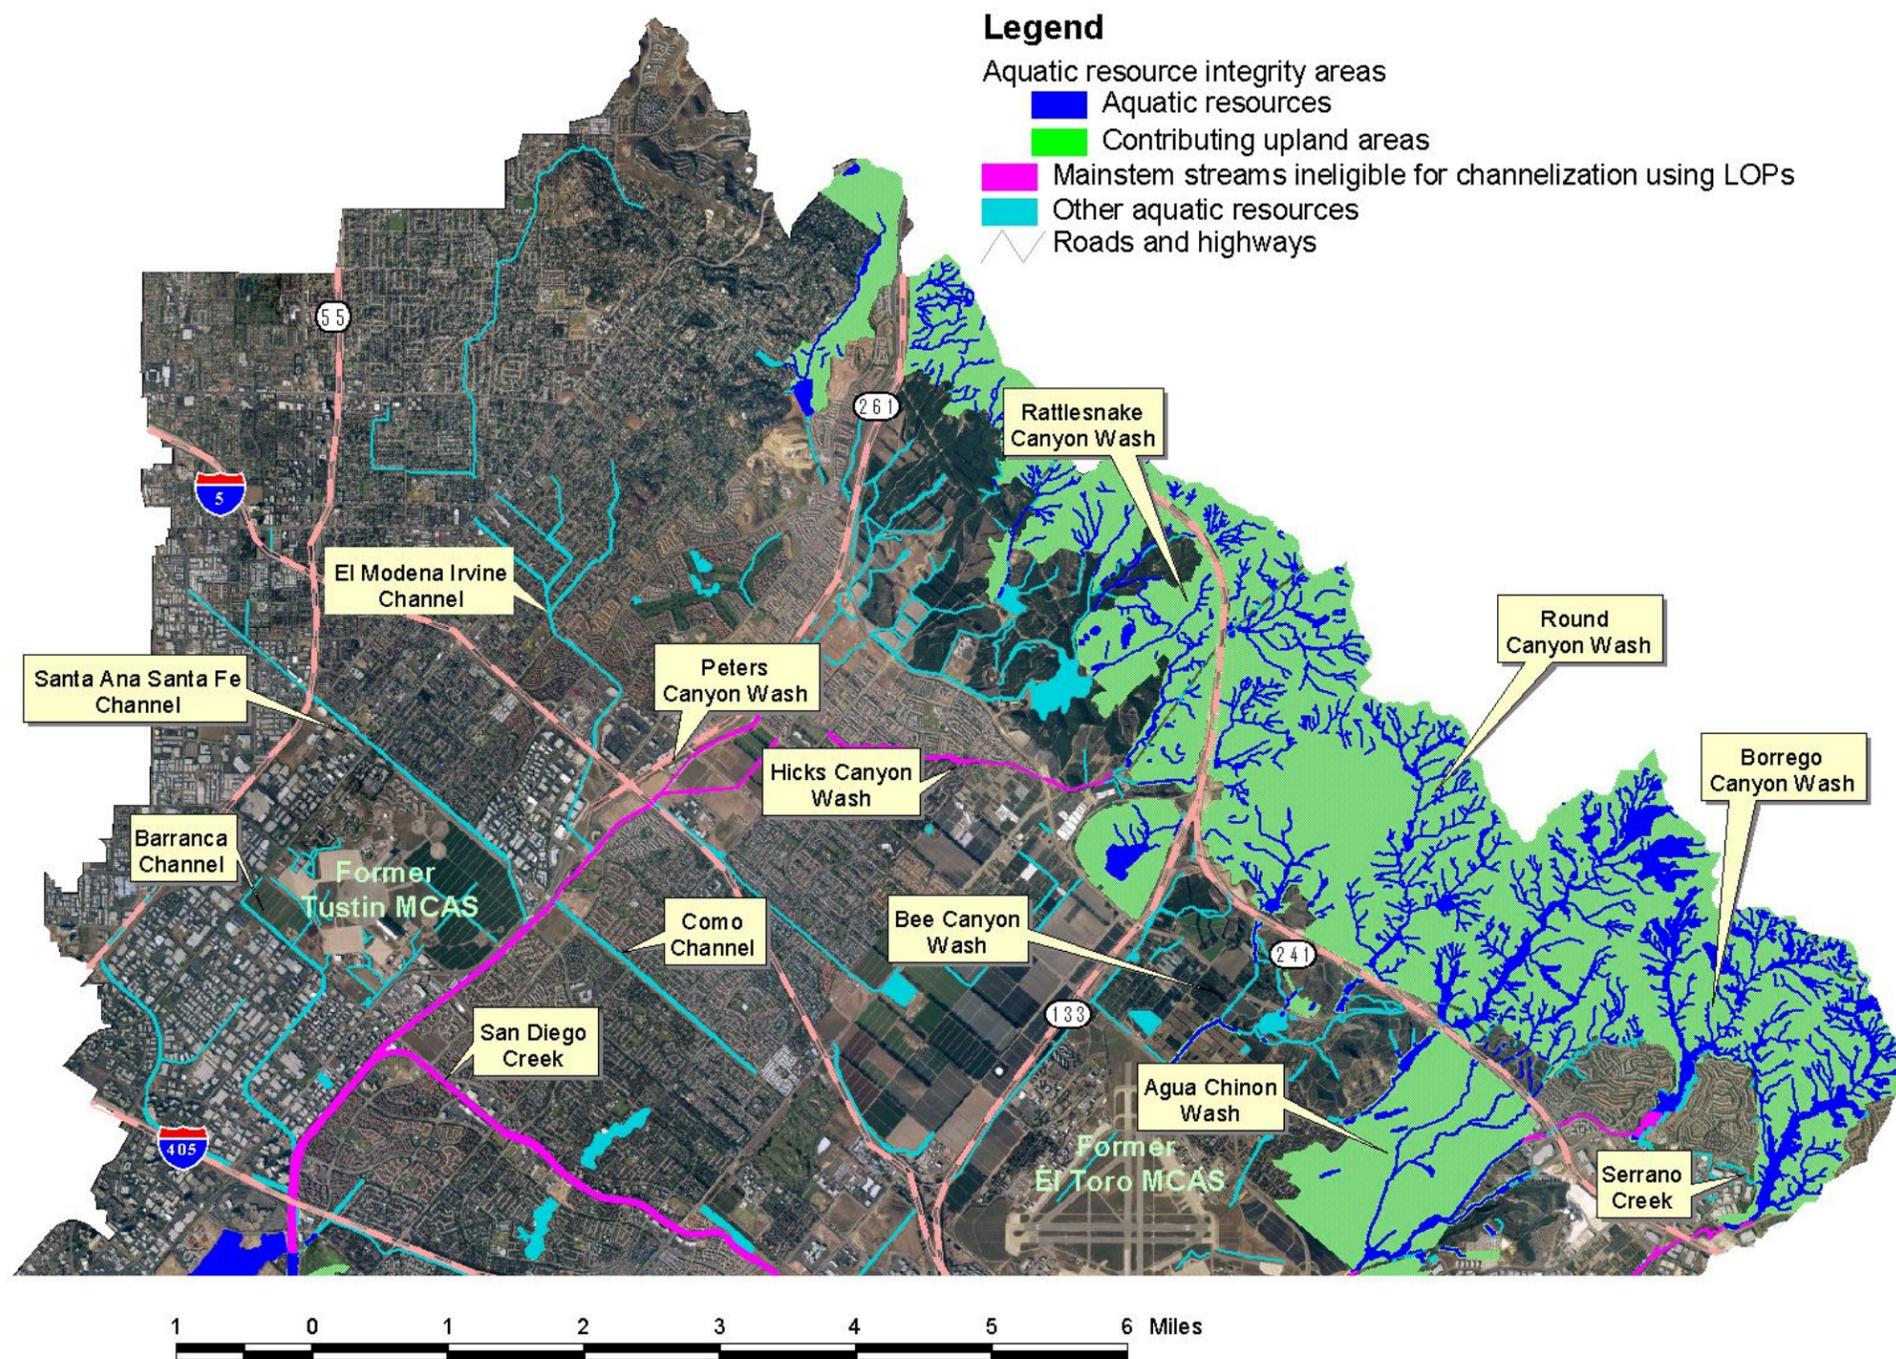
Figure 3-2. SAMP Analytical Framework was applied to identify aquatic resource integrity areas, including aquatic resources and their upland areas of influence, and mainstem drainages to determine eligibility for Corps permitting procedures within the northern portion of the Watershed.

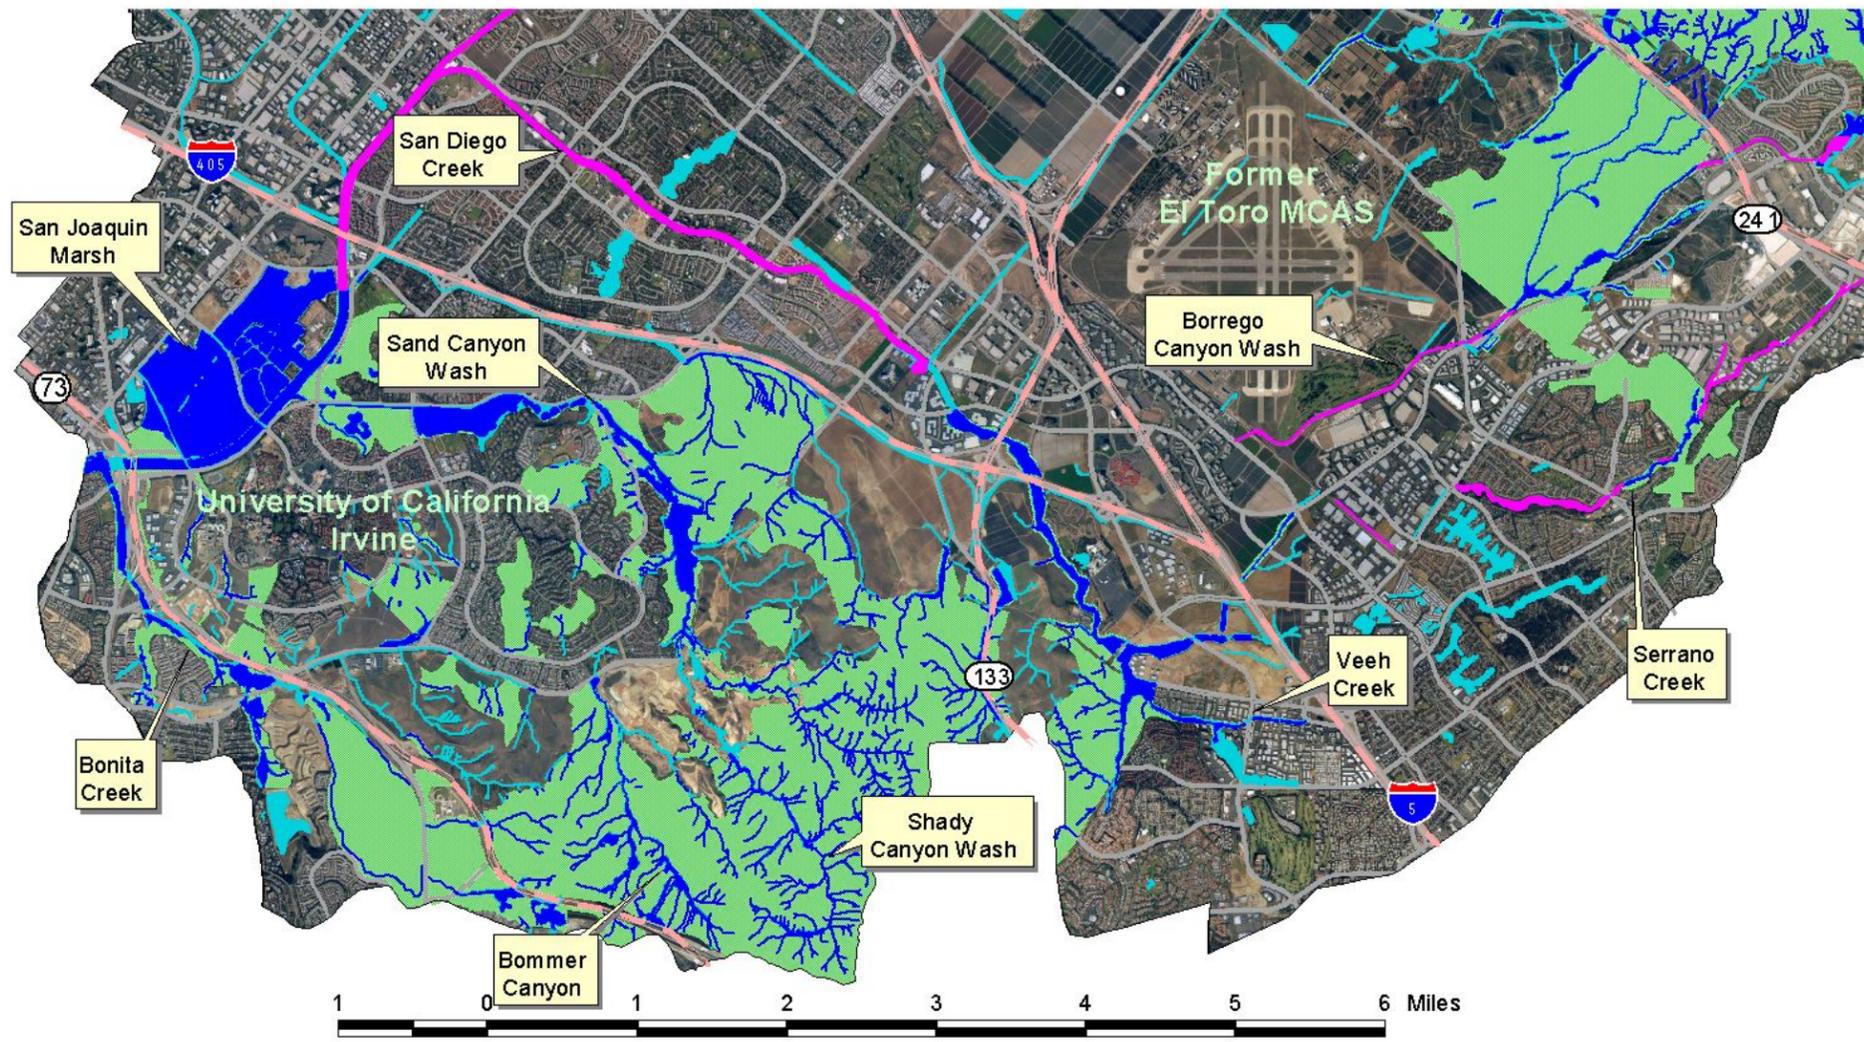
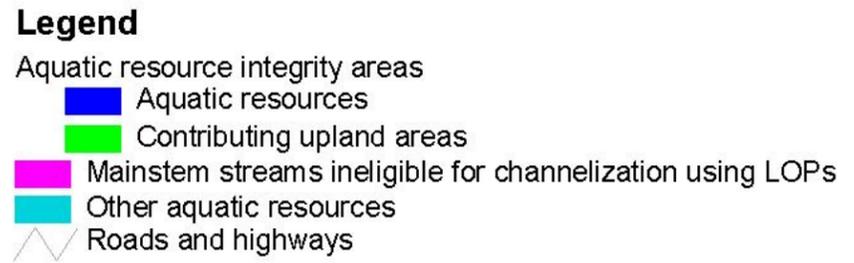
Figure 3-3. SAMP Analytical Framework was applied to identify aquatic resource integrity areas, including aquatic resources and their upland areas of influence, and mainstem drainages to determine eligibility for Corps permitting procedures within the southern portion of the Watershed.

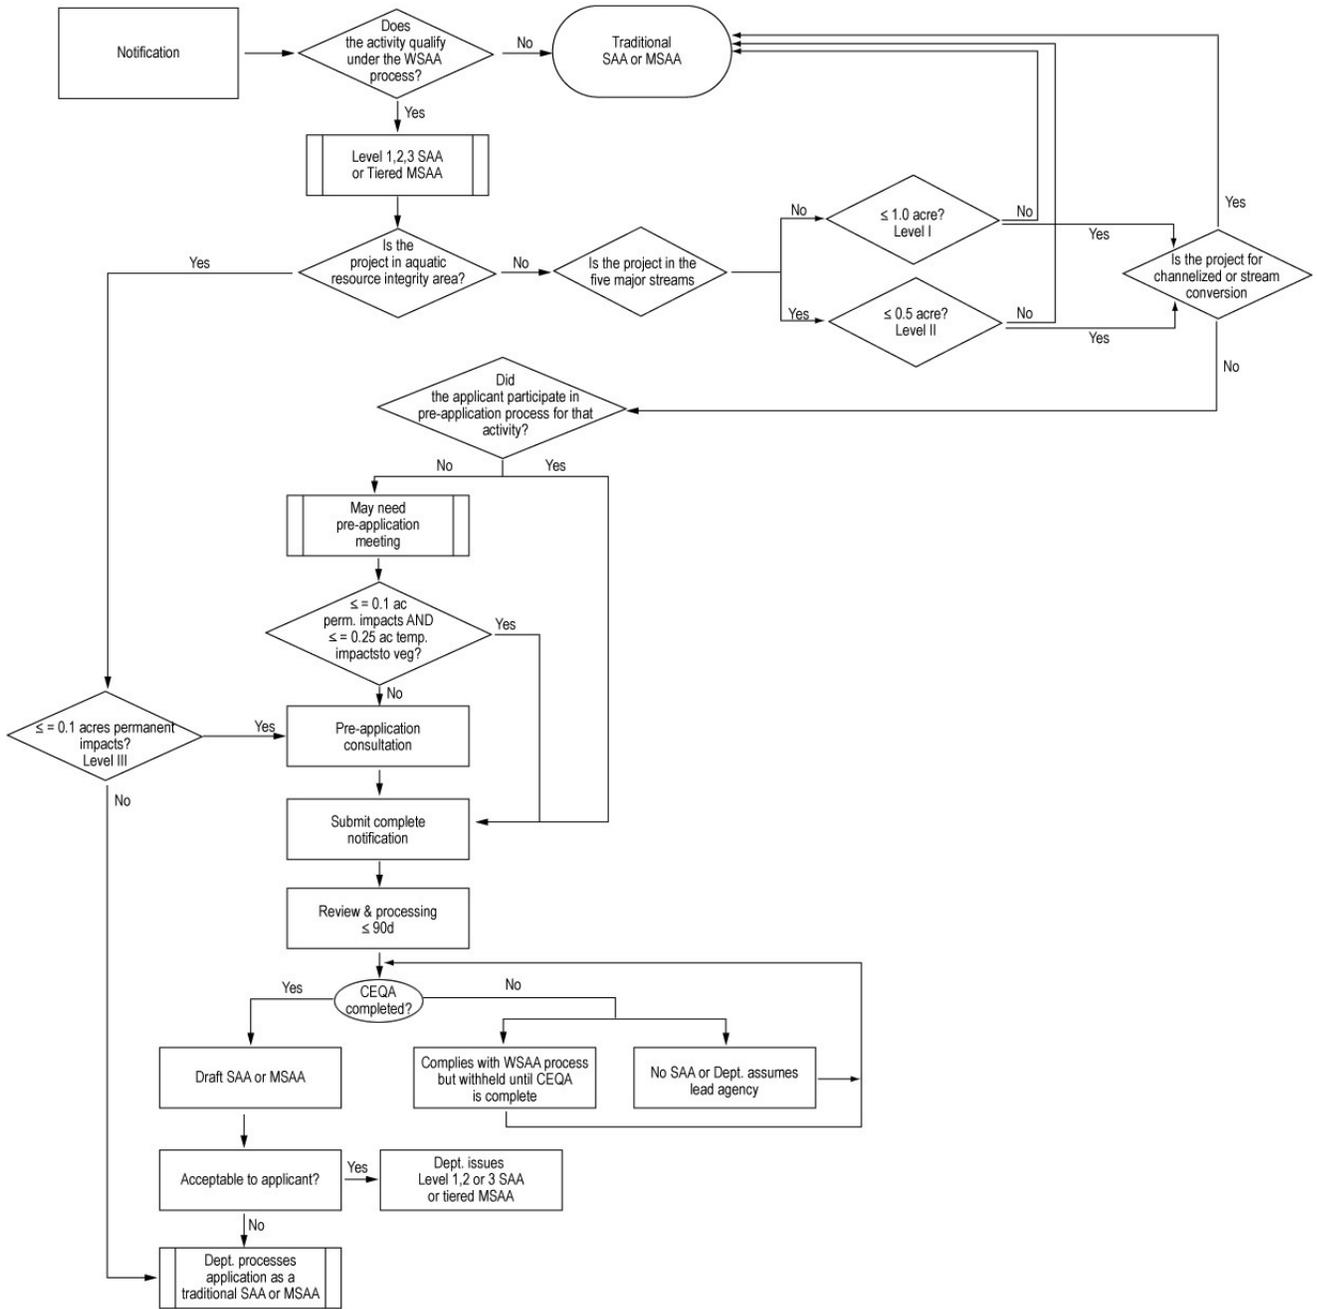
Figure 3-4. Flow diagram of the Department's WSAA Process for the San Diego Creek Watershed.

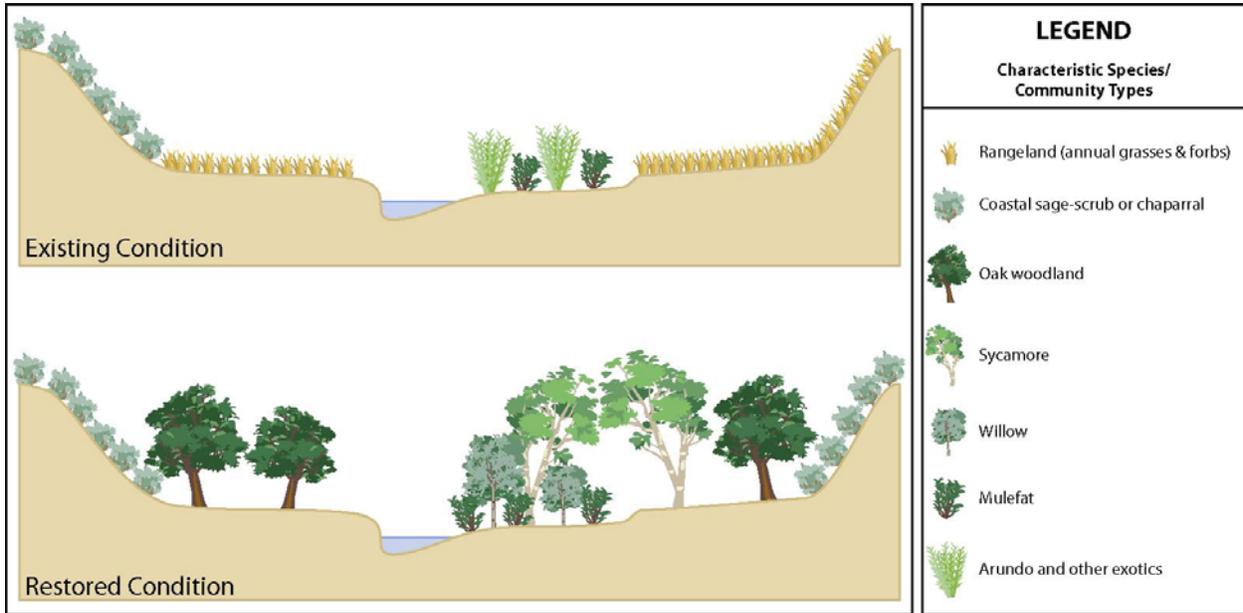
Figure 4-1. Typical pre- and post-restoration conditions of riparian reaches assigned to the Natural Template.

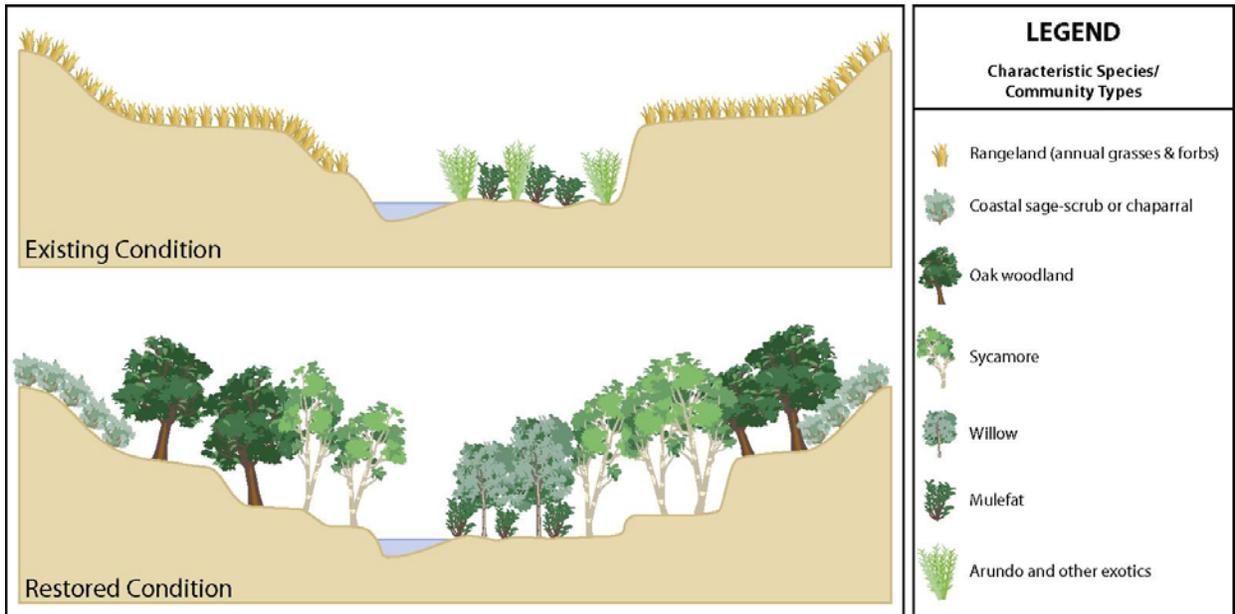
Figure 4-2. Typical pre- and post-restoration conditions of riparian reaches assigned to the Incised Template.

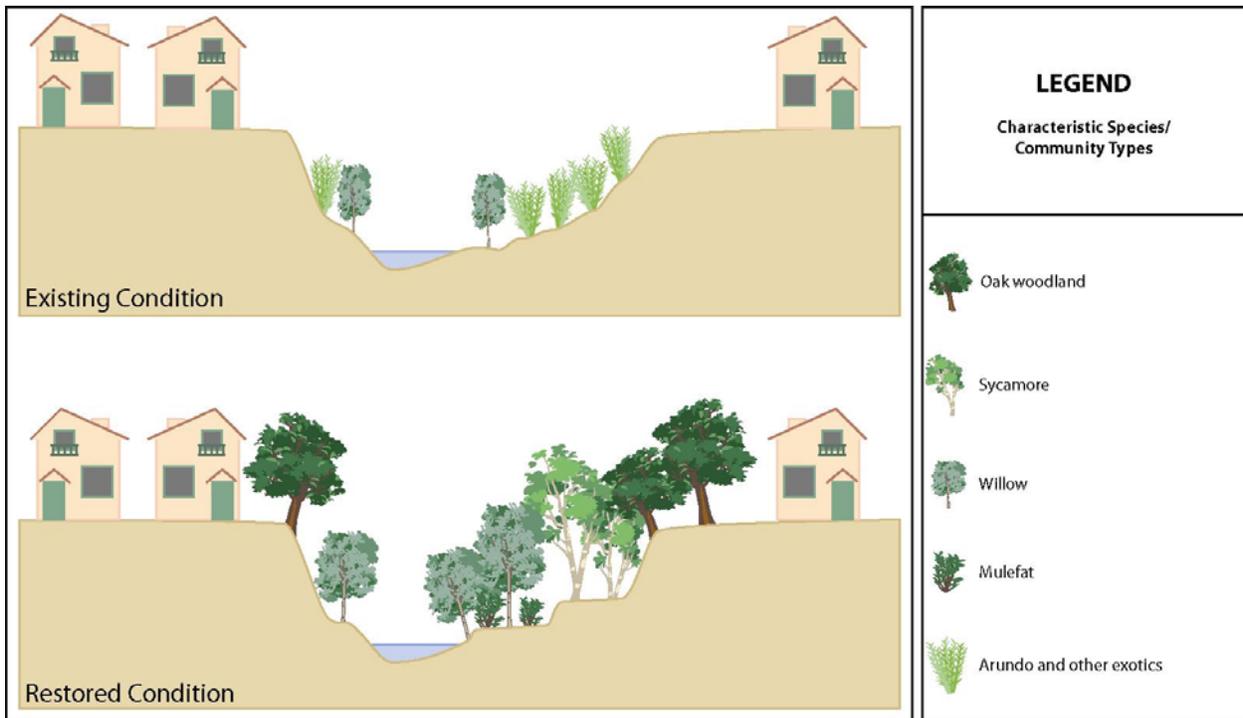
Figure 4-3. Typical pre- and post-restoration conditions of riparian reaches assigned to the Constrained Template.

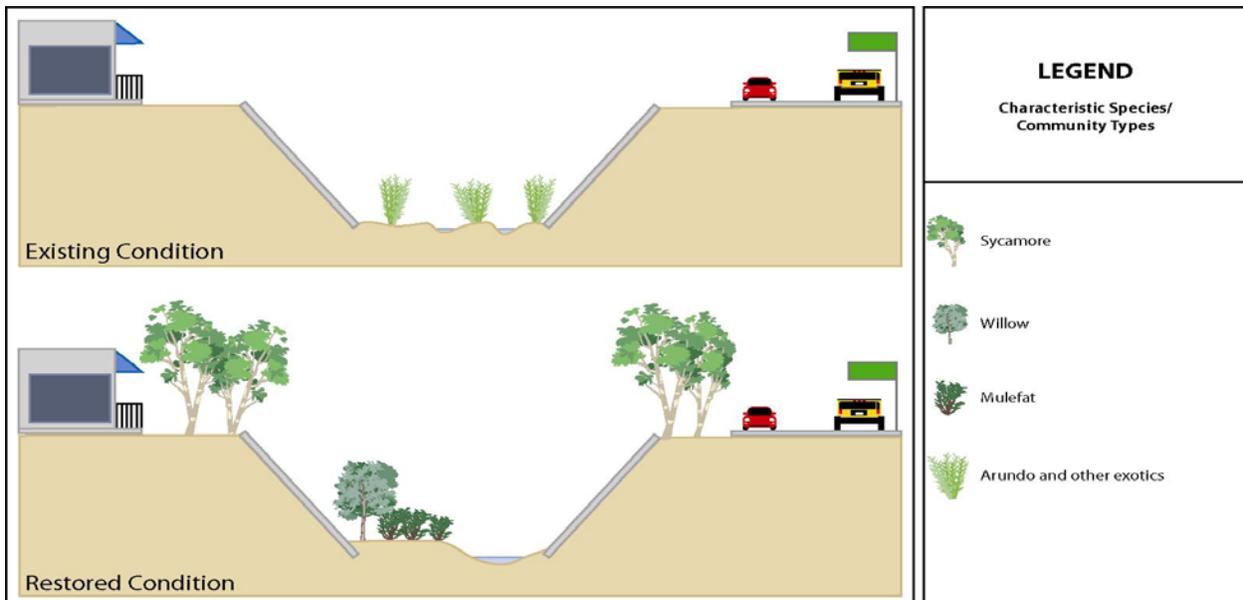
Figure 4-4. Typical pre- and post-restoration conditions of riparian reaches assigned to the Engineered Template.
