Figure 1-1. The San Diego Creek Watershed Special Area Management Plan area in Orange County, California.

Figure 1-2. Subwatersheds comprising the San Diego Creek Watershed.

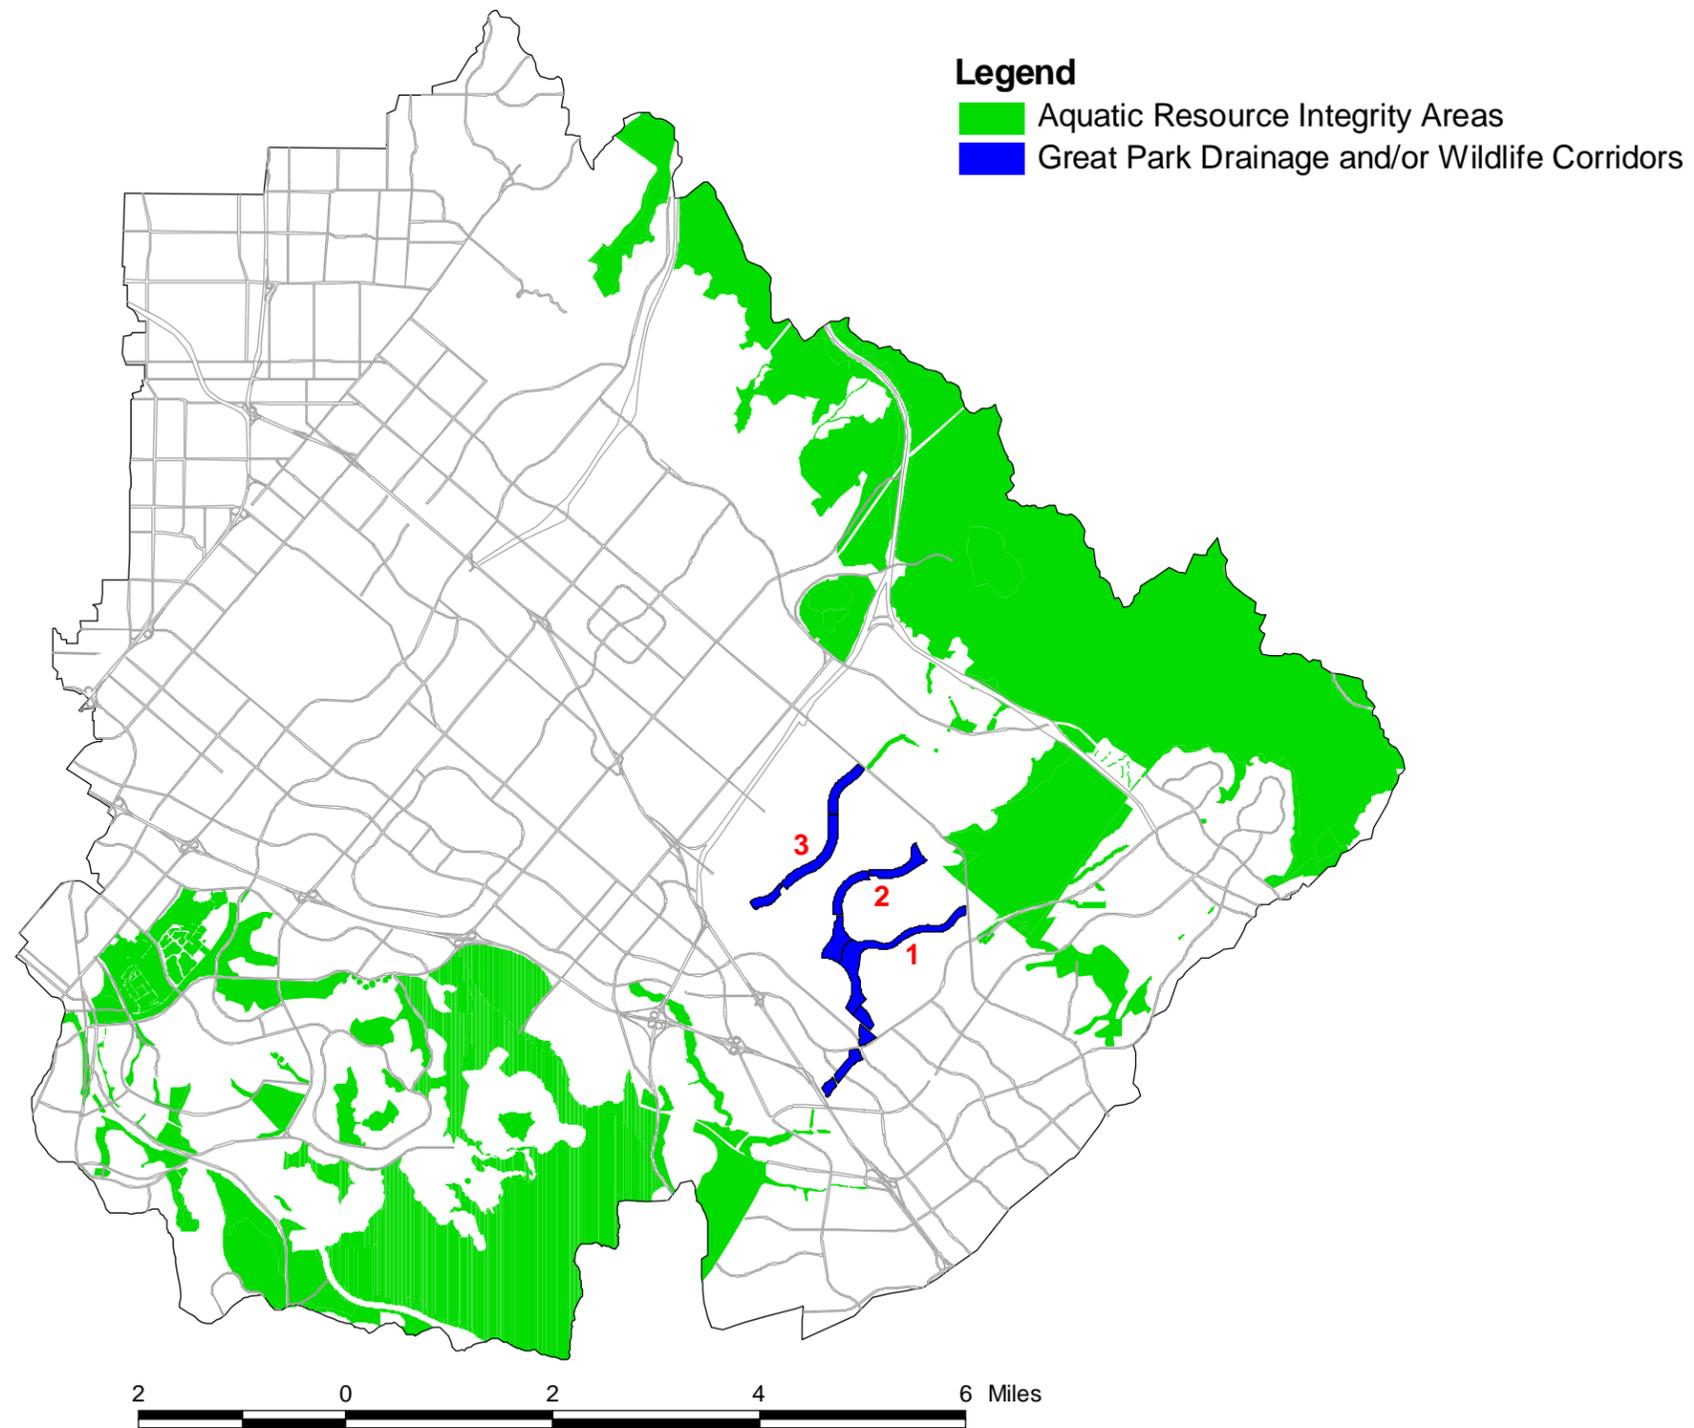
Figure 4-5. Prospective restoration areas connecting aquatic resources from the north to the south portions of the Orange County Central-Coastal NCCP Subregional Reserve System are located within the footprint of the Orange County Great Park. See Table 4-1 for the key to the numbers.

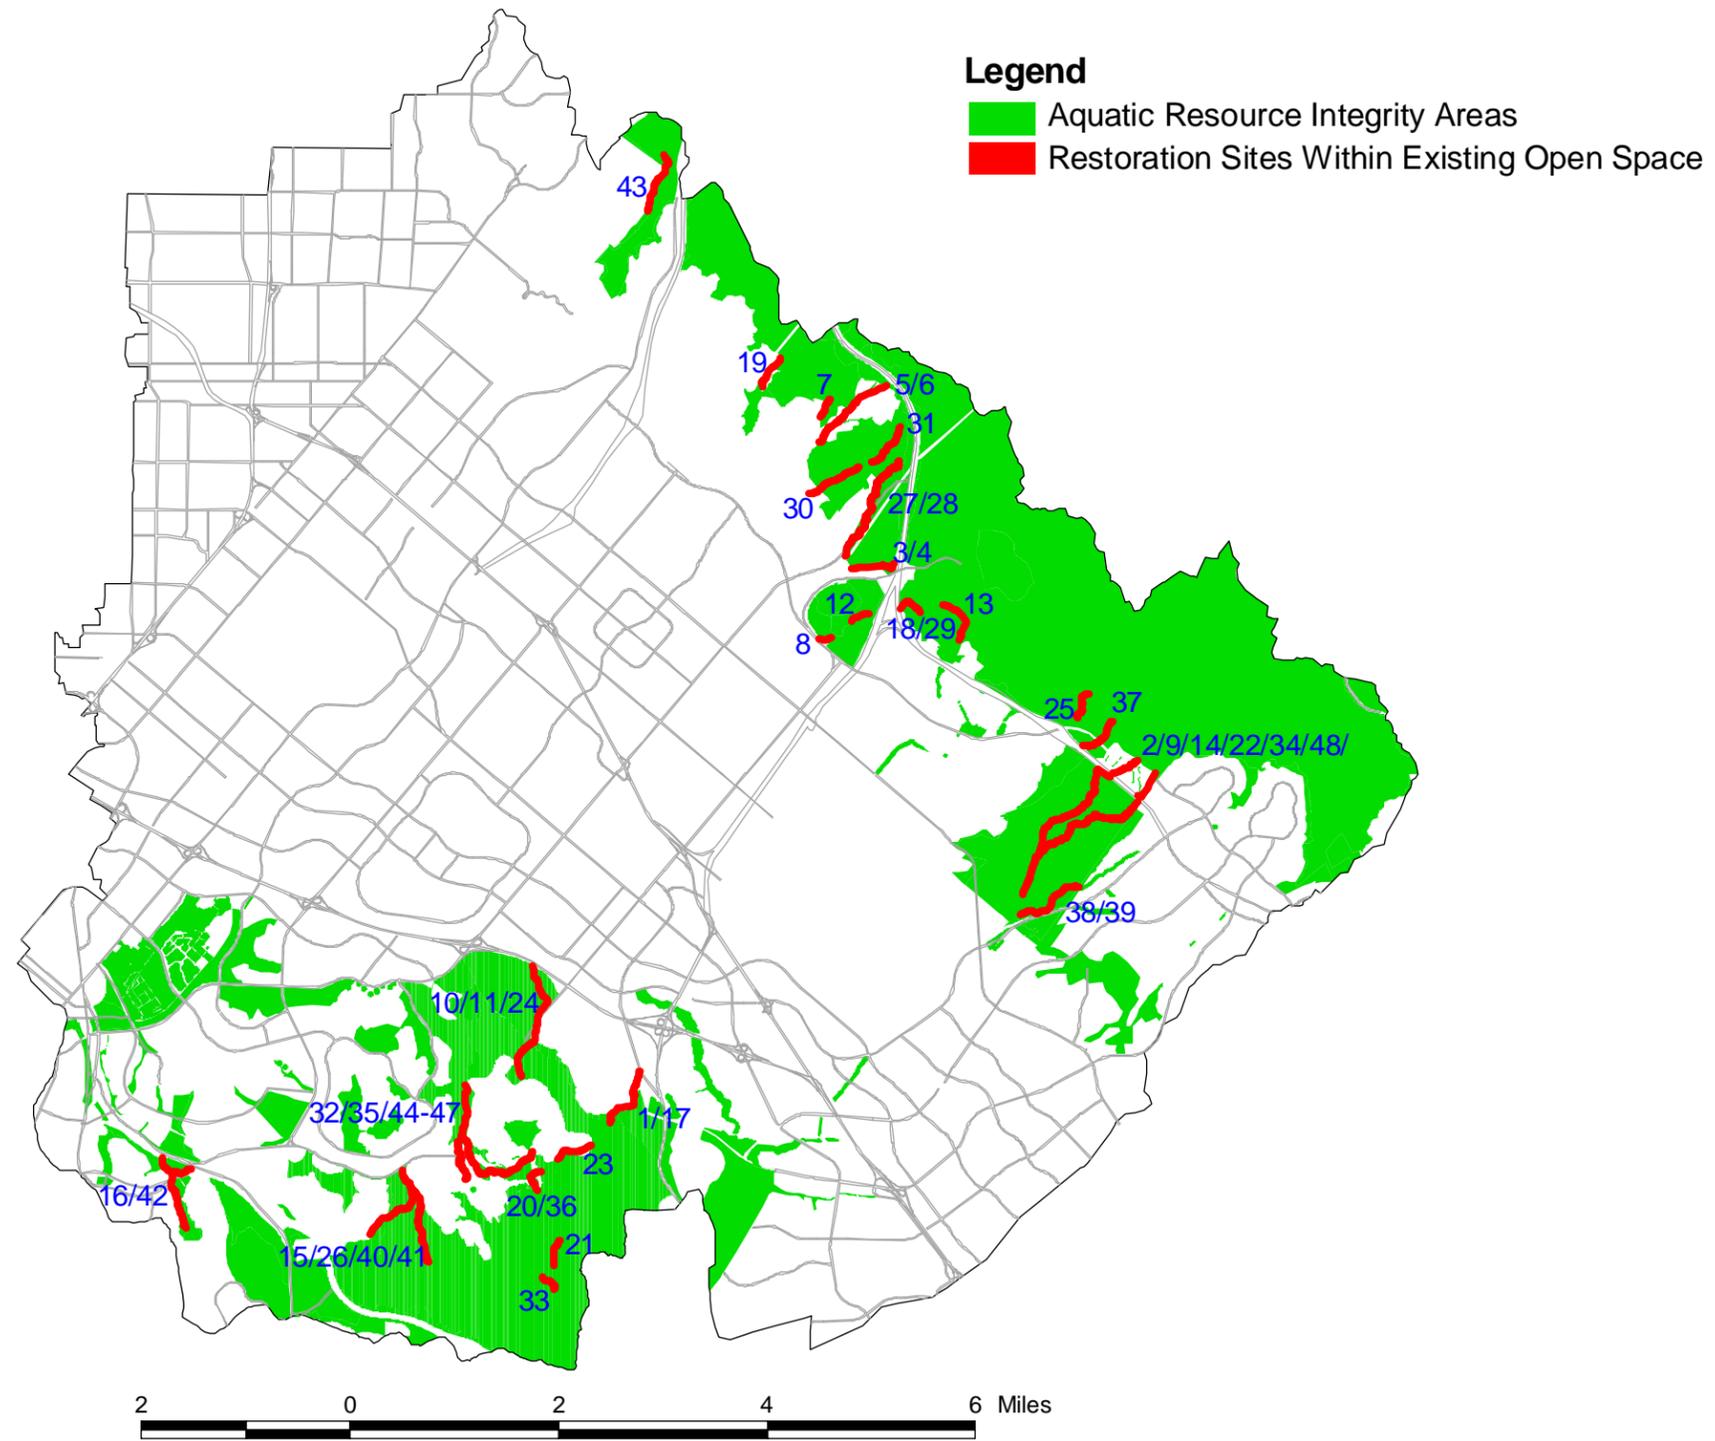
Figure 4-6. Prospective restoration sites within existing open space. See Table 4-2 for the key to the numbers.

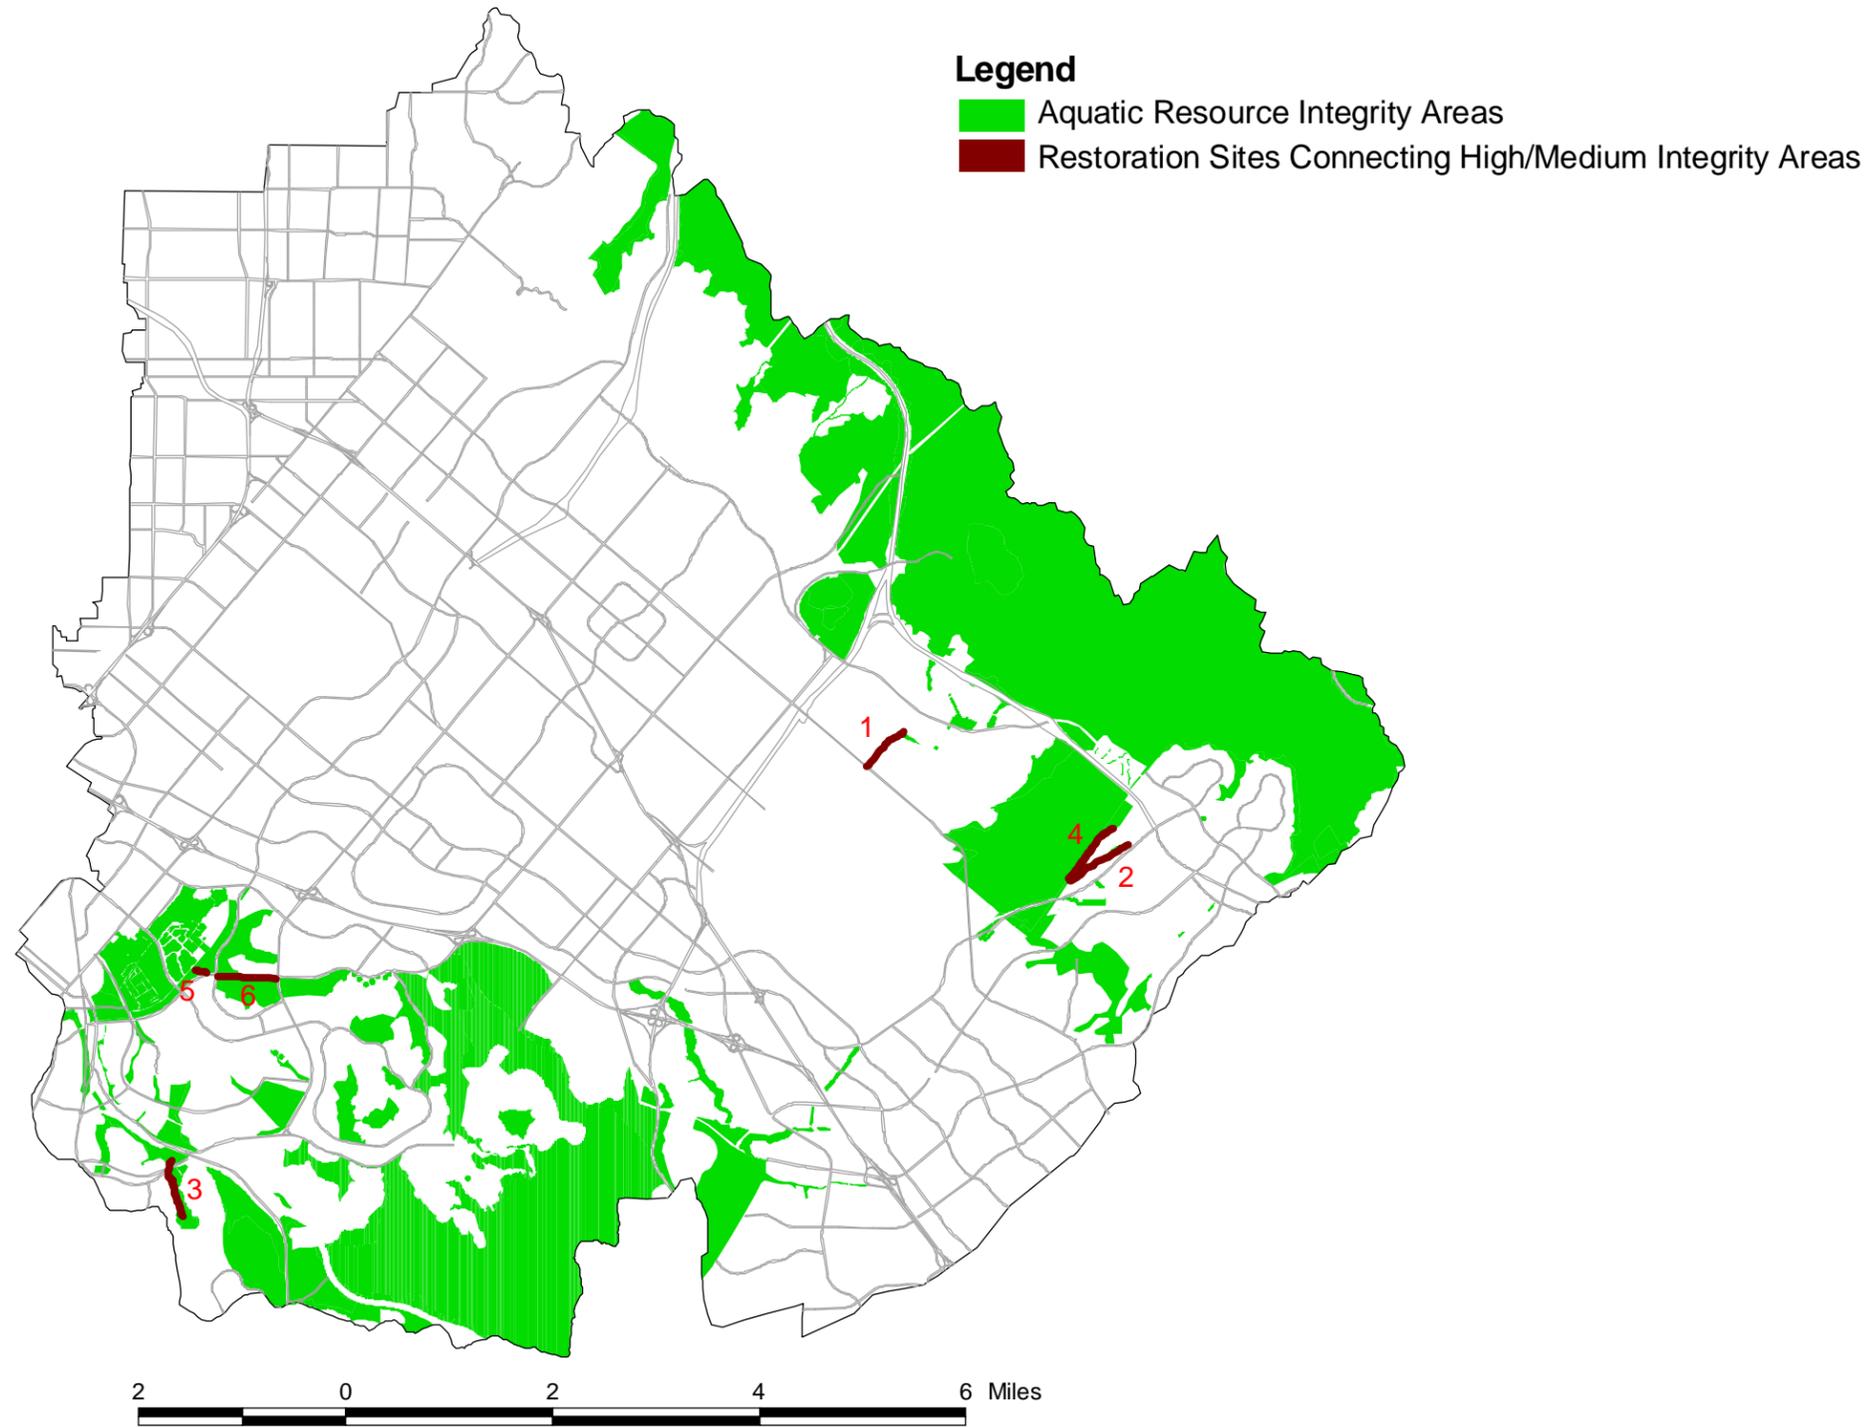
Figure 4-7. Prospective restoration sites connecting high/medium integrity resource reaches. See Table 4-3 for the key to the numbers.

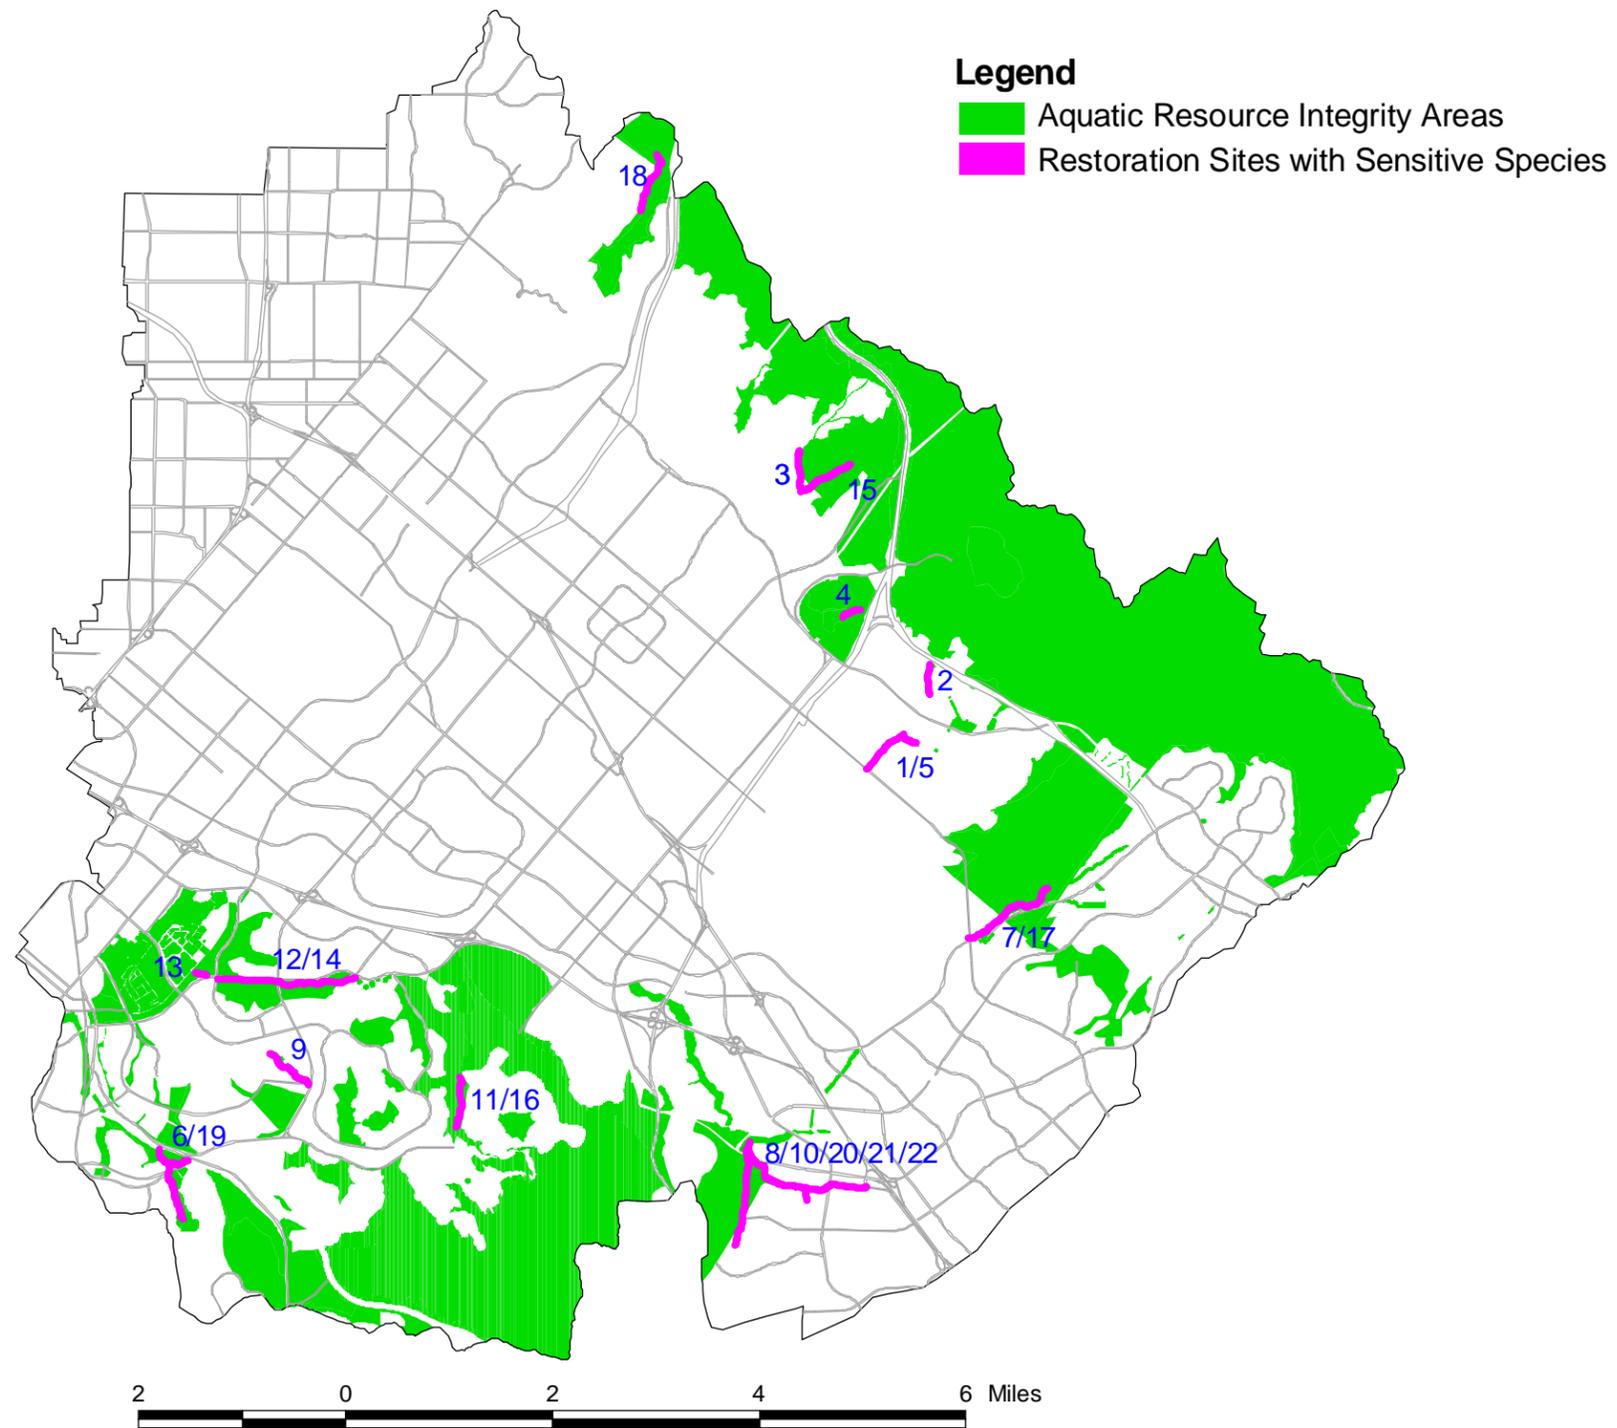
Figure 4-8. Prospective restoration sites with species that are endangered, threatened, or of special concern. See Table 4-4 for the key to the numbers.

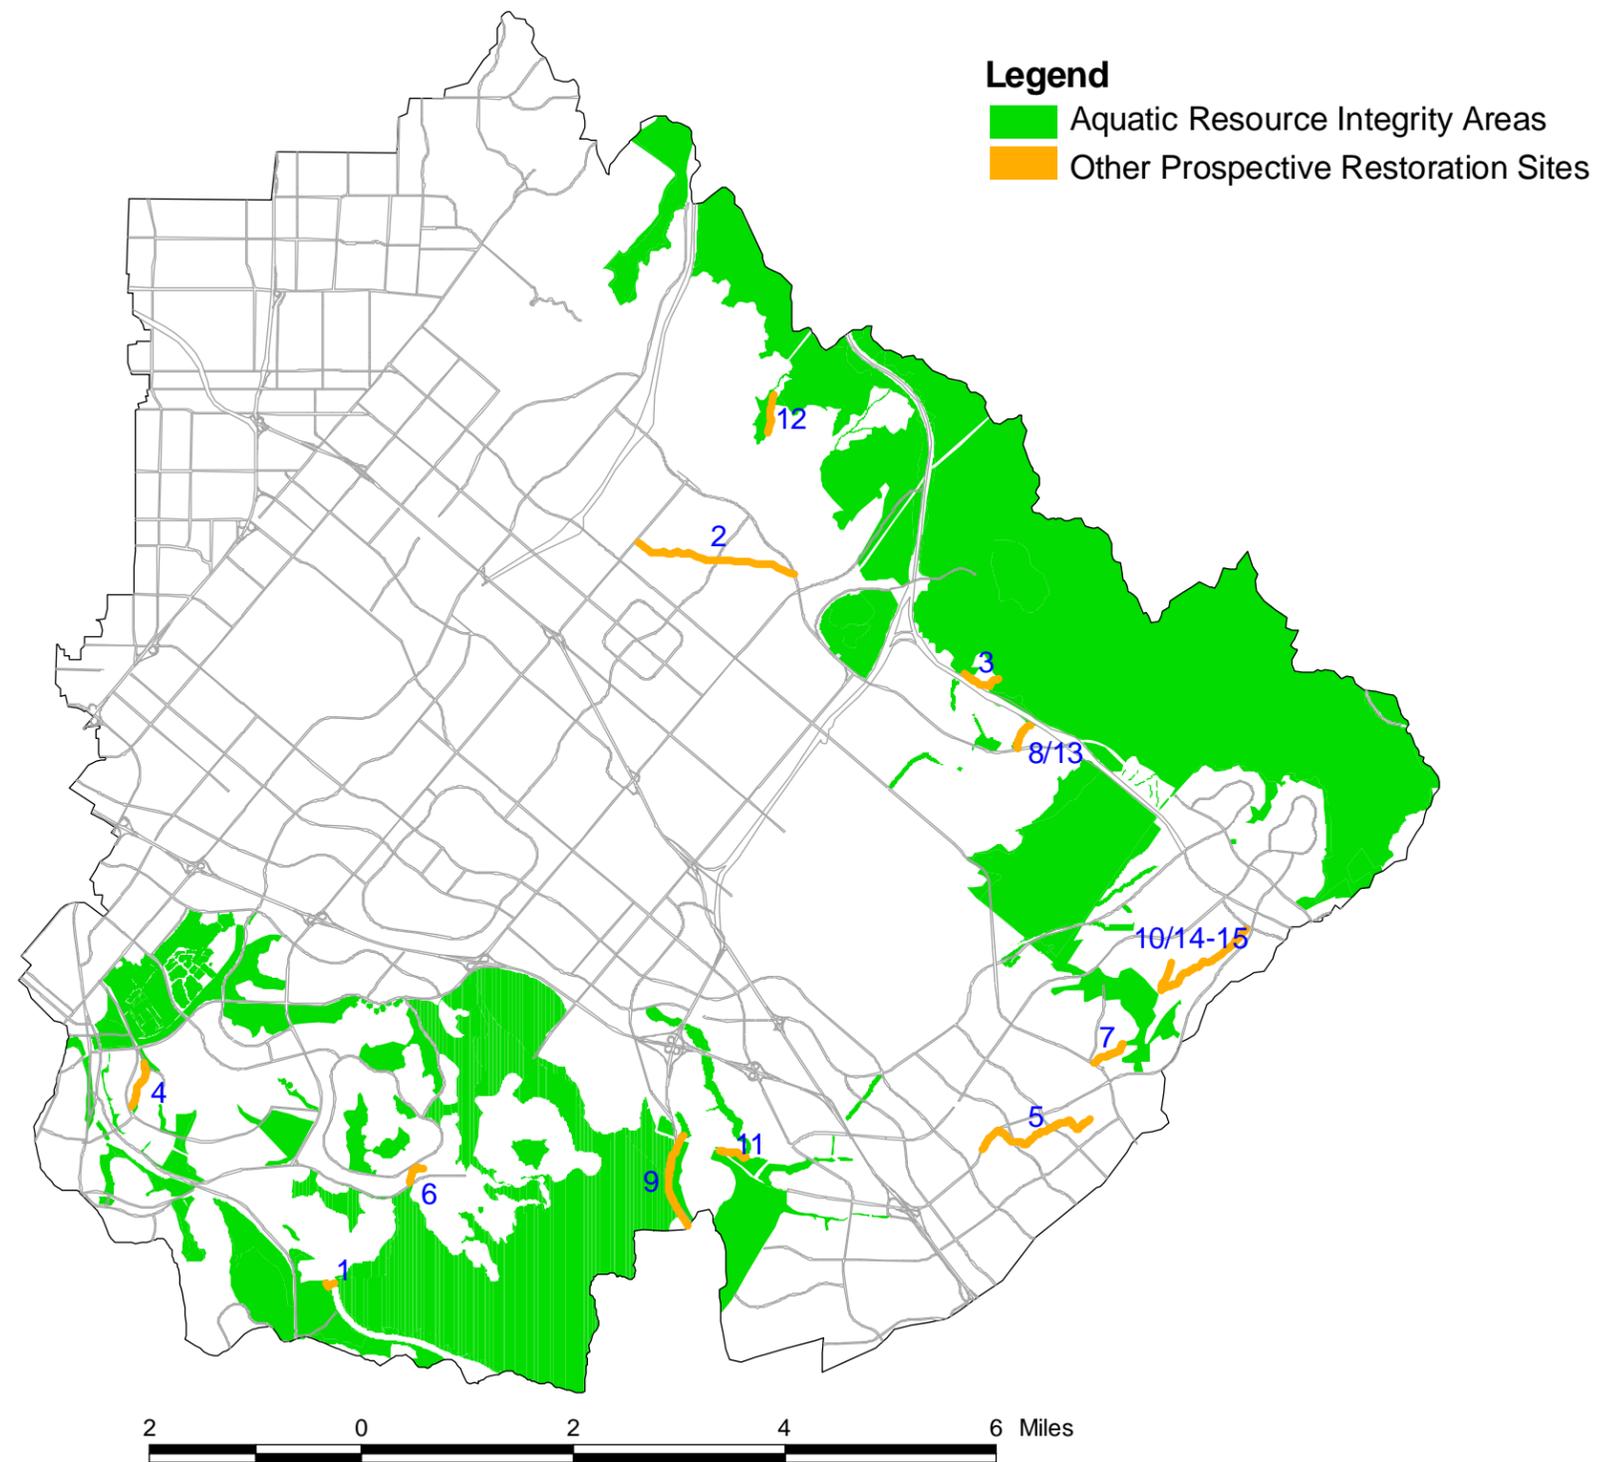
Figure 4-9. Remaining prospective restoration sites. See Table 4-5 for the key to the numbers.

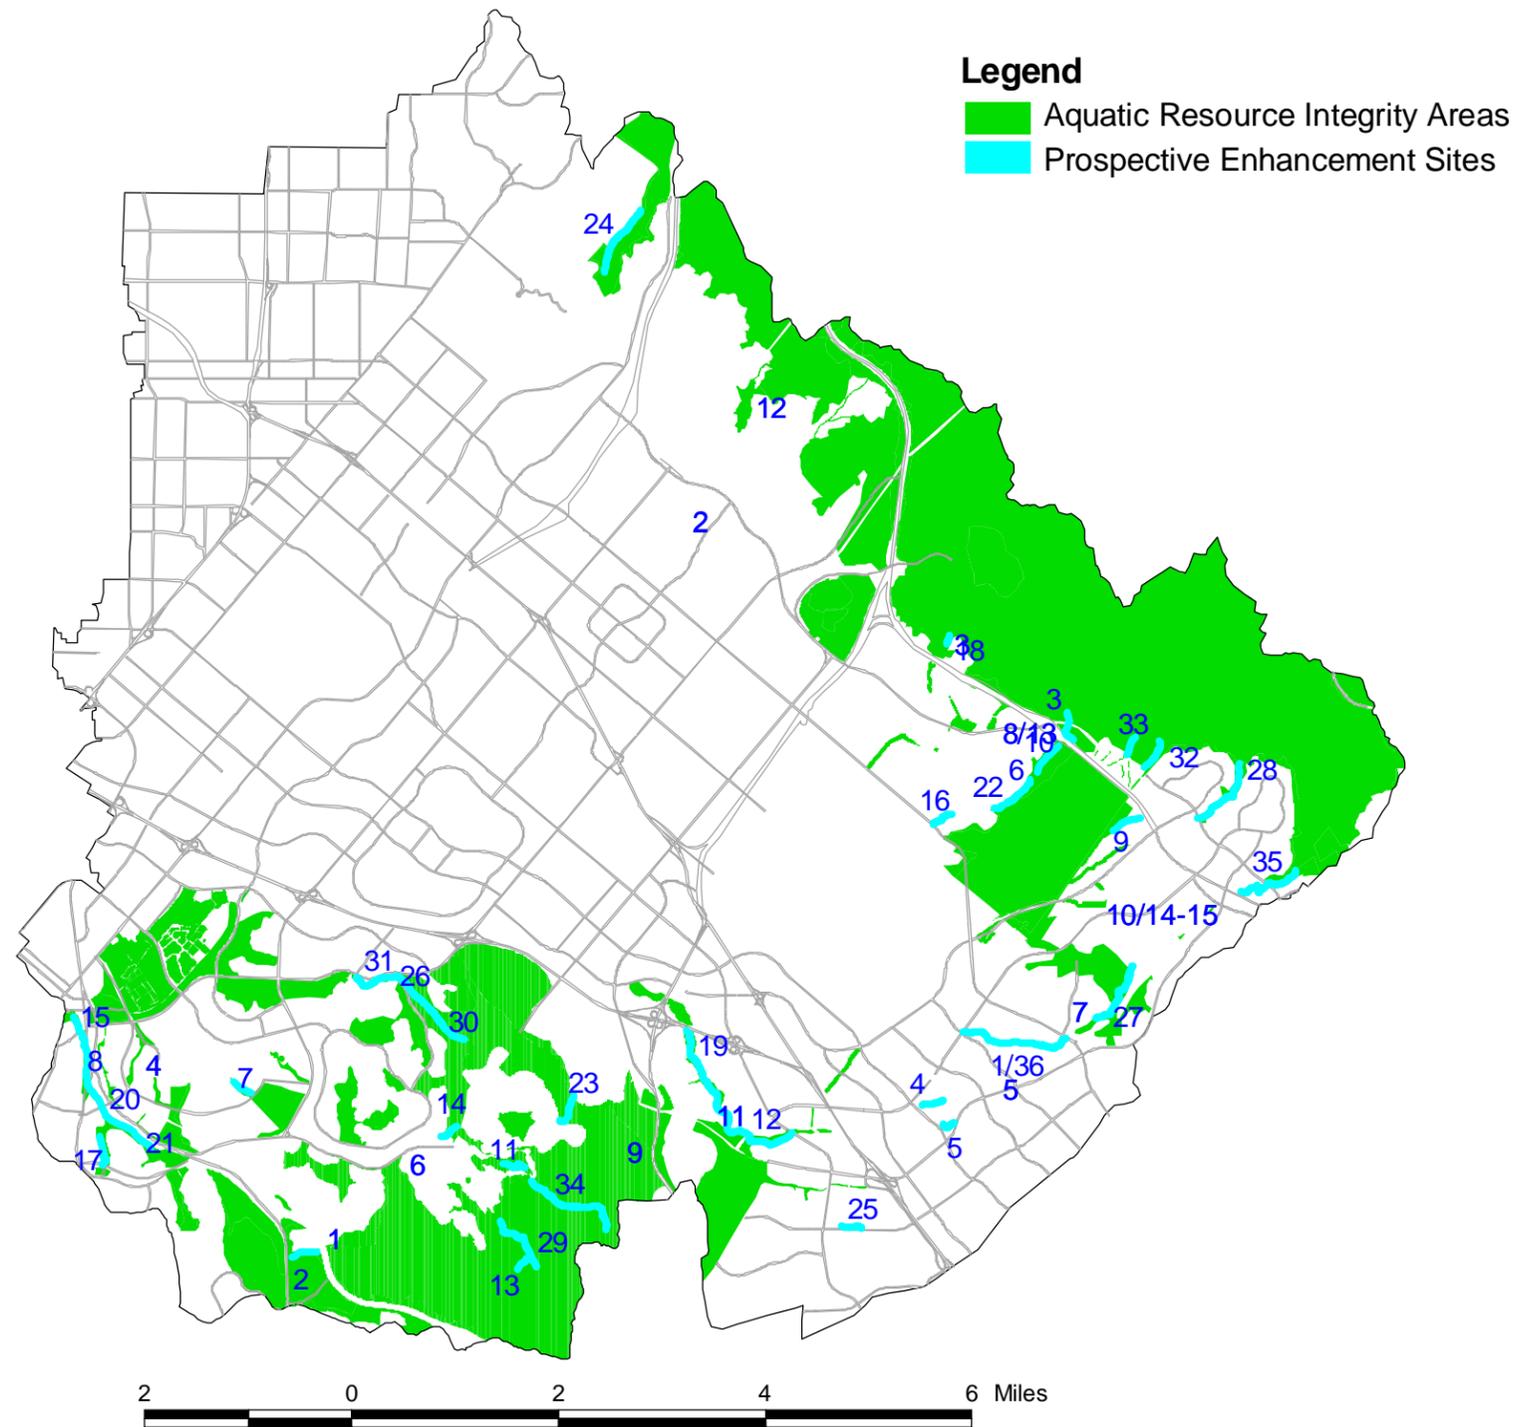
Figure 4-10. Prospective enhancement sites. See Table 4-6 for the key to the numbers.

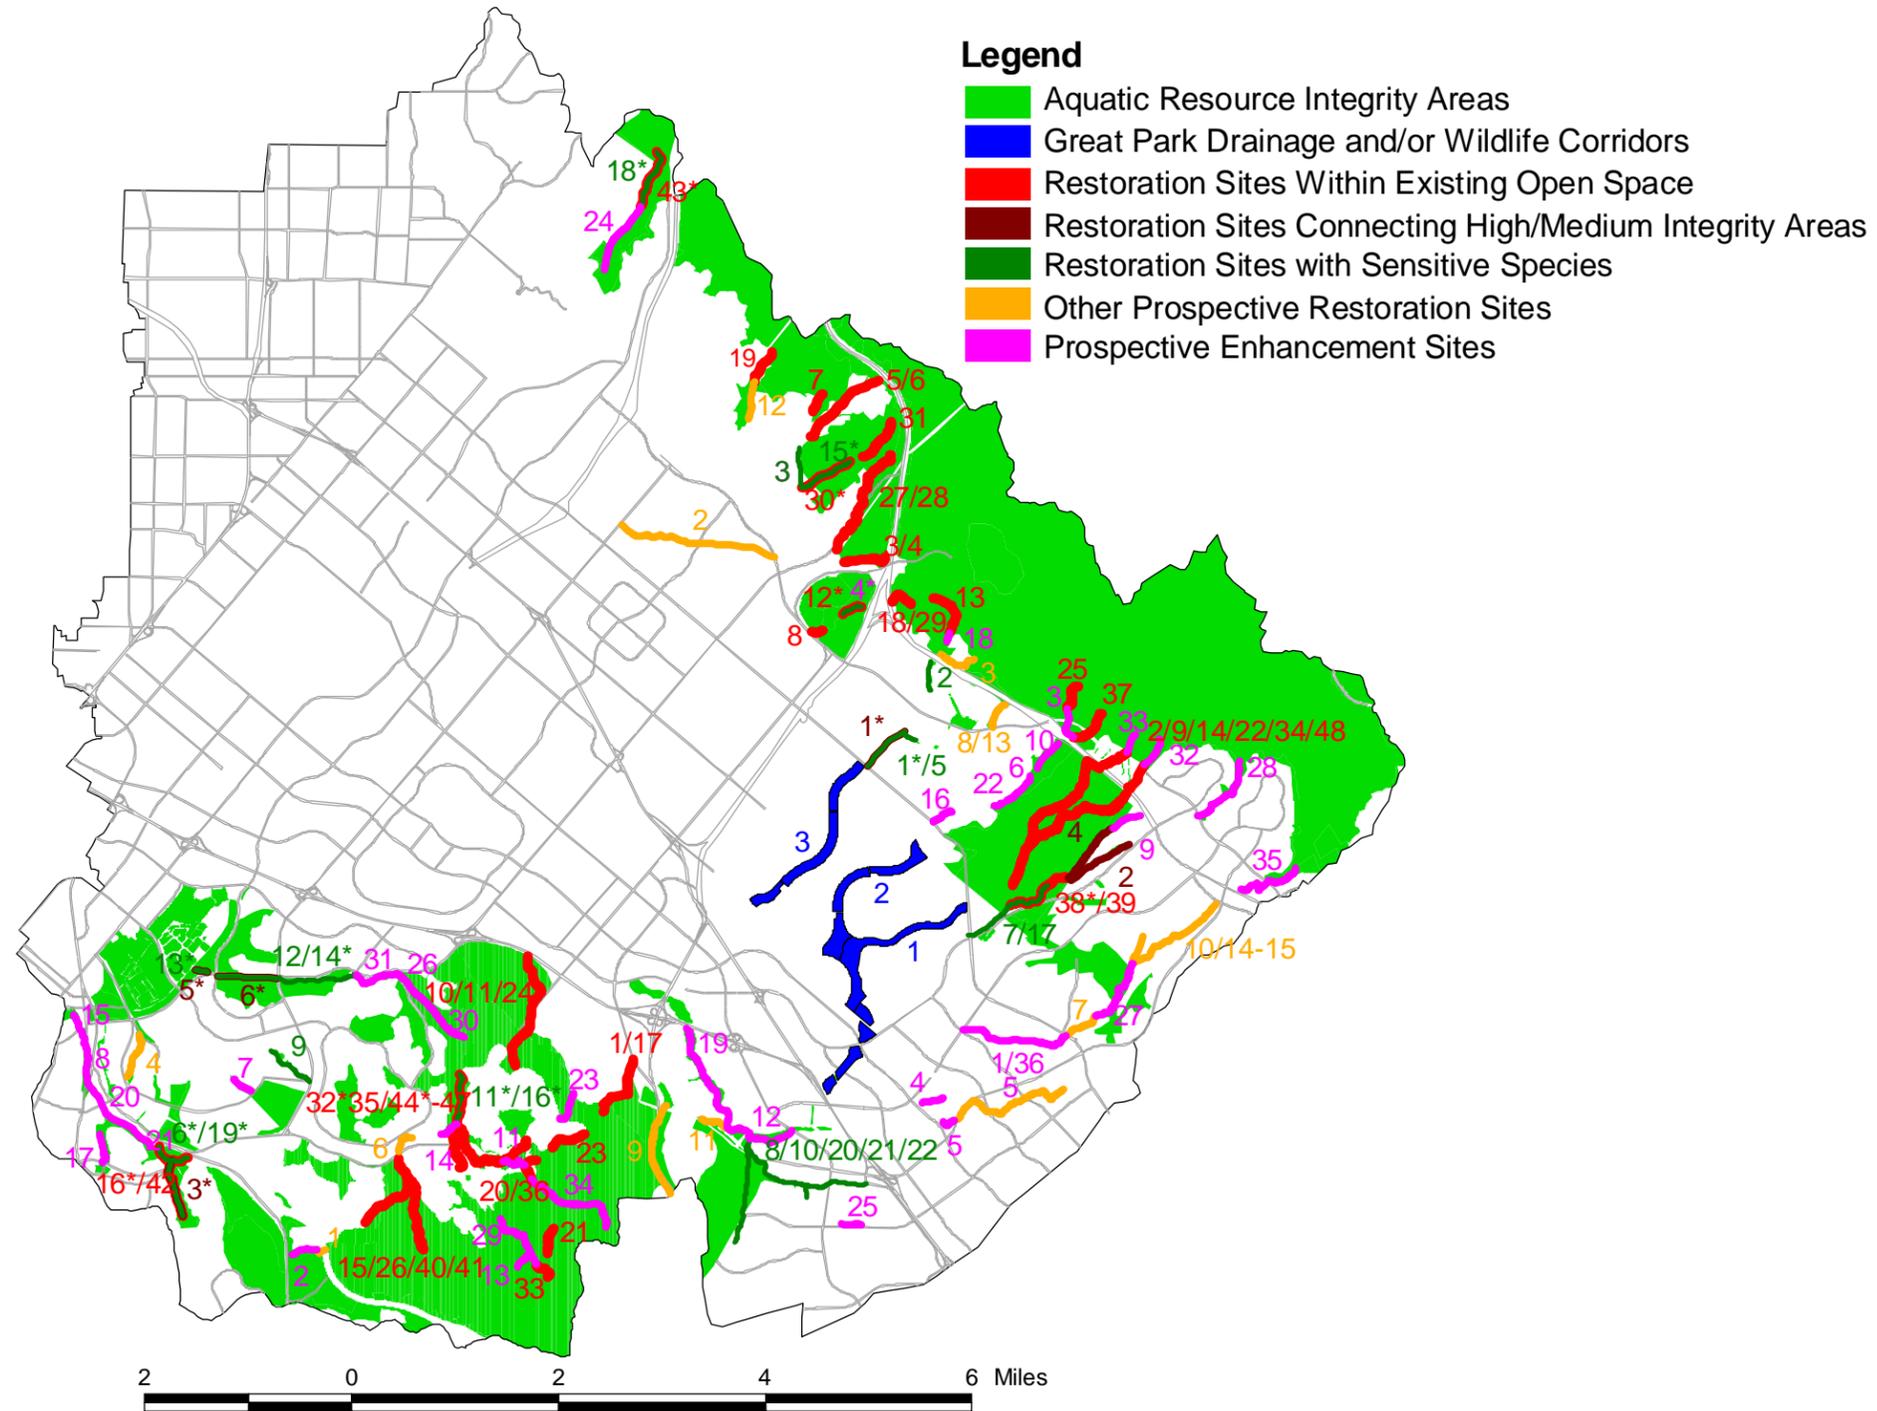
Figure 4-11. A representation of all prioritized riparian ecosystem restoration and enhancement opportunities within the San Diego Creek Watershed.
