SAN DIMAS WASH 6 LEVEE SYSTEM
LOS ANGELES COUNTY, CALIFORNIA
NLD SYSTEM ID # 3805010067

PERIODIC INSPECTION REPORT NO 1
GENERALIZED EXECUTIVE SUMMARY

FINAL SYSTEM RATING: MINIMALLY ACCEPTABLE
FINAL RATING DATE: FEBRUARY 27, 2015

PERIODIC INSPECTION REPORT PREPARED BY
PRAAD/GENTERRA/TABER LLC. FOR
THE U.S. ARMY CORPS OF ENGINEERS, LOS ANGELES DISTRICT

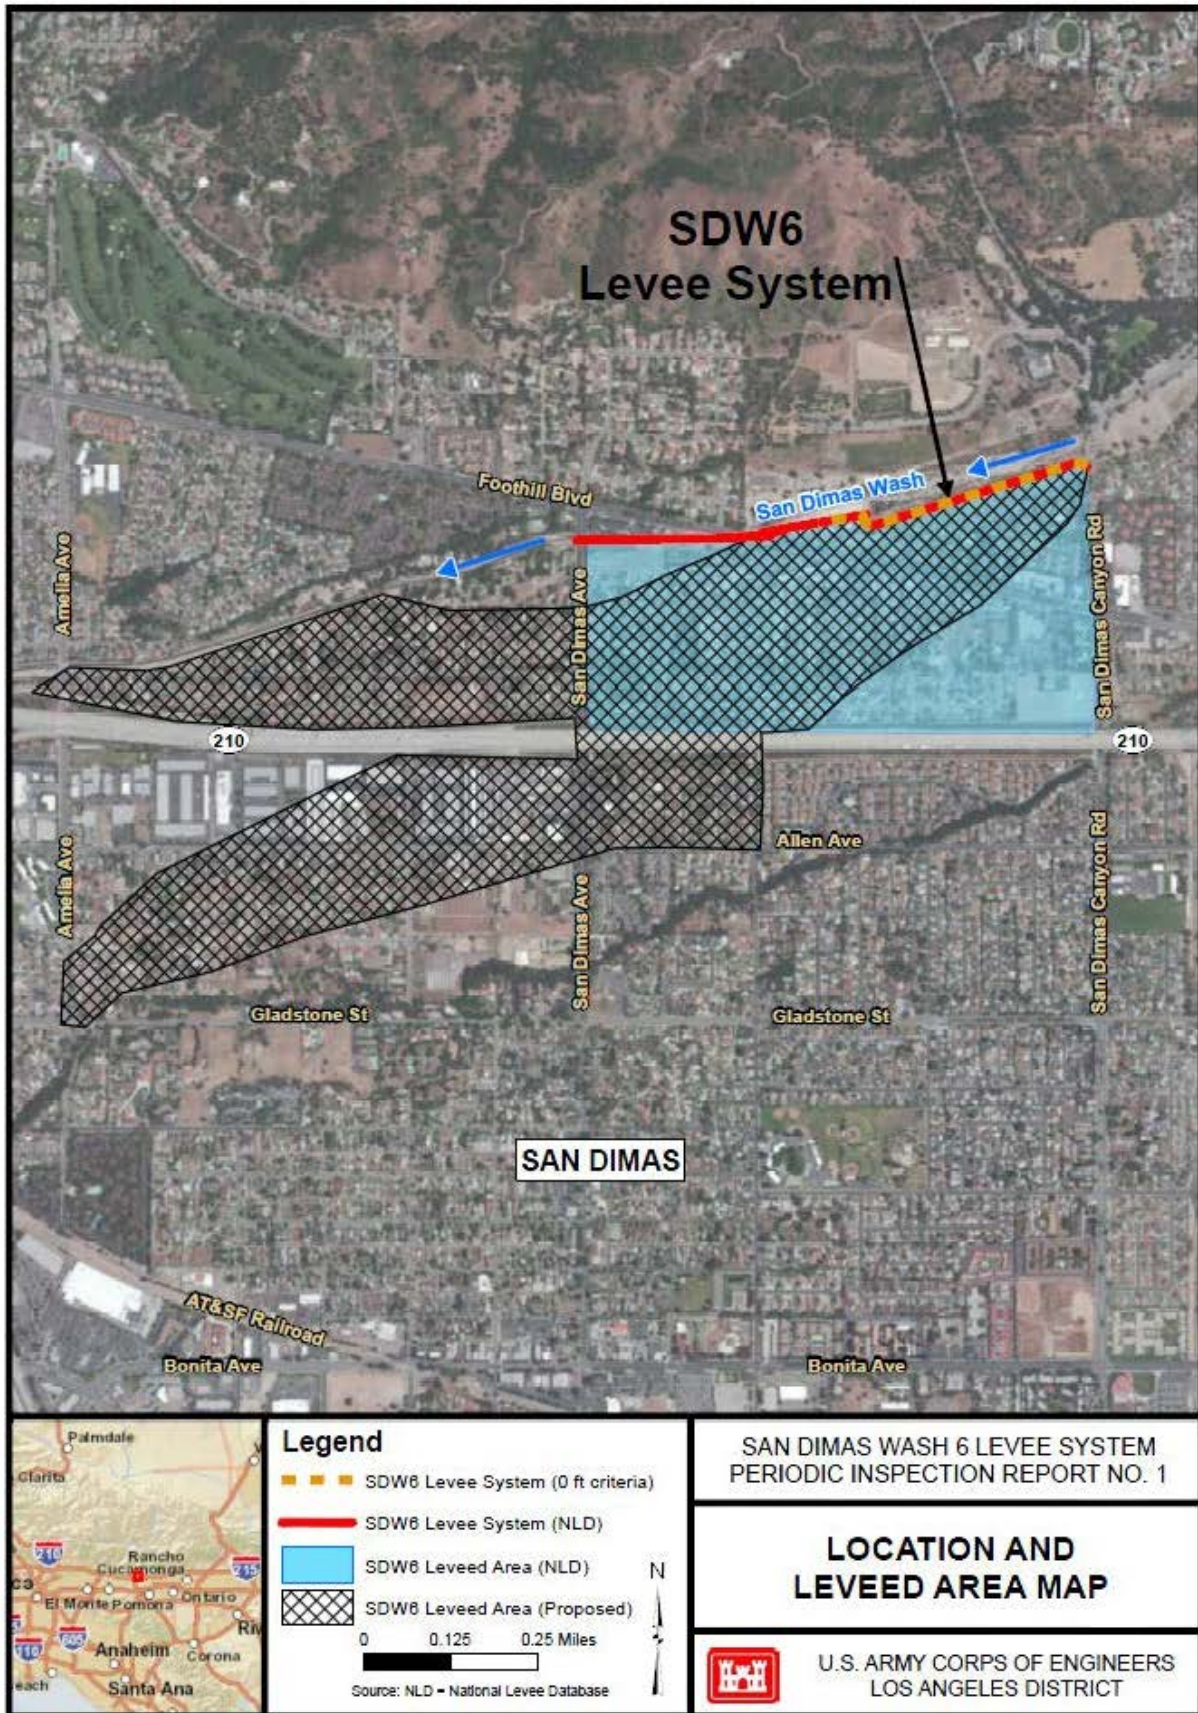
SDW6 is located in the city of San Dimas, in Los Angeles County, in the State of California. SDW6 is located along the left (south) bank of the San Dimas Wash, from STA. 409+25 (downstream side of San Dimas Canyon Road bridge) to STA. 369+77.49 (downstream side of San Dimas Avenue bridge), with a total length of 0.79 miles (per the National Levee Database (NLD)). Figure 1.1 shows the SDW6 extents and leveed area per the NLD.

Based on field observations, the levee is 0 feet in height (landside levee toe to levee crown) from approximate STA. 388+30 to STA. 369+77.49, which is the recommended channel reach (see Figures 1.1 and 1.2). As a result, the length of the levee is recommended to change from 0.79 miles (per NLD) to 0.42 miles (per field observation), from approximate STA. 409+25 to STA. 388+30 (see Part 6). The levee reach is relevant to the Periodic Inspection of the levee system. However, the channel reach was separated from the levee reach to retain the channel reach information that was obtained during the field inspection of the levee system.
