DEMENS DEBRIS BASIN COLLECTION LEVEE SYSTEM

**SAN BERNARDINO COUNTY, CALIFORNIA
NLD SYSTEM ID # 3805010080**

**PERIODIC INSPECTION REPORT NO 1
GENERALIZED EXECUTIVE SUMMARY**

**FINAL SYSTEM RATING: MINIMALLY ACCEPTABLE
FINAL RATING DATE: SEPTEMBER 17, 2013**

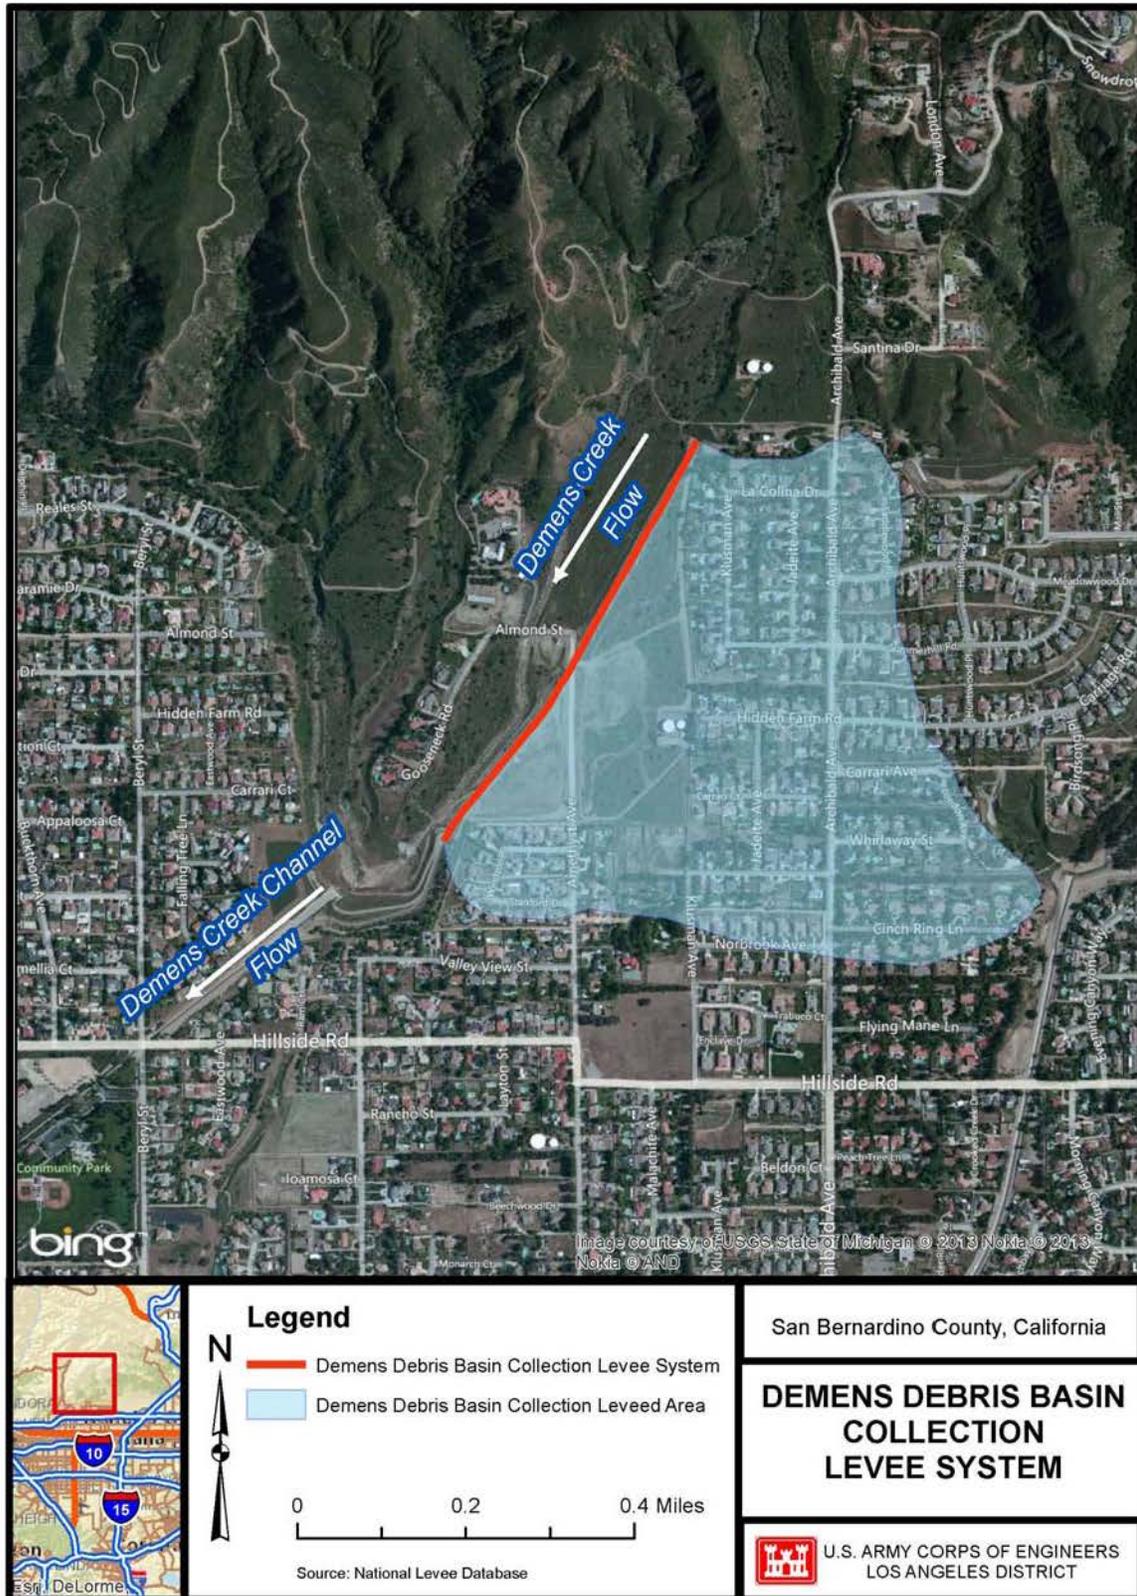
Figure 1: Demens Debris Basin Collection Levee System

On September 23, 2013, the leveed area was revised per signature of the Levee Safety Officer and is shown on Figure 1. This leveed area supersedes the leveed area in the Periodic Inspection Report No. 1.

Note: This NLD Leveed Area supersedes the leveed area shown in the PI Report.
