Biological Resources

# INCIDENTAL HARASSMENT AUTHORIZATION (IHA) APPLICATION FOR

# OPERATIONS AND MAINTENANCE (O&M) PORT SAN LUIS HARBOR BREAKWATER REPAIRS SAN LUIS OBISPO COUNTY, CALIFORNIA

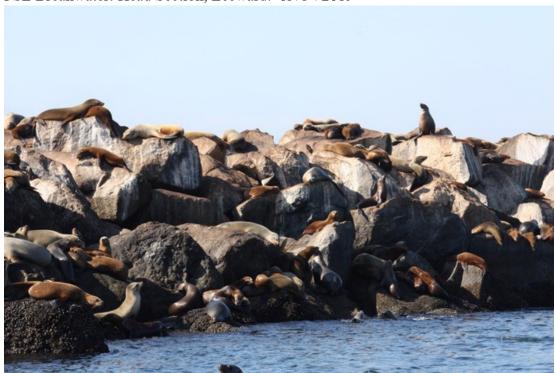
Figure 7. Pinniped Breakwater Images

PSL Breakwater: Head Section, Leeward. 6NOV2019

California sea lions are common in PSL year round where they are often hauled out on the PSL breakwater structure and within San Luis Obispo Bay on buoys and work docks (Figures 7 & 9). The general distribution of CSLs along the breakwater is influenced by direct wave energy against exposed breakwater segments. The distribution of CSLs on the breakwater is greatly influenced by the season and day to day sea state conditions. Four dead young pup carcasses were observed on the breakwater during the June 2018 survey conducted by M&A, no very young live pups were noted during either the on-water surveys or within the aerial survey photographs. During the contractor's marine mammal surveys (Table 9) and the Corps' monthly 2019 marine mammal surveys (Table 8) there was no observed nursing occurring by any of the CSLs in PSL and the majority of the animals in the pup-yearling size class (Table 9) were in the higher end of the size class, suggesting the smaller live pup-yearlings observed on the PSL breakwater may have been born elsewhere and not on the breakwater. It is believed based on observations that the pupping activities on the breakwater rock are not highly successful due to large voids between rocks that allow young pups to fall and become trapped inside the breakwater (per communication with M&A, see appendix). The PSL breakwater site is not as

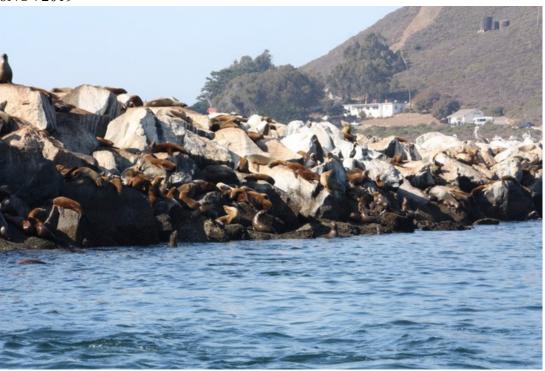
PSL Breakwater: South Eastern Section looking north towards Whaler's Rock, Leeward. 6NOV2019

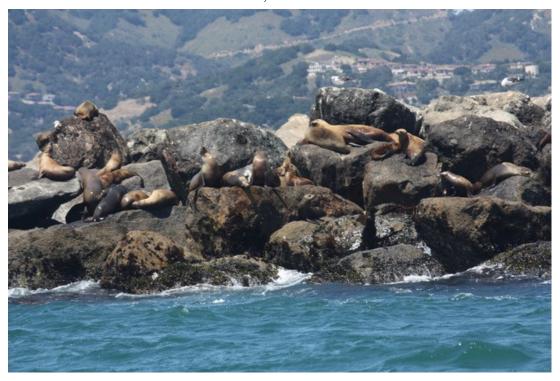
PSL Breakwater: South Eastern Section, Seaward. 3JUNE2019

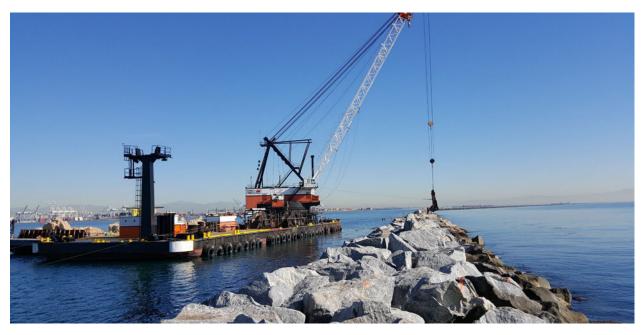
Figure 8. Crane-equipped Barge & Rock Barge at LA/LB Harbor Breakwater Repair Site

The following is a description of each type of equipment and how it will be utilized. Crane-equipped Barge(s). The crane-equipped barge (estimated to be as large as 260 ft by 80 ft) is a barge with an attached crane that will be utilized for the breakwater repair work (Figure 8) and may be utilized for the excavation of shoaled sediment. Should the crane-equipped barge be utilized for the excavation of shoaled sediment the crane will be outfitted with a clamshell bucket. The contractor may opt to utilize a separate clamshell dredge (a crane-equipped barge outfitted with a clamshell bucket, estimated to be approximately 120 ft by 60 ft) to excavate the shoaled sediment. During excavation the clamshell bucket will be lowered by the crane operator to the sea floor to excavate sediment. The crane will place material on an adjacent storage barge or into a scow for placement at a designated placement site within the vicinity. During breakwater repair construction a barge with an attached crane will be outfitted with lifting tongs to reset existing stone and retrieve stones from an adjacent storage barge tied up to the craneequipped barge, and then place those stones on damaged sections of the jetties. A boat operator in a skiff, and spotter on the jetty, would direct the operation of the crane in order to pick and place the stones. The picked stone must be able to match the dimensions of the voids along the jetty. Approximately 30 to 35 stones can be picked and placed per day using this vessel (Roughly three to four stones per hour on average). On average the crane-equipped barge and attached storage barge would move once a week along the breakwater, approximately repairing 75-100 ft linear feet per week. The movement of the barges along the breakwater would take approximately 30 minutes to 6 hours dependent on whether the main anchors require resetting. The crane-equipped barge and attached storage barge will pull approximately a couple hundred feet away from the breakwater at the end of the work day for overnight mooring for safety purposes and pull back into working position in the morning, unless adverse weather is expected. The movement of the barges at night to pull away from the breakwater will not require the main anchors to be reset, taking approximately 30 minutes.

**Storage/Rock Barge.** Another floating barge which serves as the stockpile of stone for repair work will be utilized. This barge is typically towed in from an offsite quarry location (likely Pebbly Beach Quarry on Santa Catalina Island) and is then tied up to the crane-equipped barge. The complement of this vessel is usually a spotter/oiler who works with the crane operator to select stones. The rock barge is expected to carry approximately 2,000 to 4,000 tons of stone per trip. On average every two to three weeks new stone will be brought on a storage barge to be exchanged with the existing empty storage barge, the exchange of storage barges will take approximately two to three hours each time. The unused/awaiting barges will be stored within a designated existing mooring within the established Port San Luis Harbor District designated anchorage or within Morro Bay Harbor.

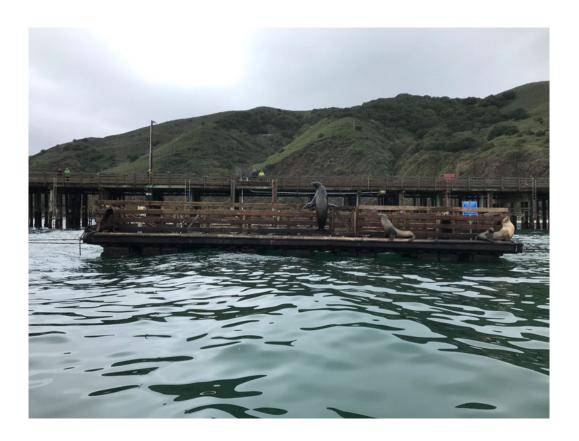
Figure 9. PSL Work Dock along Harford Pier (0.75 miles from the PSL Breakwater).

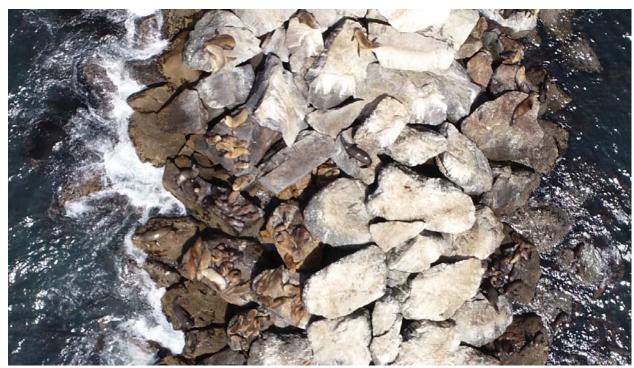
Sea lions photographed in June 2018 using high resolution low altitude UAV aerial photography. Overflights provided an opportunity to map individual animals hauled out by species, gender, and age class.

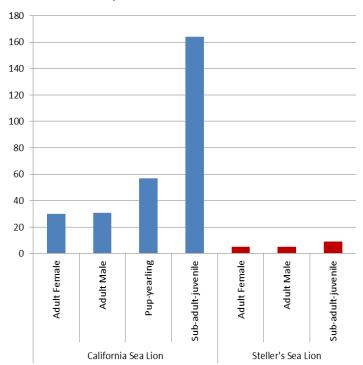
### Total Pinnipeds on Breakwater - June 2018

Population demographics of sea lions hauled out on Port San Luis Breakwater June 30, 2018

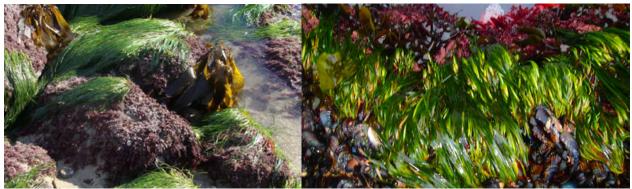
Torrey's surfgrass (Phyllospadix torreyi) (left) and Scouler's surfgrass (P. scouleri) (right). Surfgrass is attached to the rock by holdfast like roots, but generally its colonization is facilitated by compact turf like algae.

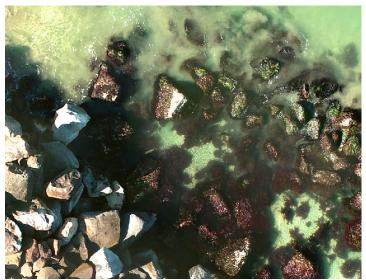
Aerial view of surfgrass on the lee side of the Port San Luis breakwater is principally found on the displaced rock that persists interspersed with sand at the lower intertidal margins of the breakwater.

of the breakwater where proposed repairs are to occur, surfgrass is most substantively found on the boulders that have been displaced from the breakwater and now persist on two low intertidal zone terraces comprised of a mosaic of displaced jetty rock and interstitial sand.

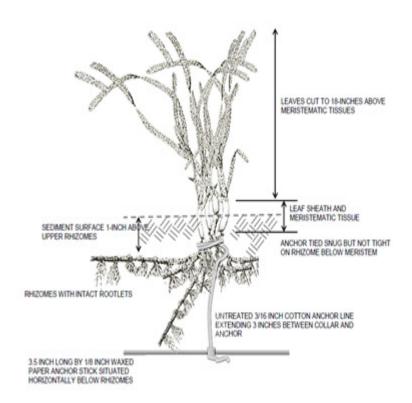
The Merkel Anchored Bare-root Eelgrass Planting Unit consists of a bundle of turions with intact rhizomes with a minimum of 3 nodes and internodes held on a biodegradable anchor consisting of a cotton twine collar that connects to a wax impregnated paper stick anchor situated horizontally below the planting unit.

The proposed mitigation will utilize anchored bare-root transplant units. Bare-root transplants preferred means of transplanting eelgrass in most situations, and anchored bare- root units are the principal planting units used in largescale restoration projects at the current time. The survival of such planting units has been shown to be quite high when properly prepared (Fonseca et al. 1982; Merkel 1987, Similarly, bare-root units 1990a). have shown an ability to rapidly expand and colonize bare substrate (Merkel 1990b). In addition to offering high unit survival and rapid expansion rates, bare-root units can be prepared with limited damage to the donor bed. Unlike plug extractions, bare-root units can be prepared using materials collected without substantial sediment disturbance. Each transplant unit for the project work will consist of 6-8 turions.

The anchors used in this program will be biodegradable and pliable anchors such as those developed initially for transplants in Mission Bay's Sail Bay (Merkel 1987) and which have subsequently been used in more than 86 eelgrass restoration projects throughout California, Oregon, Washington, and Alaska. These units have been used in successful transplanting of Pacific eelgrass within both Mission Bay and Lower Newport Bay.

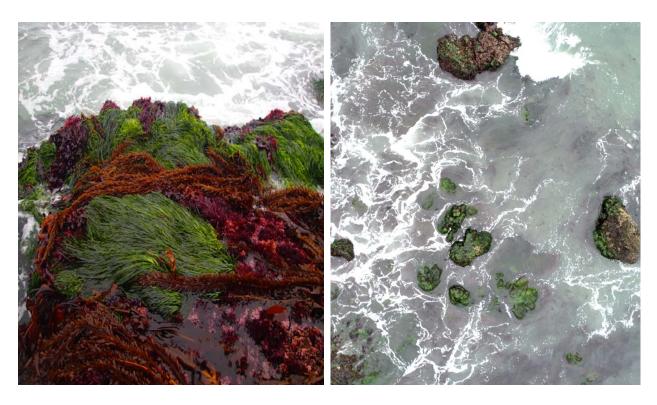
Surfgrass on bedrock (left) and within orthorectified UAV aerial image of surfgrass January-February 2019 (right). Surfgrass also occurs on what appears to be remnants of a prior breakwater roadway on the lee of the the breakwater (bottom).

Of particular note to the proposed breakwater repairs is the presence of the limited extent of surfgrass extending along the breakwater between Stations B 0+00 and B 8+00 (Figure 5). All of the surfgrass in this area is located between 0 and -3 feet MLLW. As a result, the surfgrass in this area should be outside of the elevation range within which repairs would take place, however well within the work area limits.

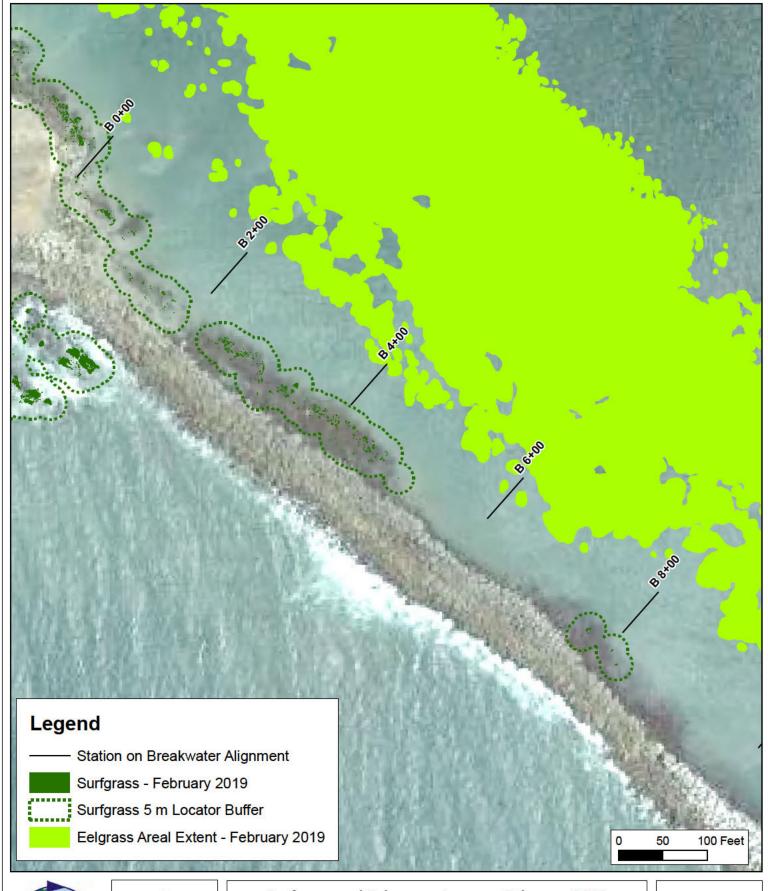
Port San Luis Breakwater Repair Sections Stations B 6+00 to Station B 13+00 San Luis Obispo County, California

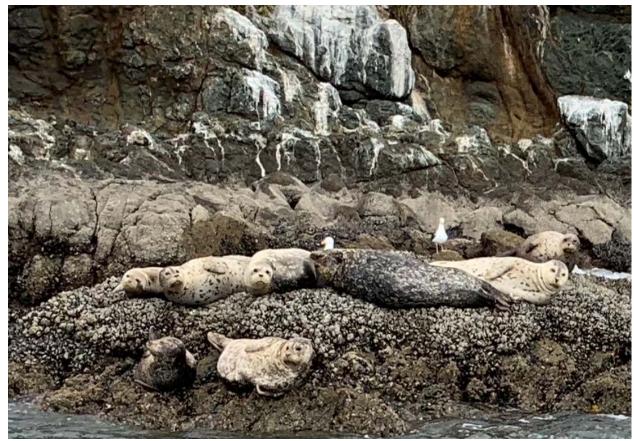
Sea lions photographed in June 2018 using high resolution low altitude UAV aerial photography. Overflights provided an opportunity to map individual animals hauled out by species, gender, and age class.

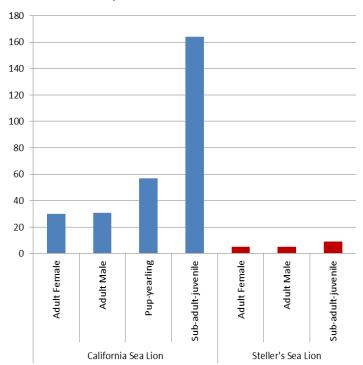
#### Total Pinnipeds on Breakwater - June 2018

Population demographics of sea lions hauled out on Port San Luis Breakwater June 30, 2018

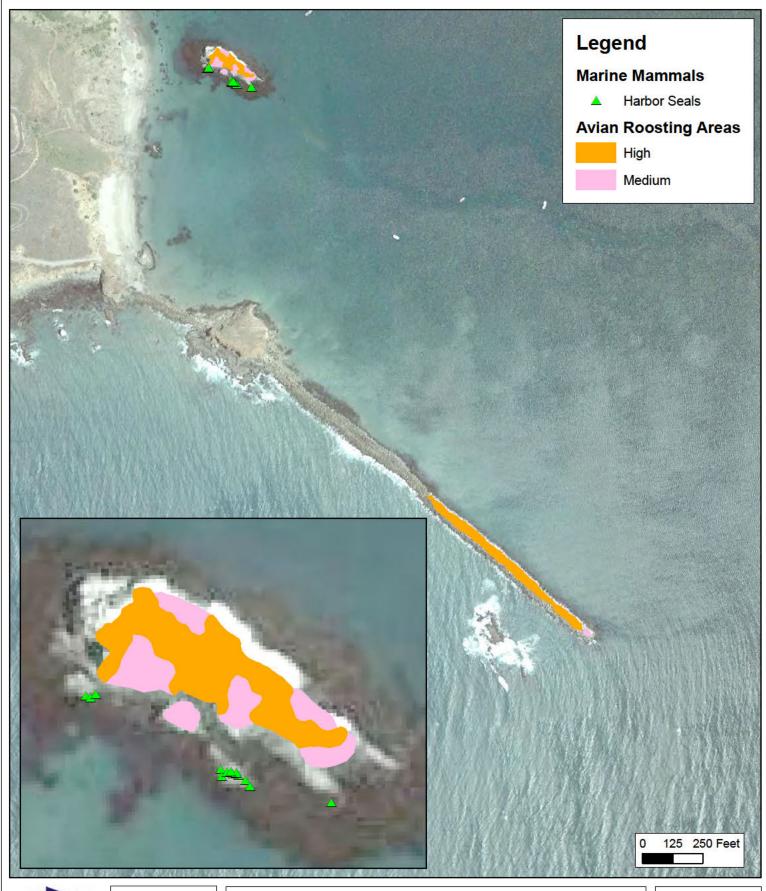
Port San Luis Breakwater Repair Sections Stations B 6+00 to Station B 13+00 San Luis Obispo County, California
