**Sediment and Chemical Analysis Results
of the Proposed Excavated Material
(1991-1992; 2013-2014; 2020)**

Port San Luis 2013 Sediment Sampling and Analysis (Source: Sediment Sampling and Analysis Report in Support of 2014 Dredge Permit Application, Port San Luis Harbor District, 2014)

Sediment Sampling and Analysis Report in Support of 2014 Dredge Permit Application

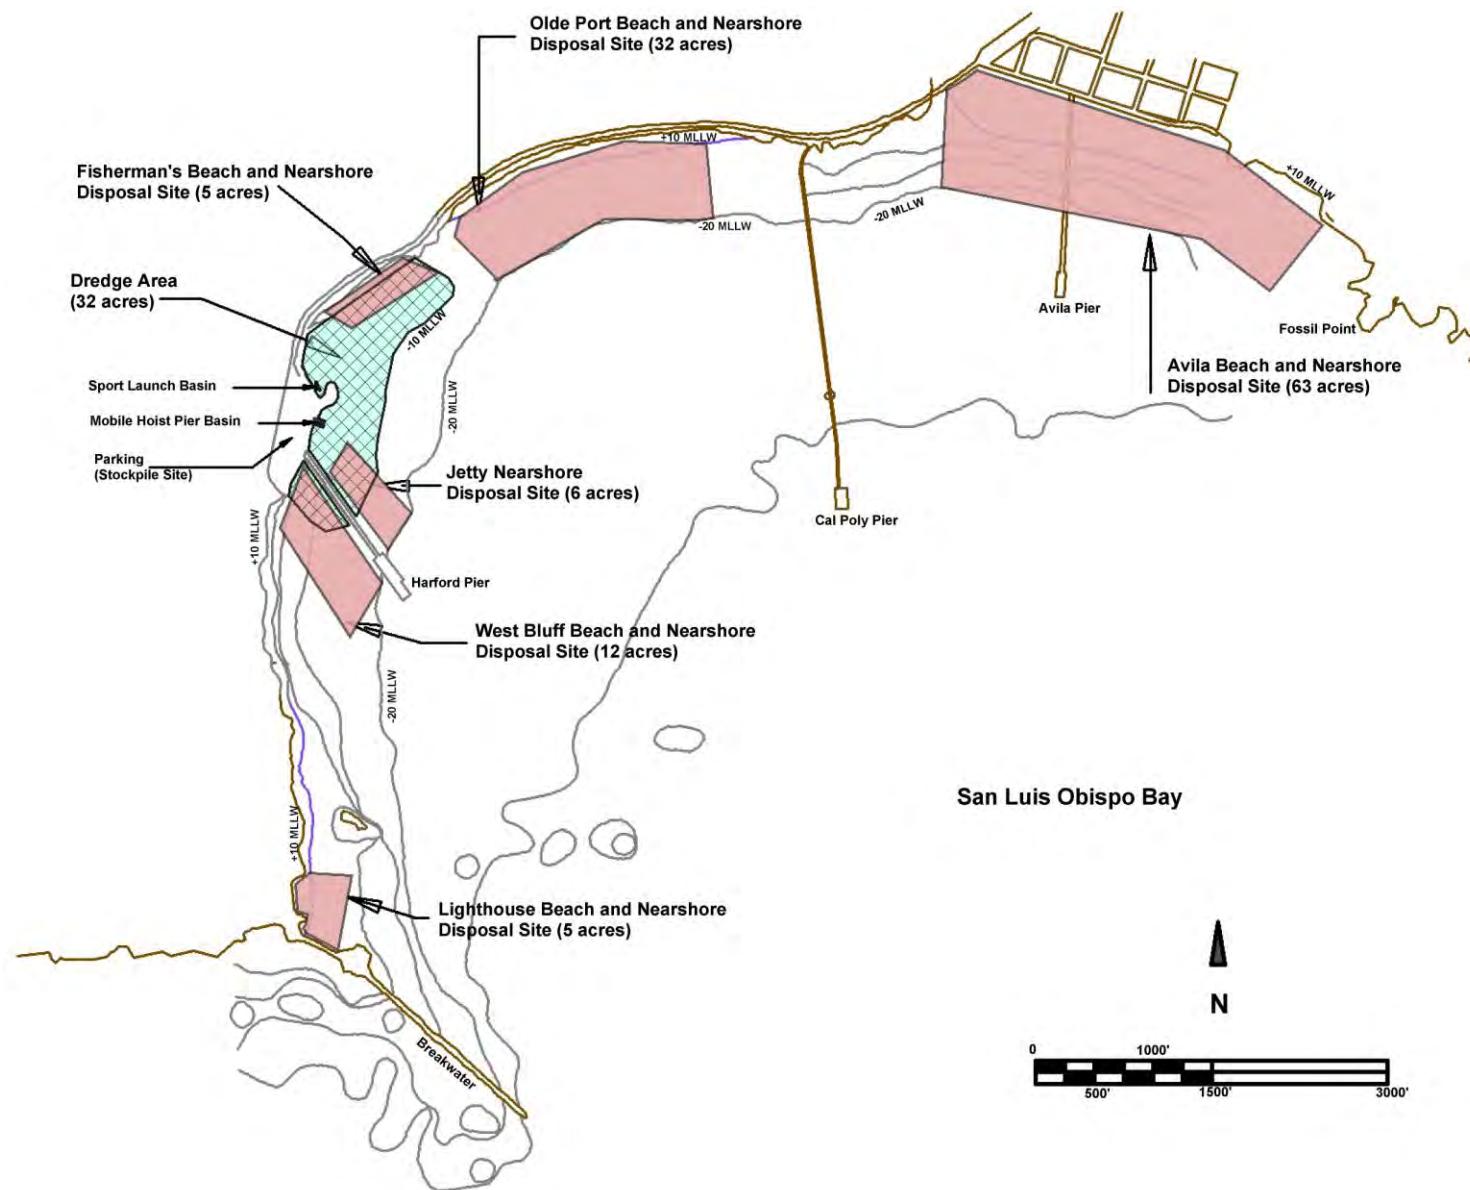
Figure 1. Map of Port San Luis Harbor 2013 Dredge and Disposal Sites

Dredged material will be used for beach nourishment at the sites shown in **Figure 1**. The sites currently permitted for this purpose include those historically used for disposal, specifically, Fisherman's Beach and Olde Port Beach, and four sites introduced in 2003: Lighthouse Beach, Avila Beach, West Bluff Beach and Jetty disposal sites. At this time, the West Bluff Beach site is being used exclusively for beach nourishment and the Fisherman's Beach site could be potentially used. The Port does not anticipate using any of the other four sites in the foreseeable future.

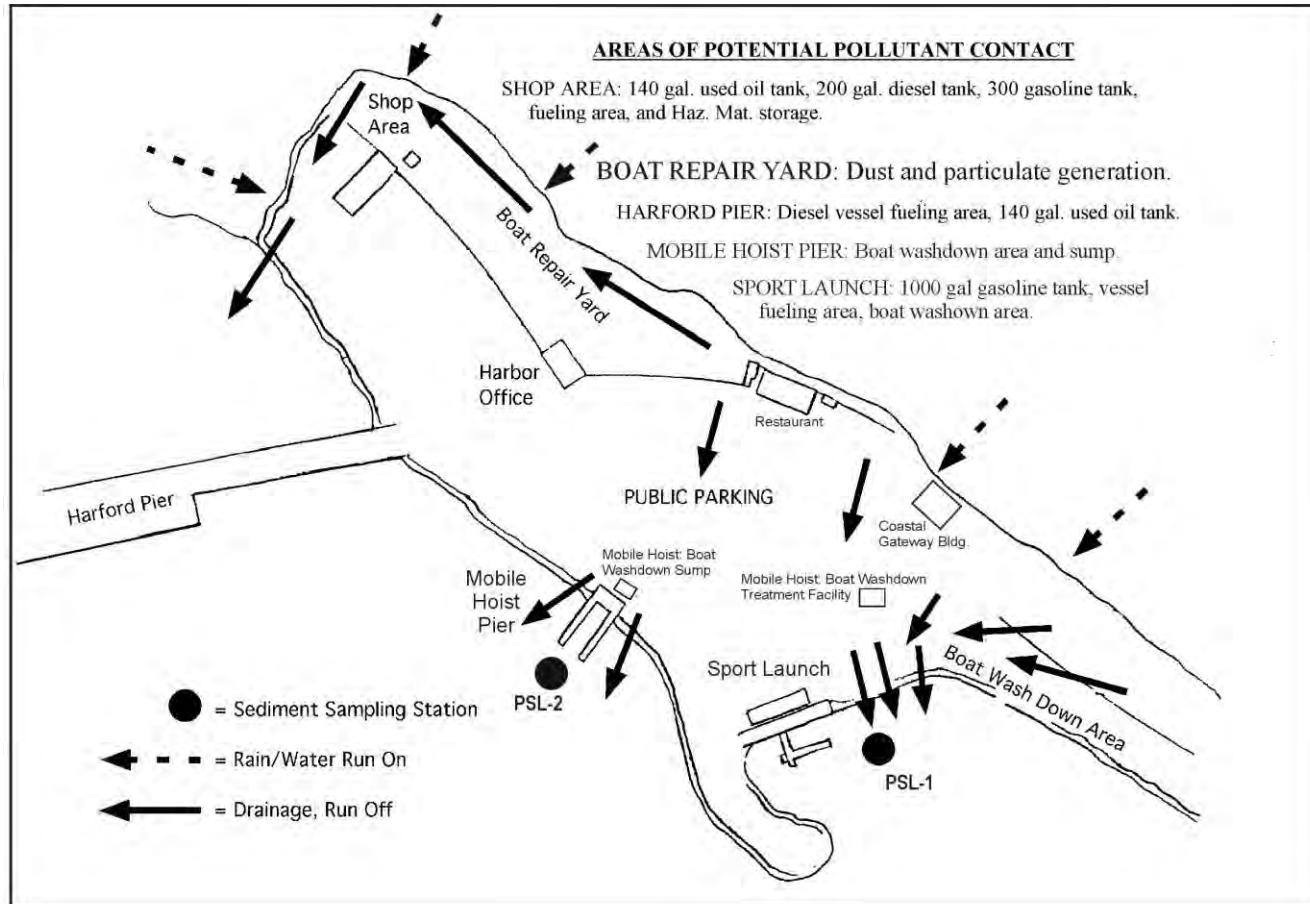
Figure 2. Port San Luis Drainage, Potential Sediment Contaminants, and Sediment Sampling Sites.

Two sediment sampling stations were established within the PSL dredge zone as shown in **Figure 2**. The locations of the sampling stations were chosen to place them adjacent to the principal storm drains that discharge into the dredge area. Proximity of the sampling stations to these discharge points should maximize the probability of sampling any potential contaminants that have accumulated in the sediments from land based sources. The locations of areas of potential pollutant contact are also shown in **Figure 2**, as is the direction of runoff, runoff discharge points and the positions of the sediment sampling stations relative to the discharge points. Each of the stations specified has been sampled at least three times previously during the period from 1996 through 2009.

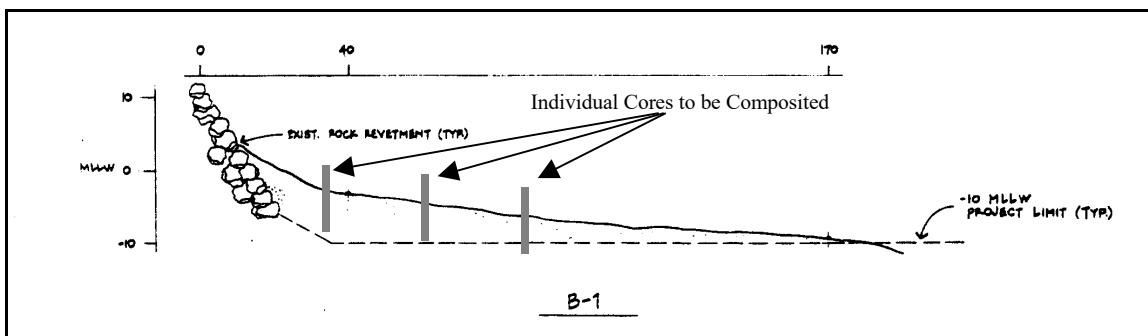
Figure 3. Profile of core sampling technique.

To accurately characterize the sediments at each of the sampling stations, three individual cores were collected along a line running perpendicular to the shoreline and proceeding down the natural slope of the bottom as shown in **Figure 3**. Individual cores were capped and extruded, then combined to produce a composite sample representative of the mixed material that will be deposited on the beach by the dredge. All sediment samples were collected using a diver-operated coring device. The device utilizes a 2-inch diameter stainless steel tube with a removable plastic liner. Each individual core was driven into the sediment achieving a nominal core length of about 3 feet. The composited samples cover the entire depth range of the area to be dredged, extending down to 11 feet below MLLW. The date and time of the sample collection, water depth where each core was taken, the depth of the core and field notes were recorded during sampling, this information is summarized in **Table 2**. The locations of the individual cores are shown graphically in **Figure 4**.

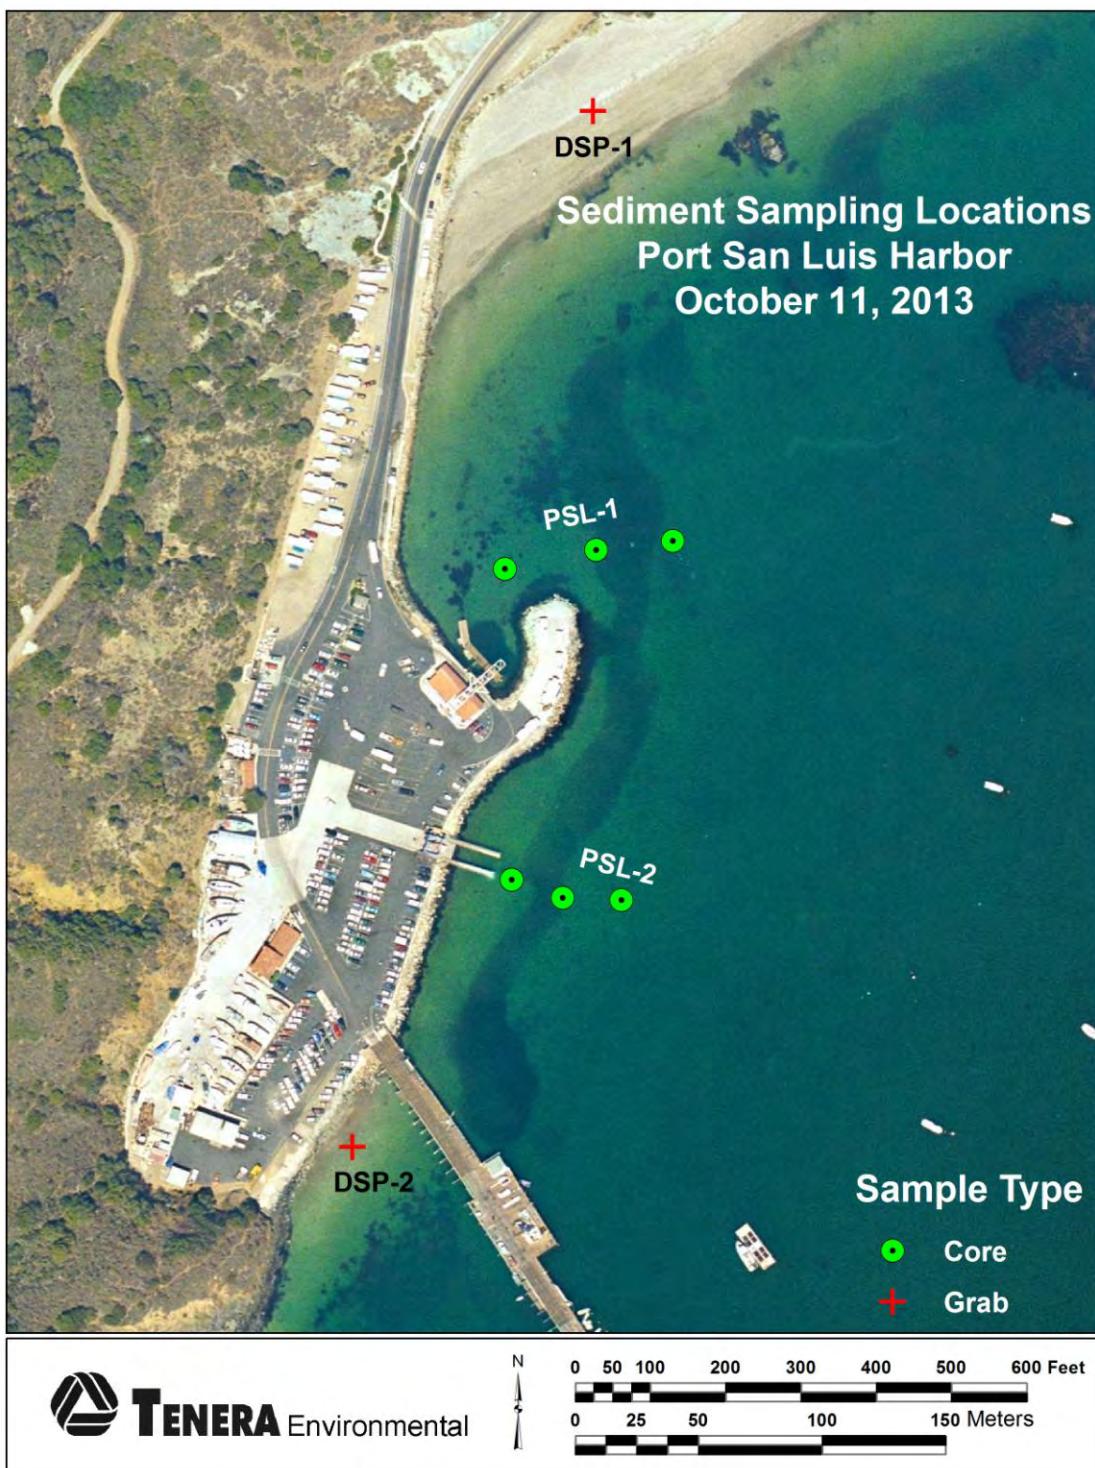
Figure 4. Locations of individual sediment cores and grab samples collected in the Port San Luis Harbor dredge and disposal areas on October 11, 2013.

Samples taken for particle grain size analysis only, were collected from the two sites that are currently being used for dredge disposal. Samples from Fisherman's Beach, and West Bluff Beach disposal sites were collected from approximately 3 feet above MLLW elevation (**Figure 4**).

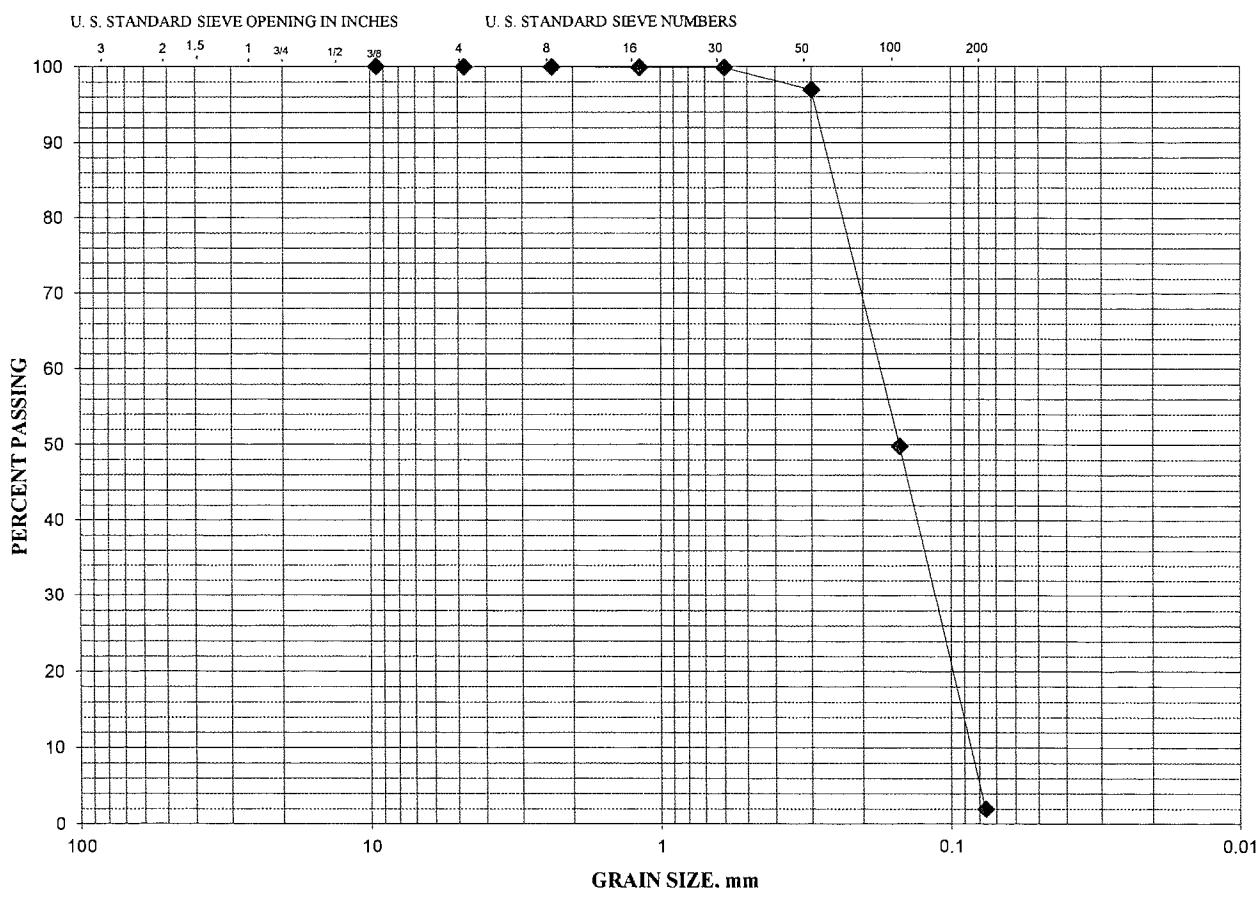
ASTM D 422-63/07; D 1140-00/06

Sieve size	% Retained	% Passing
3/8"	0	100
#4	0	100
#8	0	100
#16	0	100
#30	0	100
#50	3	97
#100	50	50
#200	98.0	2.0

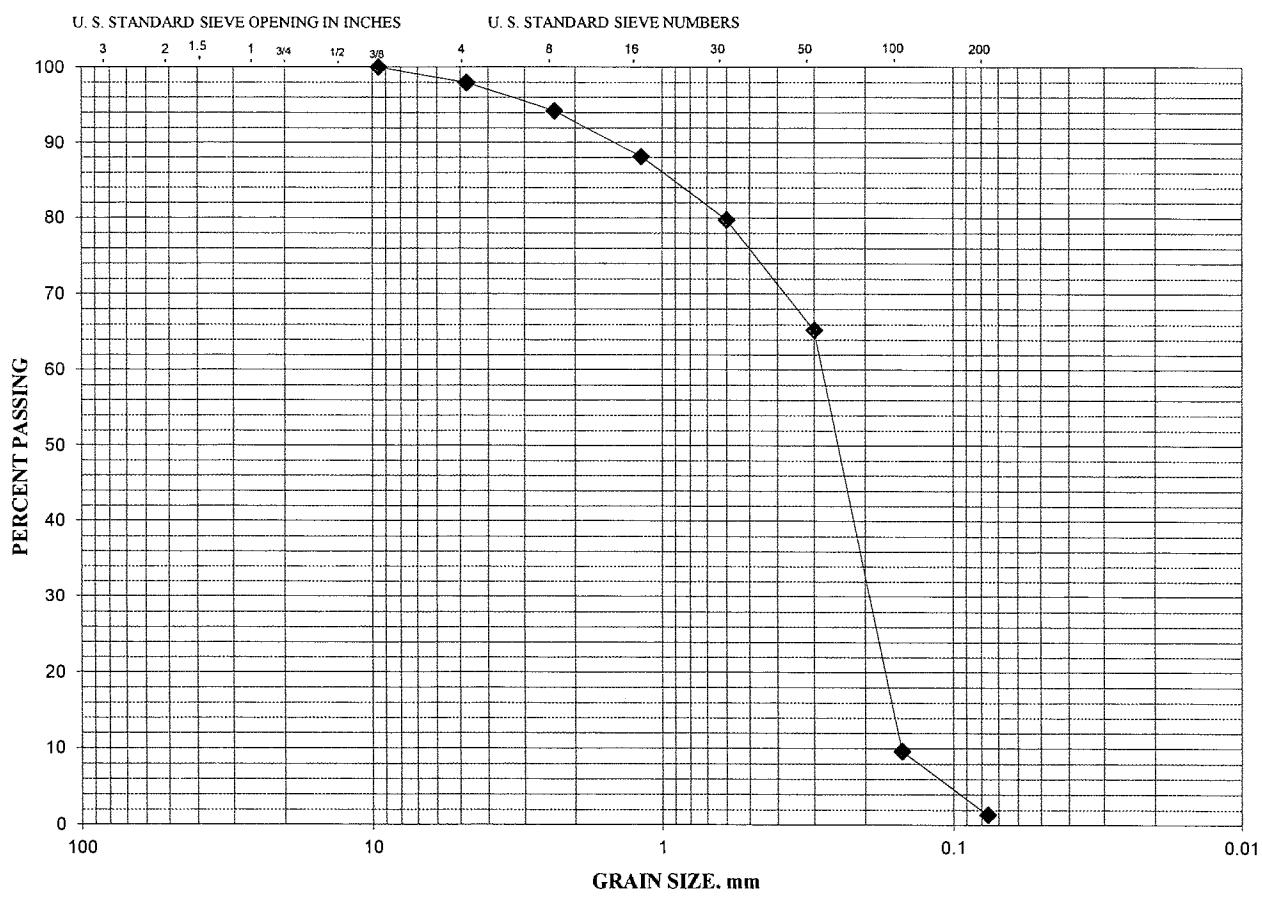
ASTM D 422-63/07; D 1140-00/06

Sieve size	% Retained	% Passing
3/8"	0	100
#4	2	98
#8	6	94
#16	12	88
#30	20	80
#50	35	65
#100	90	10
#200	98.6	1.4

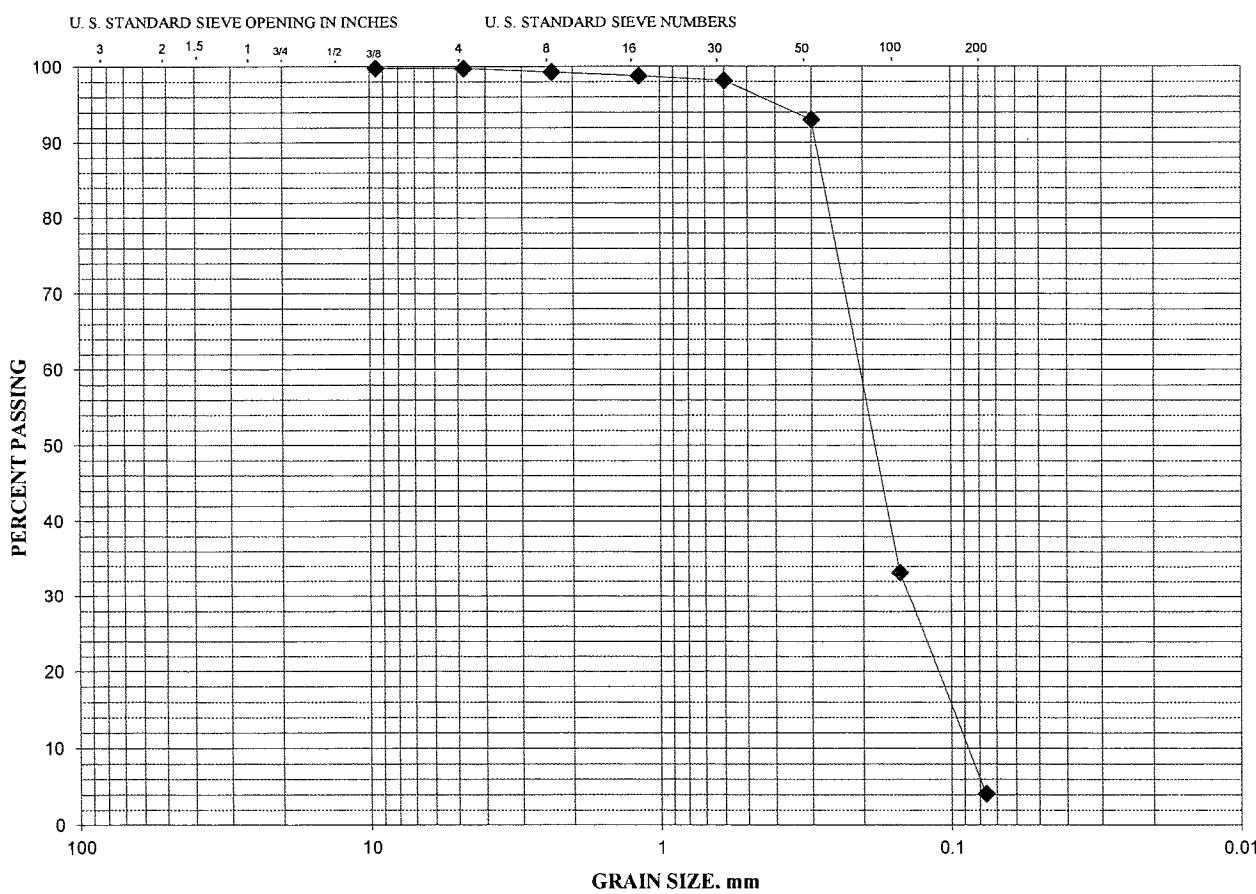
ASTM D 422-63/07; D 1140-00/06

Sieve size	% Retained	% Passing
3/8"	0	100
#4	0	100
#8	1	99
#16	1	99
#30	2	98
#50	7	93
#100	67	33
#200	95.9	4.1

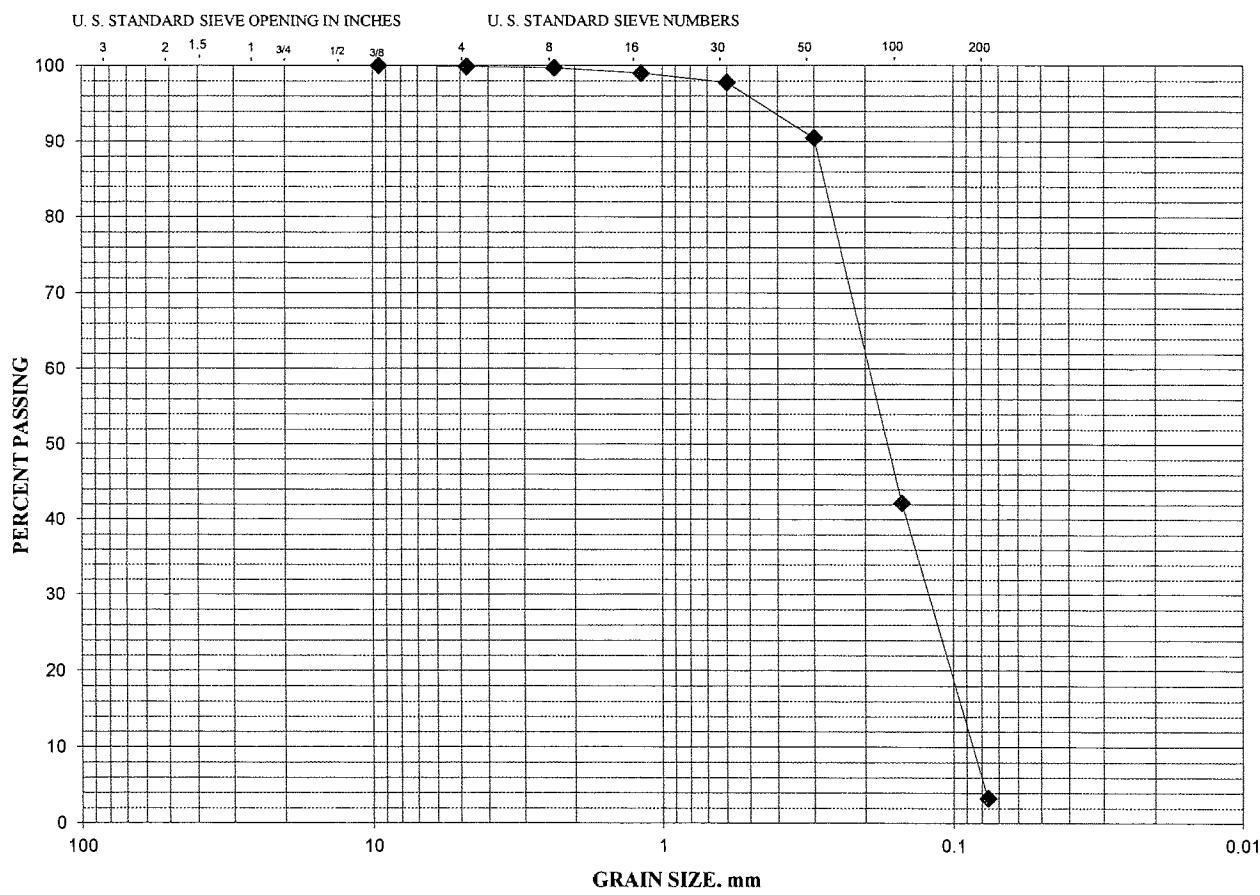
ASTM D 422-63/07; D 1140-00/06

Sieve size	% Retained	% Passing
3/8"	0	100
#4	0	100
#8	0	100
#16	1	99
#30	2	98
#50	9	91
#100	58	42
#200	96.7	3.3

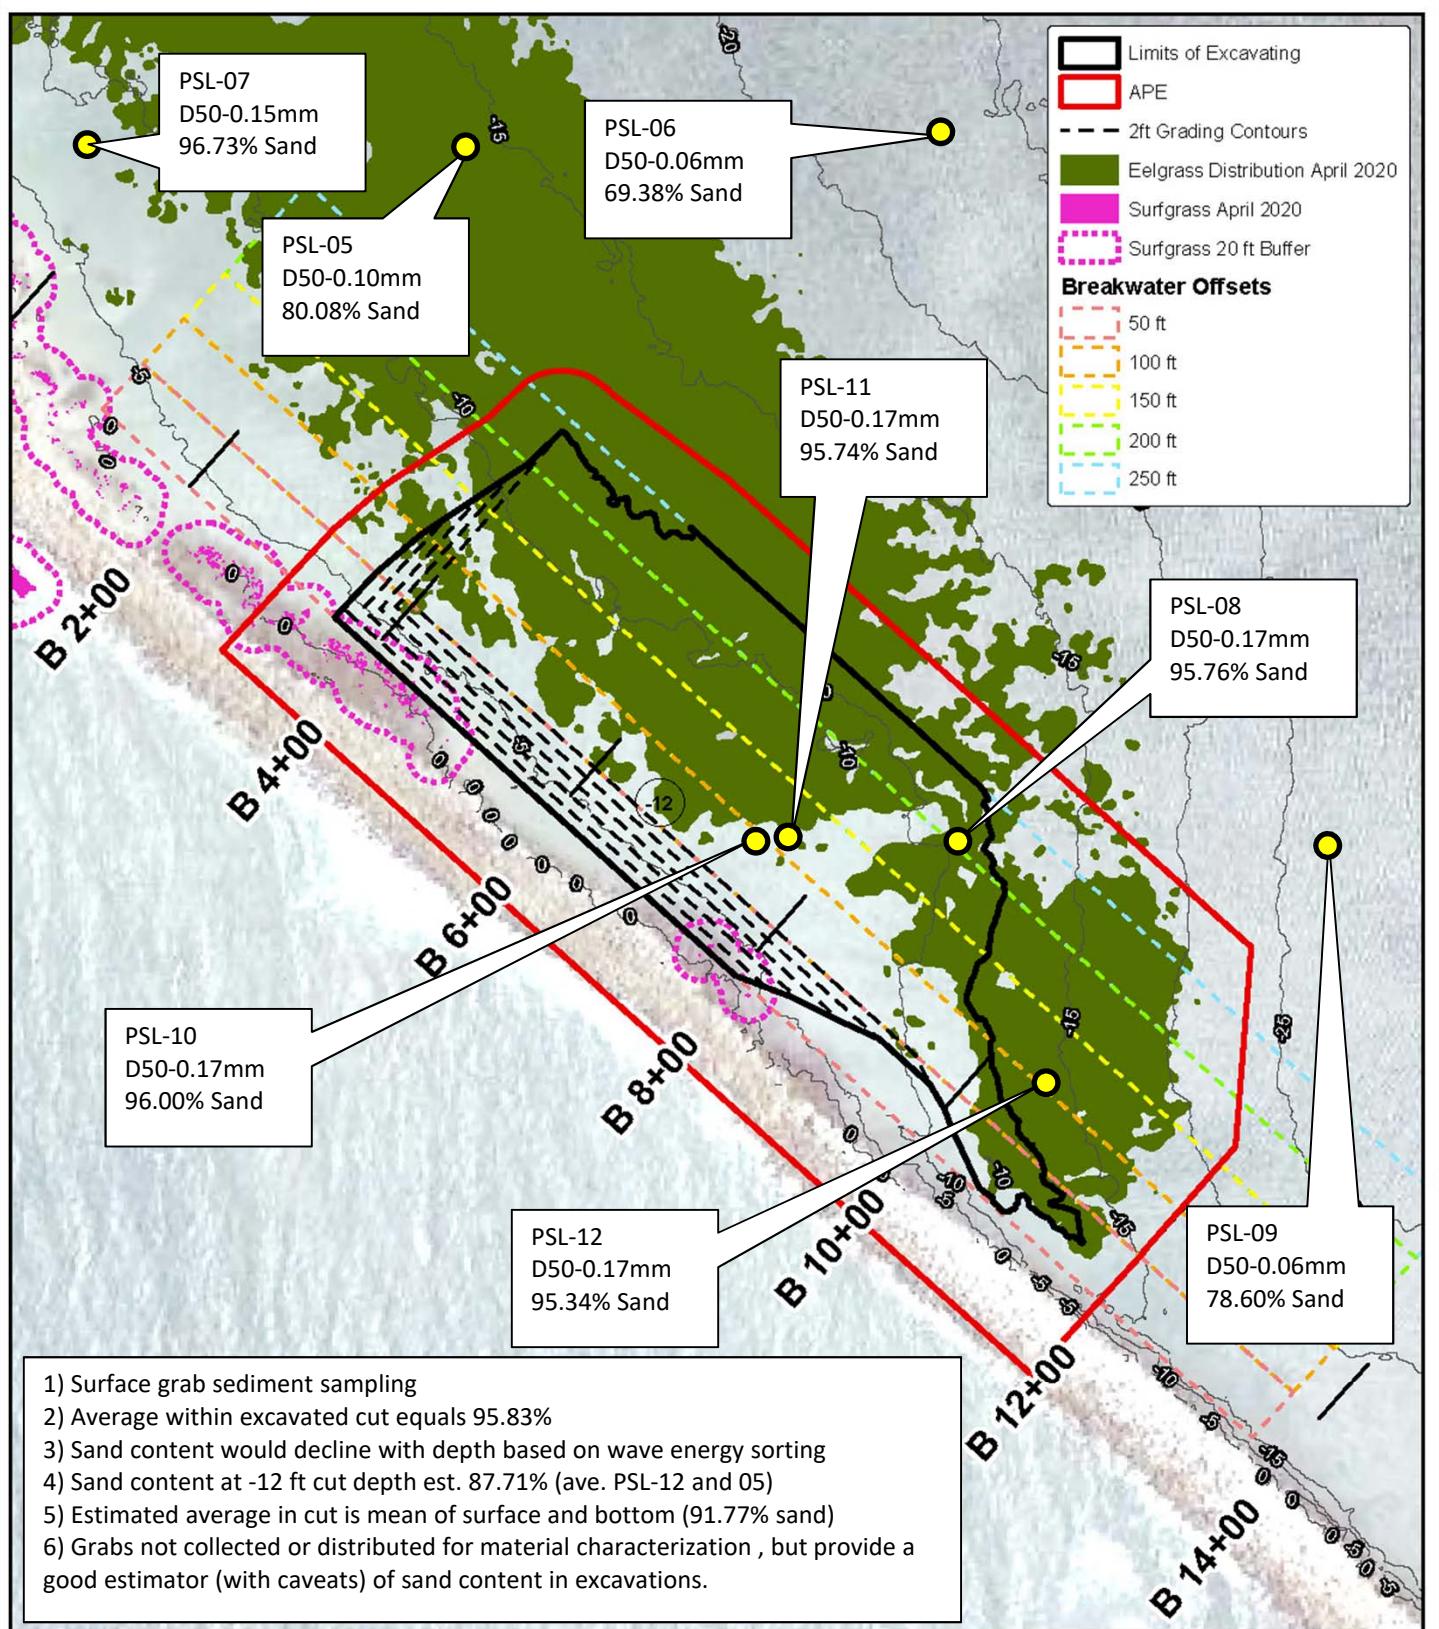
Figure 2

Project Impact Area Seagrass
Port San Luis Breakwater Repair Sections
San Luis Obispo County, California

The data from surface grab samples that were gathered from within the eelgrass can be used to perform a *discount* weighted average grain size analysis. The results, when coupled with all other factors of littoral sediment source, lack of contaminant sources in the area, a general knowledge of the driver of accumulation being the breakwater, and the planned immediate area reuse, and believe it would support a Tier 1. To make use of the surface grab data to estimate the weighted sand percentage it is necessary to consider the energetics of the environment as part of the accumulation process and note that the sand content at depth will be lower than that at the surface of the dredge area. This is because the surface sediments in shallower water are exposed to greater swell and overtopping wave energy than would be the case if the site were deeper. Since the site was deeper and has filled with sand over time, it is expected that grain size and percent sand has risen with accumulation. To develop a volume based average sand content, Keith Merkel (Merkel and Associates) averaged the surface percent sand for the three samples taken within the dredge footprint (PSL 08, 10, and 11 = 95.83%) [Figure 2]. Keith Merkel then averaged the westerly sample PSL-12 (-14.65 ft) and the easterly PSL-05 (-14.33 ft) deeper samples as surrogates of what the percent sand may look like at the bottom of the cut (87.71%). This is expected to be a low percent sand estimate for two reasons. First both samples were taken deeper than the design cut and second, PSL-05 is much more protected and within eelgrass that would retain fines than would be the case in the proposed dredge footprint. This results in an estimated (91.77%) for volume weighting.
