**US Army Corps
of Engineers®**

Los Angeles District

**DRAFT ENVIRONMENTAL ASSESSMENT
MORRO BAY
SIX YEAR FEDERAL MAINTENANCE DREDGING PROGRAM
SAN LUIS OBISPO COUNTY, CALIFORNIA**

March 2013

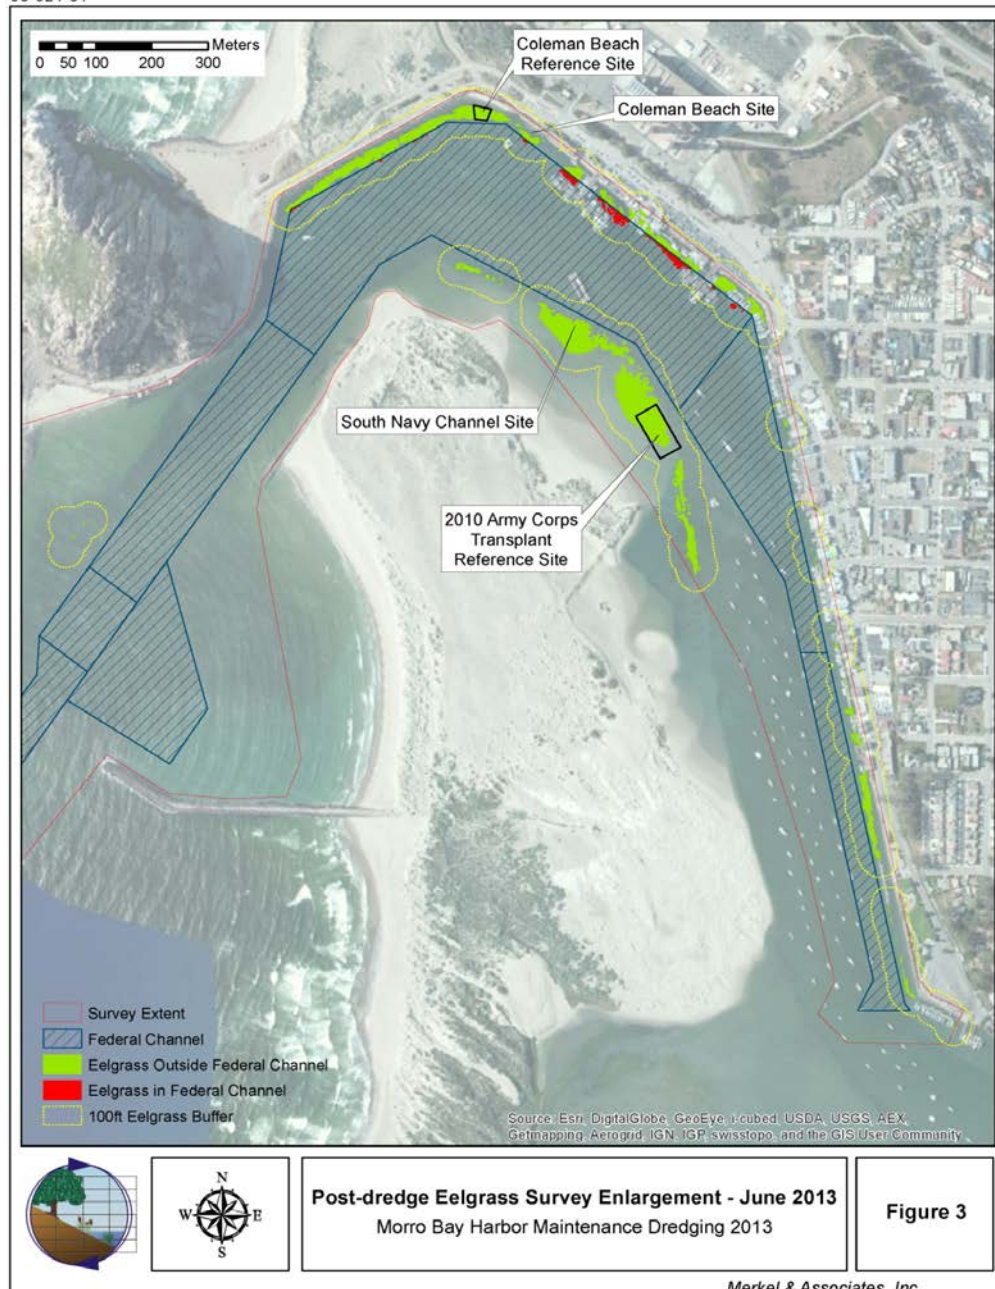
Figure 5.1.1-1 Morro Bay Eelgrass Survey Map (post-dredge 2013)

Eelgrass is present along the base of the man-made revetment located northwest of the North T Pier in the Navy Channel. Eelgrass was not observed along the manmade North and South breakwaters or the groin in Morro Bay Harbor, which are structures adjacent to, but not in the footprint of, the proposed action. Though the revetment is not within the Morro Bay Harbor maintenance dredging footprint project, the revetment is located approximately 660 feet north of the dredging footprint within the Navy Channel between the two narrowest points.

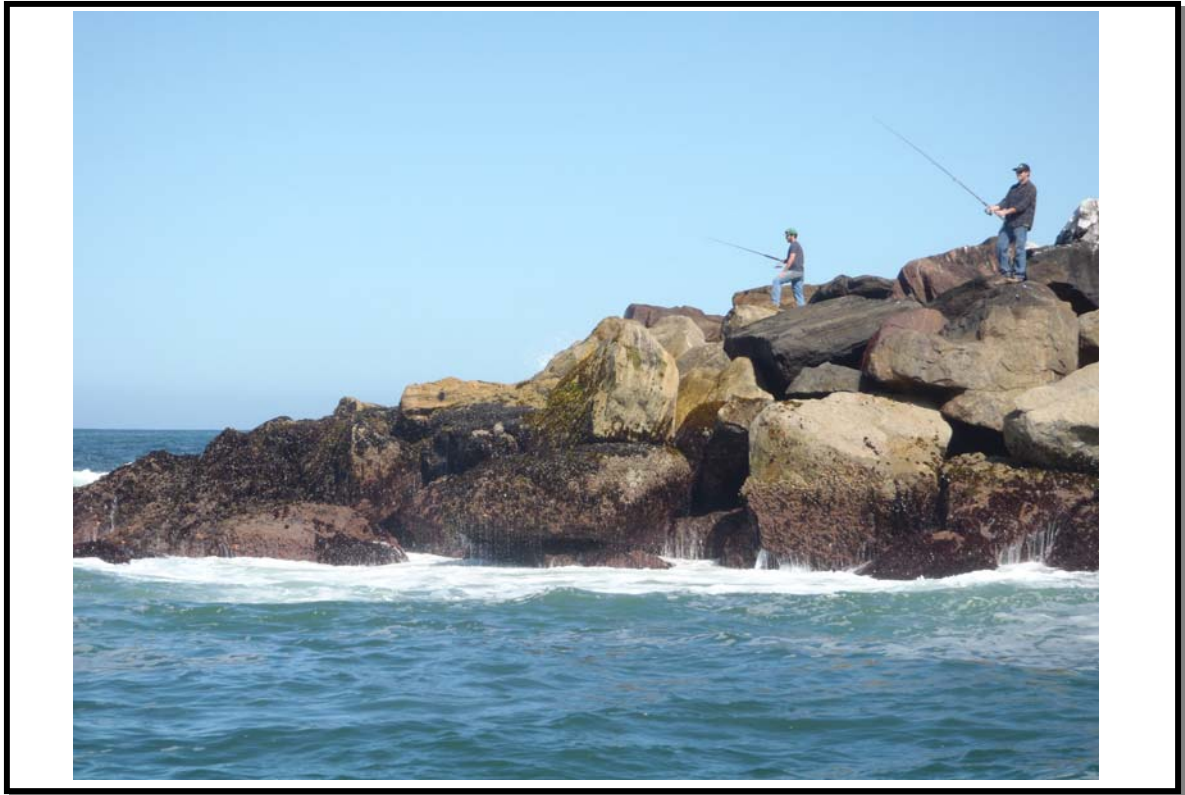
Photo 1. Tip of the northern jetty displaying typical intertidal zonation of barnacles, mussels transitioning to turf algae. Coralline algae can be seen on the lower rock.

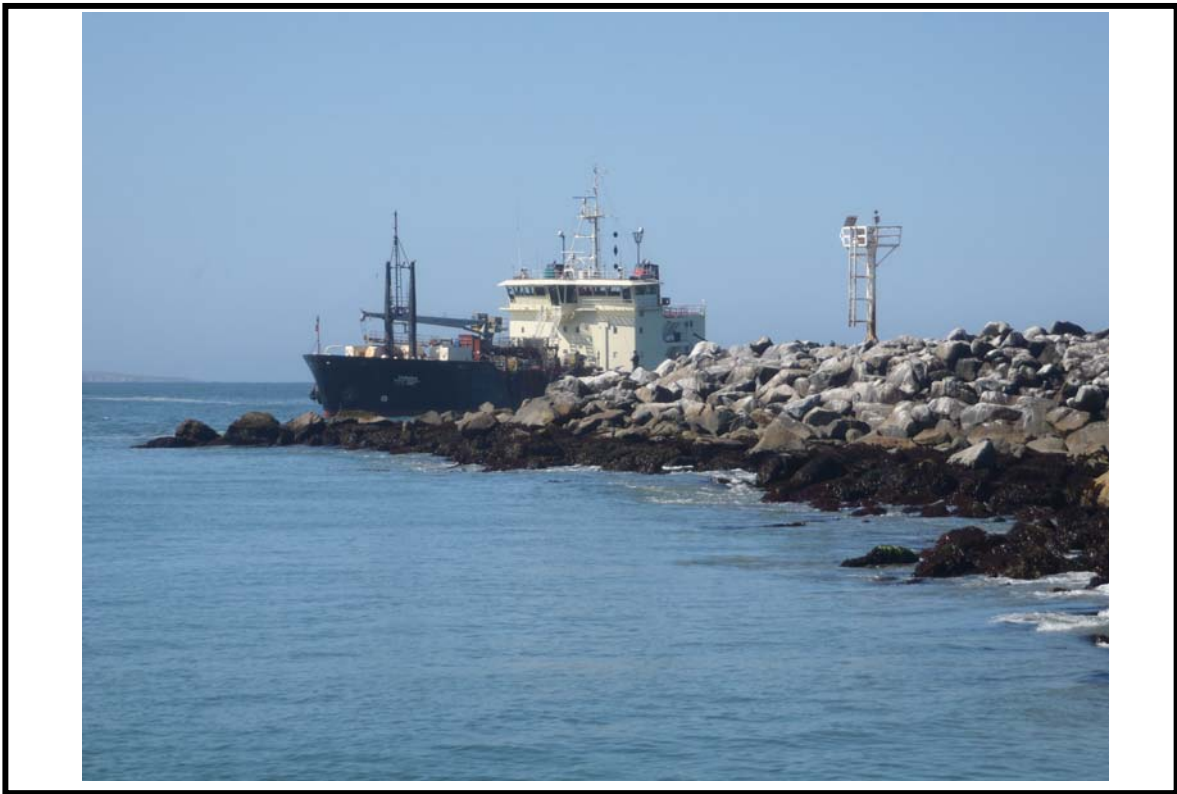
Photo 1b. Partially protected shoreline of north jetty showing turf algae.

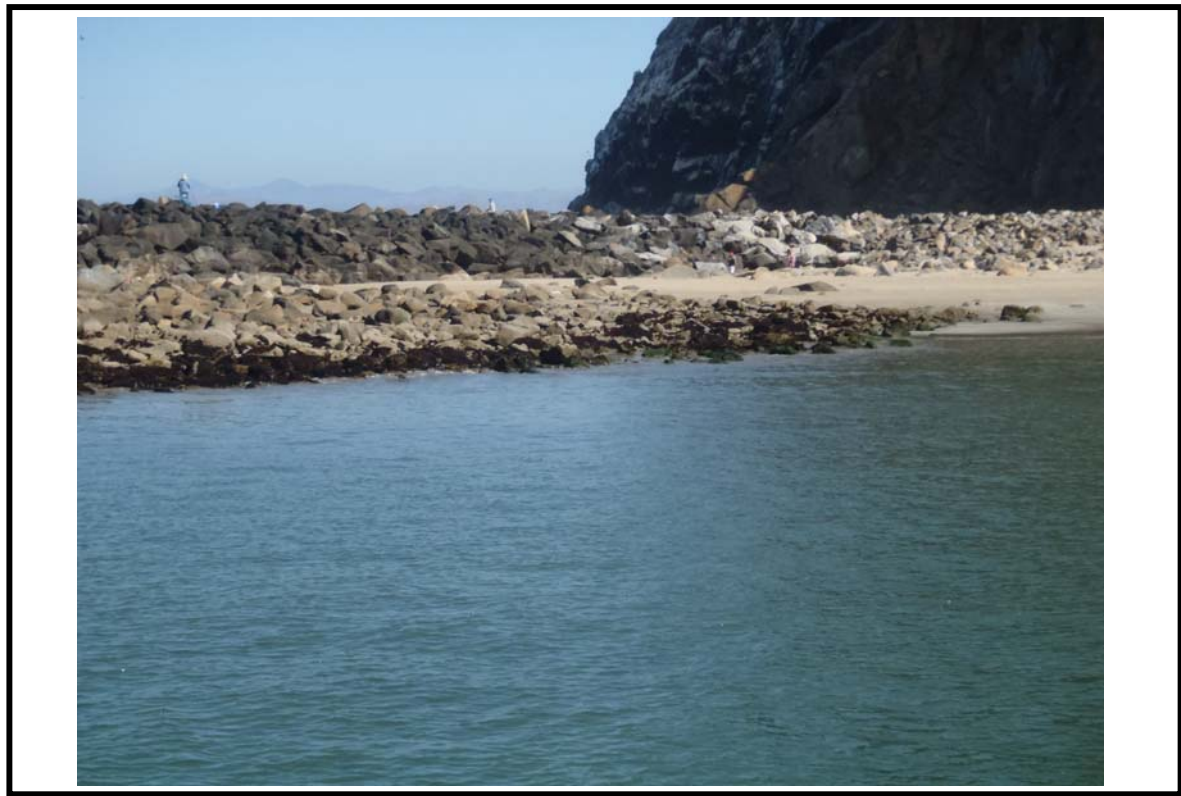
Photo 2b. Transition on north jetty from rip-rap to sand beach.

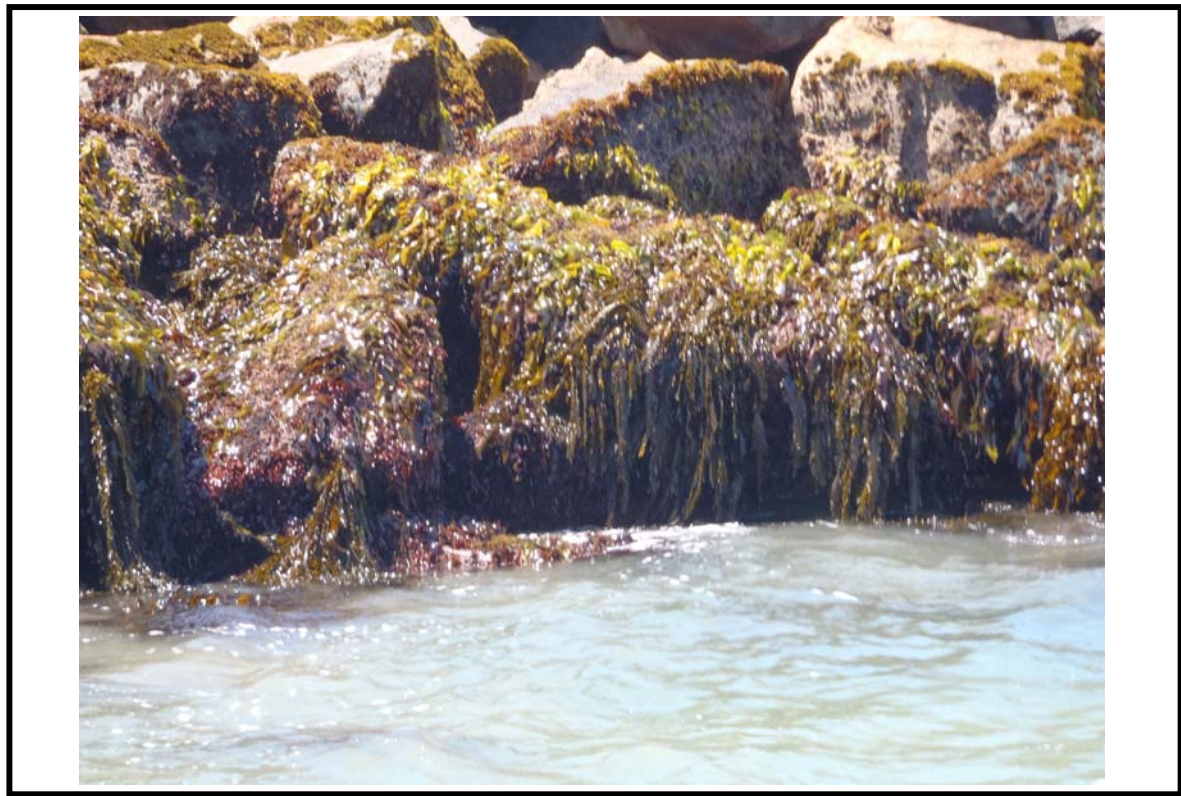
Photo 3a. Closeup of diverse algal zone on inner portion of south jetty.

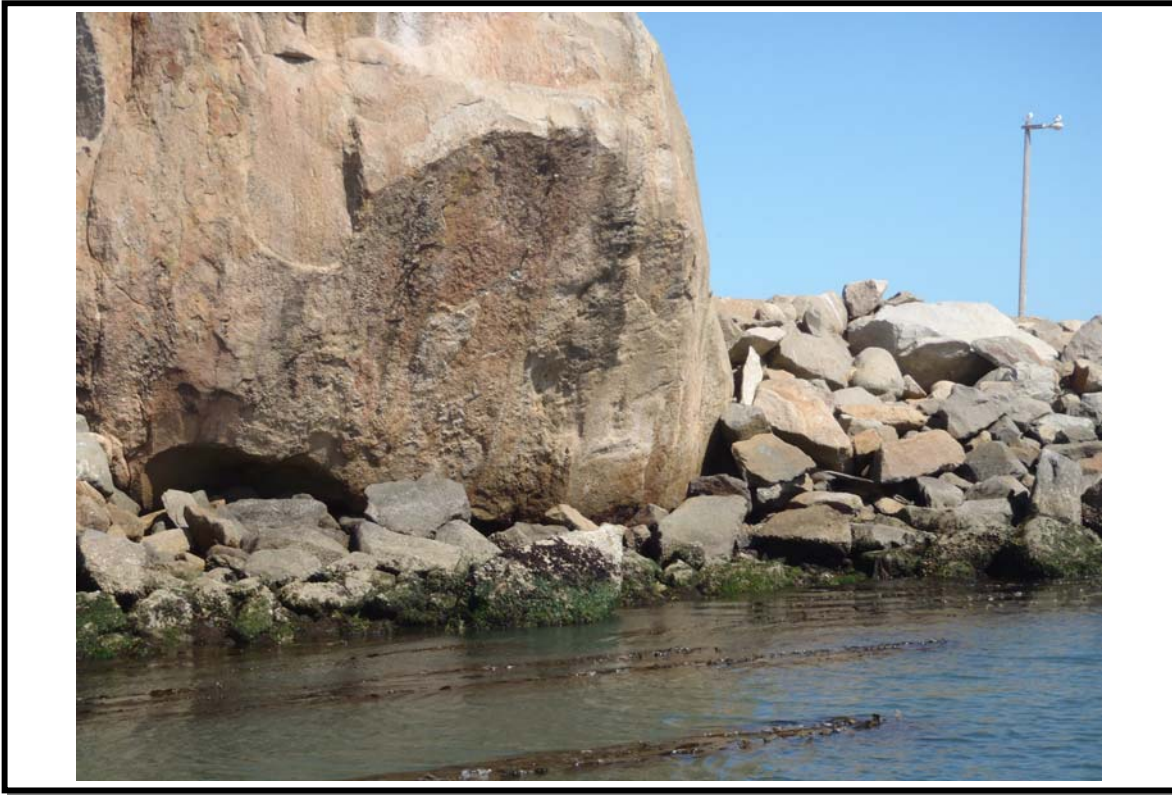
Photo 4a. Target Rock shoreline and small canopy kelp bed.

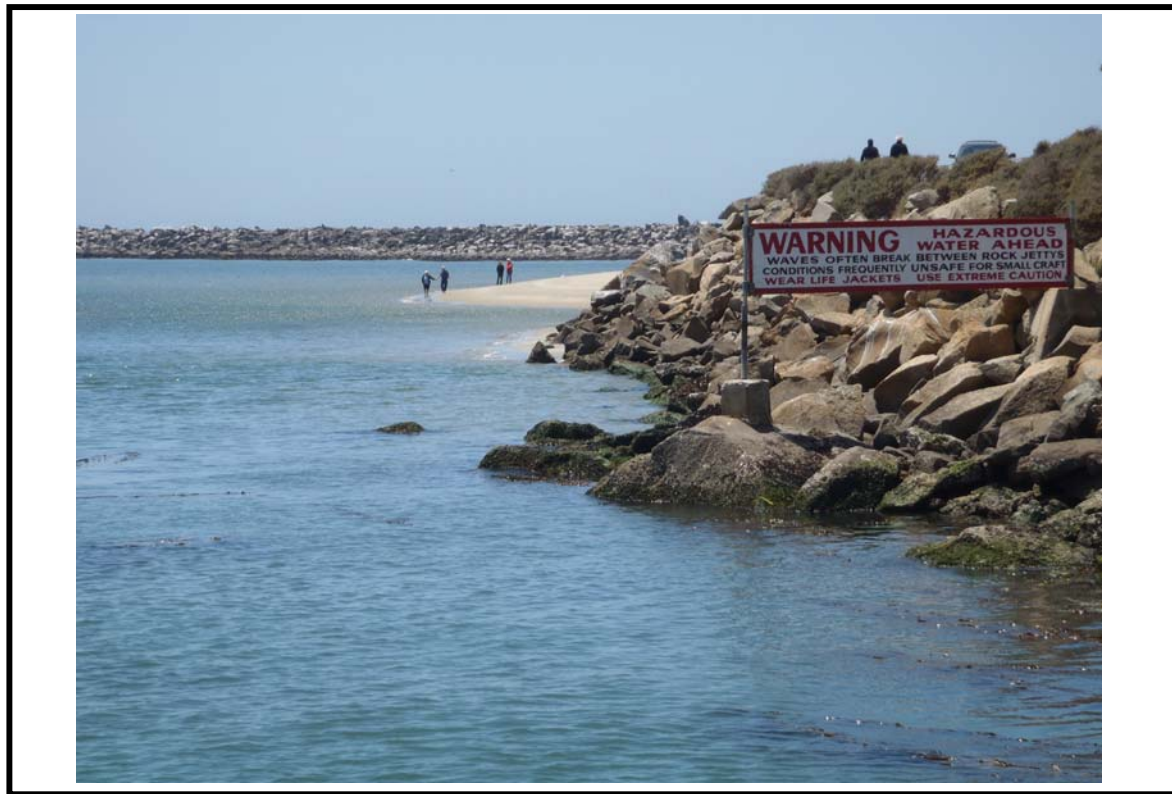
Photo 4b. Transition area from revetment to beach south of Morro Rock. The westerly end of the small kelp bed is visible in the foreground.

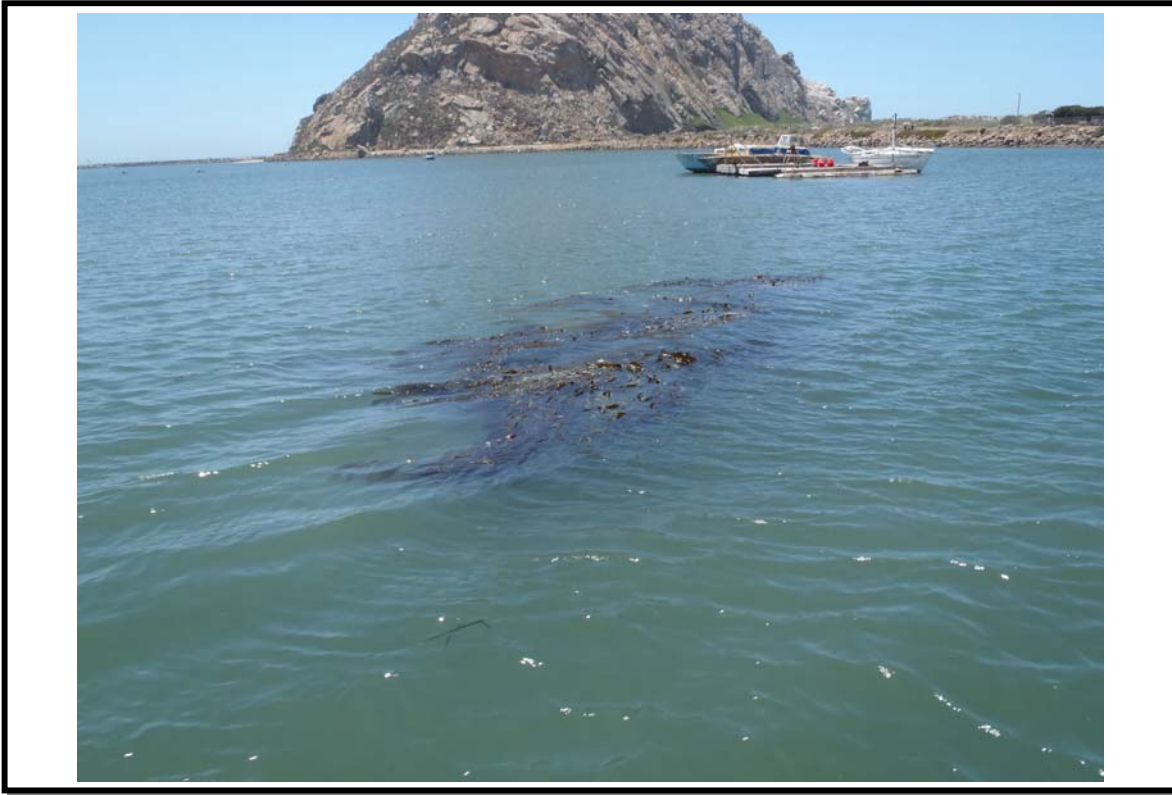
Photo 5a. Very small canopy kelp bed located near the Morro Bay Power Plant on a small rock pile.

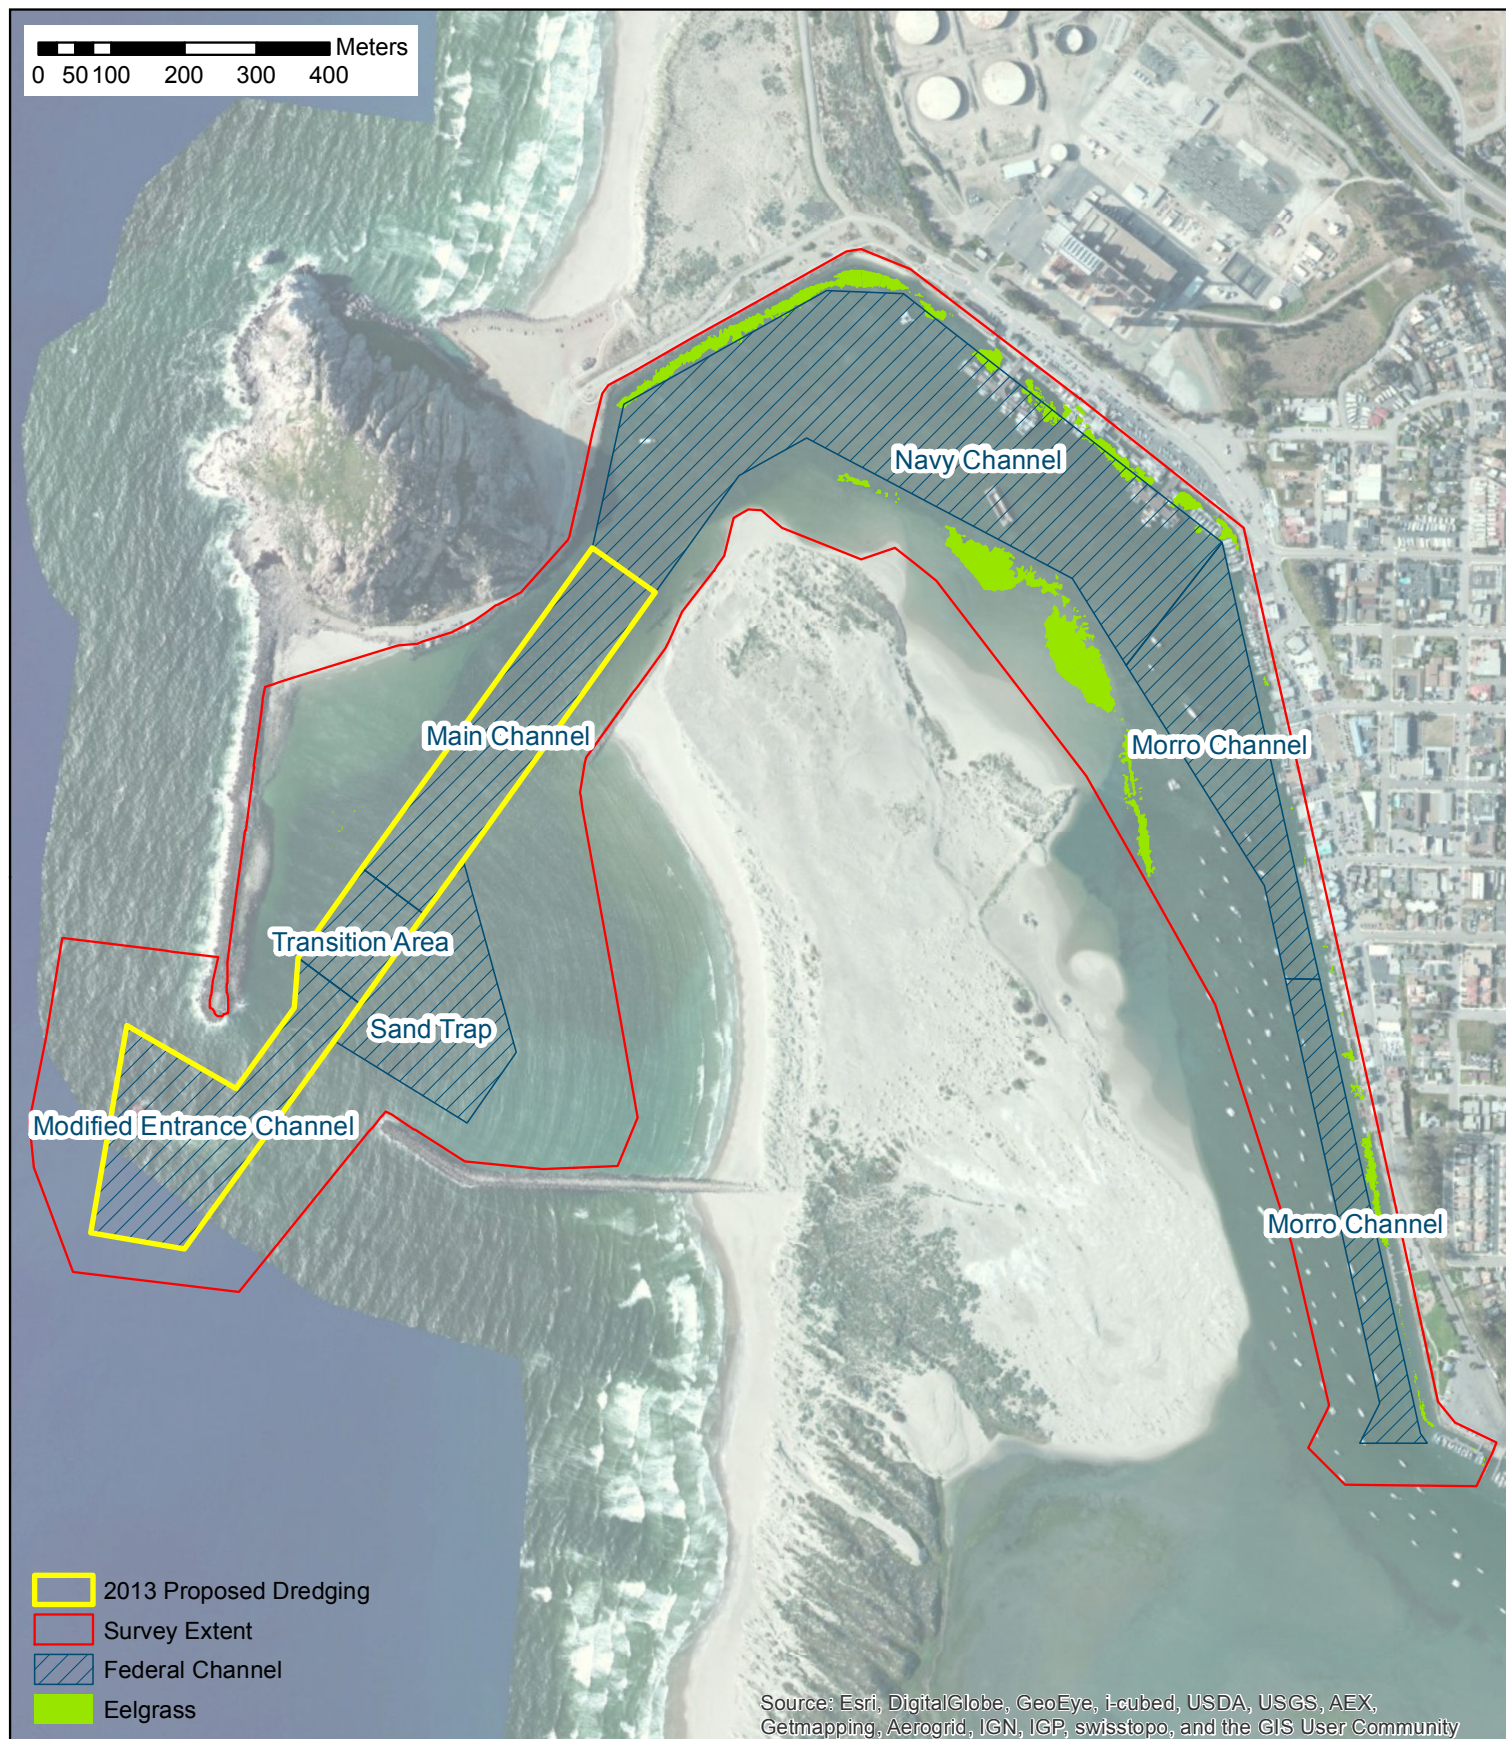
Post-dredge Eelgrass Survey - June 2013
 Morro Bay Harbor Maintenance Dredging 2013

While no eelgrass beds were located within or immediately adjacent to proposed dredging areas for the 2013 Cycle, four sites were selected for purposes of assessing bed density and vigor characteristics. These sites were selected along the edges of the Federal Channel and include Coleman Beach Site, Coleman Beach Reference Site, South Navy Channel Site, and the 2010 Corps

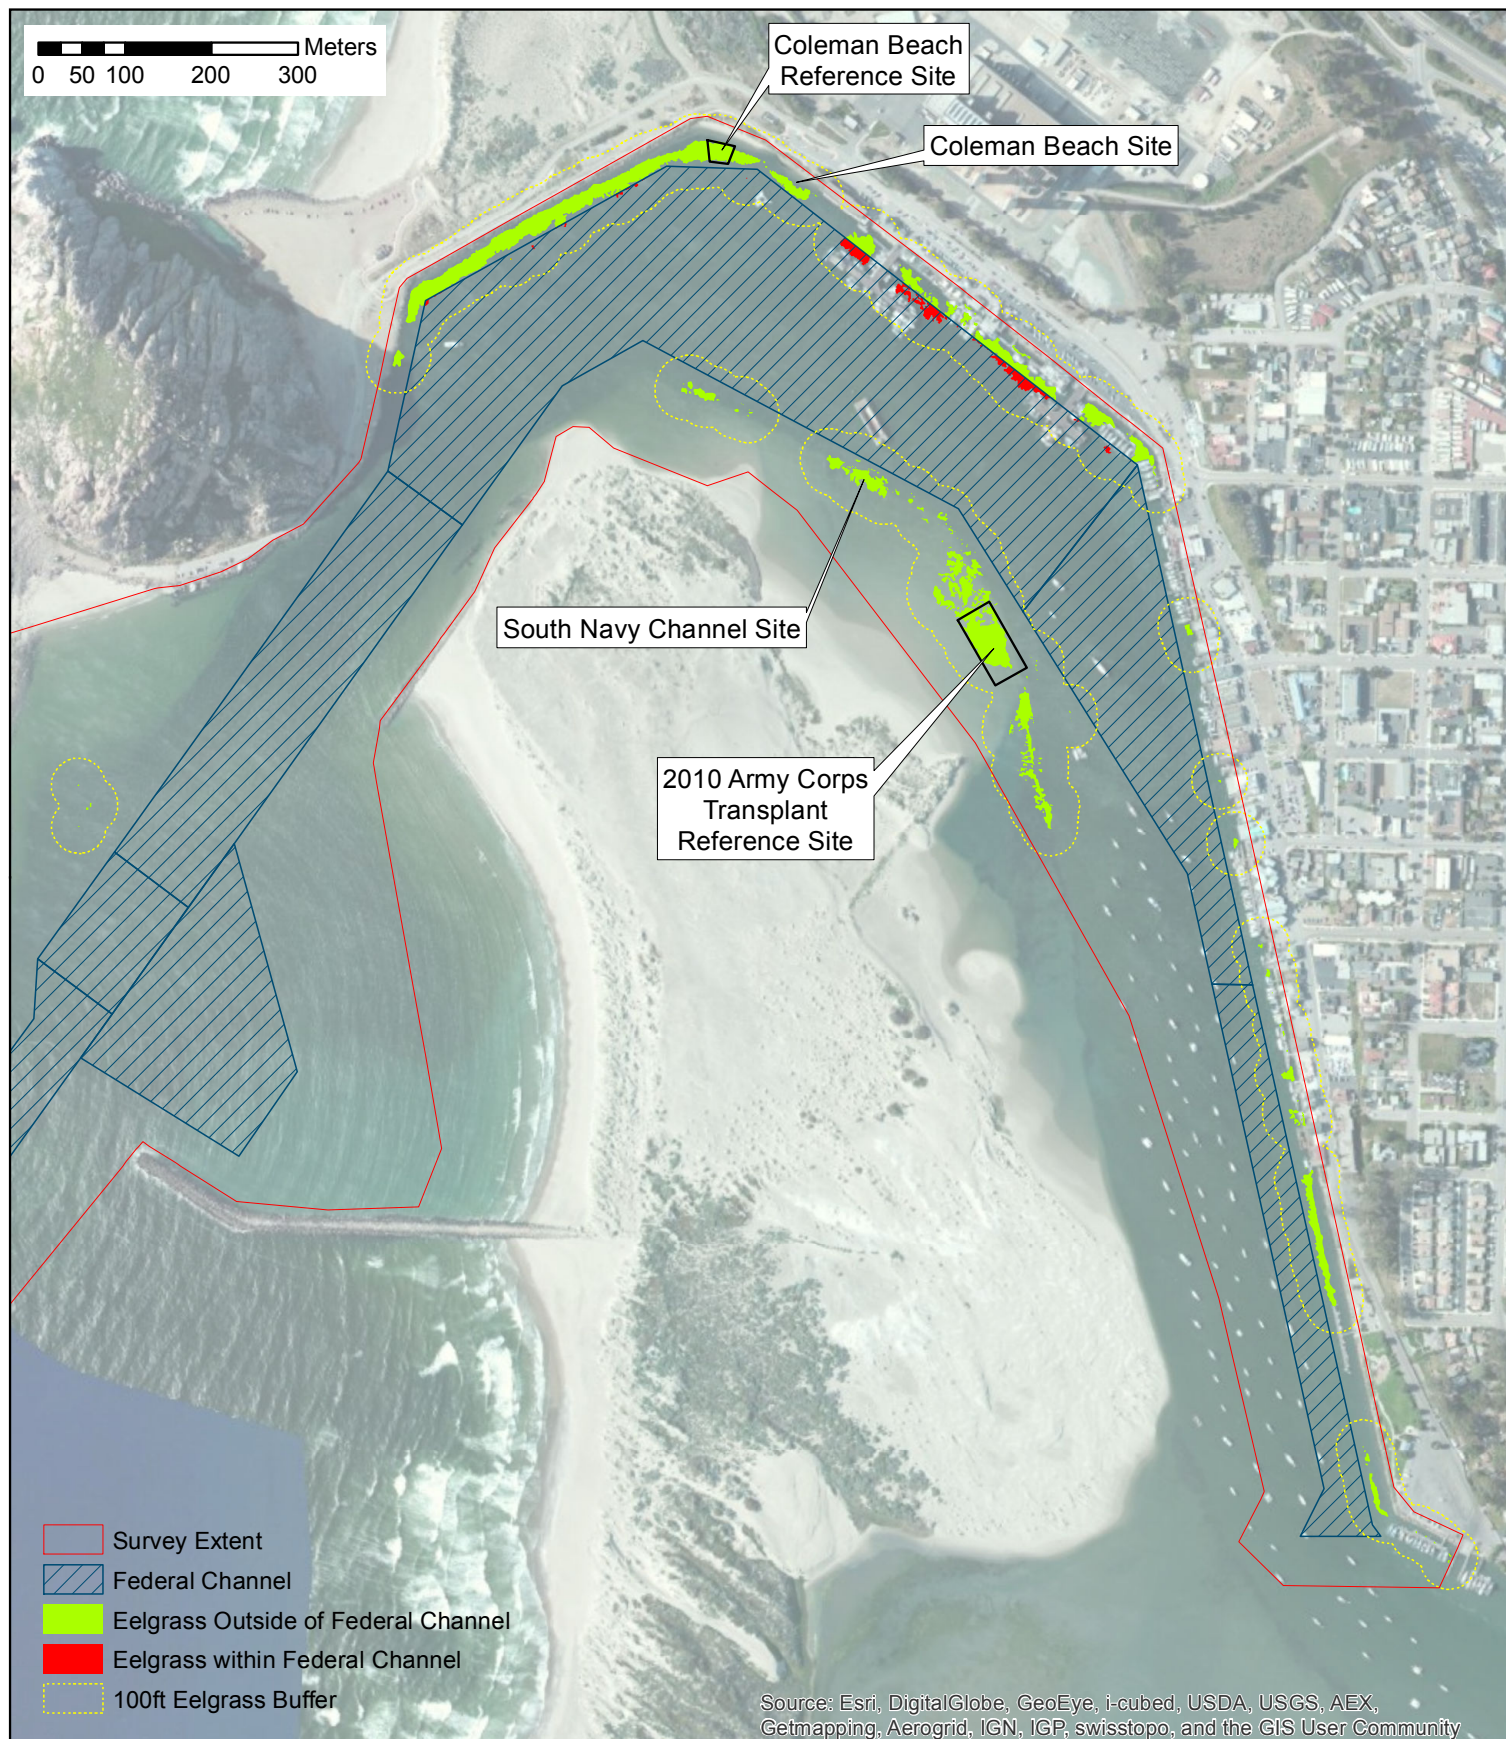
Pre-dredge Eelgrass Survey Enlargement - May 2013
 Morro Bay Harbor Maintenance Dredging 2013

Following completion of the surveys, sidescan sonar traces were joined together and geographically registered. Eelgrass was then digitized as a theme over the aerial image to calculate the amount of eelgrass coverage within the broader survey area as well as the federal channel area and to illustrate

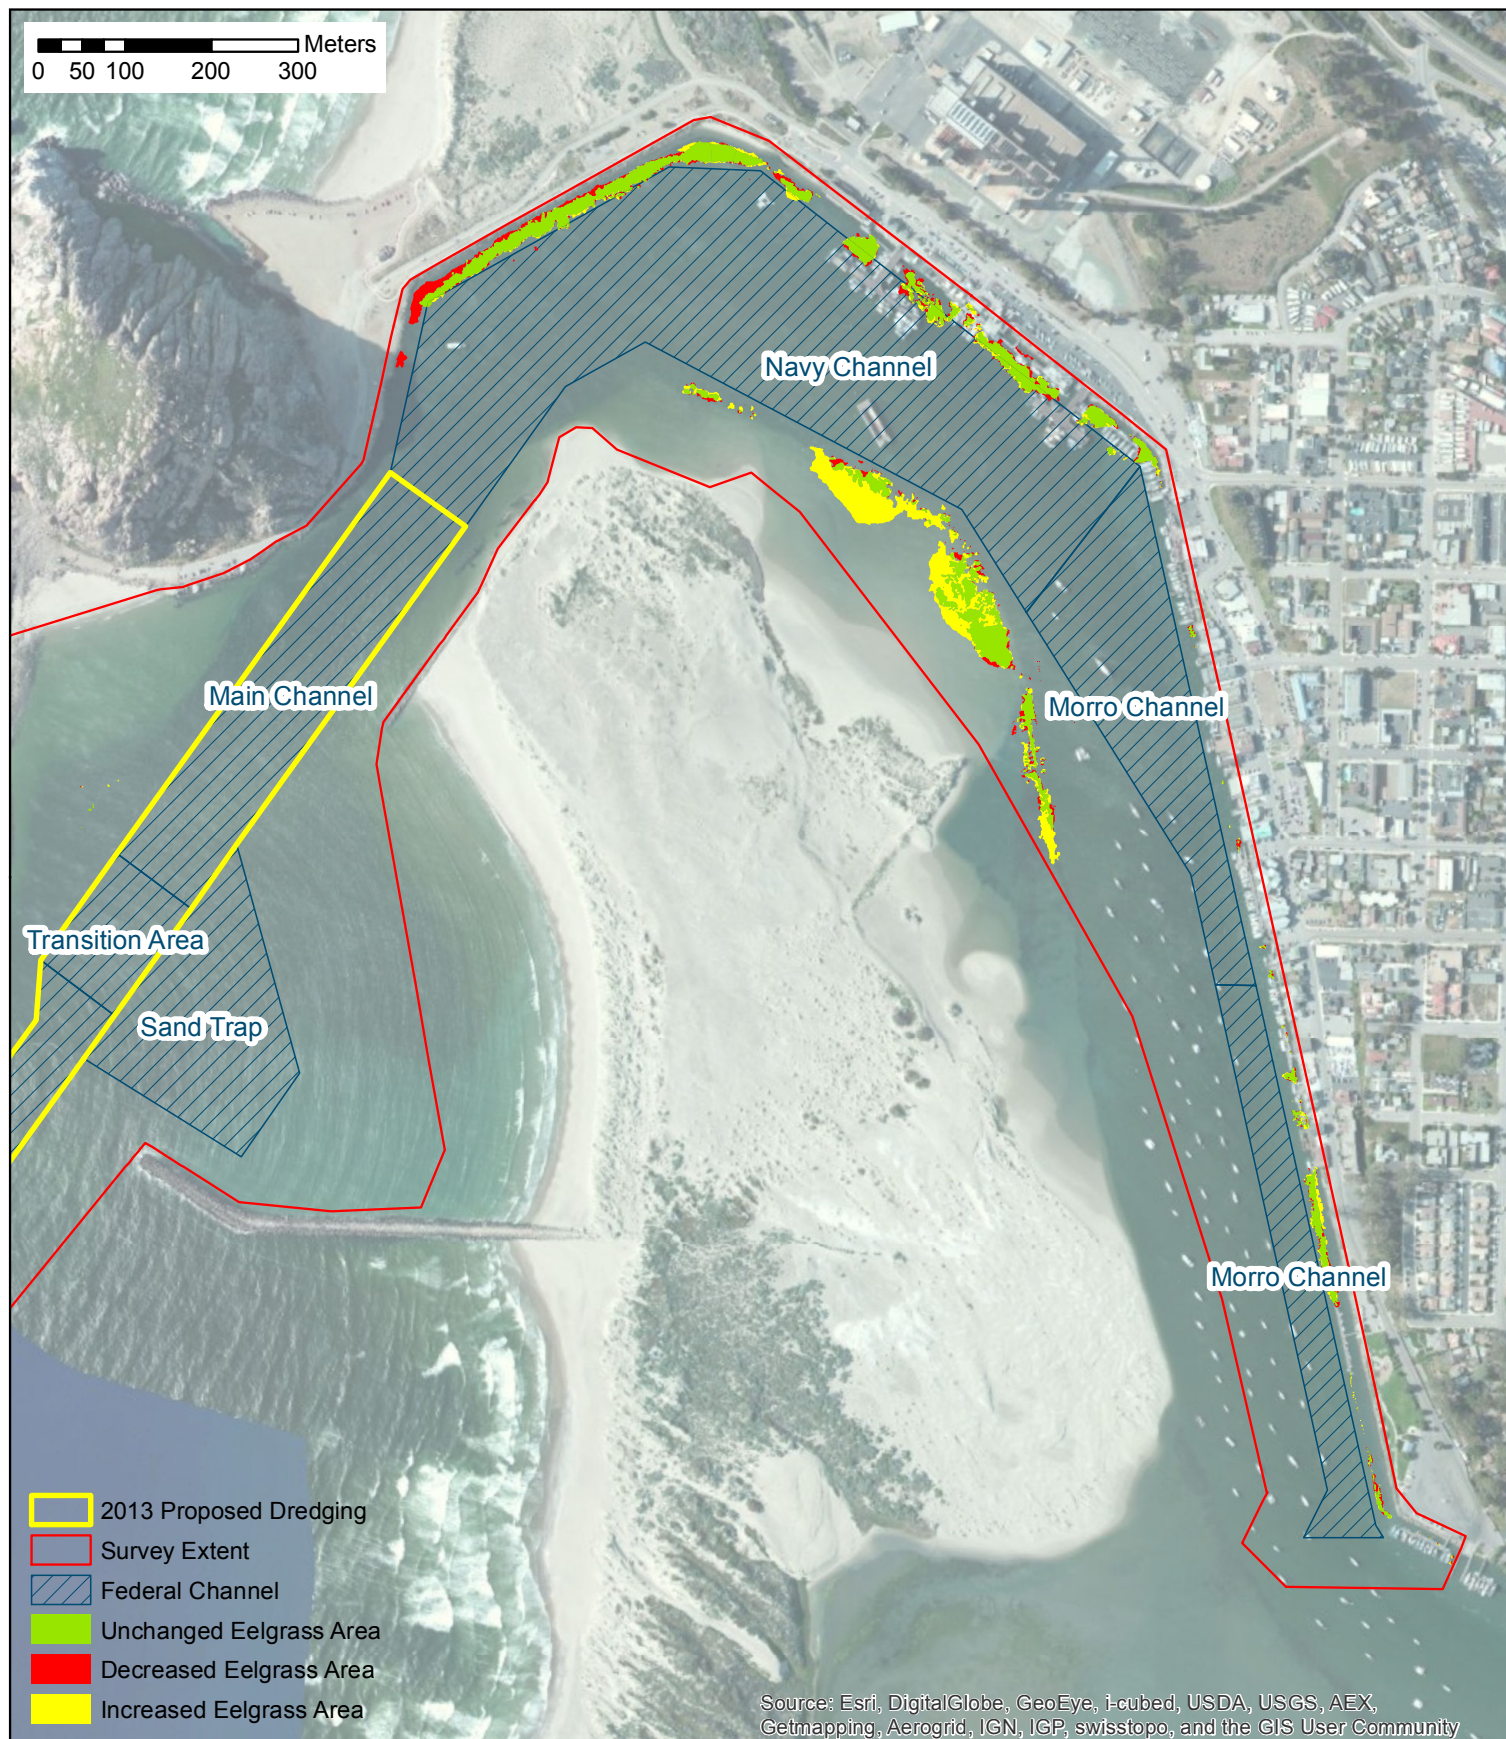
Eelgrass Change May 2013 - June 2013
Morro Bay Harbor Maintenance Dredging 2013

Declines in eelgrass have been most expansive at the edge of the macroalgae and kelp habitat near Target Rock. In this area, a previously mapped patch of eelgrass that was integrated with a small giant kelp bed in May 2013 was not detected in June 2013. Extending easterly from this location, eelgrass has declined in the shallow margin between the riprap and the fringing beds. It is not clear why this reduction has occurred while other shallow areas have seen significant eelgrass expansion between pre-dredging and post-dredging surveys.

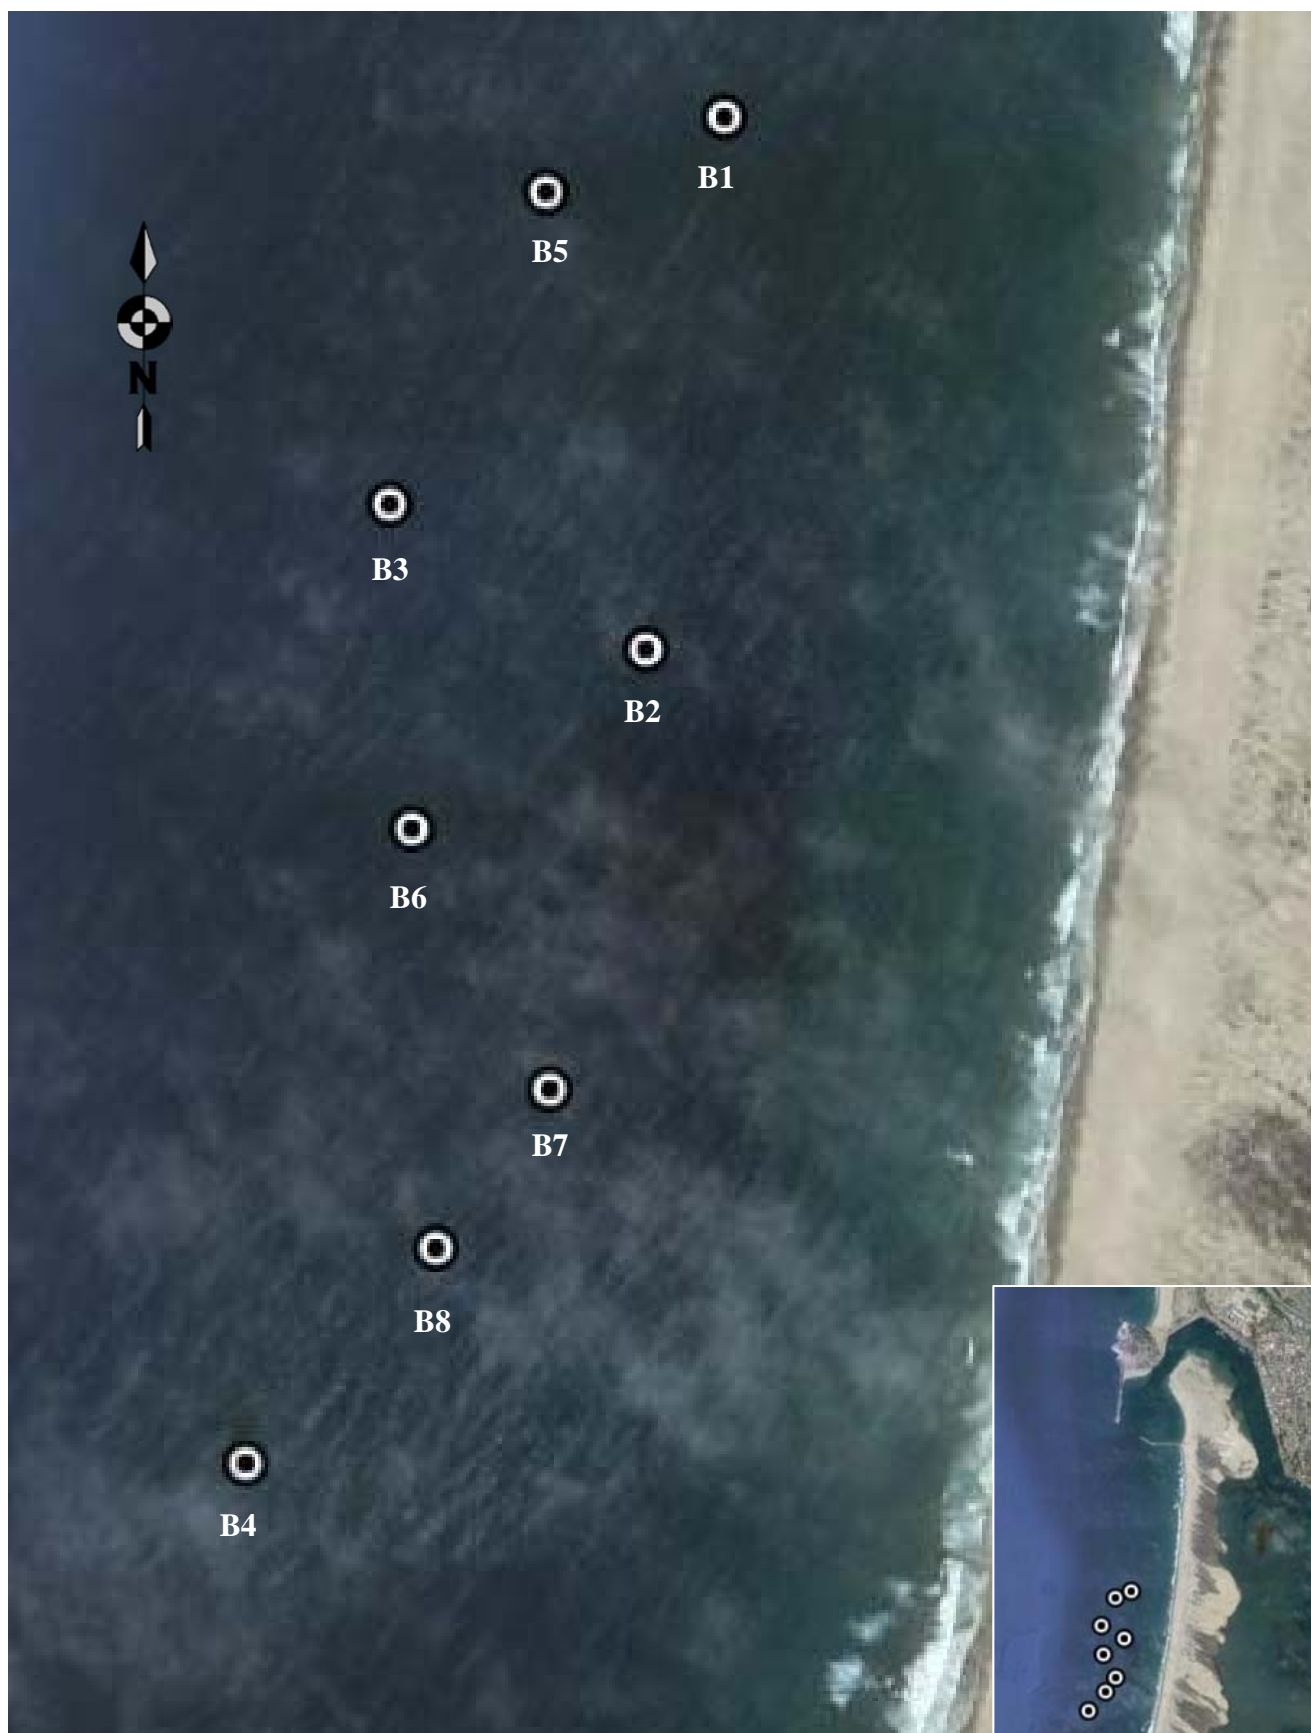
Figure 11. Sampling Locations at the Montana de Oro State Beach Nearshore Placement Area.

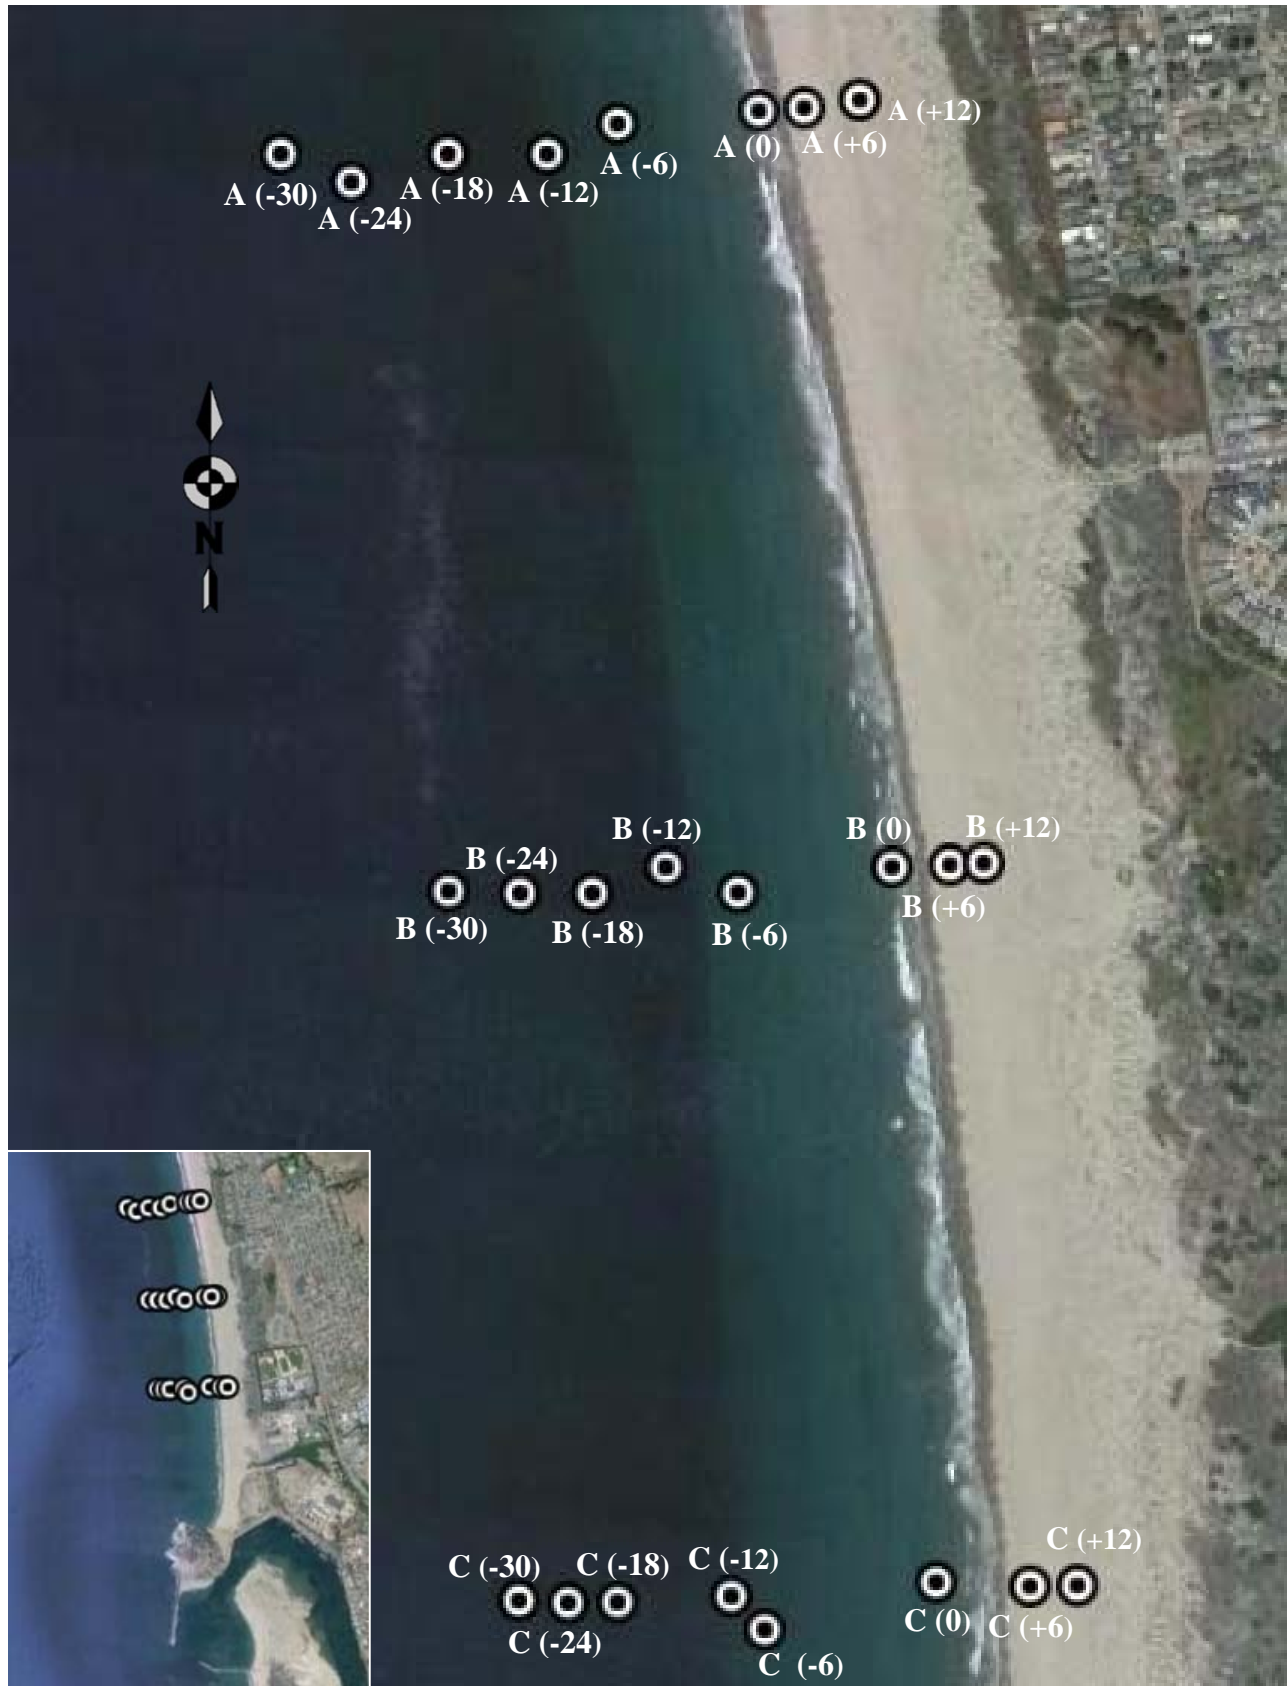
Figure 12. Sampling Transect Locations at Morro Strand State Beach.
