**US Army Corps
of Engineers®**

Los Angeles District

**DRAFT ENVIRONMENTAL ASSESSMENT
MORRO BAY
SIX YEAR FEDERAL MAINTENANCE DREDGING PROGRAM
SAN LUIS OBISPO COUNTY, CALIFORNIA**

March 2013

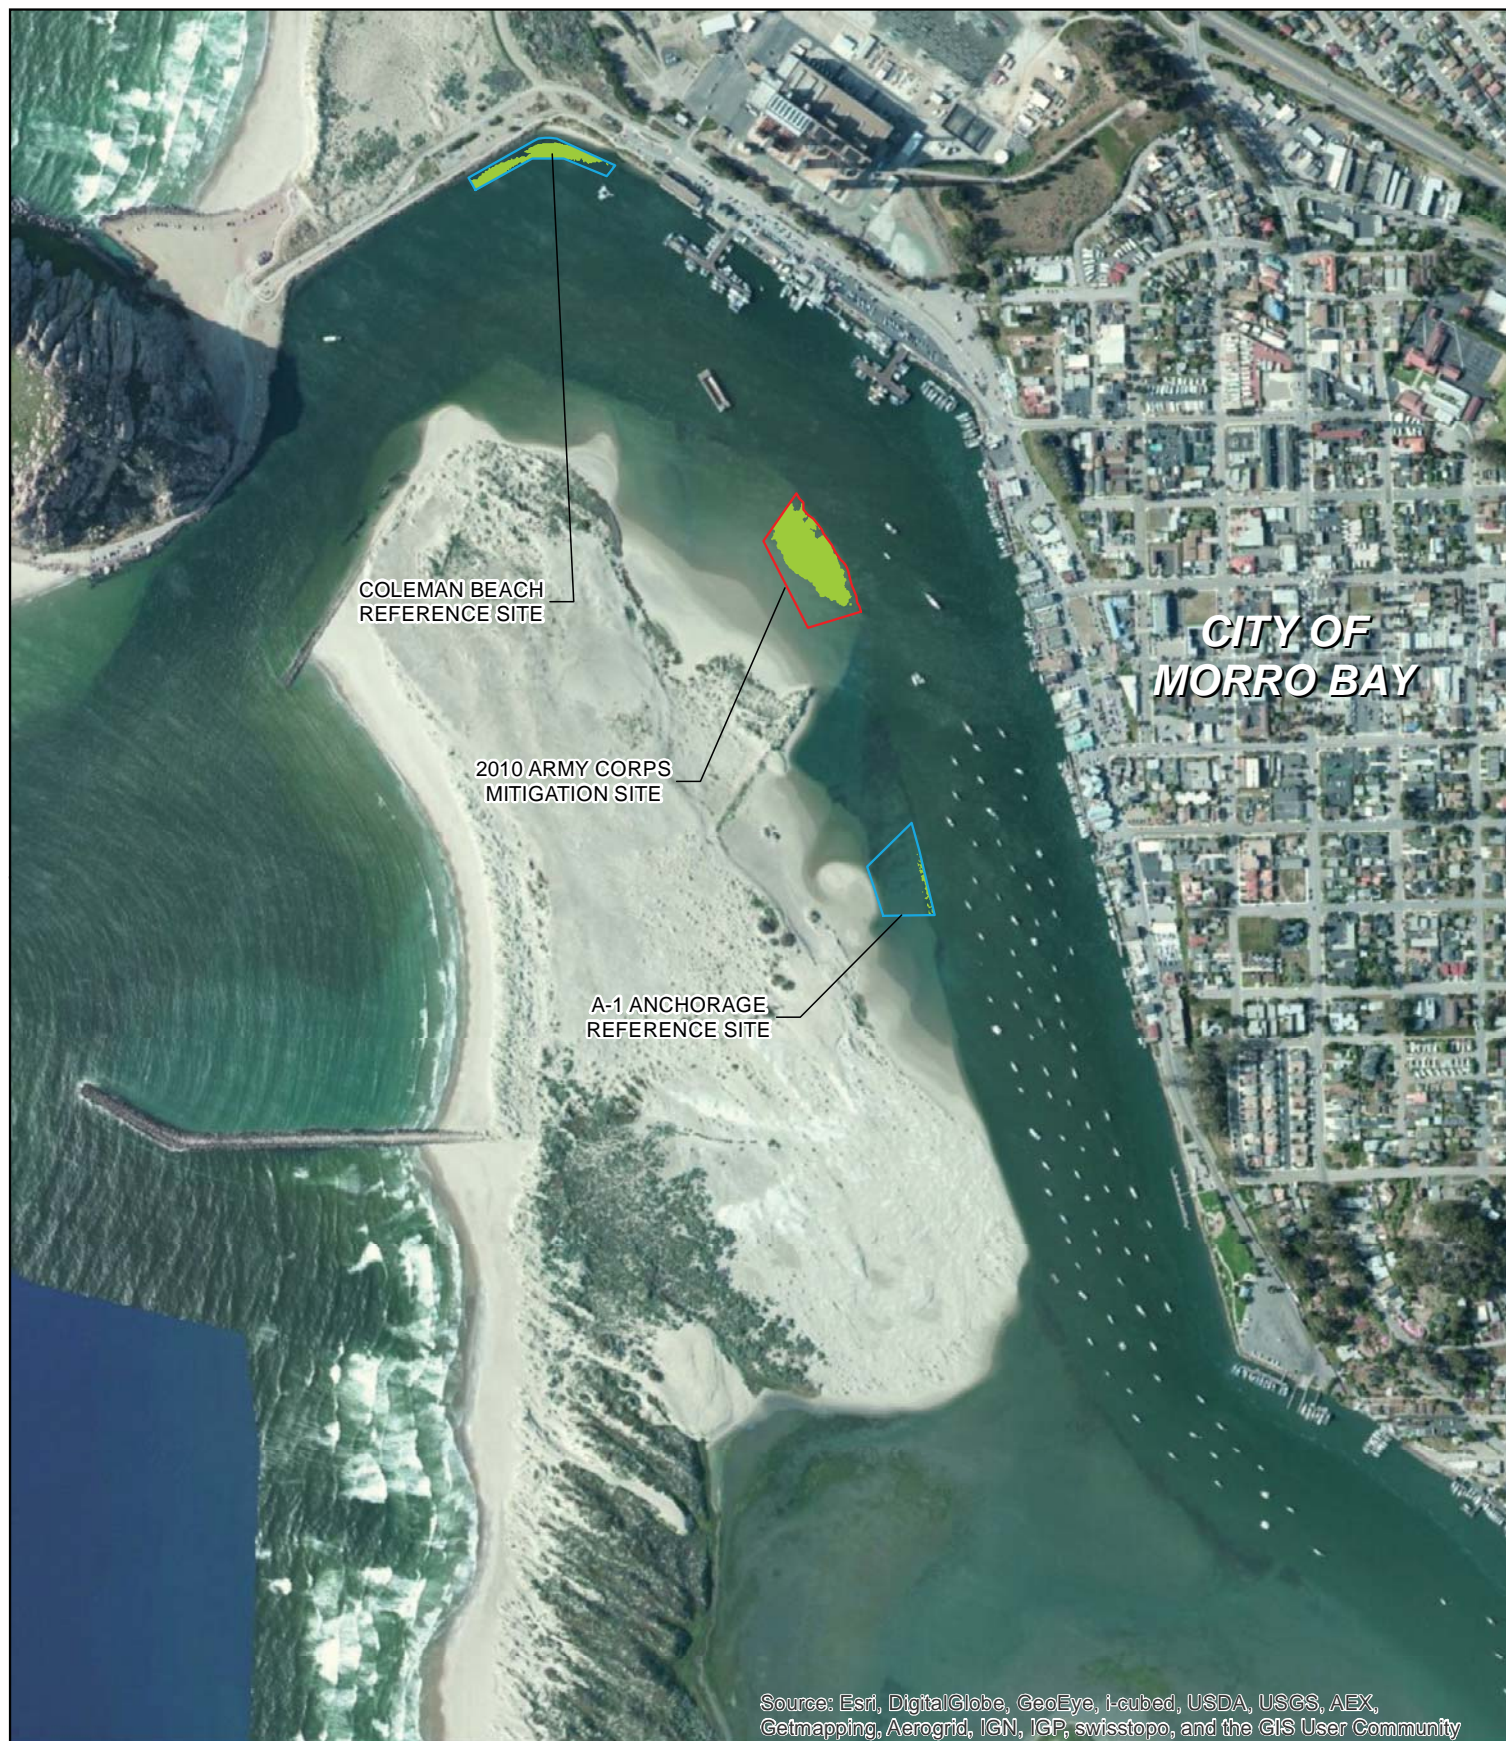
Figure 4

36-Month Eelgrass Distribution, June, 2013
Morro Bay Maintenance Dredging Project
Morro Bay, CA

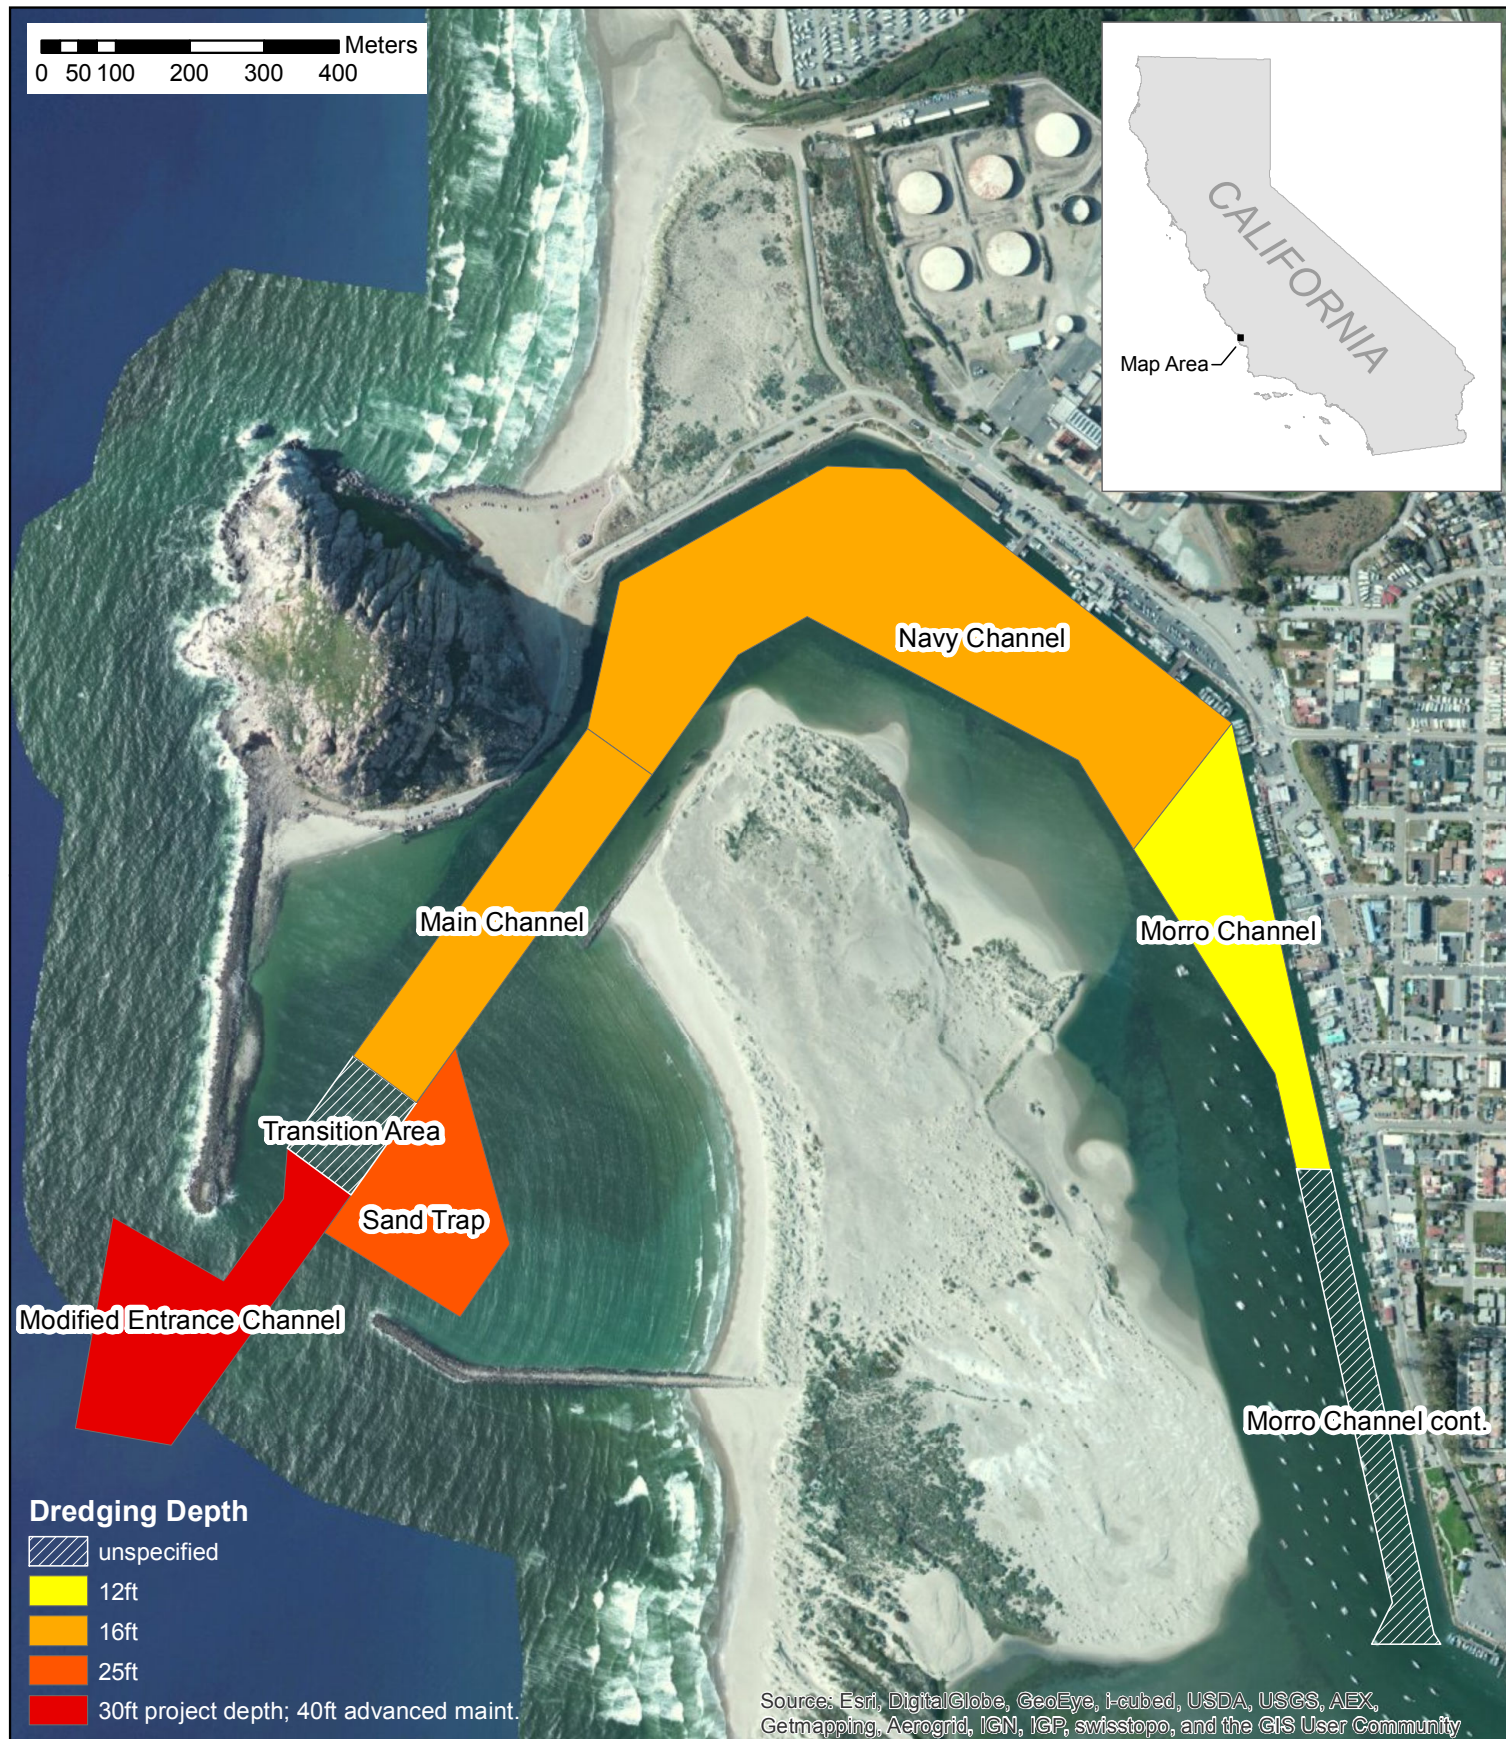
Caulerpa Survey - May 2013
Morro Bay Harbor Maintenance Dredging 2013
