**Planning Level Wetland Delineation and  
Geospatial Characterization of San Juan and  
Portions of San Mateo Watersheds,  
Orange County, California**

US Army Corps of Engineers  
Engineering and research Development Center (ERDC)  
Cold Regions Research and Engineering Laboratory (CRREL)  
Hanover, NH

19 September 2000

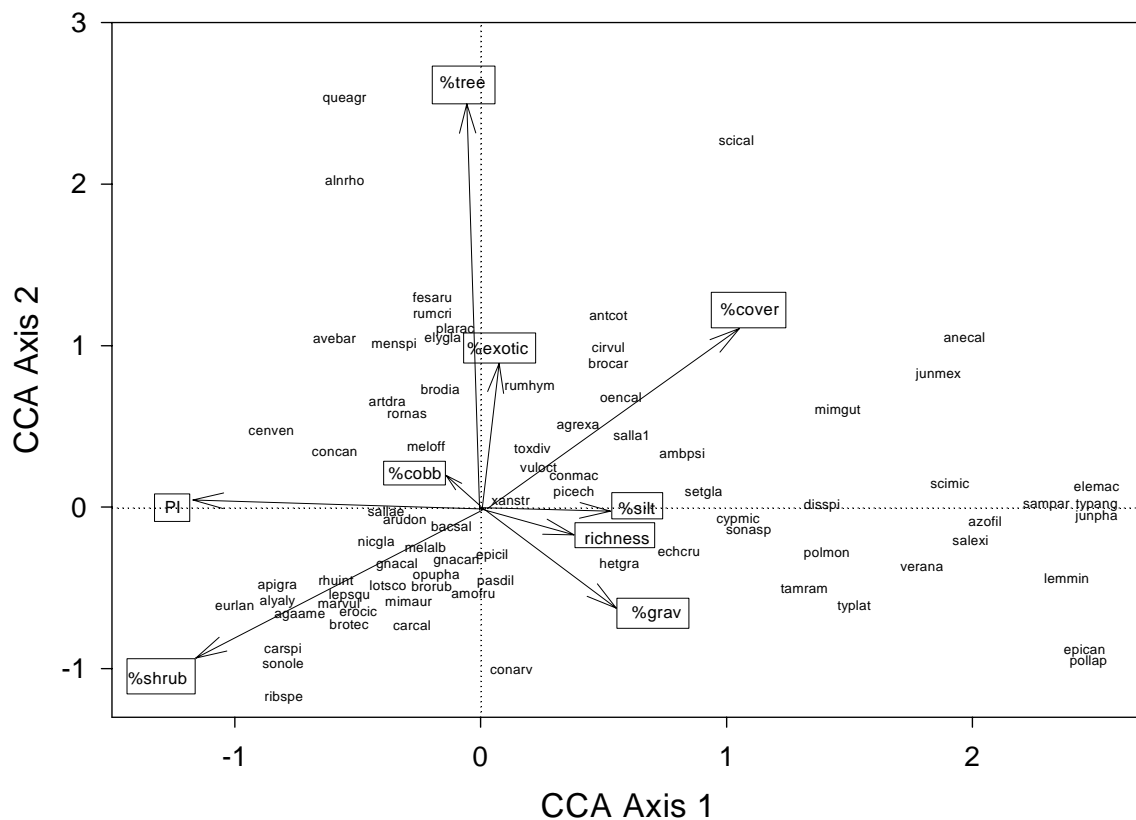
A total of 86 species in 55 sample points were used to determine the relationship between the vegetation and environmental variable. Canonical Correspondence Analysis (CCA) suggested that soil moisture was the primary factor determining species composition at San Juan and San Mateo Creeks (Figure 3). Indeed, species that occur in drier conditions (i.e. *Rhus integrifolia*, *Conzya canadensis*, *Leptospartum squarrosus*) were found on the left side of the first axis, while species occurring in wetter conditions (i.e. *Typha angustifolia*, *Eleocharis macrostachya*, *Scripus microcephalus*) were found on the right side of the first axis. Monte Carlo permutation analysis showed that all canonical axes were significant ( $p > 0.05$ ).

**Figure 3.** CCA ordination of select environmental variables using plant species occurrence frequencies.

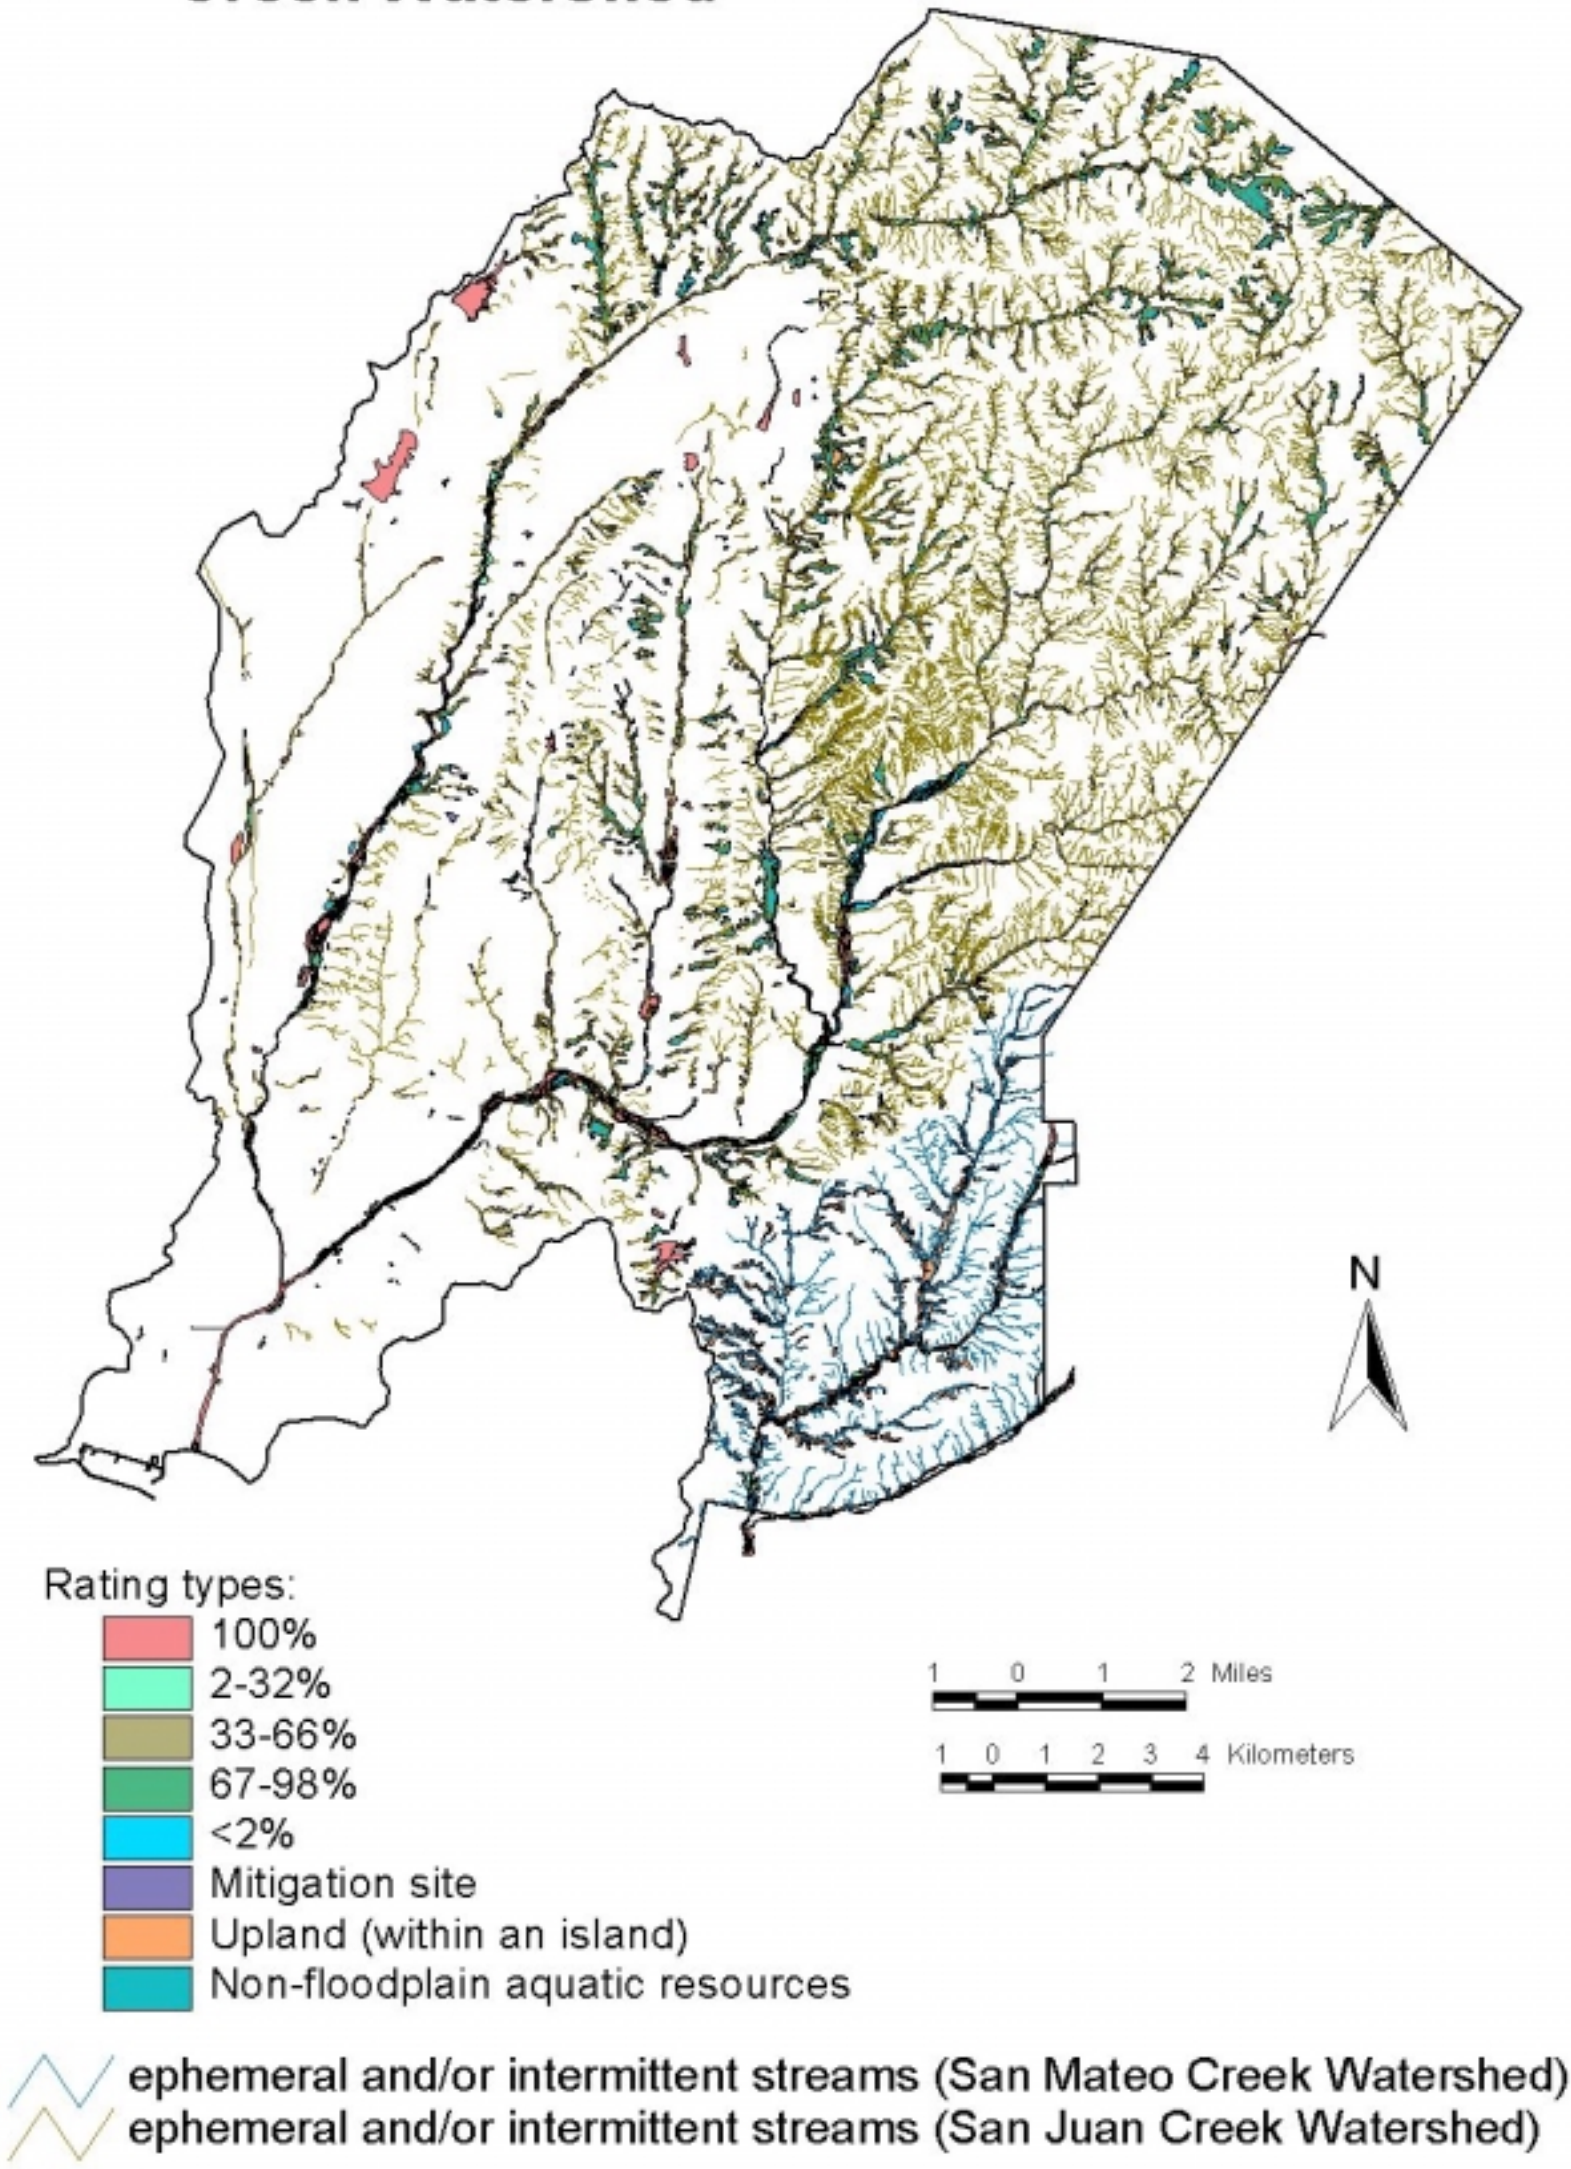
**Figure 3. Rating types in the San Juan Creek Watershed and portions of the San Mateo Creek Watershed**
