San Diego Creek Watershed Riparian Ecosystem Restoration Plan: Site Selection and General Design Criteria

**Prepared for:
U. S. Army Corps of Engineers, Los Angeles District, Regulatory Branch**

August 2004

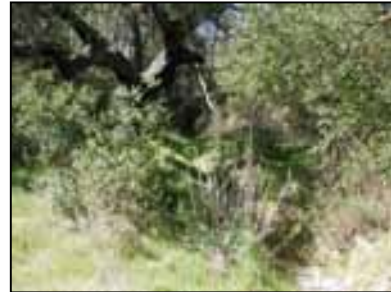
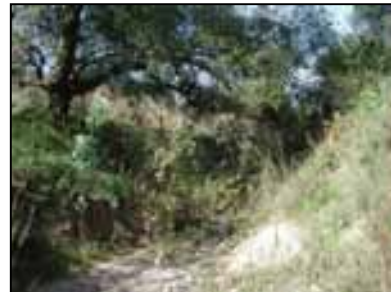
ZONE 2: Small floodplains and terrace fragments in mountain and foothill valleys, with lateral restriction due to alluvial fans and colluvium

Bankfull Width	1.9m (1.2-3.0)
Bankfull Depth	0.17m (0.10-0.25)
Flood Prone Width	3.1m (1.2-5.5)
First Terrace Width	2.4m (0.9-6.0)
Height above Bankfull	0.6m (0.3-0.9)
Second Terrace Width	NA
Height Above Bankfull

Figure 10. Natural conditions, typical existing conditions, and general restoration objectives for Zone 2 riparian areas (see Figure 5 for features legend and Table 1 for vegetation types)

Figures 9-13 illustrate common features of riparian systems and adjacent uplands for each geomorphic zone in the study area. The figures show geomorphic surfaces, water levels for the bankfull channel and flood prone area, and the distribution of dominant or characteristic vegetation. For each zone, these features are illustrated for a generalized "natural" condition, for the typical existing "incised" condition, and for a conceptual "restored" condition for that incised channel (the "incised restoration template"). Photos show examples of typical natural and existing conditions. Accompanying the conceptual "restored" condition are dimensions of geomorphic surfaces, expressed as means and ranges based on measurements in the most intact (highest function) reaches sampled in the San Diego Creek watershed (Smith 2000a) and elsewhere in the region (Smith 2002b). Note that where terraces occur on both sides of the channel the terrace width dimensions represent the sum of terraces on both sides of the channel. Conceptual design templates are not illustrated for the constrained and engineered templates. These restoration templates are limited in distribution and will require site-by-site adaptation of the general design principles described in the Approach Section, depending on opportunities and limitations associated with each site.

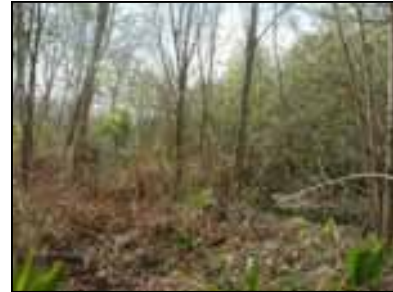
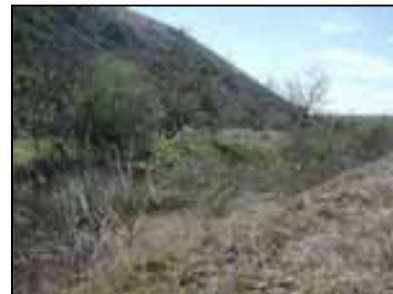
ZONE 3: Meander belts in alluvium within broad mountain and foothill valleys and trough marine terraces

Bankfull Width	3.9m (2.1-7.6)
Bankfull Depth	0.23m (0.15-0.31)
Flood Prone Width	7.8m (4.0-13.7)
First Terrace Width	4.6m (3.0-12.2)
Height above Bankfull	0.5m (0.3-0.9)
Second Terrace Width	NA
Height Above Bankfull

Figure 11. Natural conditions, typical existing conditions, and general restoration objectives for Zone 3 riparian areas (see Figure 5 for features legend and Table 1 for vegetation types)
