LOS ANGELES RIVER 5 LEVEE SYSTEM

NLD SYSTEM ID # 3805010054

PERIODIC INSPECTION REPORT NO 1
GENERALIZED EXECUTIVE SUMMARY

SUBMITTED: NOVEMBER 2014
INSPECTED: MARCH 4-5, 2014

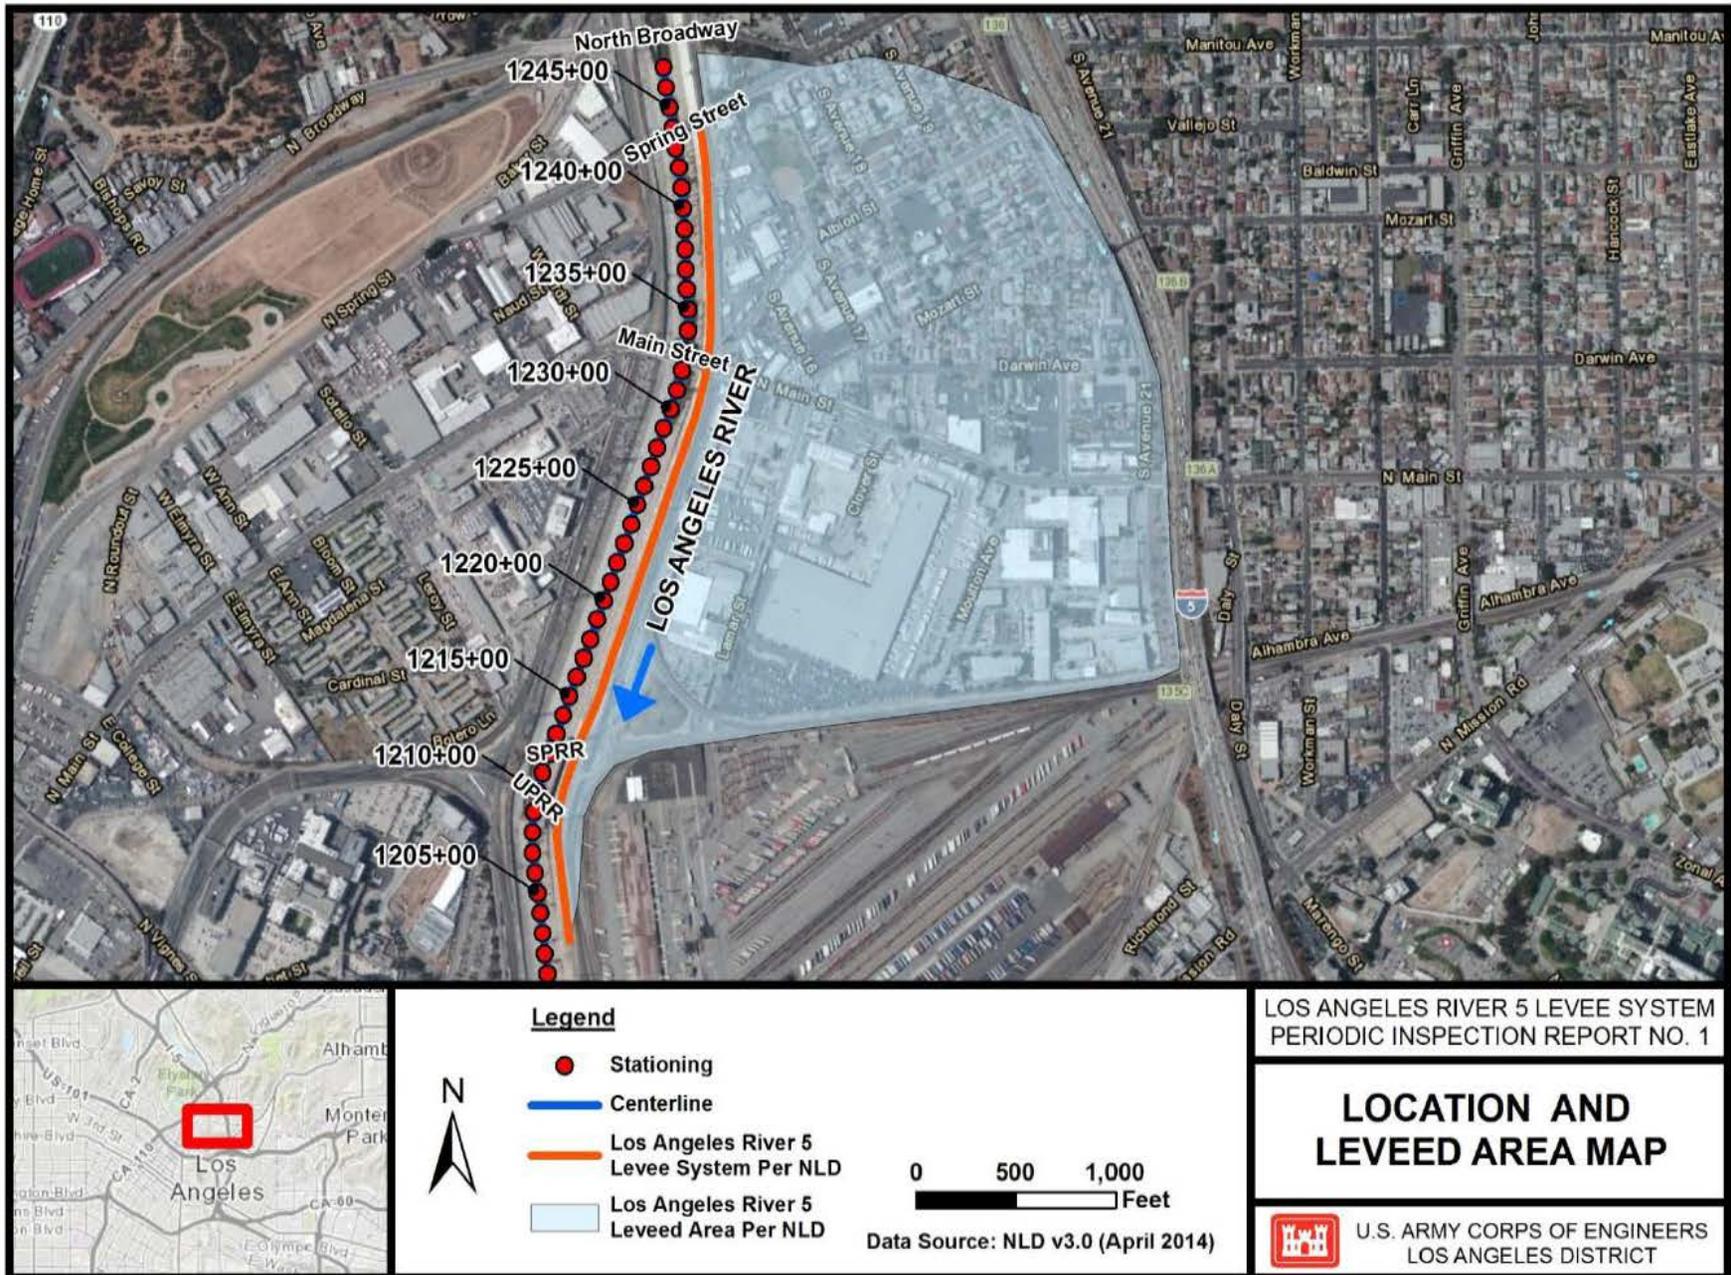
Figure 1-1: Los Angeles River 5 Levee System

After reviewing the documentation for the LAR5 System, it is the opinion of the inspection team that the LAR5 System, as shown on Figure 1-1, contains no levees or floodwalls since there is no explicit or implied design of a levee in the project documents and excavated material consistent with sands and gravels were used as backfill material behind the channel walls. This type of backfill is intended to allow water to drain from behind the wall into the river through weep holes constructed at the toe of the concrete slope and at the base of the vertical walls. The walls are designed as retaining walls in the project documents. The elevation of the backfill behind the retaining walls and the top-of-wall elevation are the same (i.e. no stick up) except at two locations: (i.) Beneath the Main Street Bridge crossing between Station 1231+99.82 and 1232+69.73 (69.9 ft long); and (ii.) Upstream from Spring Street Bridge at Station 1244+46.10 to 1267+03 (near the confluence of the Arroyo Seco). Adjacent to the left bank, there is a set of elevated railroad tracks that look similar to a levee embankment. After reviewing the project documents, the railroad embankment was pre-existing infrastructure before the river was
