Fourth Five-Year Review Report

**Former Camp Elliott-Tierrasanta, Project Number J09CA006701
Former Camp Elliott-Mission Trails, Project Number J09CA006702
San Diego, California**

Date: 7 September 2021

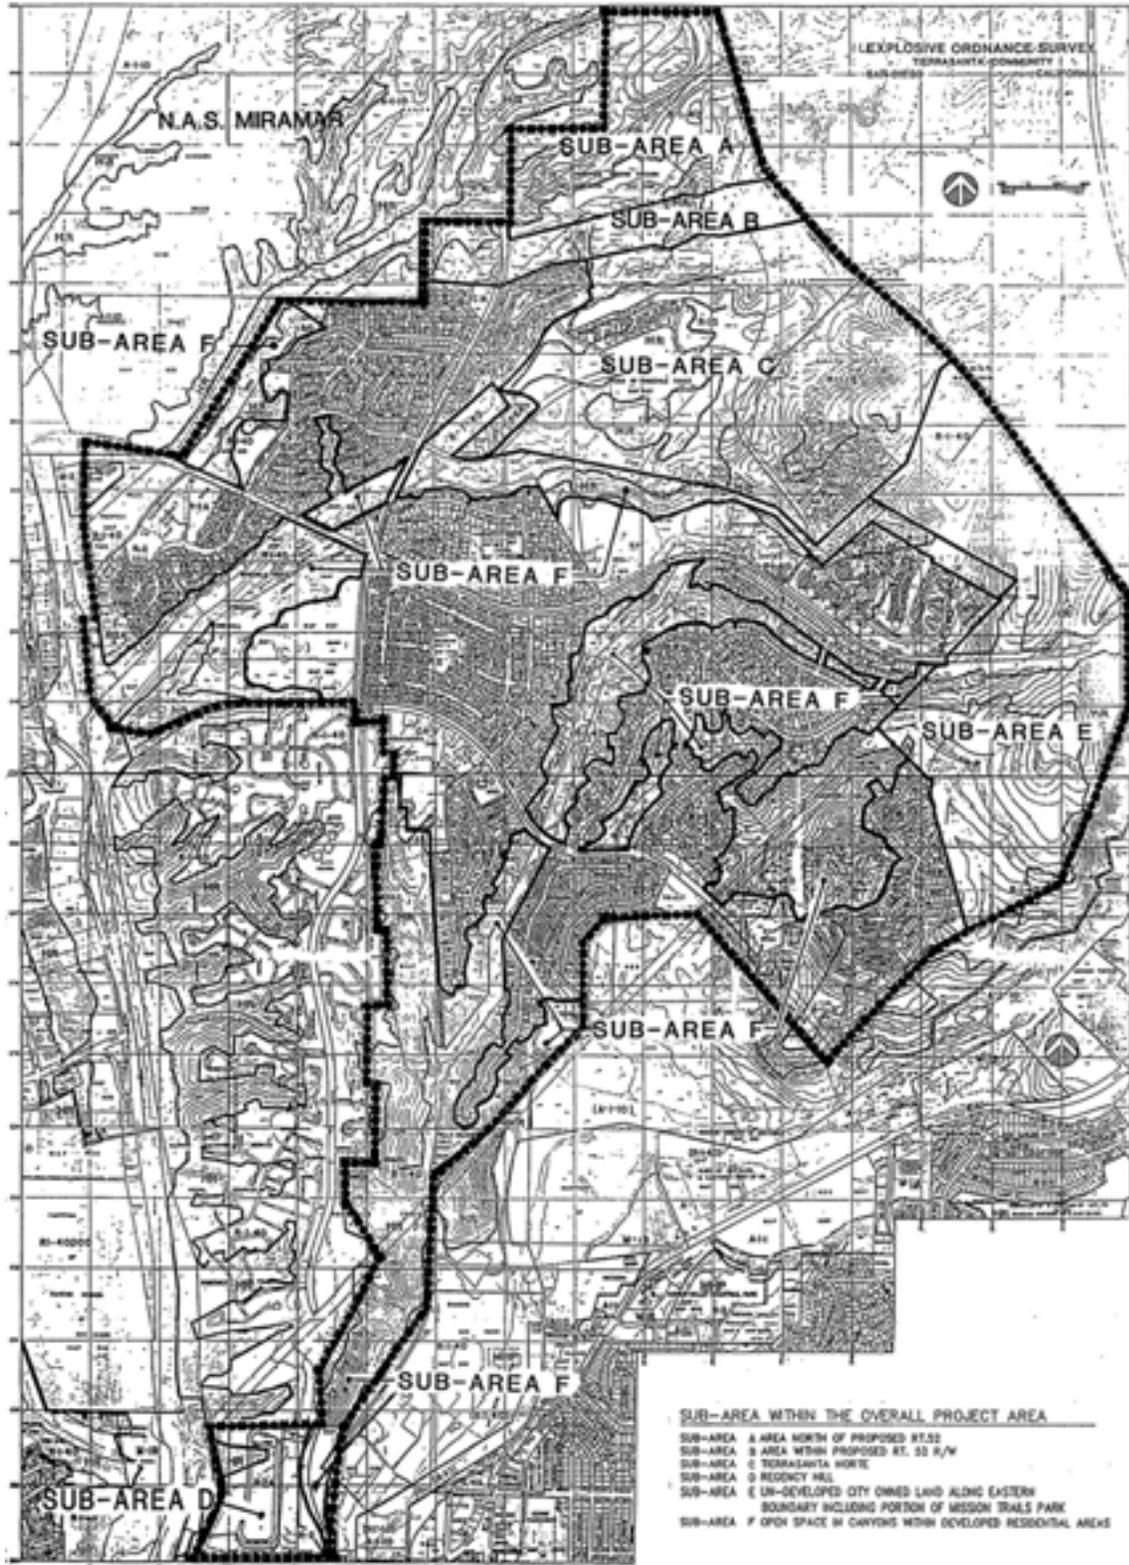
Figure 2-1. Sub-Area Boundaries Map from the Feasibility Study, April 1988
(Figure courtesy of CESPL)

The open space within the 1,897-acre portion of the former Camp Elliott project area was divided into sub-areas A, B, C, D, E, and F (**Figure 2-1**). On 19 August 1988, the Final ROD for former Camp Elliott was signed by the Deputy Assistant Secretary of Defense (Environment) to document the remedial action decision for the UXO and related debris contamination caused by previous DoD-related activities. The ROD stated that the primary objective of the project was “to protect public health, safety, and general welfare” on a portion of the former Camp Elliott Training Range. The ROD recommendations for Tierrasanta included the following remedy components (as written):

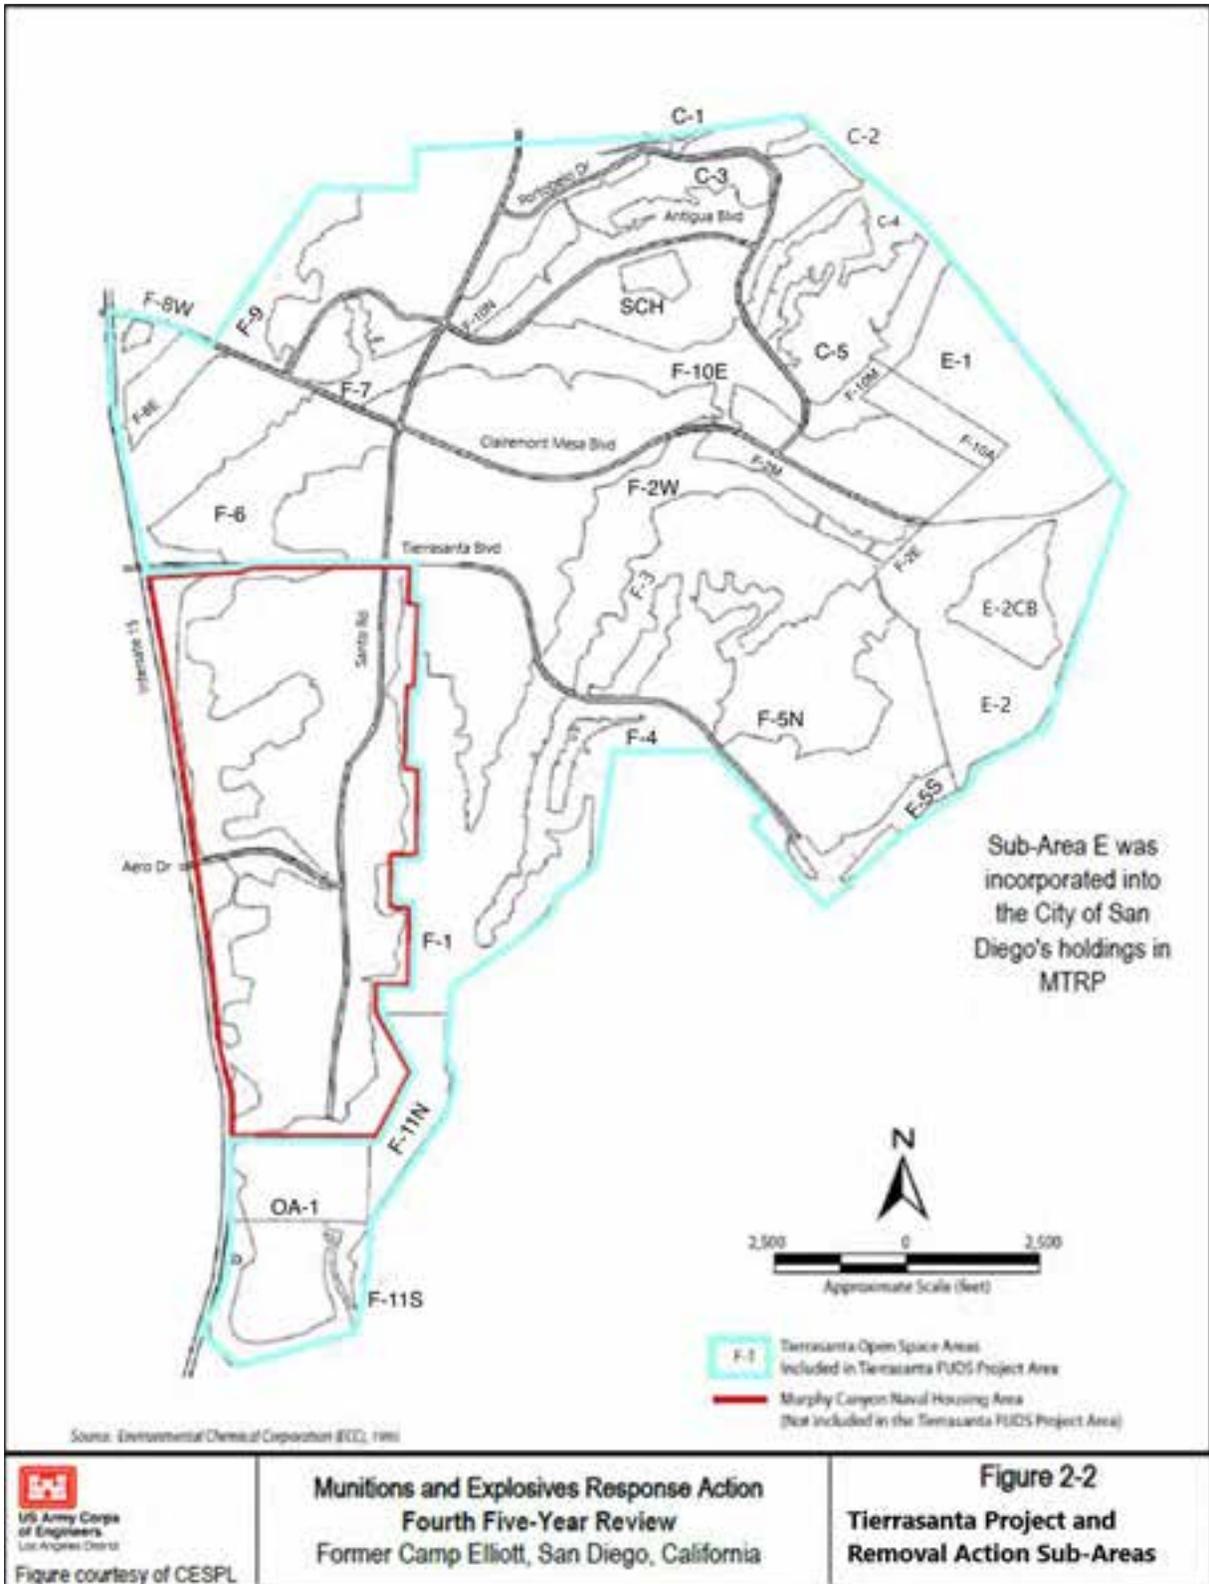
Figure 2-2. Tierrasanta Project and Removal Action Sub-Areas
(Figure courtesy of CESPL)

The area of concern for the 1990-1994 removal action included the six sub-areas detailed in **Section 2.2.2 (Figure 2-1)** with different remedy components applied to each. Two additional sub-areas were included as Sub-Area OA (presumed an acronym for “open area”) and SCH (presumed an acronym for “school”), owned by San Diego Unified School District (SDUSD) (**Figure 2-2**). Details are included below.

The USACE performed an ordnance clearance on the Tierrasanta project area (**Figure 2-2**) between November 1990 and May 1994. During this time, 1,904.24 acres were swept; 171,559.9 pounds of ferrous debris; 28,491.7 pounds of ordnance scrap; 3,991 hazardous small arms; and 1,066 hazardous items larger than small arms were located and removed. As reported in the Final Ordnance Report (Environmental Chemical Corporation [ECC], 1995a), Sub-Areas C through F were surface and subsurface cleared to three feet. It is important to note that Sub-Area E included the lands that were being held in escrow for turnover to the City of San Diego to be incorporated into the city’s holdings at MTRP. The munitions and explosives of concern (MEC) discovered during project activities was present in low densities over most of the site, with a few areas of high density. Several areas were completely devoid of UXO (USACE, 2016).

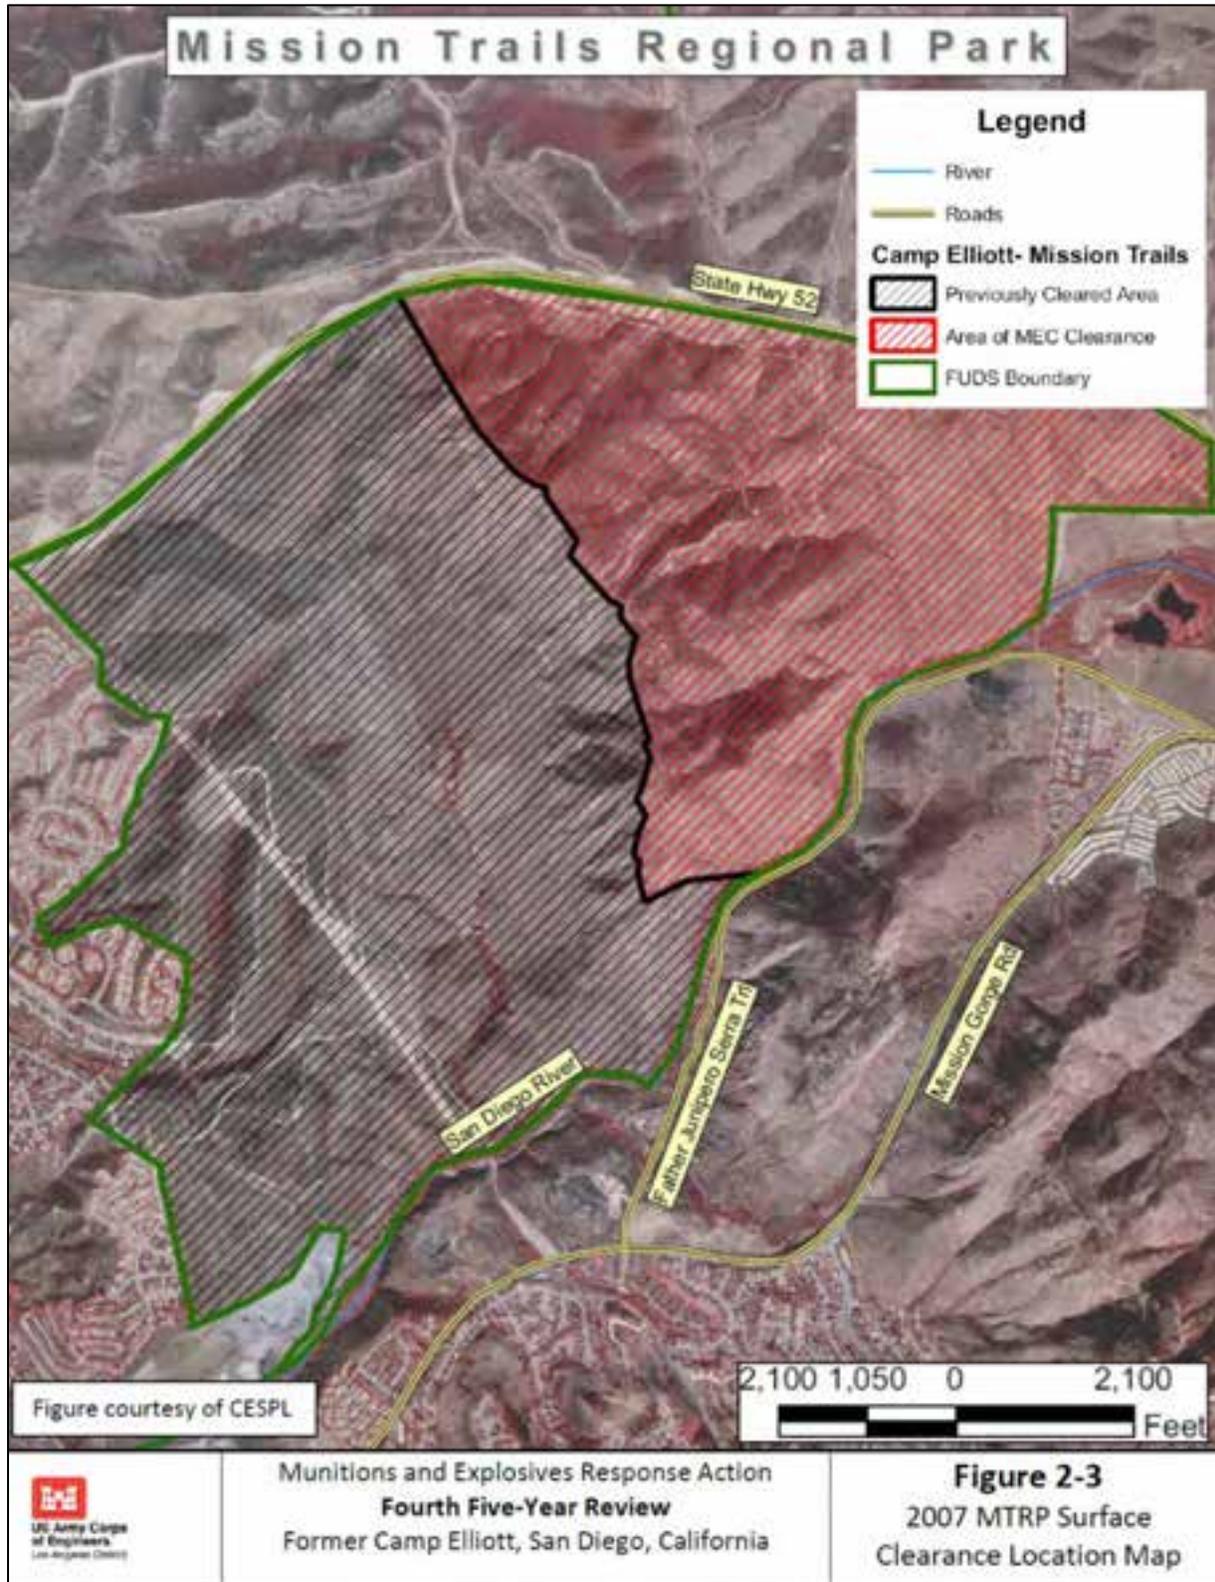
Figure 2-3. 2007 Mission Trails Regional Park Surface Clearance Location Map
(Figure courtesy of CESPL)

From July through September 2007, a surface clearance utilizing visual methods supported by use of Schonstedts (hand-held magnetometers) to check areas where visibility was restricted (high grass, brush) was conducted by USACE for East Fortuna, located within MTRP and a portion of the Mission Trails project area (see **Figure 2-3**). During the field operations, the area cleared totaled approximately 554 acres, or 83% of the surveyed acreage targeted by the project. Inaccessible areas, including steep terrain and dense brush, were not cleared. Nineteen munitions debris items, the bulk of which were 75mm practice rounds, were located and disposed either by turning over the property to MTRP (five items) for educational purposes or to the U.S. Navy Explosive Ordnance Disposal (EOD) Mobile Unit (EODMU) VII for training purposes (14 items). No MEC (or “live munitions”) were found (Project Resources Inc. 2008).

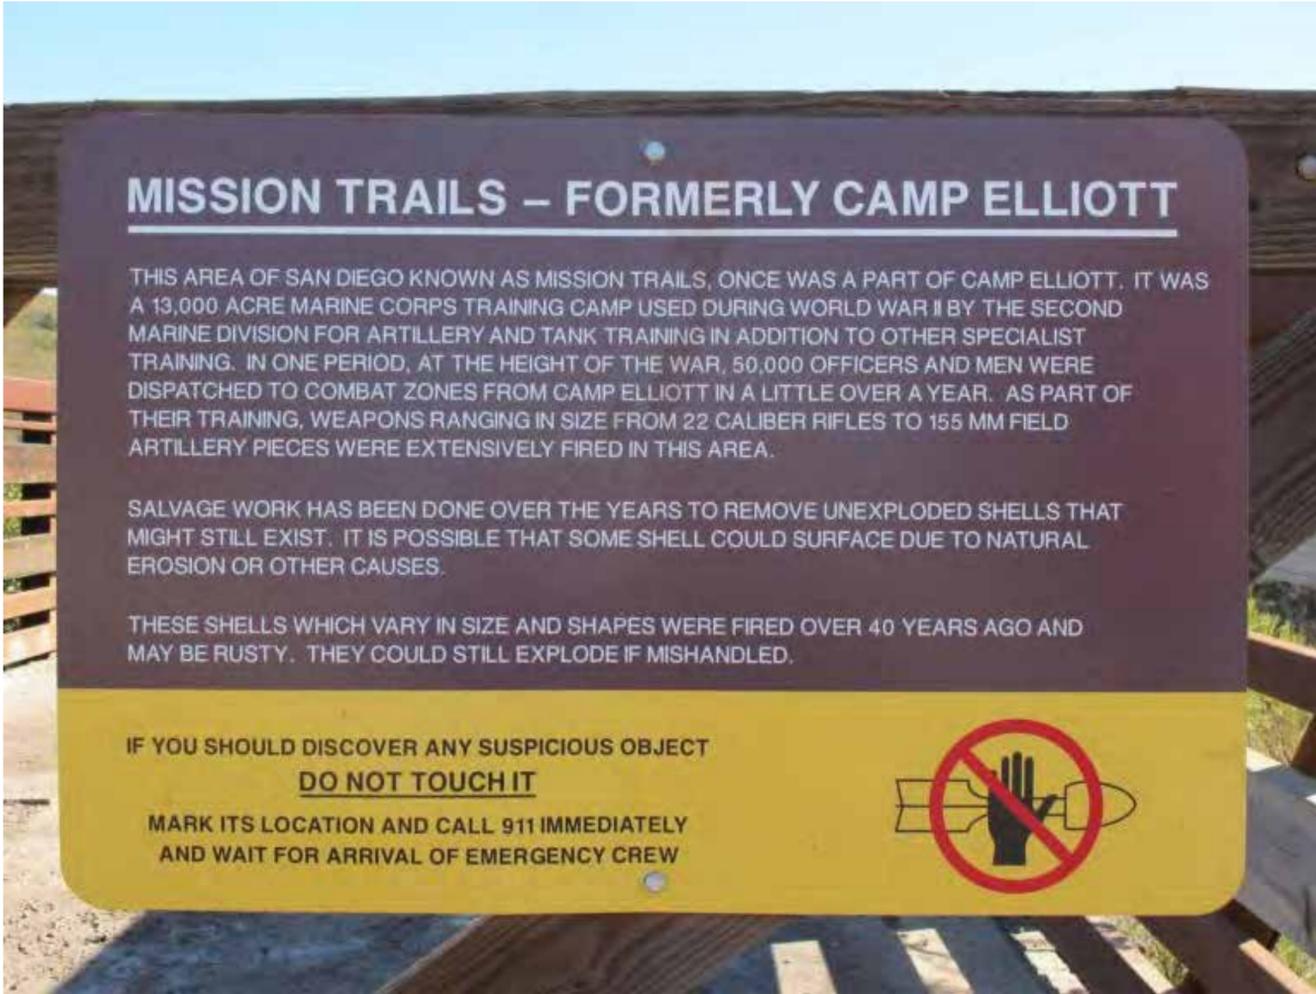
Warning signs, such as the one shown in the photo, have been installed in several locations in Mission Trails Regional Park (and throughout the neighboring Tierrasanta community). A [safety notice](#) is also available at trail kiosks in the park.

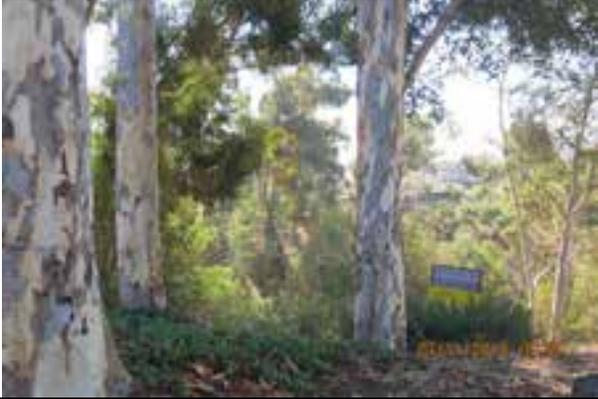
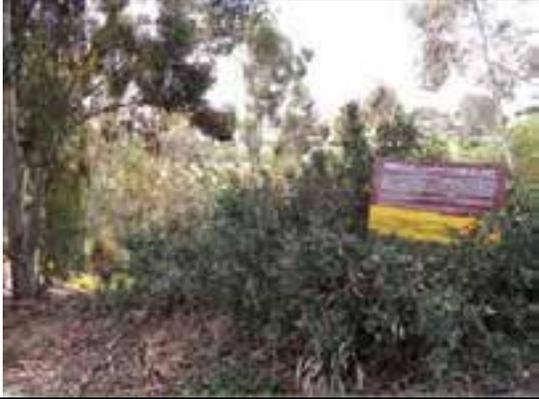
Photo/Observation ID:	TS03		
Date:	07 November 2019		
Latitude:	32.82236111		
Longitude:	-117.0845556		
Bearing (degrees):	160		
Project Area:	Tierrasanta (F-5N)		
Description:	<p>Located on Rueda Drive, between Temprano and Zorita Court.</p> <p>Good vegetation growth in the area with a faint trail; no erosion noted. Sign S-003 is in good condition.</p>

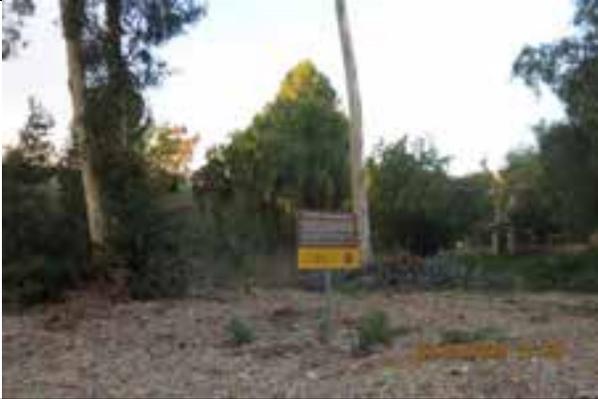
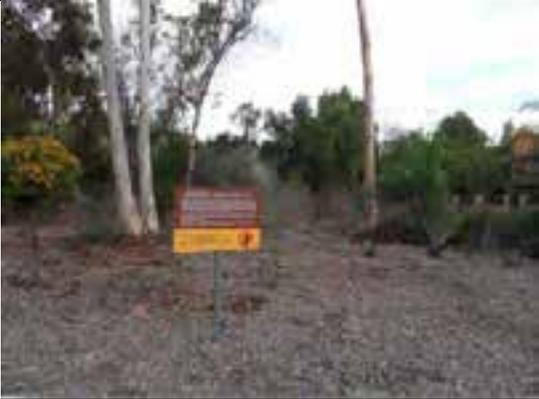
Photo/Observation ID:	TS04		
Date:	02 March 2020		
Latitude:	32.81813889		
Longitude:	-117.0915278		
Bearing (degrees):	60		
Project Area:	Tierrasanta (F-3)		
Description:	<p>Located on Tierrasanta Blvd, west of Tambor Court.</p> <p>Vegetation has grown since the last review; no erosion observed. Sign S-004 is in good condition.</p>

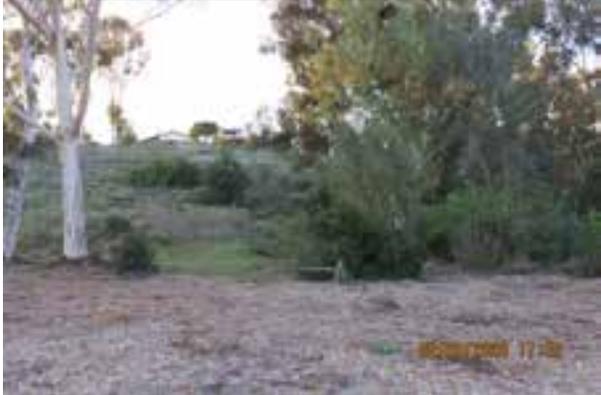
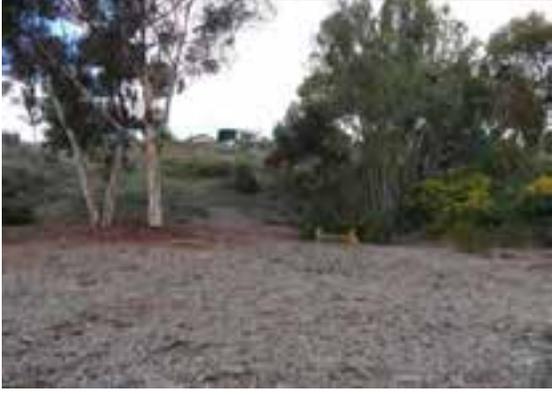
Photo/Observation ID:	TS05		
Date:	02 March 2020		
Latitude:	32.81813889		
Longitude:	-117.0915833		
Bearing (degrees):	325		
Project Area:	Tierrasanta (F-3)		
Description:	Same location as TS04. Vegetation has grown since the previous review; no erosion observed.

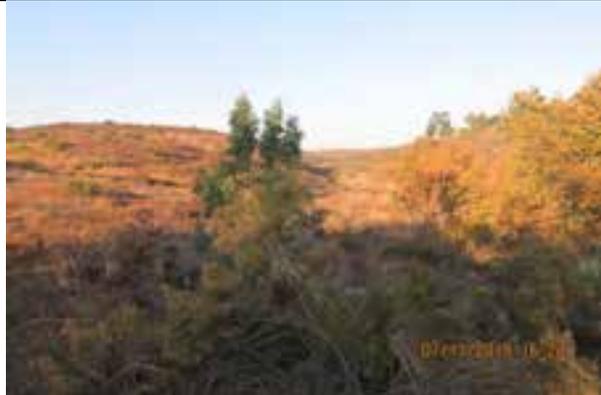
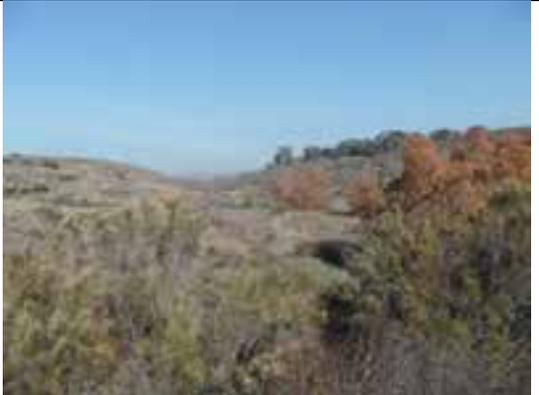
Photo/Observation ID:	TS06		
Date:	07 November 2019		
Latitude:	32.83294444		
Longitude:	-117.1131111		
Bearing (degrees):	30		
Project Area:	Tierrasanta (F-8/F-9)		
Description:	Located on the north side of Clairemont Mesa Blvd, just west of Repecho Drive. Good vegetation growth in the area; no erosion noted.

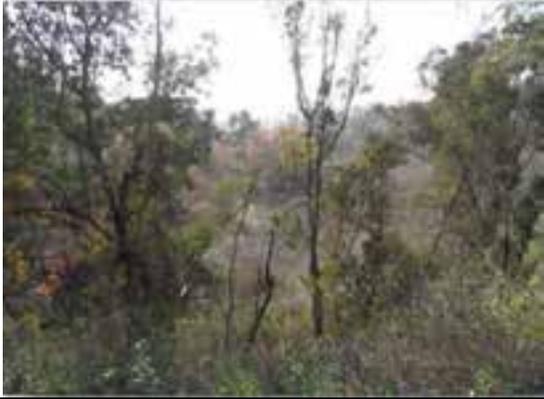
Photo/Observation ID:	TS07		
Date:	07 November 2019		
Latitude:	32.83277778		
Longitude:	-117.1133889		
Bearing (degrees):	200		
Project Area:	Tierrasanta (F-8E)		
Description:	<p>Located on the south side of Clairemont Mesa Blvd, just west of Repecho Drive.</p> <p>Good vegetation in area; no erosion noted.</p>

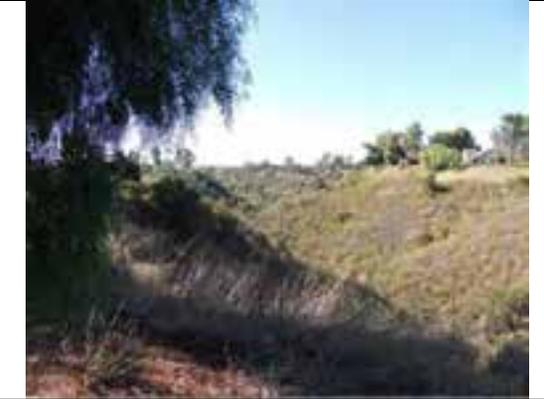
Photo/Observation ID:	TS08		
Date:	03 March 2020		
Latitude:	32.82877778		
Longitude:	-117.0884167		
Bearing (degrees):	225		
Project Area:	Tierrasanta (F-2W)		
Description:	<p>Located off of Clairemont Mesa Blvd, across the street from the Tierrasanta Recreation Center.</p> <p>Vegetation growth is heavy and appears greener/healthier than the previous review; no erosion noted.</p>

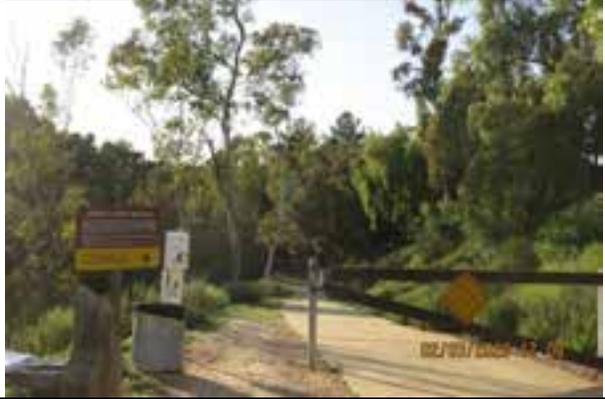
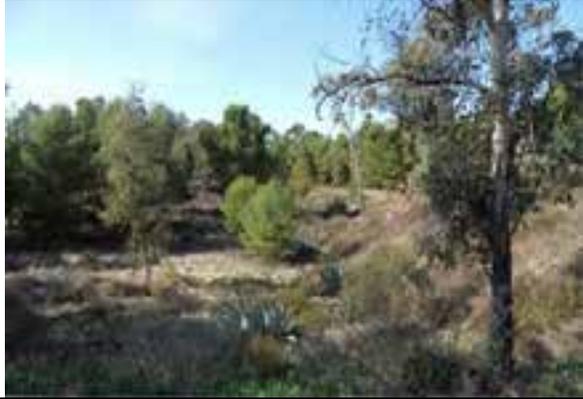
Photo/Observation ID:	TS09
Date:	02 March 2020
Latitude:	32.82569444
Longitude:	-117.08225
Bearing (degrees):	290
Project Area:	Tierrasanta (F-2W)
Description:	<p>Located on Seda Drive, between Calle De Vida and Promesa Dr.</p> <p>Observation collected approximately 40 feet north from previous five-year review, at trailhead with sign S-022. Sign is in good condition and in a visible location. Vegetation on either side of paved trail is very thick and appears healthy; no erosion noted.</p>

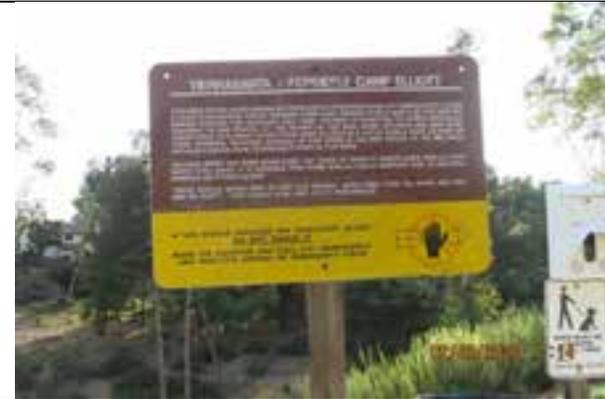
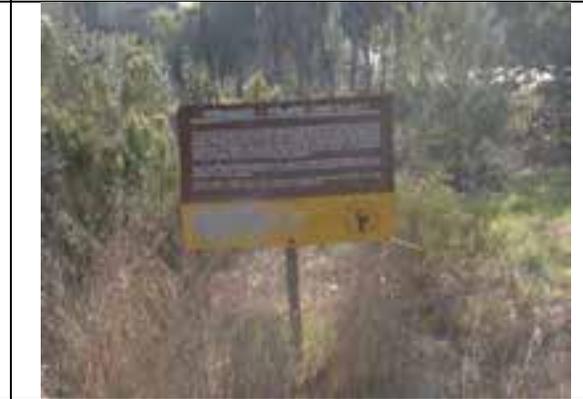
Photo/Observation ID:	TS10
Date:	02 March 2020
Latitude:	32.82569444
Longitude:	-117.08225
Bearing (degrees):	315
Project Area:	Tierrasanta (F-2W)
Description:	<p>Located on Seda Drive, between Calle De Vida and Promesa Dr.</p> <p>Closeup of sign S-022. Sign is in good condition and in a visible location.</p>

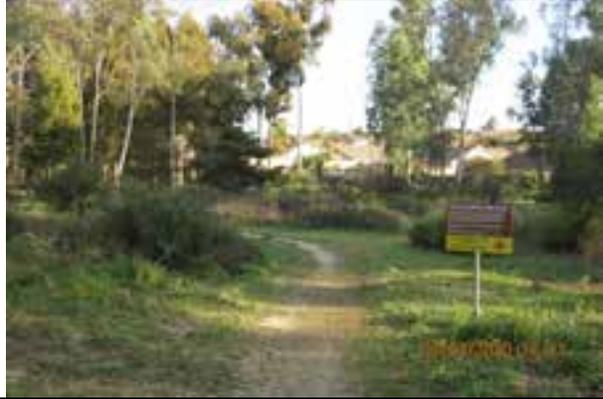
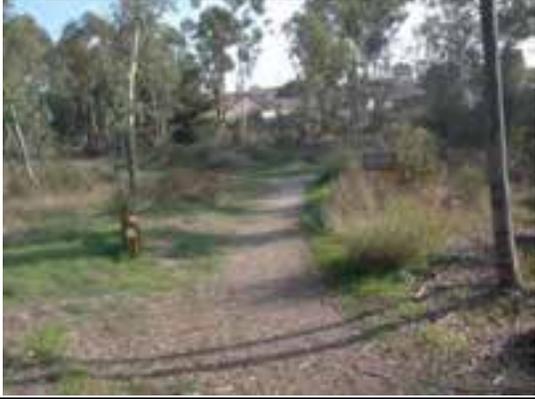
Photo/Observation ID:	TS11		
Date:	02 March 2020		
Latitude:	32.82563889		
Longitude:	-117.0820556		
Bearing (degrees):	134		
Project Area:	Tierrasanta (F-2W)		
Description:	<p>Located on Seda Drive, between Calle De Vida and Promesa Dr.</p> <p>Good vegetation, and no erosion noted in the area. Sign S-023 is located directly off a trail and is in good condition.</p>

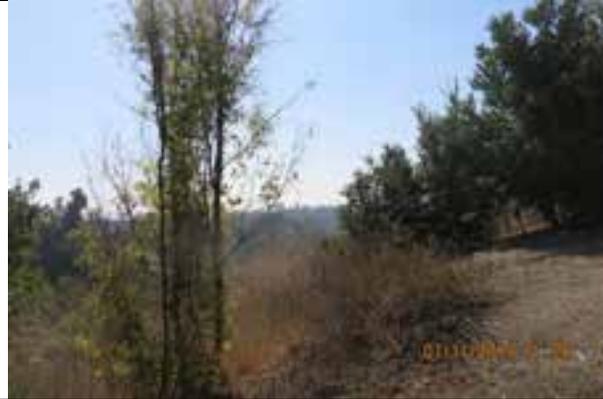
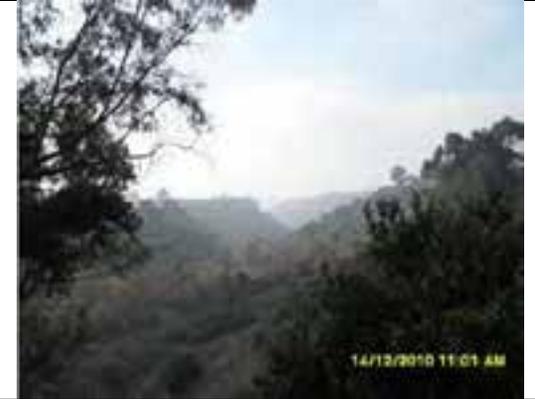
Photo/Observation ID:	TS12		
Date:	07 November 2019		
Latitude:	32.81844444		
Longitude:	-117.0959444		
Bearing (degrees):	180		
Project Area:	Tierrasanta (F-1)		
Description:	<p>Located on Tierrasanta Blvd; observation was collected directly off the trail.</p> <p>Good heavy vegetation in canyon with no visible signs of erosion. Sign S-054 is located at trailhead.</p>

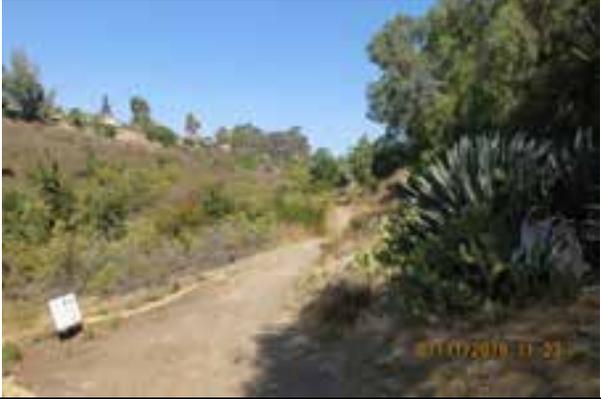
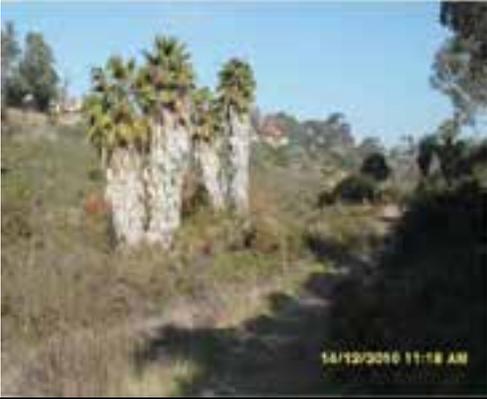
Photo/Observation ID:	TS13		
Date:	07 November 2019		
Latitude:	32.81844444		
Longitude:	-117.0946111		
Bearing (degrees):	5		
Project Area:	Tierrasanta (F-2S)		
Description:	<p>Located on the north side of Tierrasanta Blvd, ~125 feet down trail from sign S-035.</p> <p>Trees are no longer present, but otherwise heavy vegetation on either side of the trail and no erosion was observed.</p>

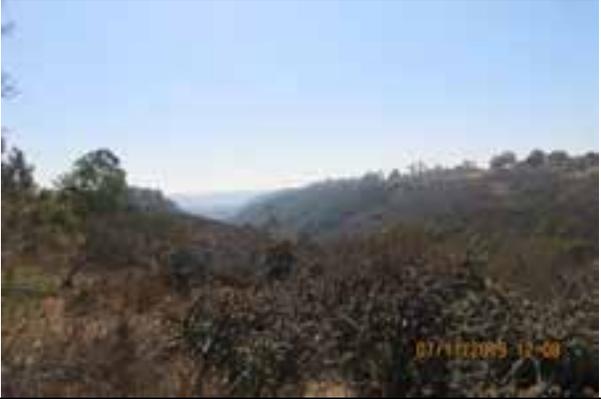
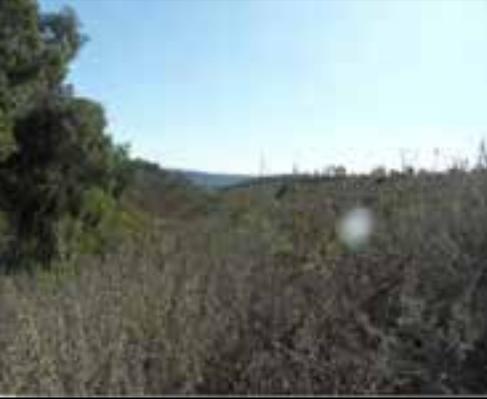
Photo/Observation ID:	TS14		
Date:	07 November 2019		
Latitude:	32.81797222		
Longitude:	-117.1008333		
Bearing (degrees):	182		
Project Area:	Tierrasanta (F-1)		
Description:	<p>Located west of Roadrunner Park at the top of the canyon, near MEC warning signs S-110 and S-113.</p> <p>Heavy vegetation and cholla cactus in area; no erosion observed.</p>

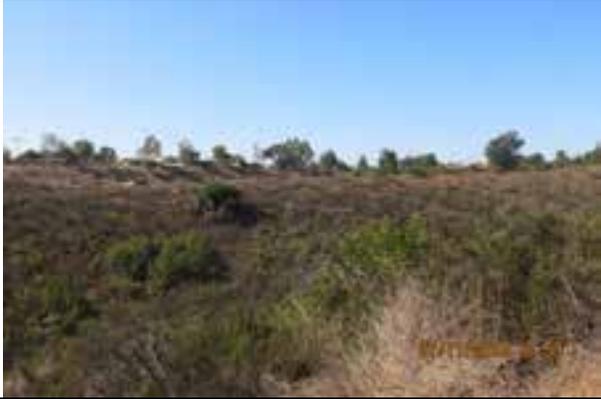
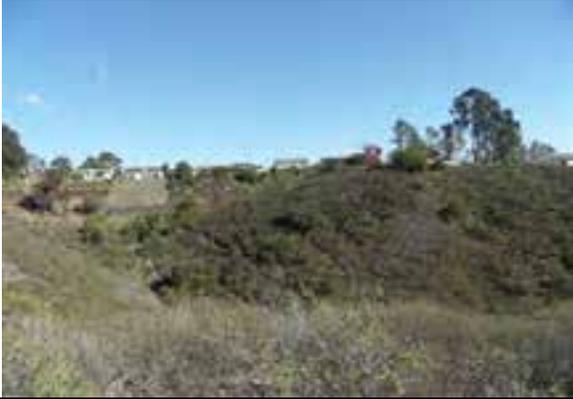
Photo/Observation ID:	TS15		
Date:	07 November 2019		
Latitude:	32.81672222		
Longitude:	-117.1014722		
Bearing (degrees):	90		
Project Area:	Tierrasanta (F-1)		
Description:	<p>Observation is located in a canyon. Field team did not access due to safety concerns (i.e., no clear trail, cholla cactus) and collected observation at 32.81724, -117.10066 and bearing 170°.</p> <p>Canyon is heavily vegetated; no erosion observed.</p>

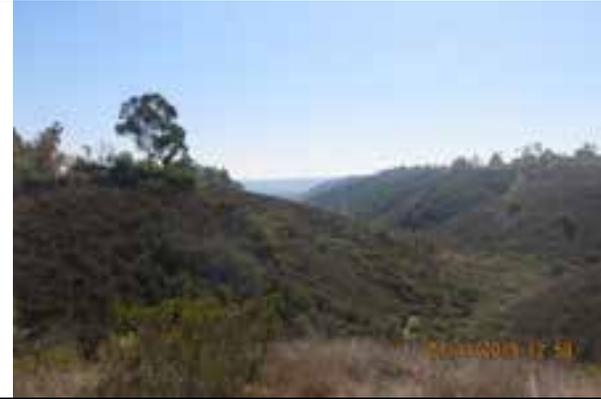
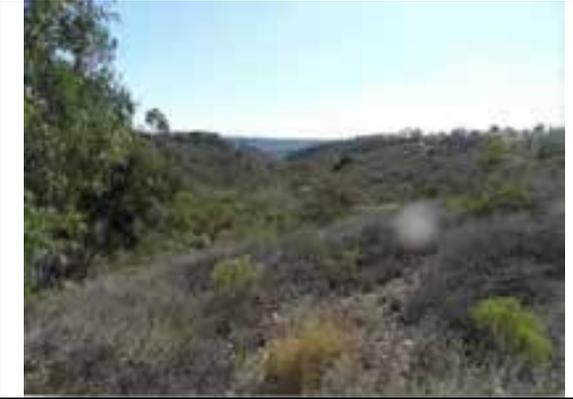
Photo/Observation ID:	TS16		
Date:	07 November 2019		
Latitude:	32.81672222		
Longitude:	-117.1014722		
Bearing (degrees):	168		
Project Area:	Tierrasanta (F-1)		
Description:	<p>Observation is located in a canyon. Field team did not access due to safety concerns (i.e., no clear trail, cholla cactus) and observation collected at 32.81724, -117.10066 and bearing 270°.</p> <p>Canyon is heavily vegetated; no erosion observed.</p>

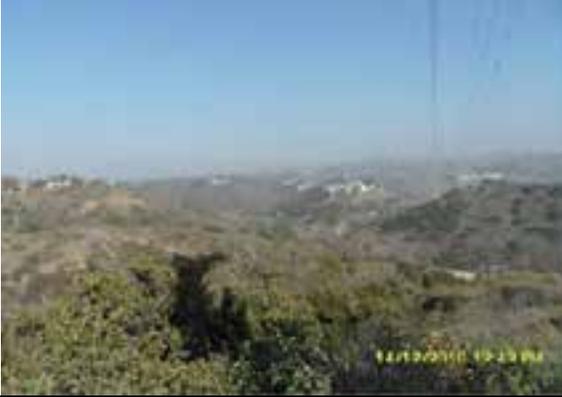
Photo/Observation ID:	TS17
Date:	07 November 2019
Latitude:	32.80208333
Longitude:	-117.10325
Bearing (degrees):	22
Project Area:	Tierrasanta (F-1)
Description:	<p>Observation point could not be accessed due to fencing. Coordinates and bearing above are from Third Five-Year Review.</p> <p>See TS87.</p>

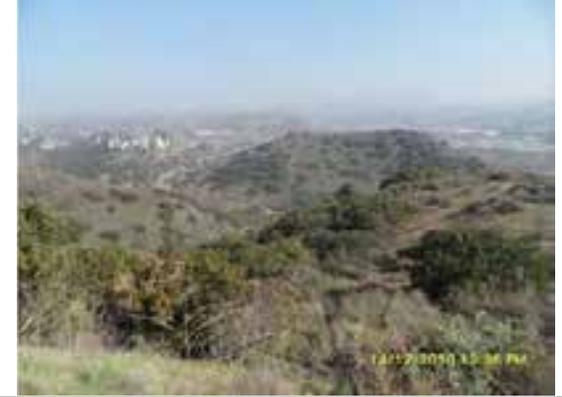
Photo/Observation ID:	TS18
Date:	07 November 2019
Latitude:	32.80308333
Longitude:	-117.1030278
Bearing (degrees):	58
Project Area:	Tierrasanta (F-1)
Description:	<p>Observation point could not be accessed due to fencing. Coordinates and bearing above are from Third Five-Year Review.</p> <p>See TS87.</p>

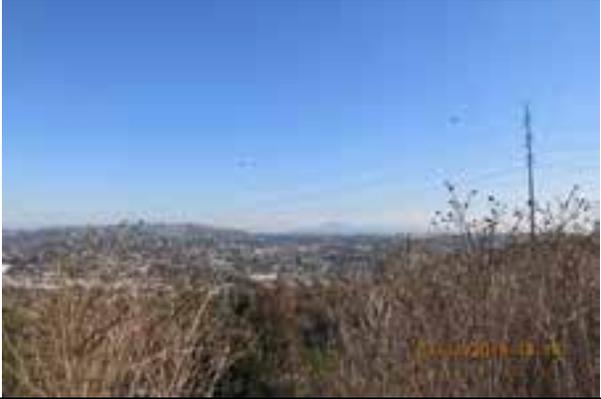
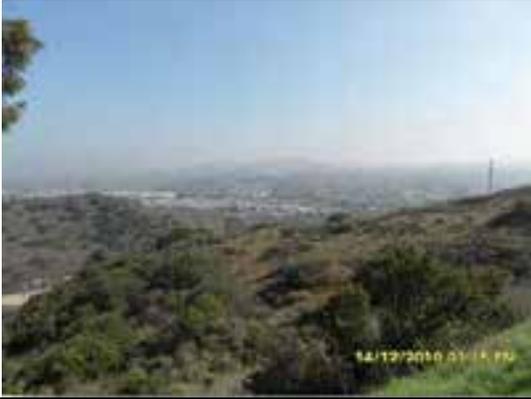
Photo/Observation ID:	TS19a
Date:	07 November 2019
Latitude:	32.80319444
Longitude:	-117.1039722
Bearing (degrees):	190
Project Area:	Tierrasanta (OA-1)
Description:	<p>Located off Santos Road, behind the YMCA playground.</p> <p>Good vegetation in the area with no erosion noted. Fencing along eastern perimeter with MEC warning sign (see TS19b). Observation collected at bearing 190 degrees.</p>

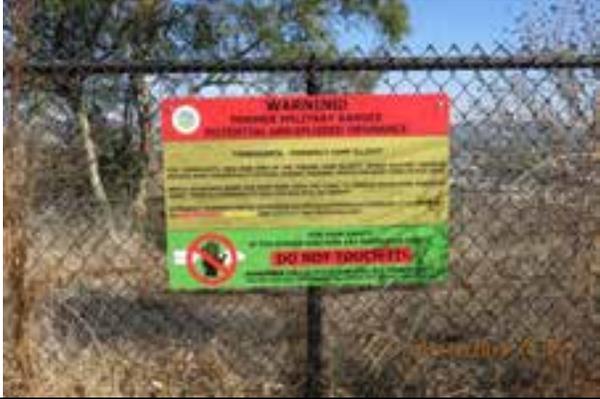
<p data-bbox="1036 1245 1255 1276"><i>No photo collected.</i></p>
Photo/Observation ID:	TS19b
Date:	07 November 2019
Latitude:	32.80319444
Longitude:	-117.1039722
Bearing (degrees):	-
Project Area:	Tierrasanta (OA-1)
Description:	<p>MEC warning sign on fencing along eastern perimeter of the YMCA playground.</p>

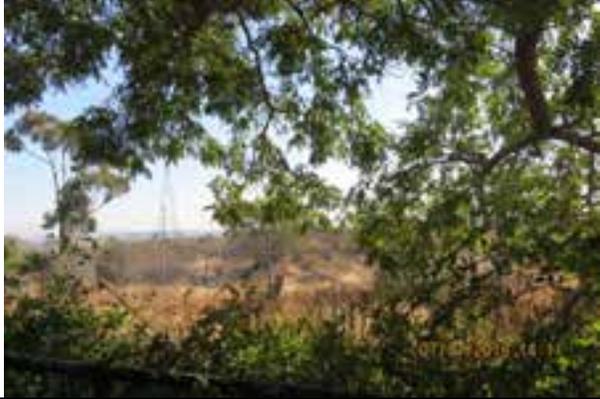
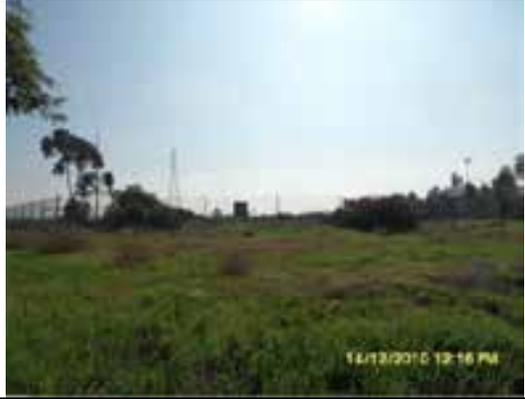
Photo/Observation ID:	TS20		
Date:	07 November 2019		
Latitude:	32.80319444		
Longitude:	-117.1044167		
Bearing (degrees):	156		
Project Area:	Tierrasanta (OA-1)		
Description:	Located off Santos Road, taken from the fence by the YMCA. Vegetation appears dry; no erosion noted.

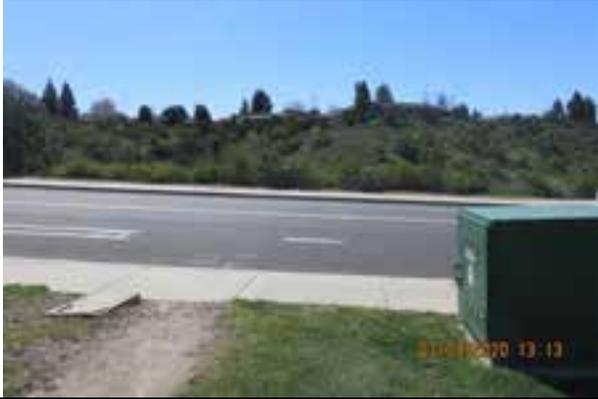
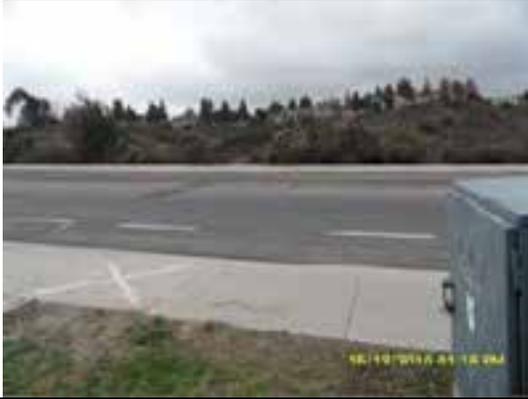
Photo/Observation ID:	TS21		
Date:	03 March 2020		
Latitude:	32.80158333		
Longitude:	-117.1005833		
Bearing (degrees):	0		
Project Area:	Tierrasanta (F-1)		
Description:	Located at Admiral Baker Golf Course, on Admiral Baker Road. Area F-1 and driving range in the background. Area is covered with vegetation and impervious surface (i.e., asphalt).

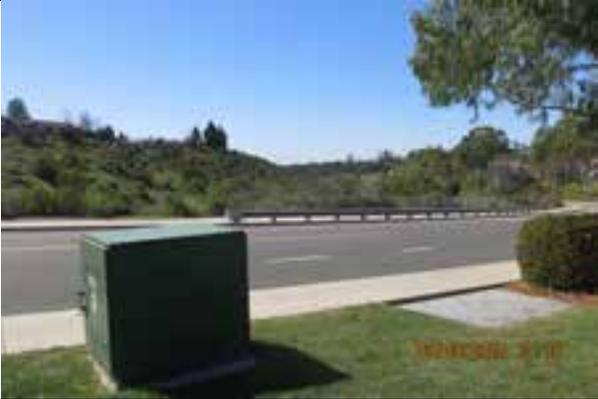
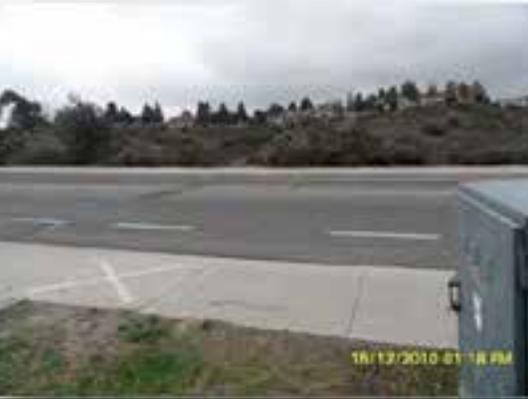
Photo/Observation ID:	TS22		
Date:	03 March 2020		
Latitude:	32.84080556		
Longitude:	-117.0850278		
Bearing (degrees):	213		
Project Area:	Tierrasanta (C-3)		
Description:	<p>Located at San Diego Aqueduct Service Road, looking across Portobelo Drive; same location as TS23.</p> <p>Heavily vegetated with no erosion observed.</p>

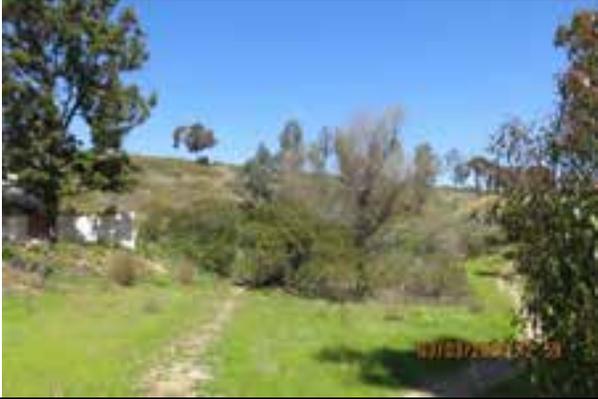
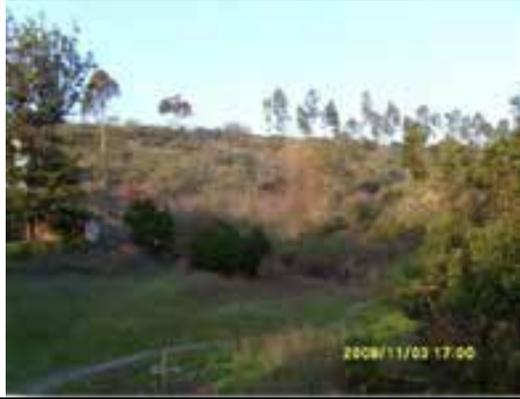
Photo/Observation ID:	TS23		
Date:	03 March 2020		
Latitude:	32.84080556		
Longitude:	-117.0850278		
Bearing (degrees):	251		
Project Area:	Tierrasanta (C-3)		
Description:	<p>Located at San Diego Aqueduct Service Road, looking across Portobelo Drive; same location as TS22.</p> <p>Heavily vegetated with no erosion observed.</p>

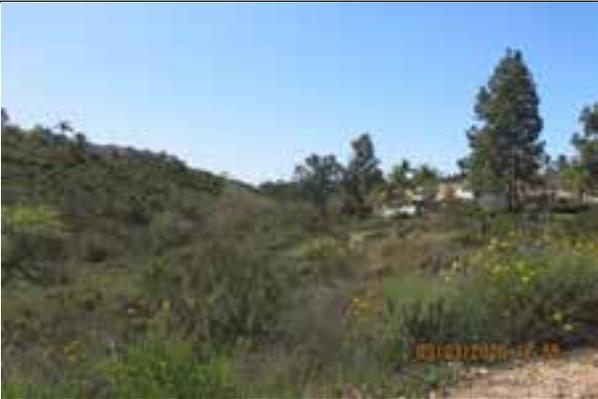
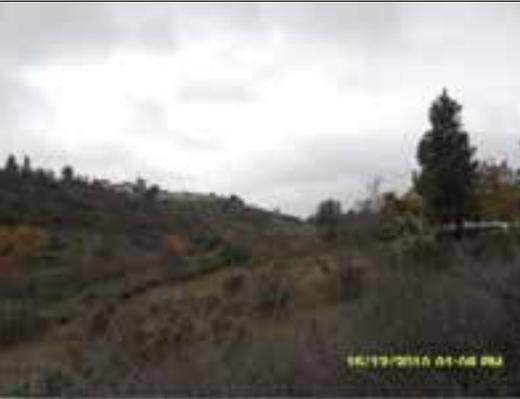
Photo/Observation ID:	TS24		
Date:	03 March 2020		
Latitude:	32.84108333		
Longitude:	-117.0897778		
Bearing (degrees):	13		
Project Area:	Tierrasanta (C-1)		
Description:	<p>Located on the north side of Portobelo Drive, next to a home at 10974 Portobelo Drive.</p> <p>Good vegetation and no erosion noted. Trail leads to Mission Trails Regional Park (~0.5 miles). No MEC warning sign observed at the trailhead.</p>

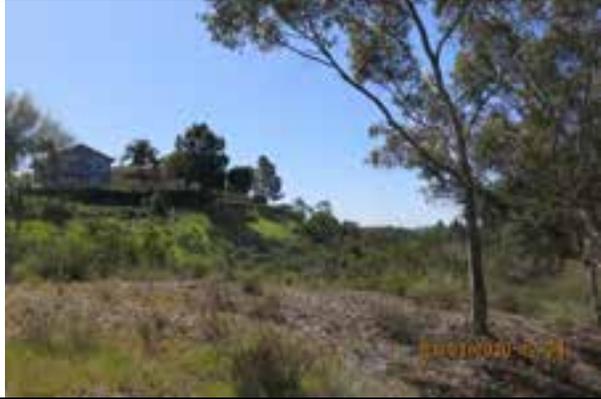
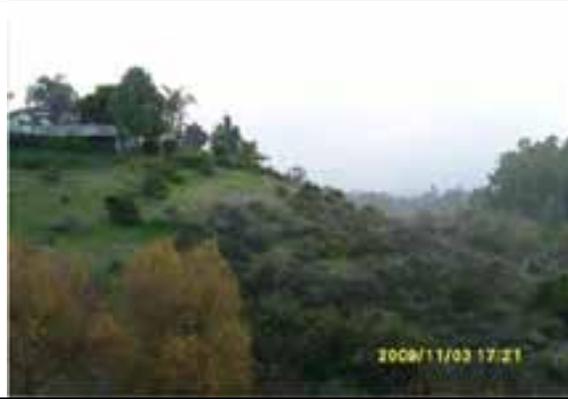
Photo/Observation ID:	TS25		
Date:	03 March 2020		
Latitude:	32.84097222		
Longitude:	-117.0899722		
Bearing (degrees):	242		
Project Area:	Tierrasanta (C-3)		
Description:	<p>Location is across the street from TS24.</p> <p>Good vegetation growth and no erosion observed.</p>

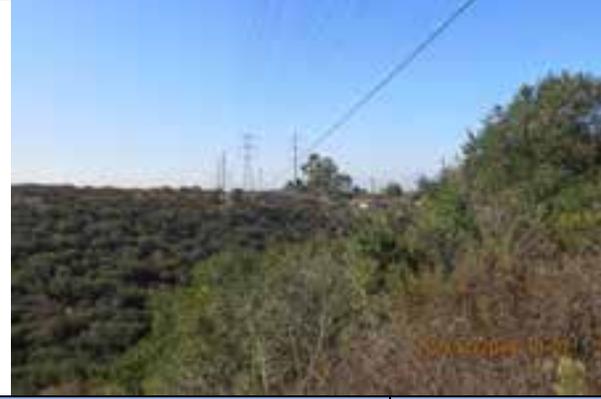
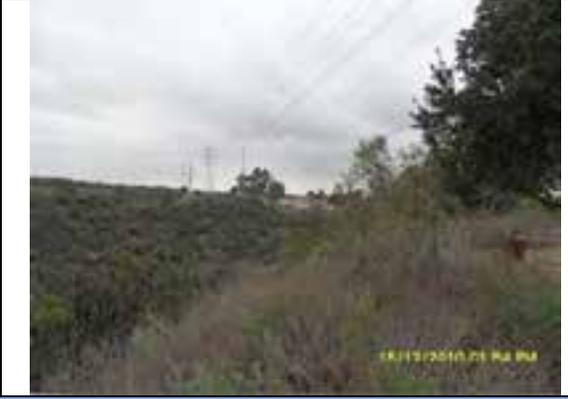
Photo/Observation ID:	TS26		
Date:	03 March 2020		
Latitude:	32.83772222		
Longitude:	-117.0946667		
Bearing (degrees):	230		
Project Area:	Tierrasanta (F-10N)		
Description:	<p>Located on the southwest side of Villaricca Way, near the intersection of Corte Playa Barcelona.</p> <p>Heavy vegetation in the canyon; no erosion noted. MEC warning sign S-111 observed at the trailhead. Sign is in good condition and is in a visible location.</p>

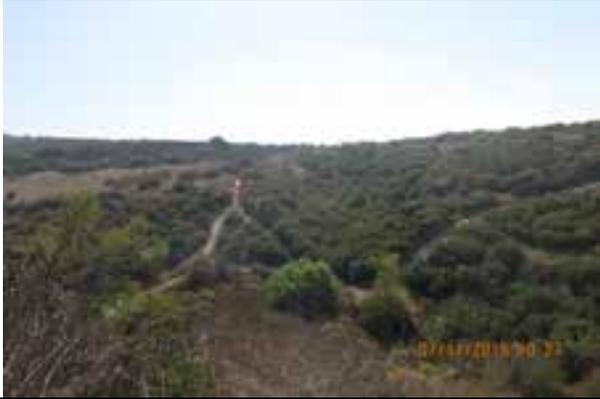
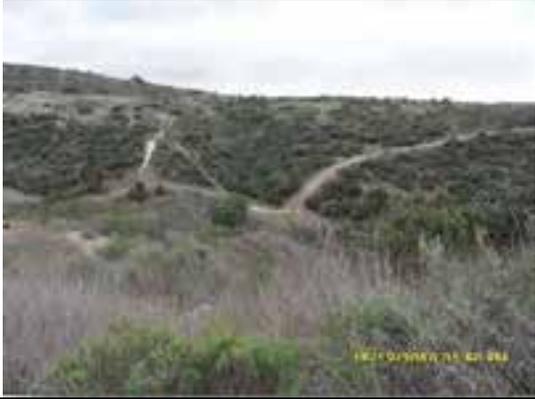
Photo/Observation ID:	TS27		
Date:	07 November 2019		
Latitude:	32.82486111		
Longitude:	-117.0763611		
Bearing (degrees):	230		
Project Area:	Tierrasanta (E-2)		
Description:	<p>Located at the entrance to Mission Trails Regional Park on Clairemont Mesa Blvd.</p> <p>Heavily vegetated with no signs of erosion.</p>

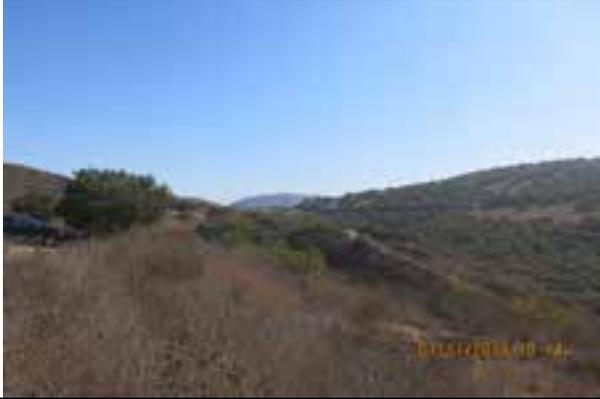
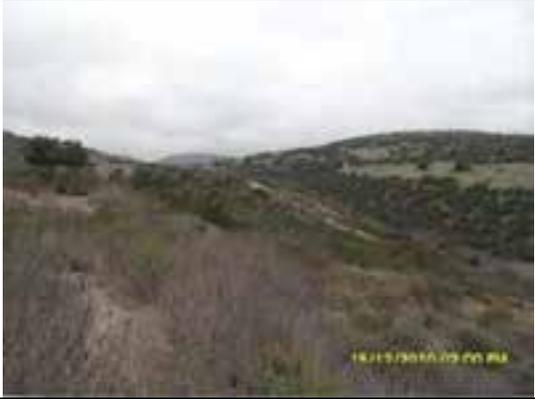
Photo/Observation ID:	TS28		
Date:	07 November 2019		
Latitude:	32.82486111		
Longitude:	-117.0763611		
Bearing (degrees):	140		
Project Area:	Tierrasanta (E-2)		
Description:	View of Mission Trails Regional Park from the parking area at the end of Clairemont Mesa Blvd. Vegetation is much taller and thicker since previous review. No signs of erosion noted.

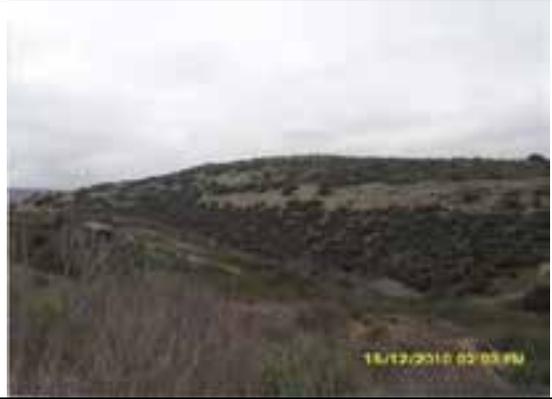
Photo/Observation ID:	TS29		
Date:	07 November 2019		
Latitude:	32.82486111		
Longitude:	-117.07625		
Bearing (degrees):	69		
Project Area:	Tierrasanta (E-1)		
Description:	View of Mission Trails Regional Park from the parking area at the end of Clairemont Mesa Blvd. Vegetation is much taller and thicker since previous review. No signs of erosion noted.

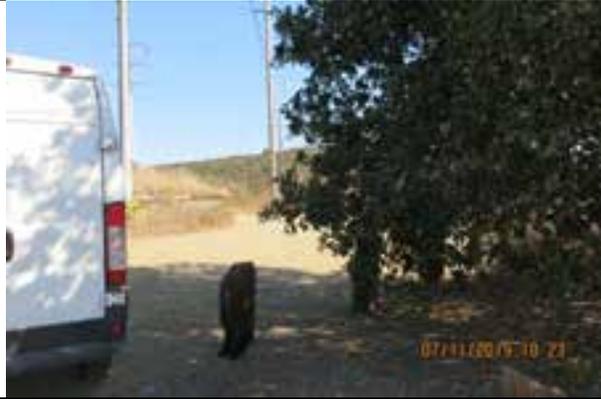
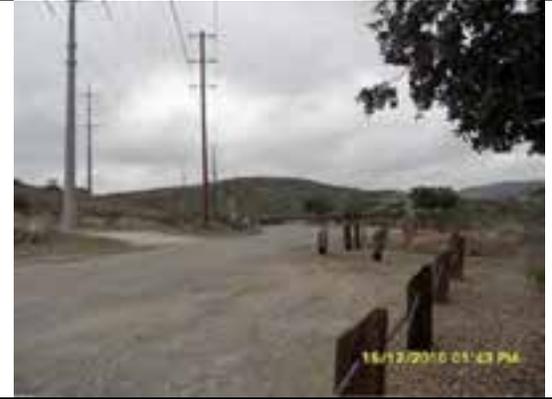
Photo/Observation ID:	TS30		
Date:	07 November 2019		
Latitude:	32.82497222		
Longitude:	-117.0761389		
Bearing (degrees):	110		
Project Area:	Tierrasanta (E-2CB)		
Description:	<p>View of Mission Trails Regional Park from the parking area at the end of Clairemont Mesa Blvd. Observation collected at 32.82501, -117.07630 with the same bearing as the previous review.</p> <p>Vegetation is much taller and thicker; no erosion noted. Looking at a trailhead with no MEC warning sign. The trail leads into the park.</p>
