Fourth Five-Year Review Report

**Former Camp Elliott-Tierrasanta, Project Number J09CA006701
Former Camp Elliott-Mission Trails, Project Number J09CA006702
San Diego, California**

Date: 7 September 2021

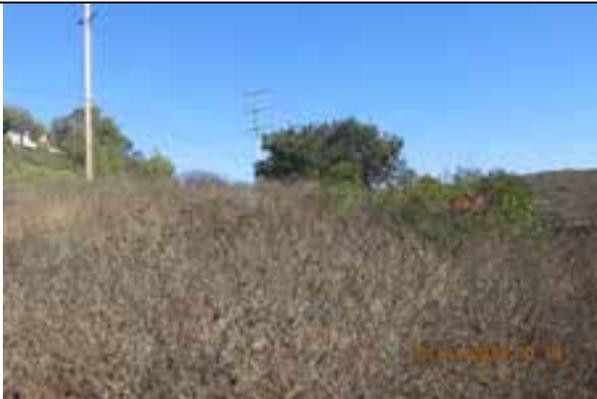
Photo/Observation ID:	TS31		
Date:	07 November 2019		
Latitude:	32.82488889		
Longitude:	-117.0763611		
Bearing (degrees):	50		
Project Area:	Tierrasanta		
Description:	<p>View of Mission Trails Regional Park from the parking area at the end of Clairemont Mesa Blvd.</p> <p>Vegetation is much taller and thicker since the previous review; no erosion noted.</p>

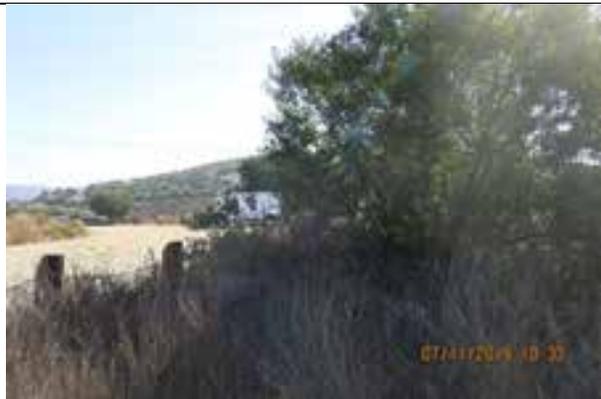
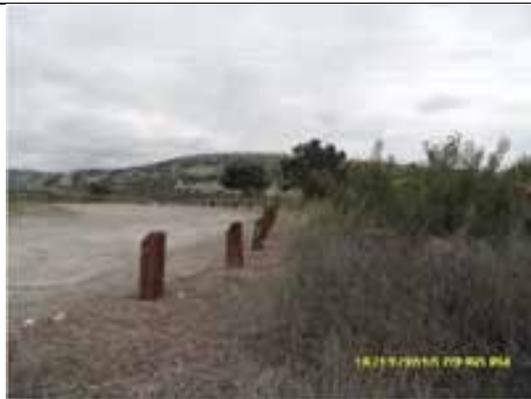
<p><i>No photo collected. Location not found.</i></p>	
Photo/Observation ID:	TS32		
Date:	07 November 2019		
Latitude:	32.82475		
Longitude:	-117.0760833		
Bearing (degrees):	15		
Project Area:	Tierrasanta		
Description:	<p>Entrance to Mission Trails Regional Park at the end of Clairemont Mesa Blvd. Observation collected at 32.82478, -117.07610 with the same bearing as the previous review.</p> <p>Good vegetation and no erosion noted.</p>

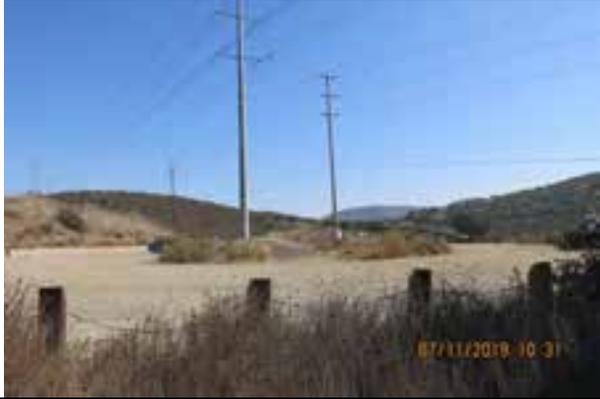
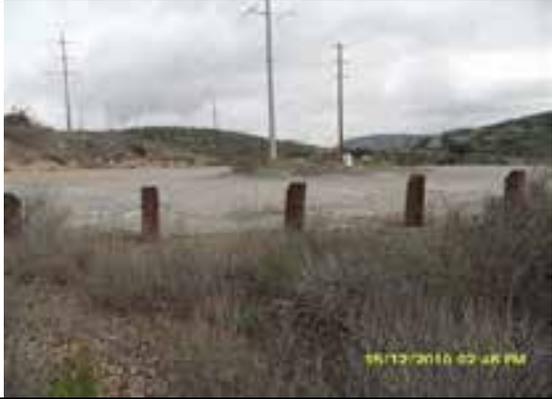
Photo/Observation ID:	TS33		
Date:	07 November 2019		
Latitude:	32.82502778		
Longitude:	-117.0767778		
Bearing (degrees):	115		
Project Area:	Tierrasanta		
Description:	<p>Located at the entrance to Mission Trails Regional Park at the end of Clairemont Mesa Blvd.</p> <p>Vegetation is taller and thicker than previous review and no erosion noted.</p>

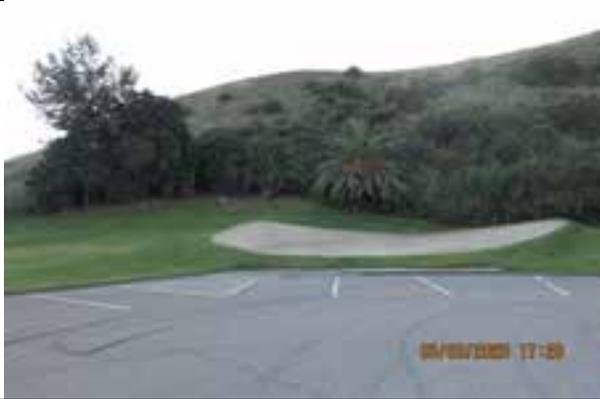
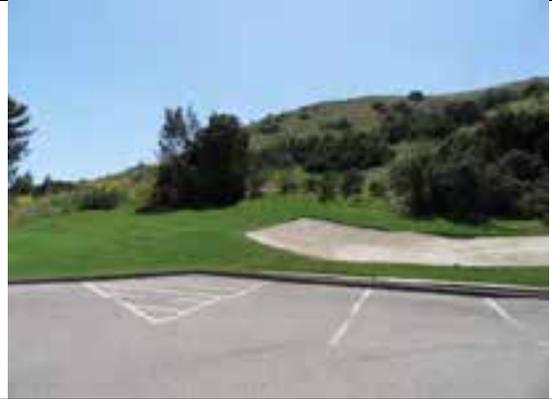
Photo/Observation ID:	TS34		
Date:	07 November 2019		
Latitude:	32.82502778		
Longitude:	-117.0767778		
Bearing (degrees):	75		
Project Area:	Tierrasanta		
Description:	<p>Located at the entrance to Mission Trails Regional Park at the end of Clairemont Mesa Blvd.</p> <p>Good vegetation and no erosion noted.</p>

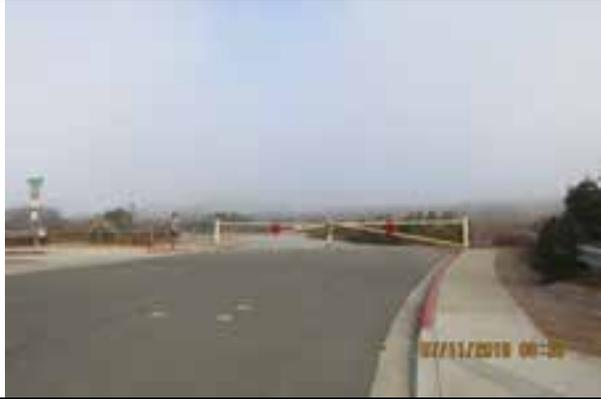
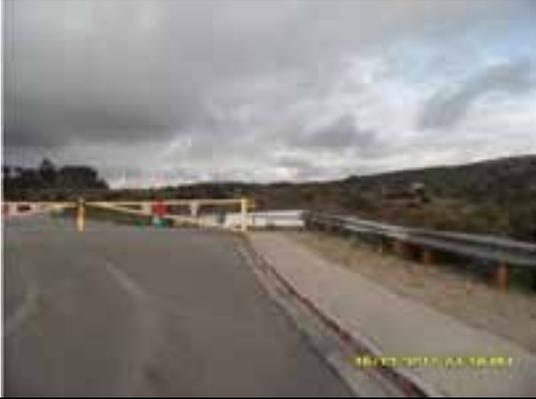
Photo/Observation ID:	TS35		
Date:	03 March 2020		
Latitude:	32.80194444		
Longitude:	-117.1005		
Bearing (degrees):	220		
Project Area:	Tierrasanta (F-11N)		
Description:	<p>Located at Admiral Baker Golf Course, on Admiral Baker Road, and includes the golf course putting green.</p> <p>Good vegetation and no erosion noted in area. Vegetation is much larger than previous review.</p>

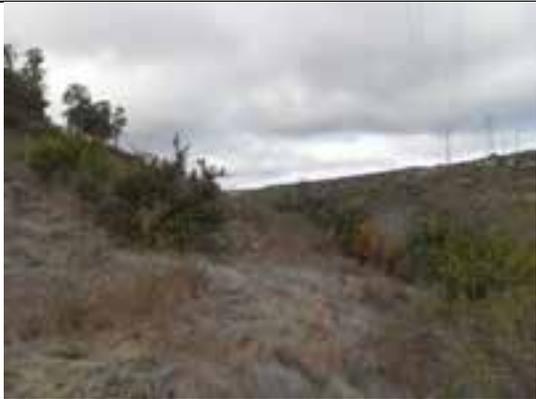
Photo/Observation ID:	TS36		
Date:	07 November 2019		
Latitude:	32.82072222		
Longitude:	-117.0771111		
Bearing (degrees):	22		
Project Area:	Tierrasanta (E-2)		
Description:	<p>Located at the entrance to Mission Trails Regional Park, at the intersection of Colina Dorado Drive and Calle de Vida.</p> <p>Sign S-008 / S-093 observed at trailhead. Lower yellow portion of sign is faded (see MT42 and sign log). Observation collected with bearing at 0°.</p>

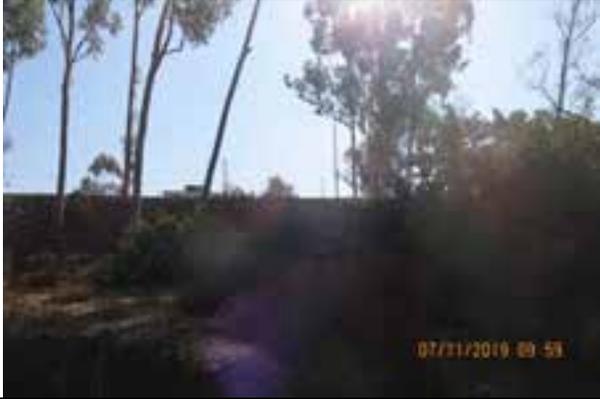
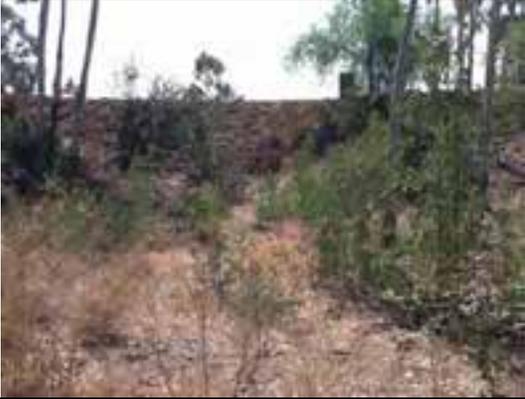
Photo/Observation ID:	TS37		
Date:	06 November 2019		
Latitude:	32.82541667		
Longitude:	-117.0753889		
Bearing (degrees):	350		
Project Area:	Tierrasanta (F-10A)		
Description:	<p>Located on a wooden bridge at the entrance to Mission Trails Regional Park from Clairemont Mesa Blvd.</p> <p>Good vegetation with some bare ground observed on the hillside.</p>

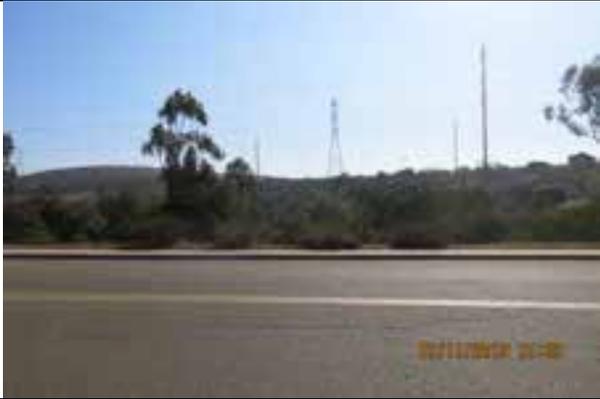
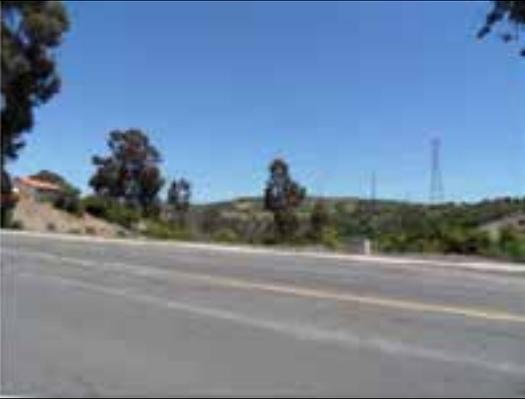
Photo/Observation ID:	TS38		
Date:	07 November 2019		
Latitude:	32.82441667		
Longitude:	-117.0795556		
Bearing (degrees):	285		
Project Area:	Tierrasanta (F-2M)		
Description:	<p>Located on the west side of Rueda Drive, between Via Promesa and Palabra Circle. Observation collected at 32.82456, -117.07994 with a bearing of 130°.</p> <p>Good vegetation in the area and no erosion noted. Area is accessed by Seda Nature Trail. Sign S-016 observed at trailhead off of Rueda Drive. Sign is in good condition and is in a visible location.</p>

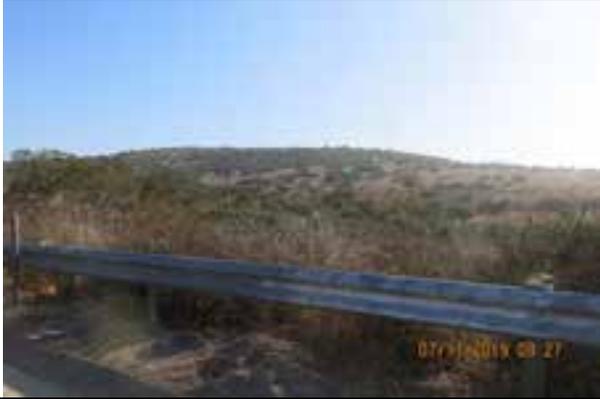
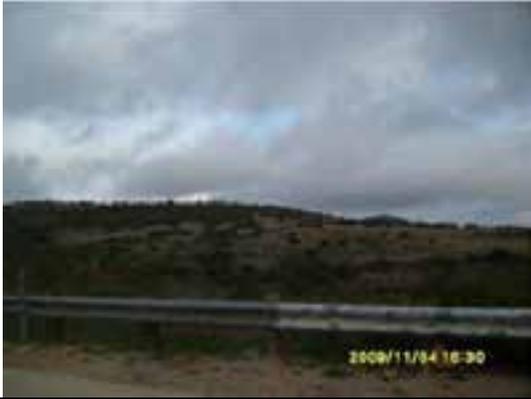
Photo/Observation ID:	TS39		
Date:	07 November 2019		
Latitude:	32.82447222		
Longitude:	-117.0795833		
Bearing (degrees):	110		
Project Area:	Tierrasanta (F-2E)		
Description:	<p>Located on Rueda Drive, between Via Promesa and Palabra Circle.</p> <p>Good vegetation in area and no erosion noted.</p>

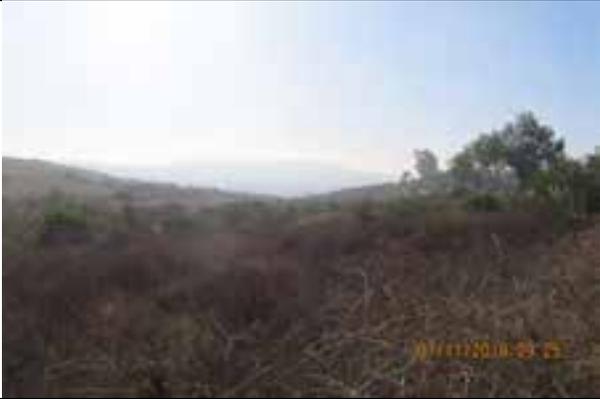
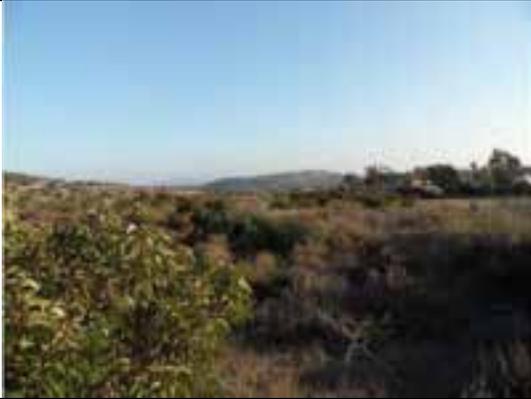
Photo/Observation ID:	TS40		
Date:	07 November 2019		
Latitude:	32.82069444		
Longitude:	-117.0771111		
Bearing (degrees):	70		
Project Area:	Tierrasanta (E-2CB)		
Description:	Located at the intersection of Colina Dorada Drive and Calle de Vida. Good vegetation in the area and no erosion noted.

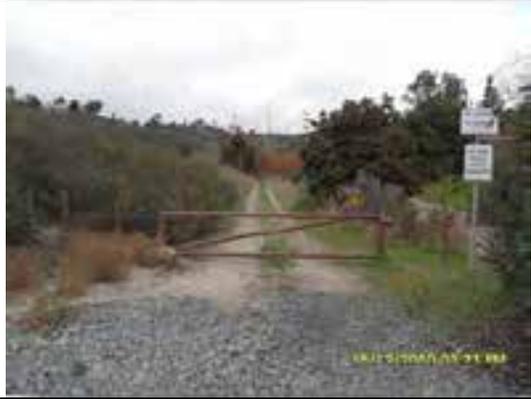
Photo/Observation ID:	TS41		
Date:	07 November 2019		
Latitude:	32.82072222		
Longitude:	-117.0770833		
Bearing (degrees):	150		
Project Area:	Tierrasanta (E-2)		
Description:	Located off Calle de Vida, near the intersection with Colina Dorado Drive. Good vegetation in the area and no erosion observed.

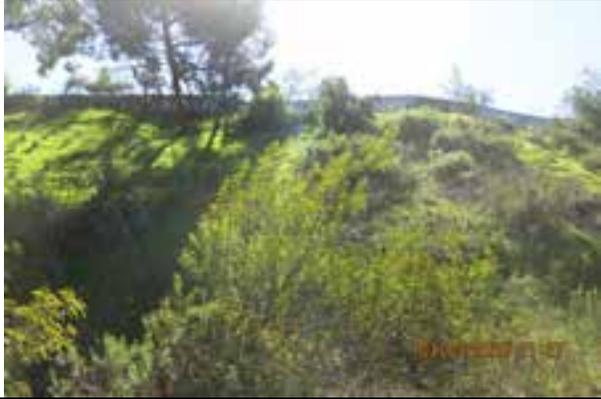
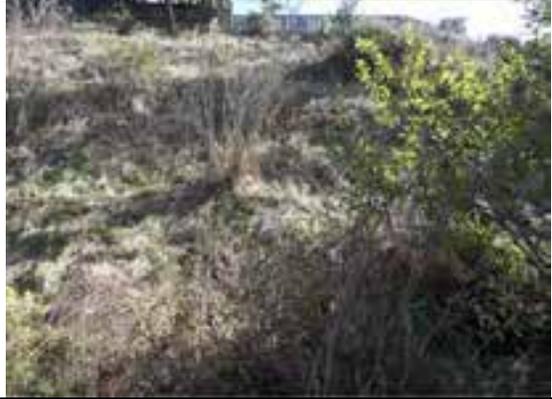
Photo/Observation ID:	TS43		
Date:	03 March 2020		
Latitude:	32.81169444		
Longitude:	-117.0829722		
Bearing (degrees):	100		
Project Area:	Tierrasanta (F-5S)		
Description:	<p>Located at western terminus of Tierrasanta Blvd.</p> <p>Area is vegetated with a graded trail; no signs of erosion. Copperleaf neighborhood (completed in 2012-2013) observed (right side of photo). No MEC warning sign observed at trailhead or down trail.</p>

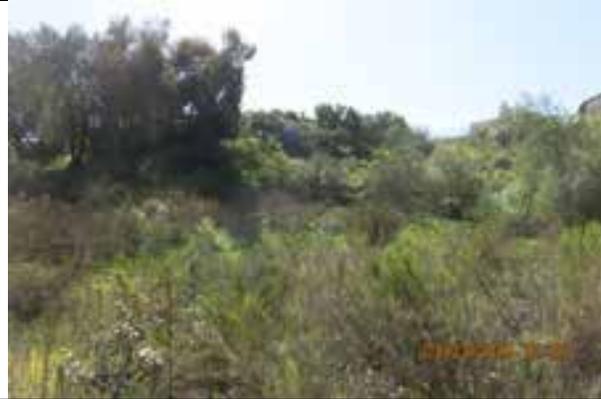
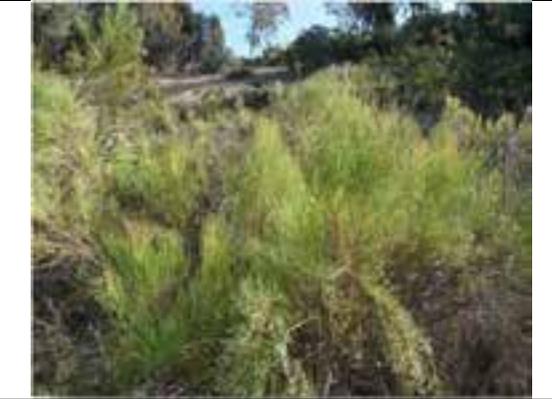
Photo/Observation ID:	TS44		
Date:	03 March 2020		
Latitude:	32.83175		
Longitude:	-117.102		
Bearing (degrees):	150		
Project Area:	Tierrasanta (F-10E)		
Description:	<p>Located on Santo Road, north of Remora Street and down trail from TS67 and sign S-036.</p> <p>Good vegetation on the slope with no erosion noted.</p>

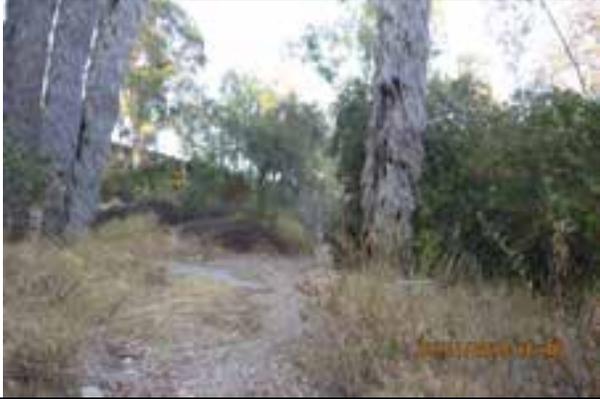
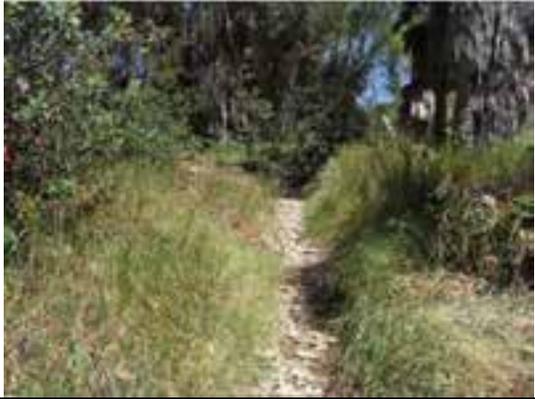
Photo/Observation ID:	TS45		
Date:	03 March 2020		
Latitude:	32.83208333		
Longitude:	-117.0985		
Bearing (degrees):	180		
Project Area:	Tierrasanta (F-10E)		
Description:	<p>Located off the south side of Antigua Blvd and east of Santo Road, on an unpaved trail in Shepherd Canyon.</p> <p>Heavily vegetated slope looking up towards the back of homes. Orientation from previous review could not be duplicated; current photograph matches orientation from Second Five-Year Review.</p>

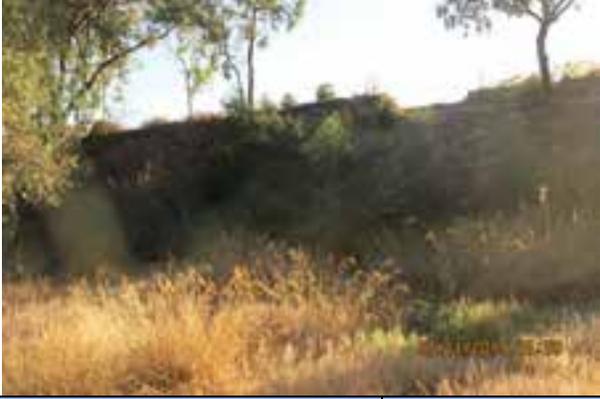
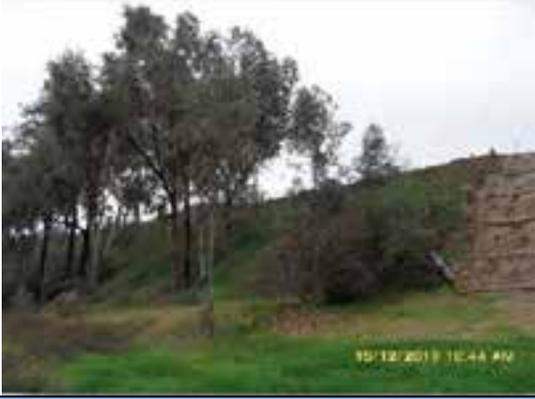
Photo/Observation ID:	TS46		
Date:	07 November 2019		
Latitude:	32.83155556		
Longitude:	-117.1051667		
Bearing (degrees):	44		
Project Area:	Tierrasanta (F-7)		
Description:	<p>Located east of Antigua Blvd, off of Veracruz Court. Observation collected off paved concrete trail and near sign S-041.</p> <p>Erosion noted in the canyon approaching the observation point. Area is vegetated but appears thinner from previous review.</p>

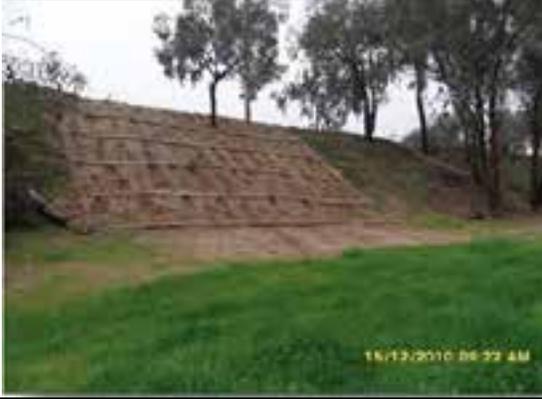
Photo/Observation ID:	TS47		
Date:	07 November 2019		
Latitude:	32.83088889		
Longitude:	-117.1065556		
Bearing (degrees):	160		
Project Area:	Tierrasanta (F-7)		
Description:	<p>Located on the north side of Clairemont Mesa Blvd, between Antigua Blvd and Santo Road.</p> <p>Vegetation appears dry. Serious erosion observed, and erosion control measures appear to be failing on the hillside. See also TS48, TS49, and TS89.</p>

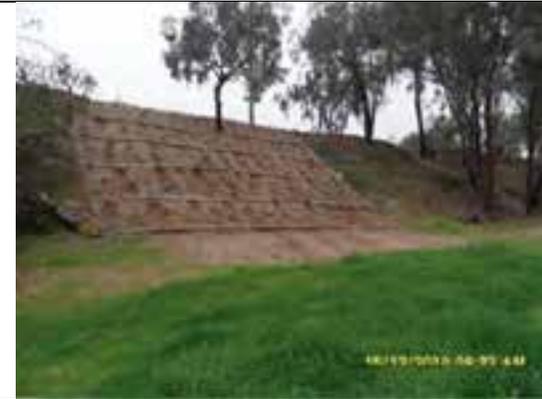
Photo/Observation ID:	TS48
Date:	07 November 2019
Latitude:	32.83088889
Longitude:	-117.1063611
Bearing (degrees):	188
Project Area:	Tierrasanta (F-7)
Description:	<p>Located on the north side of Clairemont Mesa Blvd, between Antigua Blvd and Santo Road.</p> <p>Vegetation appears dry. Serious erosion observed, and erosion control measures appear to be failing on the hillside. See also TS47, TS49, and TS89.</p>

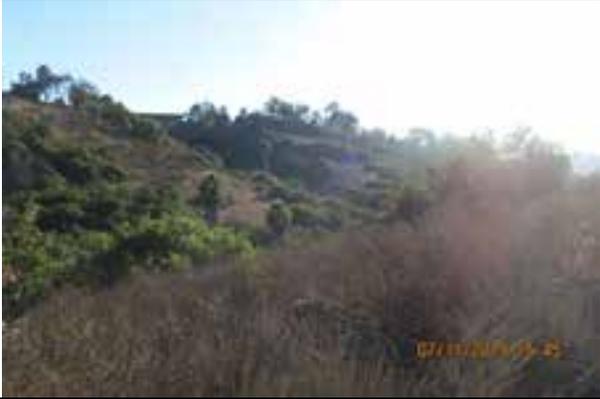
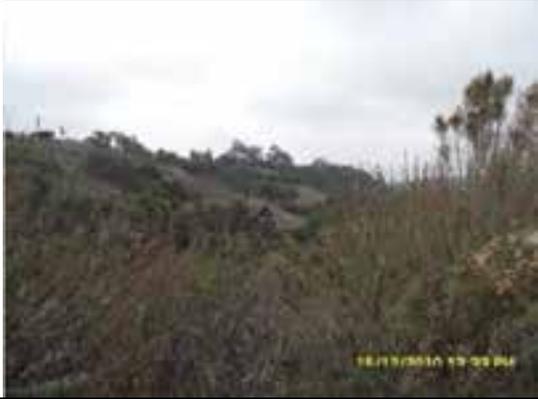
Photo/Observation ID:	TS49
Date:	07 November 2019
Latitude:	32.83086111
Longitude:	-117.1065
Bearing (degrees):	220
Project Area:	Tierrasanta (F-7)
Description:	<p>Located on the north side of Clairemont Mesa Blvd, between Antigua Blvd and Santo Road.</p> <p>Vegetation appears dry. Serious erosion observed, and erosion control measures appear to be failing on the hillside. See also TS47 to TS49.</p>

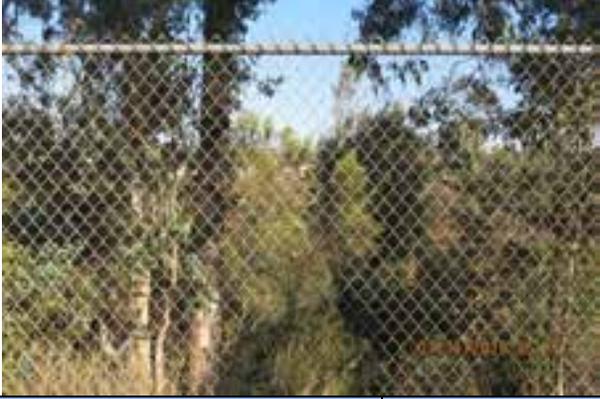
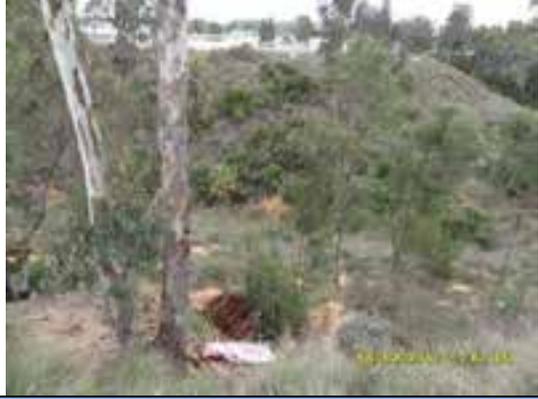
Photo/Observation ID:	TS50		
Date:	07 November 2019		
Latitude:	32.82955556		
Longitude:	-117.1050556		
Bearing (degrees):	195		
Project Area:	Tierrasanta (F-6)		
Description:	<p>Located on the south side of Clairemont Mesa Blvd, just west of Santo Road and across the street from a shopping center.</p> <p>Gated dirt road with no MEC warning sign. Heavy vegetation in area and no erosion noted.</p>

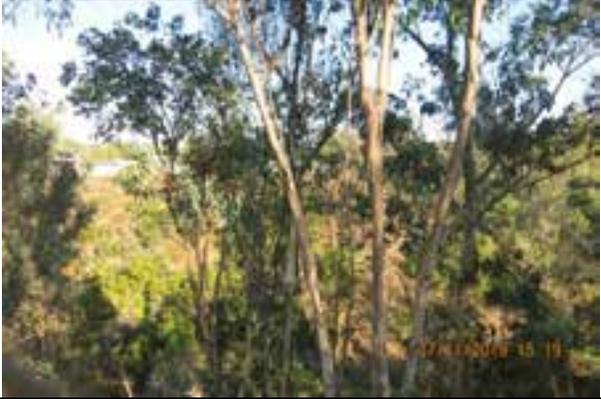
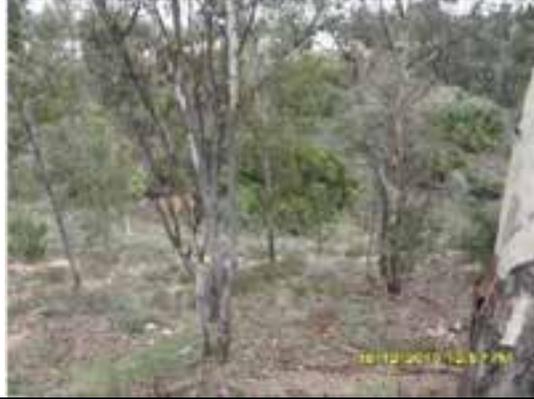
Photo/Observation ID:	TS51		
Date:	07 November 2019		
Latitude:	32.81980556		
Longitude:	-117.1033333		
Bearing (degrees):	70		
Project Area:	Tierrasanta (F-1)		
Description:	<p>Located in the parking lot of Murphy Canyon Youth Center, off Santo Road and Orlec Street.</p> <p>Curb is preventing parking lot runoff from eroding hillside. The slope appears more vegetated than in the previous review. Fence not photographed in previous five-year review.</p>

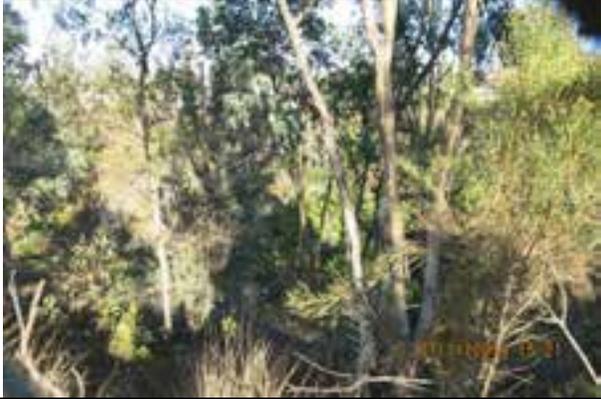
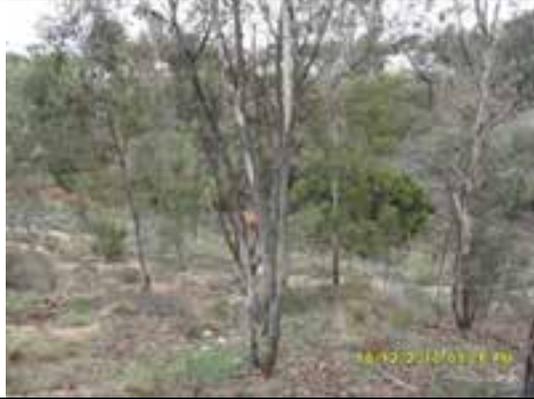
Photo/Observation ID:	TS52
Date:	07 November 2019
Latitude:	32.81961111
Longitude:	-117.1033611
Bearing (degrees):	70
Project Area:	Tierrasanta (F-1)
Description:	<p>Located in the parking lot of Murphy Canyon Youth Center, off Santo Road and Orlec Street.</p> <p>Curb is preventing parking lot runoff from eroding the hillside. The slope appears more vegetated than in the previous review.</p>

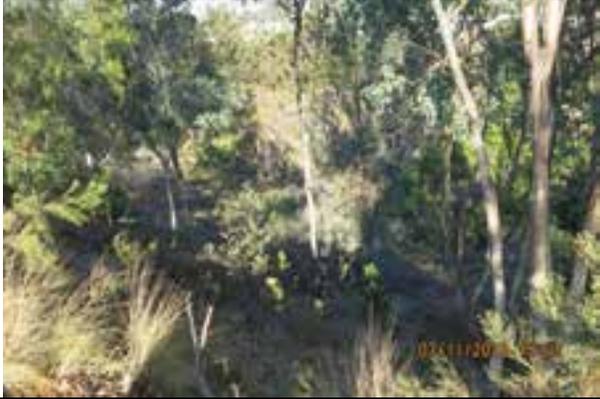
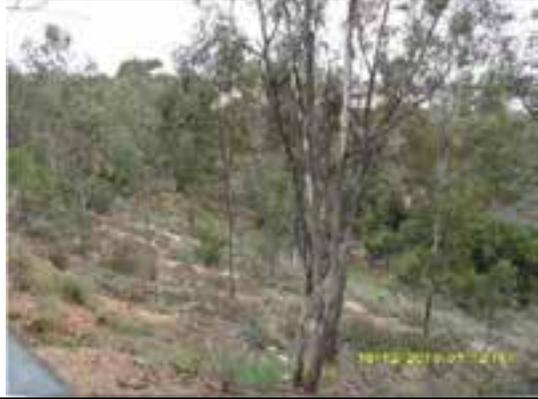
Photo/Observation ID:	TS53
Date:	07 November 2019
Latitude:	32.81961111
Longitude:	-117.1033611
Bearing (degrees):	45
Project Area:	Tierrasanta (F-1)
Description:	<p>Located in the parking lot of Murphy Canyon Youth Center, off Santo Road and Orlec Street.</p> <p>Curb is preventing parking lot runoff from eroding the hillside. The slope appears more vegetated than in the previous review.</p>

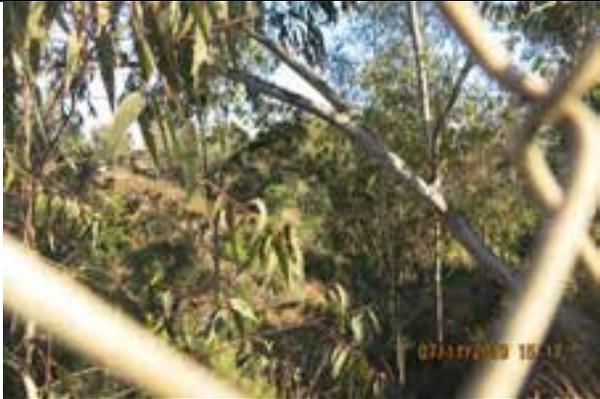
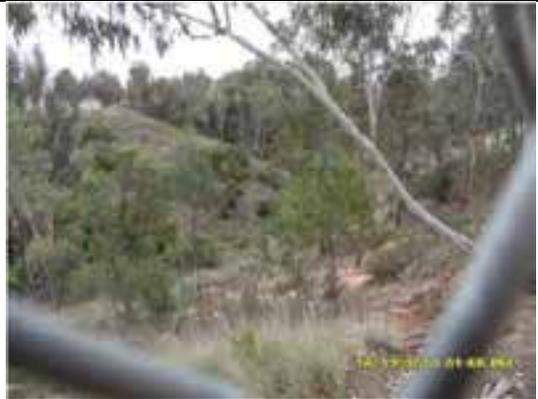
Photo/Observation ID:	TS54		
Date:	07 November 2019		
Latitude:	32.81961111		
Longitude:	-117.1033611		
Bearing (degrees):	22		
Project Area:	Tierrasanta (F-1)		
Description:	<p>Located in the parking lot of Murphy Canyon Youth Center, off Santo Road and Orlec Street.</p> <p>Curb is preventing parking lot runoff from eroding the hillside. The slope appears more vegetated than in the previous review.</p>

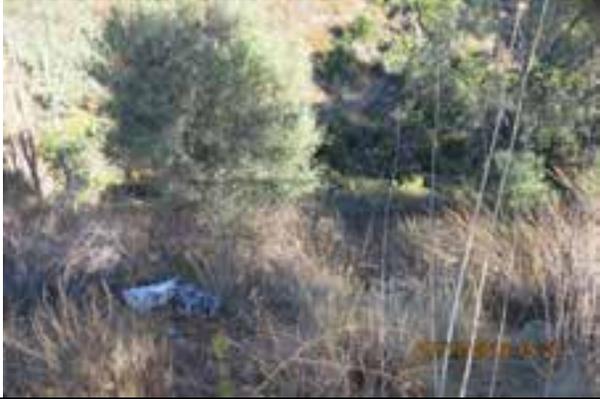
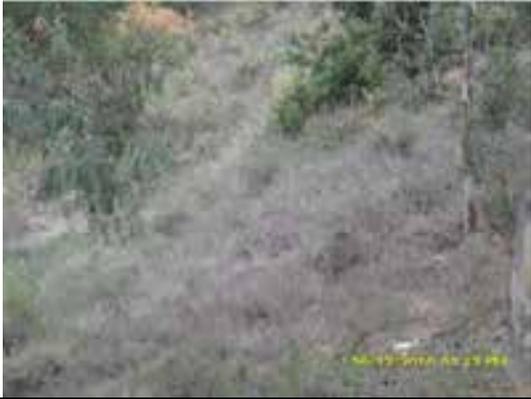
Photo/Observation ID:	TS55		
Date:	07 November 2019		
Latitude:	32.81980556		
Longitude:	-117.1033611		
Bearing (degrees):	125		
Project Area:	Tierrasanta (F-1)		
Description:	<p>Located in the parking lot of Murphy Canyon Youth Center, off Santo Road and Orlec Street. Observation collected at 32.81975, -117.10336 with same bearing as previous review.</p> <p>Curb is preventing parking lot runoff from eroding the hillside. Slope appears more vegetated than in the previous review.</p>

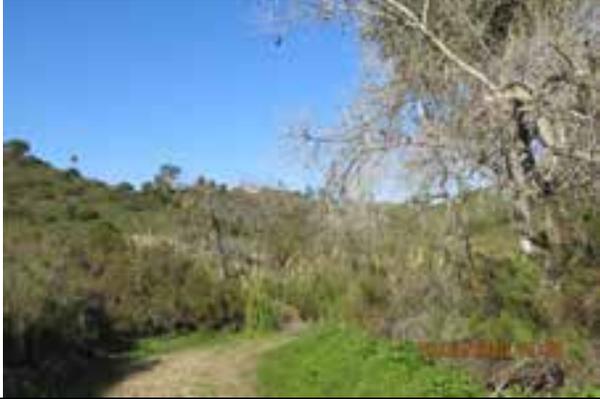
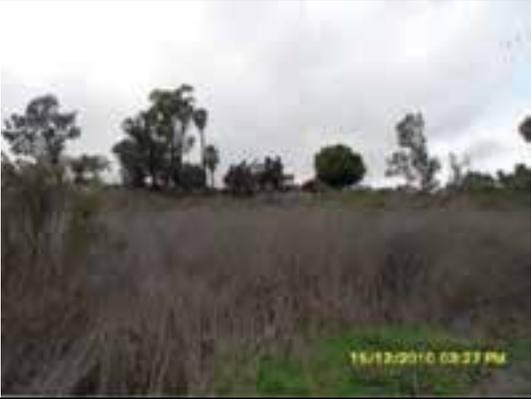
Photo/Observation ID:	TS56		
Date:	07 November 2019		
Latitude:	32.82002778		
Longitude:	-117.1033333		
Bearing (degrees):	70		
Project Area:	Tierrasanta (F-1)		
Description:	<p>Located in the parking lot of Murphy Canyon Youth Center, off Santo Road and Orlec Street.</p> <p>Curb is preventing parking lot runoff from eroding the hillside. Slope appears more vegetated than in the previous review.</p>

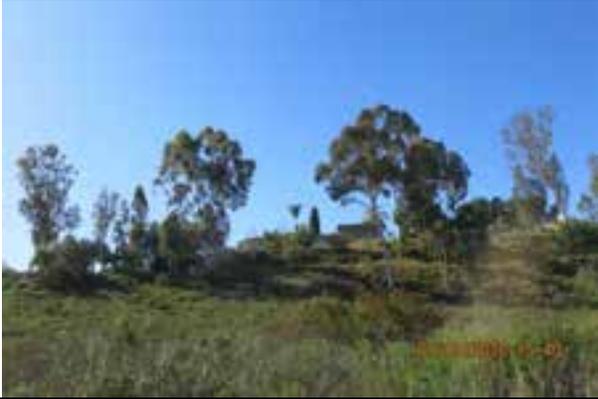
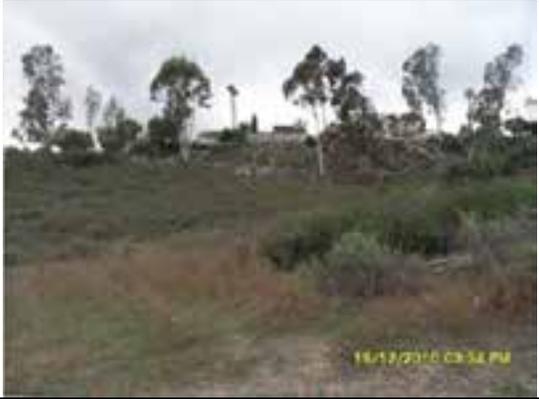
Photo/Observation ID:	TS57		
Date:	03 March 2020		
Latitude:	32.81672222		
Longitude:	-117.0863889		
Bearing (degrees):	56		
Project Area:	Tierrasanta (F-5N)		
Description:	<p>Located down the service road from TS42.</p> <p>Heavy vegetation in the area and no erosion noted. (Note: Field team could not locate the exact orientation of the photo from previous review using coordinates and bearing provided.)</p>

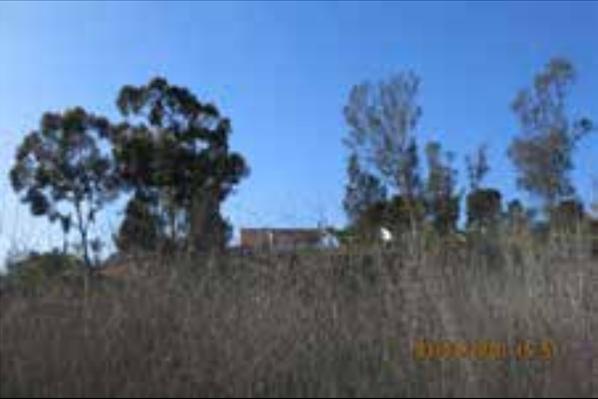
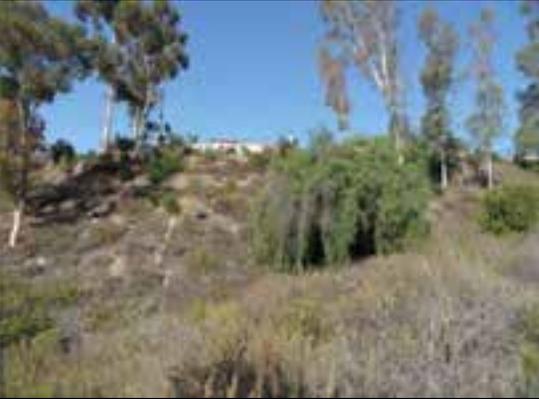
Photo/Observation ID:	TS58		
Date:	03 March 2020		
Latitude:	32.81730556		
Longitude:	-117.0858333		
Bearing (degrees):	290		
Project Area:	Tierrasanta (F-5N)		
Description:	<p>Located down the service road from TS42.</p> <p>The area is heavily vegetated; no erosion noted.</p>

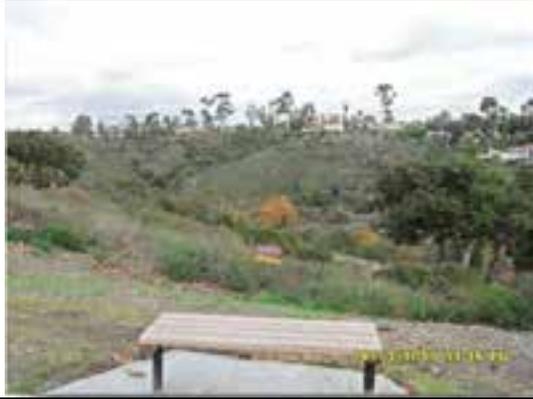
Photo/Observation ID:	TS59		
Date:	03 March 2020		
Latitude:	32.81802778		
Longitude:	-117.0860833		
Bearing (degrees):	284		
Project Area:	Tierrasanta (F-2W)		
Description:	<p>Located down the service road from TS42.</p> <p>Due to heavy vegetation in the area, the observation was collected off the service road ~180 feet south of coordinates provided in previous review at 32.817679, -117.985661 with the same bearing. No erosion noted.</p>

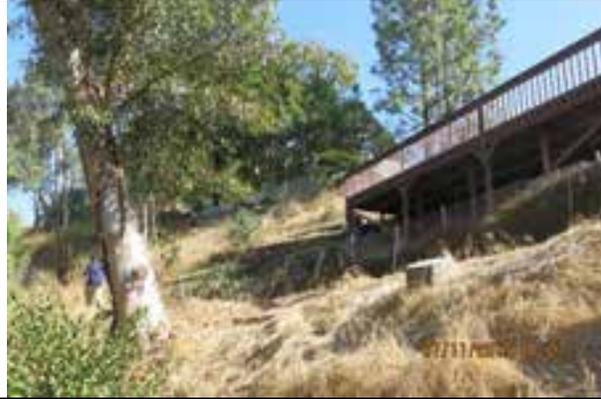
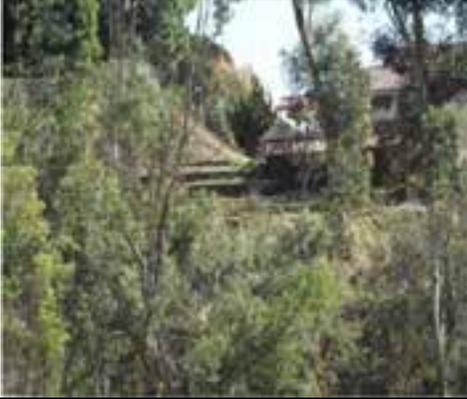
Photo/Observation ID:	TS60		
Date:	07 November 2019		
Latitude:	32.82030556		
Longitude:	-117.0954167		
Bearing (degrees):	55		
Project Area:	Tierrasanta (F-2W)		
Description:	<p>Located behind apartments near the intersection of Ducos Place and Tierrasanta Blvd.</p> <p>MEC warning sign no longer present; bench and concrete pad have also been removed. Some erosion noted down the slope.</p>

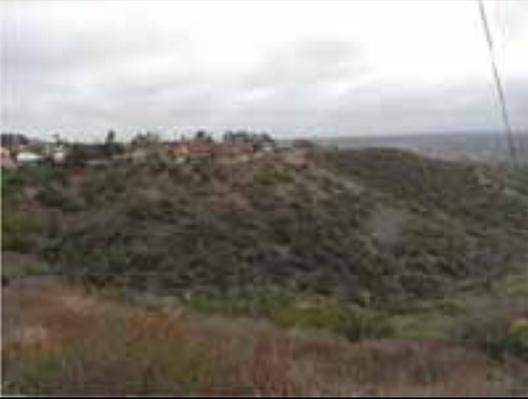
Photo/Observation ID:	TS61		
Date:	07 November 2019		
Latitude:	32.82180556		
Longitude:	-117.0843611		
Bearing (degrees):	40		
Project Area:	Tierrasanta (F-5N)		
Description:	<p>Observation collected on what appears to be a faint (social) trail on the canyon slope.</p> <p>Heavy vegetation prevented access to the exact location of the previous review.</p>

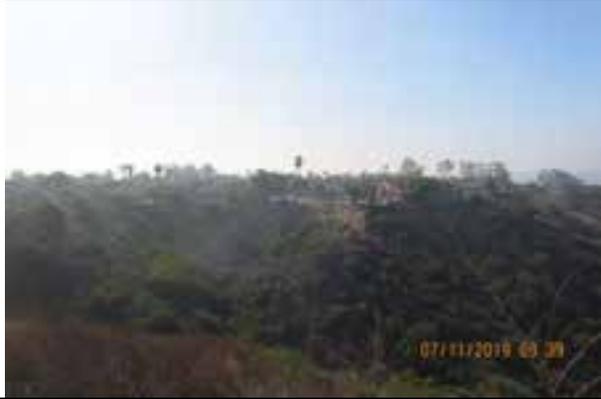
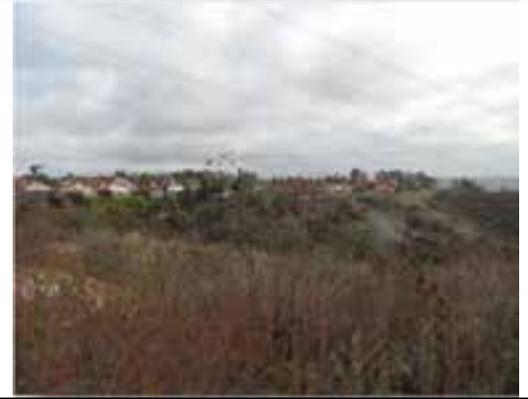
Photo/Observation ID:	TS62		
Date:	07 November 2019		
Latitude:	32.82191667		
Longitude:	-117.07975		
Bearing (degrees):	182		
Project Area:	Tierrasanta (F-5N)		
Description:	<p>Located on the south side of Calle de Vida, off of a trail/service road that leads into Elanus Canyon.</p> <p>No MEC warning sign observed. Sides of canyon are vegetated. Survey stakes present at the observation point. Fog is obscuring the image.</p>

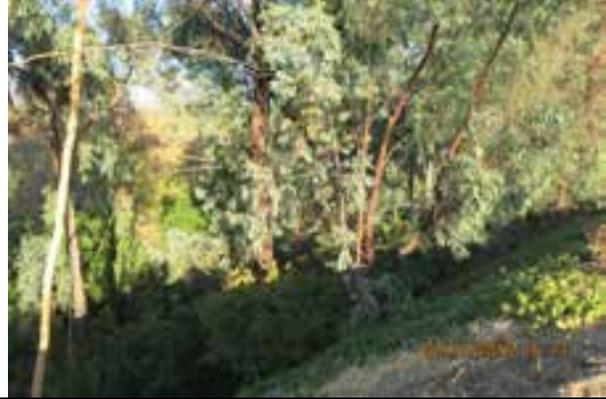
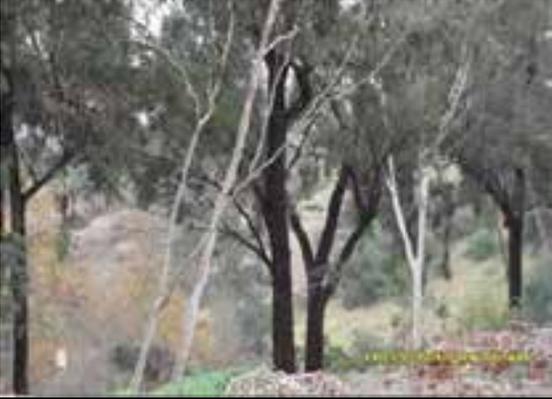
Photo/Observation ID:	TS63		
Date:	07 November 2019		
Latitude:	32.82191667		
Longitude:	-117.07975		
Bearing (degrees):	150		
Project Area:	Tierrasanta (F-5N)		
Description:	<p>Located on the south side of Calle de Vida, off of trail/service road that leads into Elanus Canyon.</p> <p>No MEC warning sign observed. Sides of canyon are vegetated, but minor erosion noted below the house across canyon from observation point.</p>

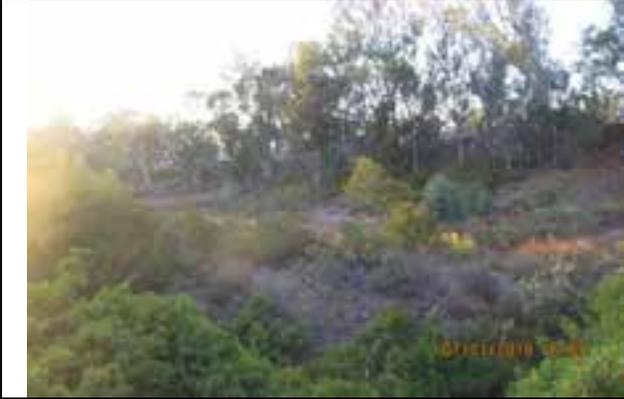
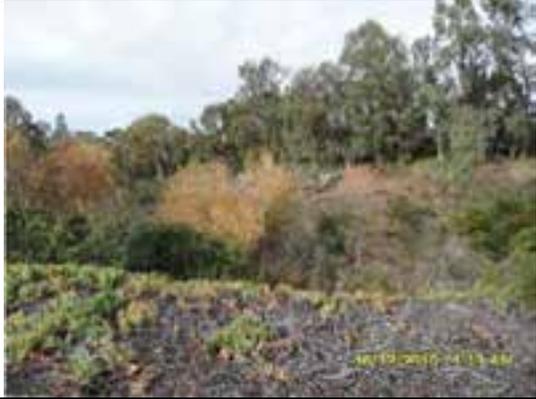
Photo/Observation ID:	TS65		
Date:	03 March 2020		
Latitude:	32.83141667		
Longitude:	-117.10275		
Bearing (degrees):	240		
Project Area:	Tierrasanta (F-7)		
Description:	<p>Taken from sidewalk off of Santo Road, north of intersection with Remore Street.</p> <p>Heavy vegetation with no signs of erosion. A faint (social) trail observed going into the canyon.</p>

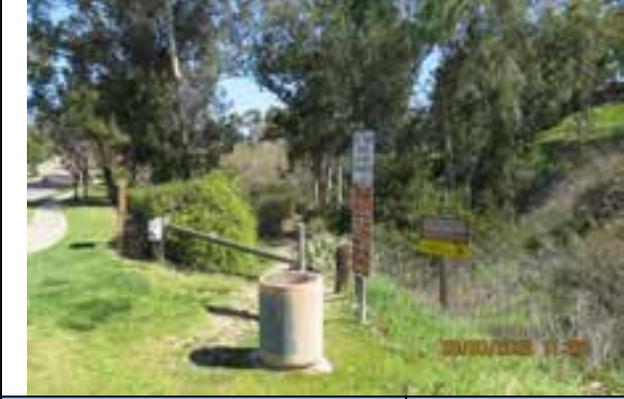
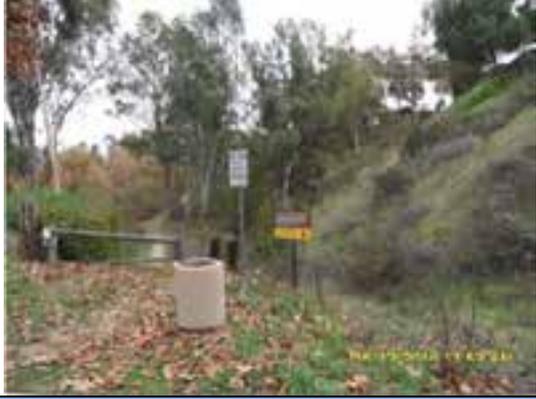
Photo/Observation ID:	TS66		
Date:	07 November 2019		
Latitude:	32.83236111		
Longitude:	-117.1021944		
Bearing (degrees):	255		
Project Area:	Tierrasanta (F-7)		
Description:	<p>Taken from sidewalk off of Santo Road, south of intersection with Antigua Blvd; looking at West Shepherd Canyon Trail.</p> <p>Vegetation is heavier on canyon sides than previous review; no erosion noted.</p>

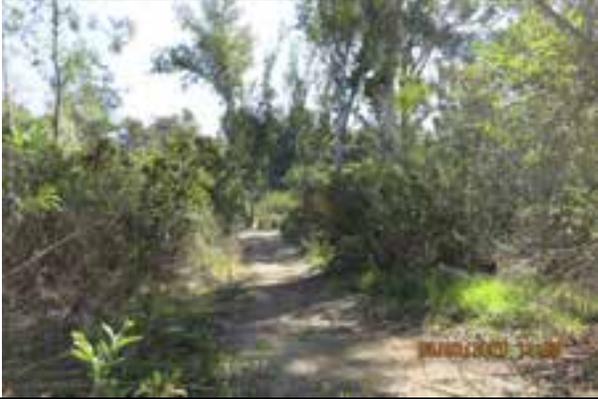
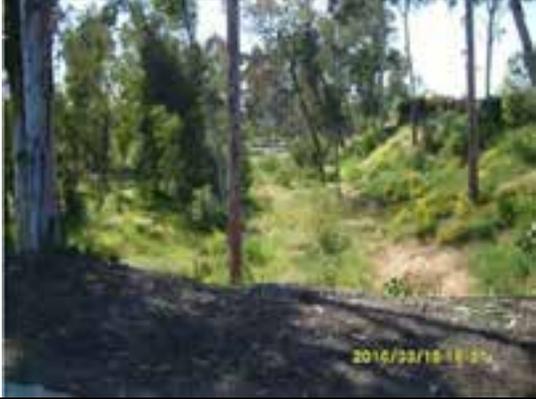
Photo/Observation ID:	TS67		
Date:	03 March 2020		
Latitude:	32.83161111		
Longitude:	-117.10225		
Bearing (degrees):	40		
Project Area:	Tierrasanta (F-10E)		
Description:	<p>Located off of Santo Road, at a trailhead for Shepherd Canyon.</p> <p>Good vegetation in the area with no erosion noted. Sign S-036 is in good condition. Location of sign is visible.</p>

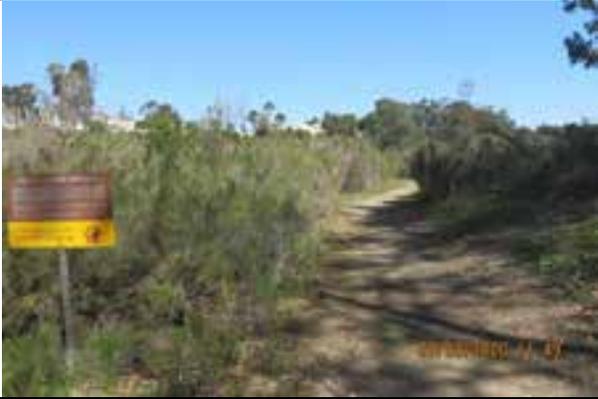
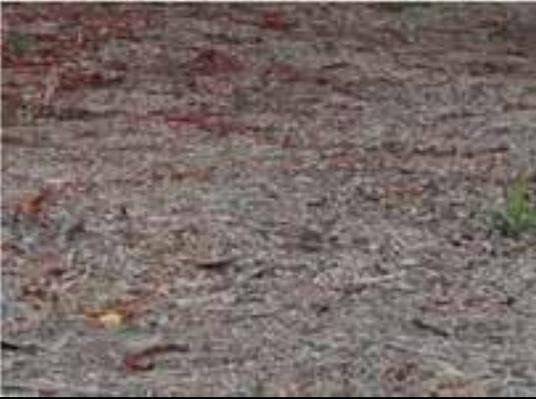
Photo/Observation ID:	TS68		
Date:	03 March 2020		
Latitude:	32.83255556		
Longitude:	-117.0993056		
Bearing (degrees):	150		
Project Area:	Tierrasanta (F-10E)		
Description:	Area on either side of the trail is heavily vegetated and no erosion noted. Observation collected just past sign S-104

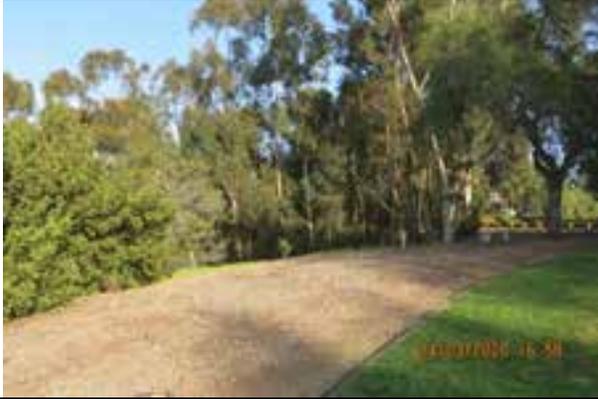
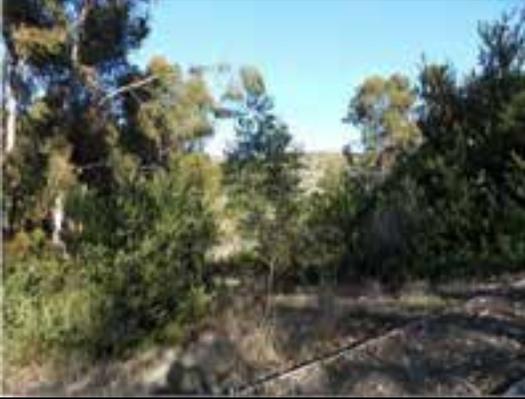
Photo/Observation ID:	TS69		
Date:	03 March 2020		
Latitude:	32.83347222		
Longitude:	-117.09975		
Bearing (degrees):	355		
Project Area:	Tierrasanta (EF-10E)		
Description:	<p>Located at a trailhead for Lower North Shepherd Canyon Trail, next to Villa Colina housing complex.</p> <p>Trail is no longer covered in mulch, as shown in the previous review. Vegetation on both sides of the trail; no erosion observed. Sign S-112 is in a visible location but is fading.</p>

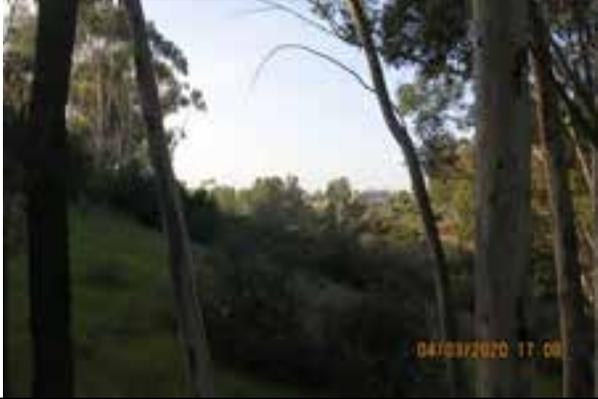
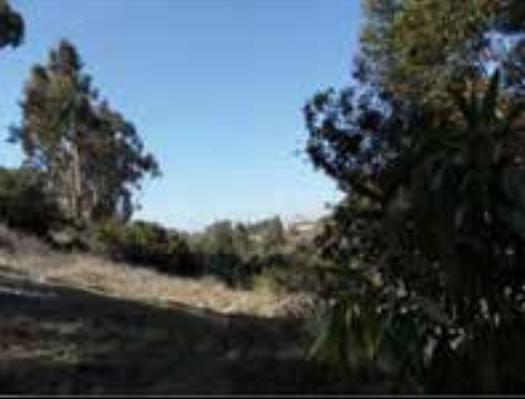
Photo/Observation ID:	TS70		
Date:	04 March 2020		
Latitude:	32.82925		
Longitude:	-117.0828333		
Bearing (degrees):	45		
Project Area:	Tierrasanta (F-10M)		
Description:	<p>Located at the intersection of Via Valarta and Via Dominique.</p> <p>Area appears to be newly landscaped as part of the Villa Dominique townhome development. There are signs of erosion in the canyon along with large amounts of trash.</p>

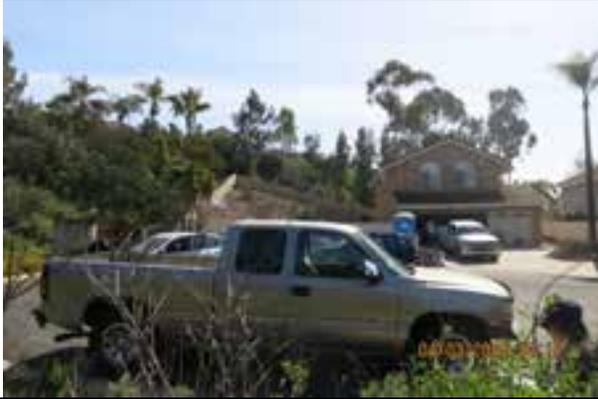
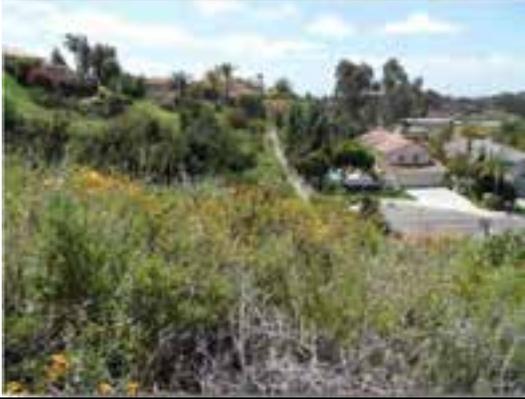
Photo/Observation ID:	TS71		
Date:	04 March 2020		
Latitude:	32.83013889		
Longitude:	-117.0836944		
Bearing (degrees):	310		
Project Area:	Tierrasanta (F-10E)		
Description:	<p>Located on an unpaved trail off of Via Valarta, next to Seventh Day Adventist Church.</p> <p>The areas surrounding the trail are covered with grassy vegetation and eucalyptus trees. Heavy vegetation noted in the canyon. Erosion was noted on the trail. This location is down trail from sign S-021.</p>

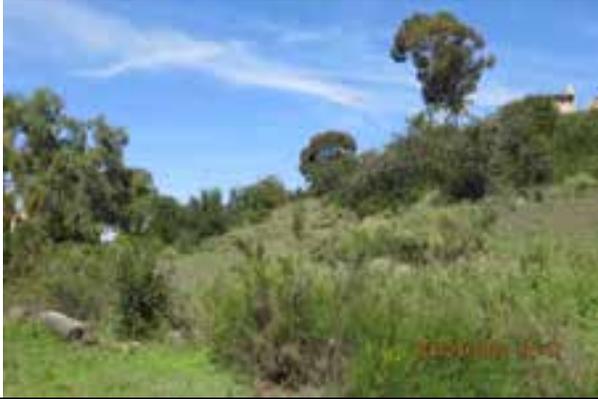
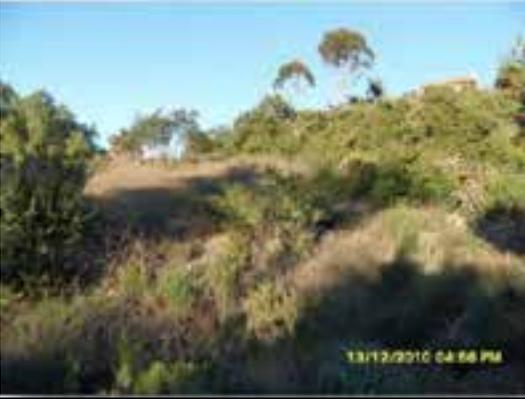
Photo/Observation ID:	TS72		
Date:	04 March 2020		
Latitude:	32.83427778		
Longitude:	-117.08375		
Bearing (degrees):	185		
Project Area:	Tierrasanta (C-5)		
Description:	<p>Photo taken in the cul-de-sac of Corte Playa De Cortes at 32.834091, -117.083992, approximately 100 feet southwest from previous five-year review, due to heavy vegetation and slope of hillside.</p> <p>The hillside behind photo is heavily vegetated (see TS73).</p>

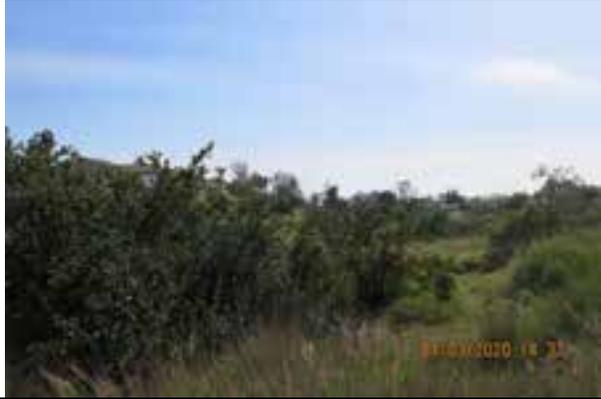
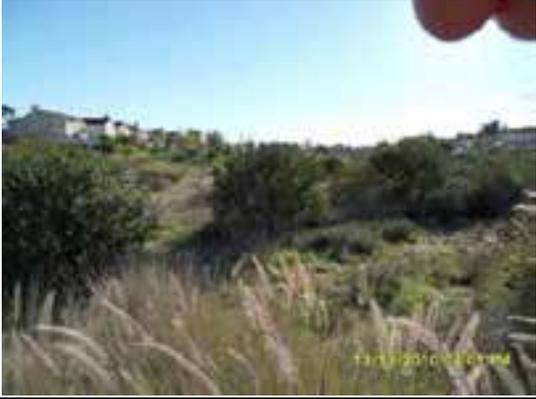
Photo/Observation ID:	TS73		
Date:	04 March 2020		
Latitude:	32.83422222		
Longitude:	-117.08425		
Bearing (degrees):	10		
Project Area:	Tierrasanta (C-5)		
Description:	<p>Photo taken in same area as TS72.</p> <p>Hillside is heavily vegetated and no erosion noted. Vegetation appears much denser than the previous review.</p>

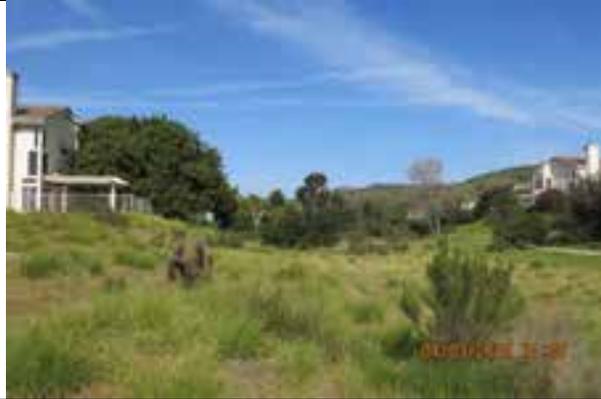
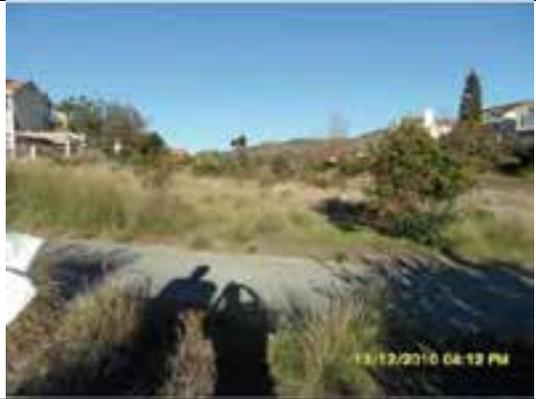
Photo/Observation ID:	TS74		
Date:	04 March 2020		
Latitude:	32.83705556		
Longitude:	-117.0844167		
Bearing (degrees):	190		
Project Area:	Tierrasanta (C-4)		
Description:	<p>Located on a gravel trail between Avenida Playa Cancun and Via Playa De Cortes.</p> <p>Good vegetation in area and no erosion noted.</p>

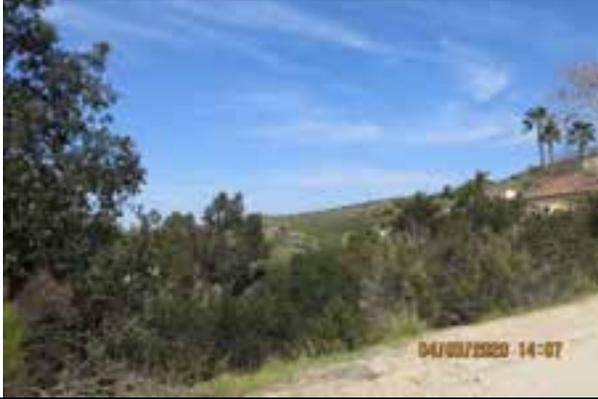
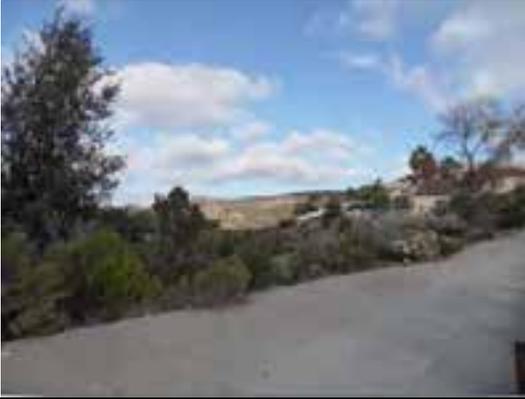
Photo/Observation ID:	TS75		
Date:	04 March 2020		
Latitude:	32.83705556		
Longitude:	-117.0844167		
Bearing (degrees):	40		
Project Area:	Tierrasanta (C-4)		
Description:	<p>Same area as TS74.</p> <p>Good vegetation and no erosion noted.</p>
