Fourth Five-Year Review Report

**Former Camp Elliott-Tierrasanta, Project Number J09CA006701
Former Camp Elliott-Mission Trails, Project Number J09CA006702
San Diego, California**

Date: 7 September 2021

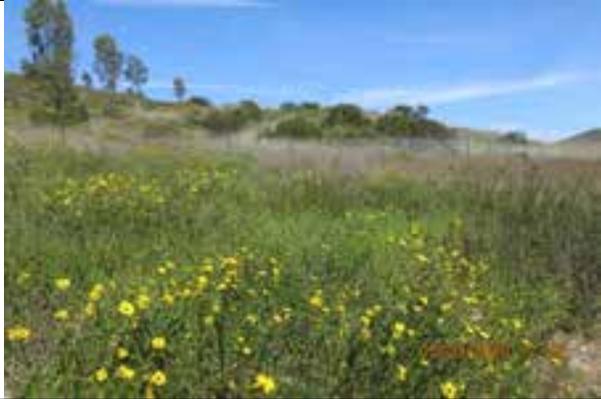
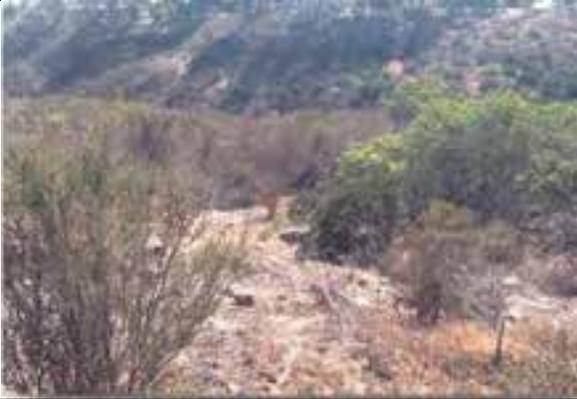
Photo/Observation ID:	TS76		
Date:	04 March 2020		
Latitude:	32.83772222		
Longitude:	-117.0825278		
Bearing (degrees):	35		
Project Area:	Tierrasanta (C-4)		
Description:	<p>Located near the intersection of Playa De Cortes and Corte Playa San Juan.</p> <p>Heavily vegetated area; no erosion observed.</p>

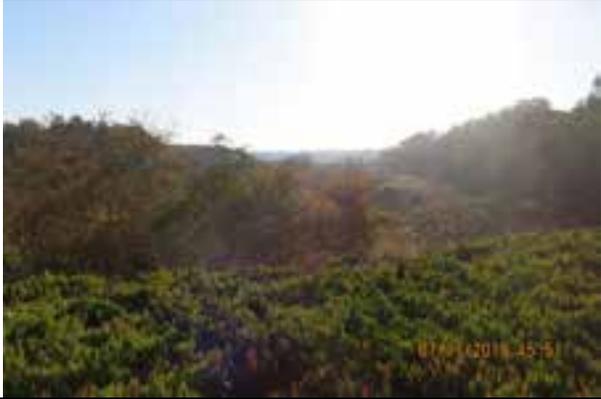
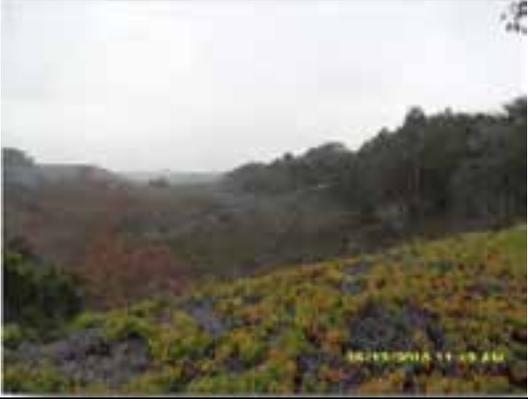
Photo/Observation ID:	TS77		
Date:	05 March 2020		
Latitude:	32.84280556		
Longitude:	-117.0825		
Bearing (degrees):	210		
Project Area:	Tierrasanta (C-2)		
Description:	<p>Located near the Portobelo entrance to Mission Trails Regional Park.</p> <p>Vegetation growth has improved in area; no erosion noted.</p>

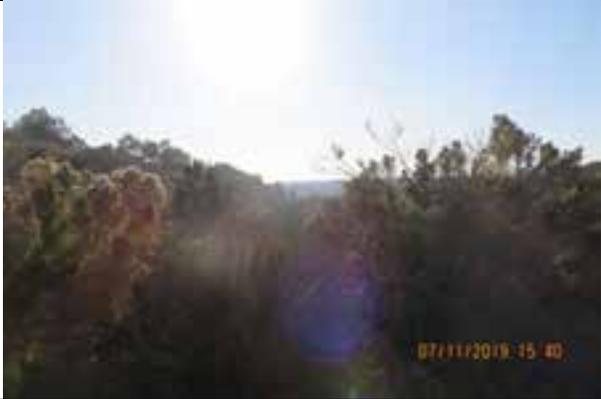
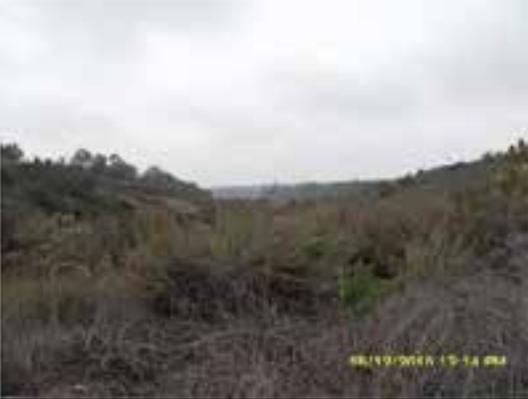
Photo/Observation ID:	TS78		
Date:	07 November 2019		
Latitude:	32.83041667		
Longitude:	-117.1068611		
Bearing (degrees):	212		
Project Area:	Tierrasanta (F-6)		
Description:	<p>Located off Clairemont Mesa Blvd between Antigua Blvd and Santo Rd.</p> <p>Good vegetation in the area; no erosion noted.</p>

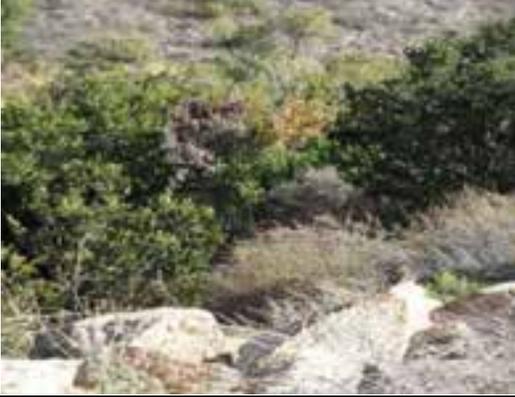
Photo/Observation ID:	TS79		
Date:	07 November 2019		
Latitude:	32.82941667		
Longitude:	-117.1041667		
Bearing (degrees):	230		
Project Area:	Tierrasanta (F-6)		
Description:	<p>Located on the south side of Clairemont Mesa Blvd, just west of Santo Road.</p> <p>Good vegetation growth; denser than the previous review. No erosion noted.</p>

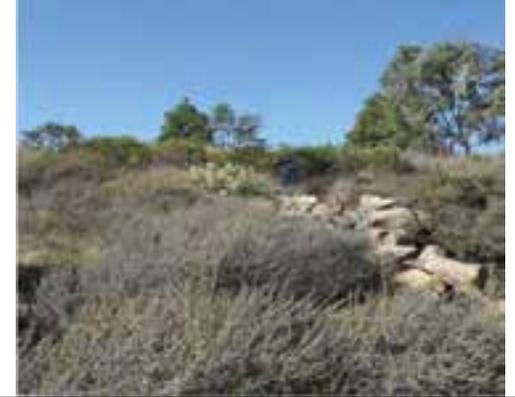
Photo/Observation ID:	TS80
Date:	07 November 2019
Latitude:	32.81816667
Longitude:	-117.1036111
Bearing (degrees):	352
Project Area:	Tierrasanta (F-1)
Description:	<p>Located behind a fence and locked gate; observation point could not be accessed.</p> <p>See TS88, which is ~251 feet north of observation point.</p>

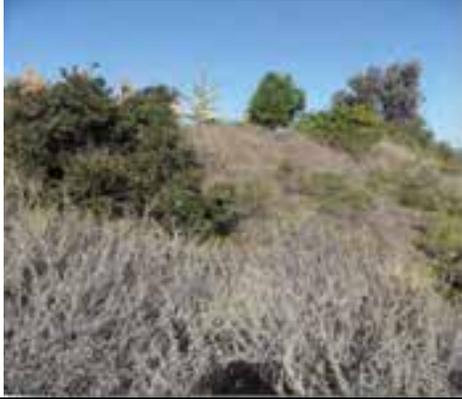
Photo/Observation ID:	TS81
Date:	07 November 2019
Latitude:	32.81816667
Longitude:	-117.1034444
Bearing (degrees):	270
Project Area:	Tierrasanta (F-1)
Description:	<p>Located behind a fence and locked gate; observation point could not be accessed.</p> <p>See TS88, which is ~228 feet north of observation point.</p>

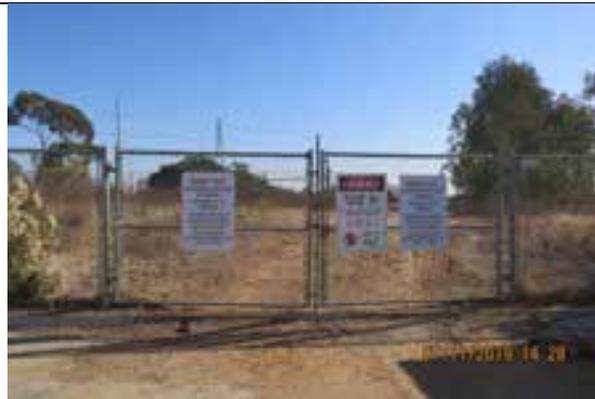
Photo/Observation ID:	TS86
Date:	07 November 2019
Latitude:	32.80183
Longitude:	-117.10454
Bearing (degrees):	90°
Project Area:	Tierrasanta (OA-1)
Description:	New observation collected to document fenced area at Murphy Canyon Child Development Center with UXO warning sign.

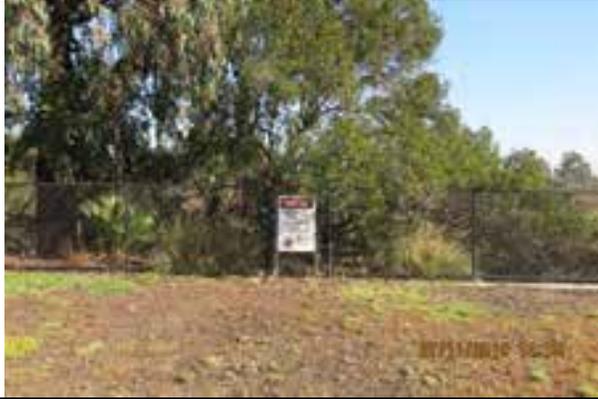
Photo/Observation ID:	TS87
Date:	07 November 2019
Latitude:	32.80320
Longitude:	-117.10462
Bearing (degrees):	135°
Project Area:	Tierrasanta (OA-1)
Description:	New observation collected to document fence and locked gate with UXO warning sign next to YMCA blocking access to TS17 or TS18.

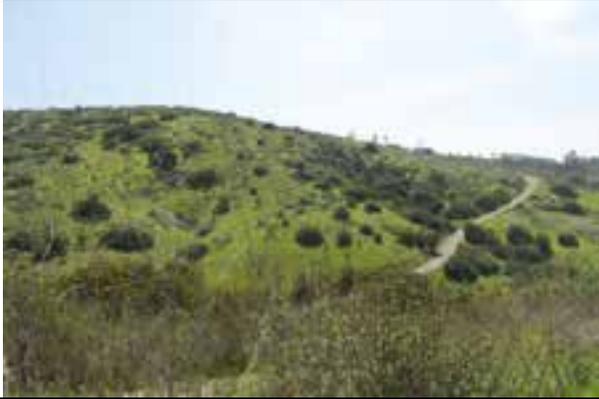
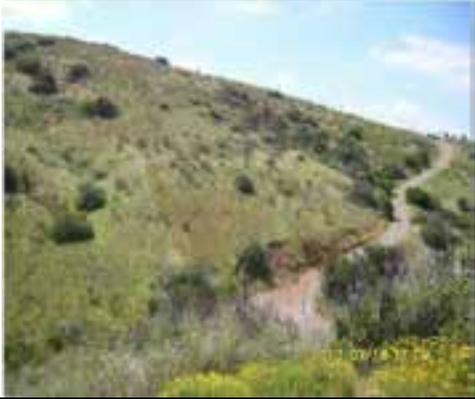
Photo/Observation ID:	TS89
Date:	07 November 2019
Latitude:	32.83058
Longitude:	-117.10661
Bearing (degrees):	10°
Project Area:	Tierrasanta (F-7)
Description:	Photo taken from sidewalk off Clairemont Mesa Boulevard. Preventative soil control measure is failing (see TS47 and TS48).

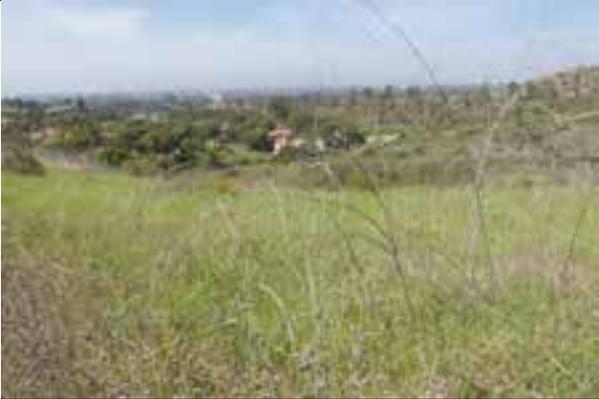
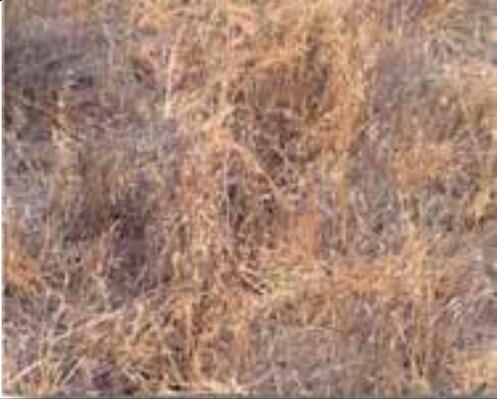
Photo/Observation ID:	MT01		
Date:	04 March 2020		
Latitude:	32.84111111		
Longitude:	-117.0788889		
Bearing (degrees):	125		
Project Area:	Mission Trails		
Description:	<p>Due to tall grass and ground slope, observation collected from trail at 32.841363, -117.079161 (~120 feet northwest from previous review).</p> <p>Improved vegetation in area; no erosion observed.</p>

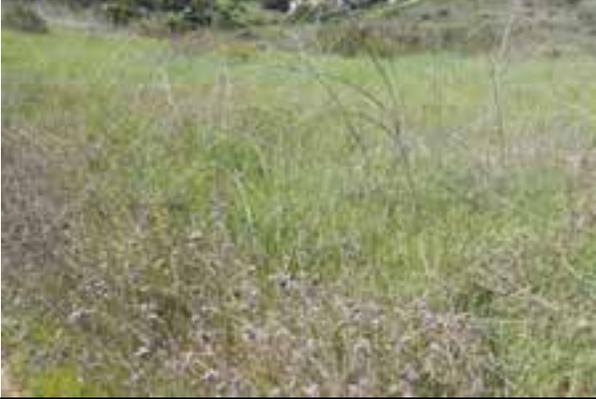
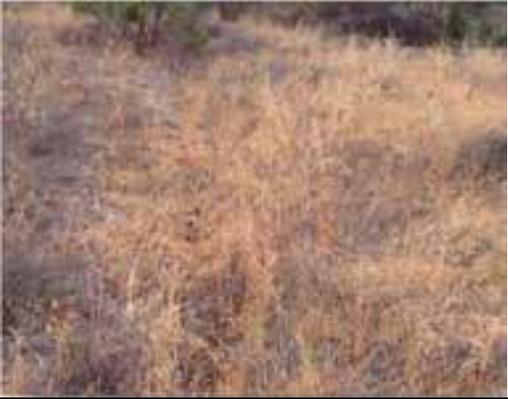
Photo/Observation ID:	MT02		
Date:	04 March 2020		
Latitude:	32.84163889		
Longitude:	-117.0791389		
Bearing (degrees):	240		
Project Area:	Mission Trails		
Description:	<p>Due to tall grass and ground slope, observation collected from trail at 32.841507, -117.079114 (~50 feet south from previous review).</p> <p>Improved vegetation in area; no erosion noted.</p>

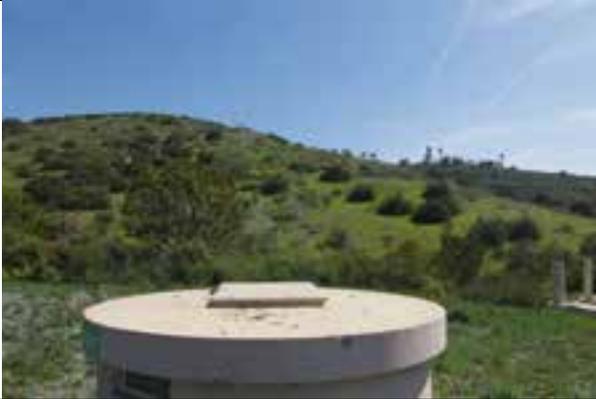
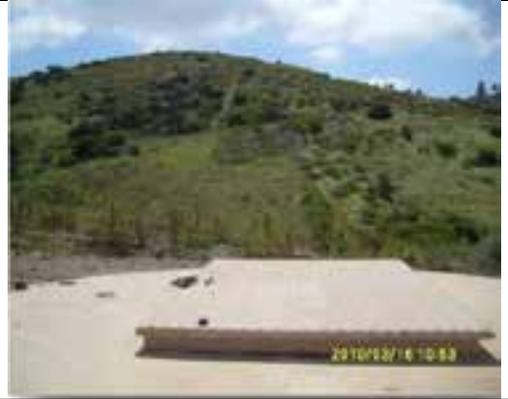
Photo/Observation ID:	MT03		
Date:	04 March 2020		
Latitude:	32.84163889		
Longitude:	-117.0791389		
Bearing (degrees):	240		
Project Area:	Mission Trails		
Description:	Due to tall grass and ground slope, observation collected from trail (approximately ~50 feet south from previous review). Improved vegetation in area; no erosion noted.

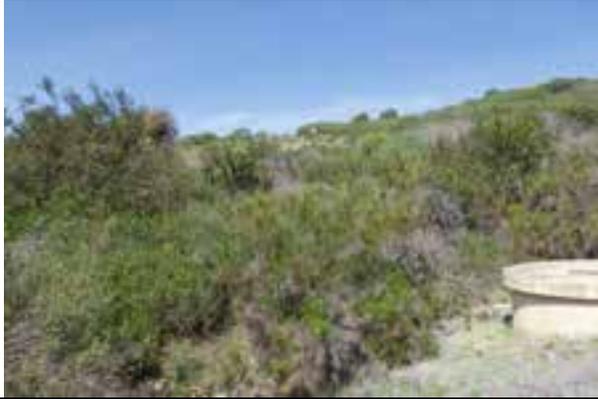
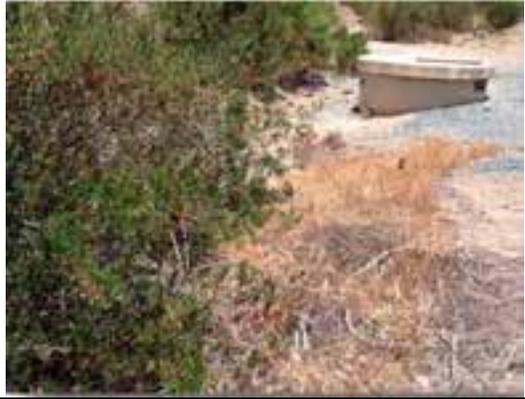
Photo/Observation ID:	MT04		
Date:	04 March 2020		
Latitude:	32.84027778		
Longitude:	-117.0804167		
Bearing (degrees):	162		
Project Area:	Mission Trails		
Description:	Improved vegetation in Shepherd Canyon; no erosion noted.

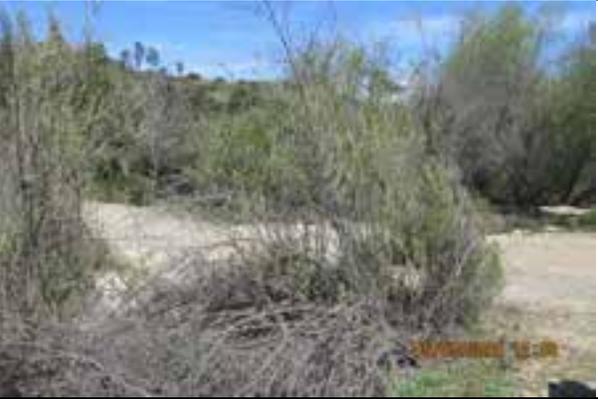
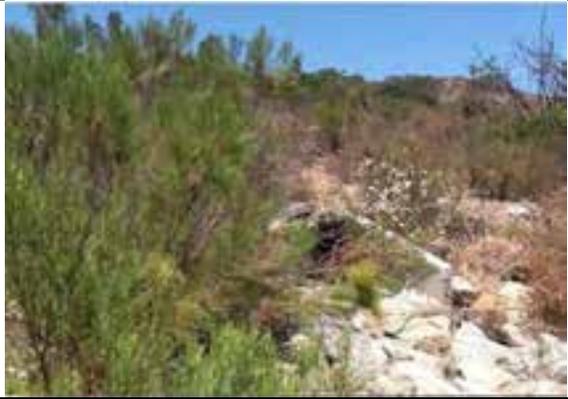
Photo/Observation ID:	MT05		
Date:	04 March 2020		
Latitude:	32.84002778		
Longitude:	-117.0800278		
Bearing (degrees):	340		
Project Area:	Mission Trails		
Description:	Improved vegetation in former erosion area.

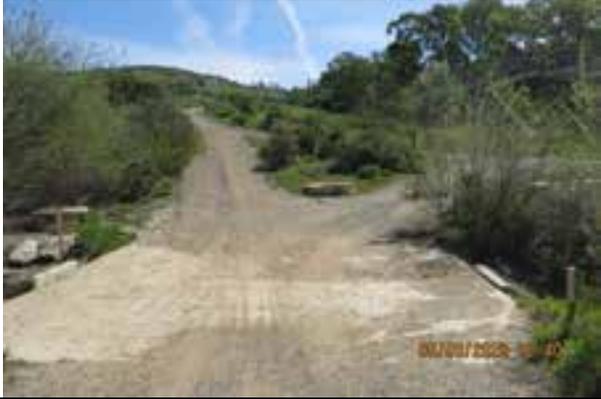
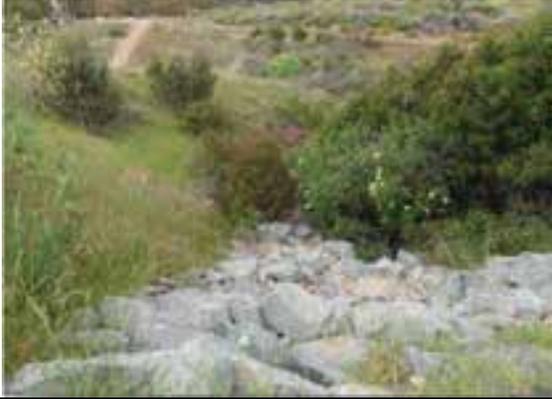
Photo/Observation ID:	MT06		
Date:	05 March 2020		
Latitude:	32.84227778		
Longitude:	-117.0824167		
Bearing (degrees):	18		
Project Area:	Mission Trails		
Description:	Field team could not access location of observation from previous review due to heavy vegetation around culvert; observation collected at 32.841965, -117.082491 with the same bearing.

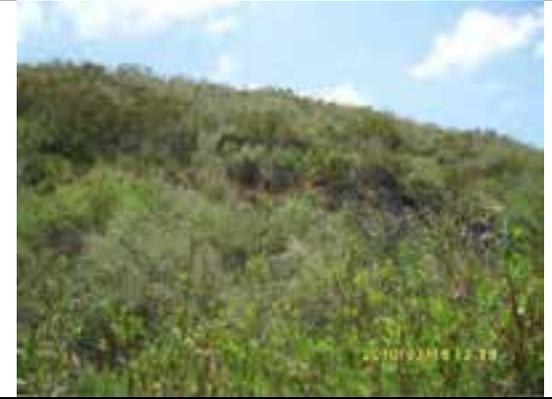
Photo/Observation ID:	MT07		
Date:	05 March 2020		
Latitude:	32.84227778		
Longitude:	-117.0824167		
Bearing (degrees):	135		
Project Area:	Mission Trails		
Description:	Bridge with intact culvert. Healthy vegetation in area. Observation collected at 32.842115, -117.082481.

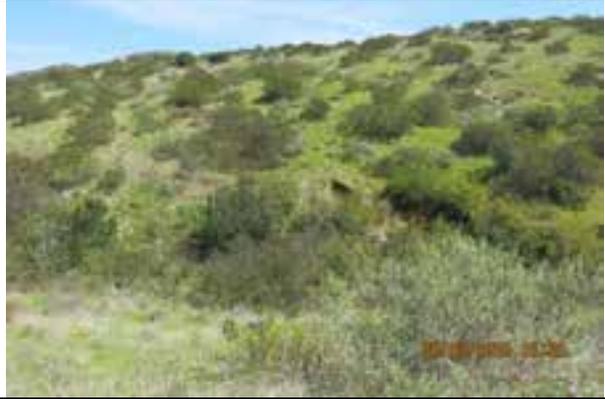
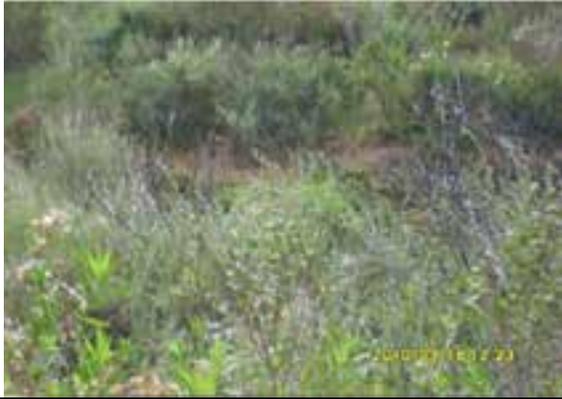
Photo/Observation ID:	MT08		
Date:	05 March 2020		
Latitude:	32.84844444		
Longitude:	-117.0735		
Bearing (degrees):	128		
Project Area:	Mission Trails		
Description:	Good vegetation on sloped hillside; no erosion noted.

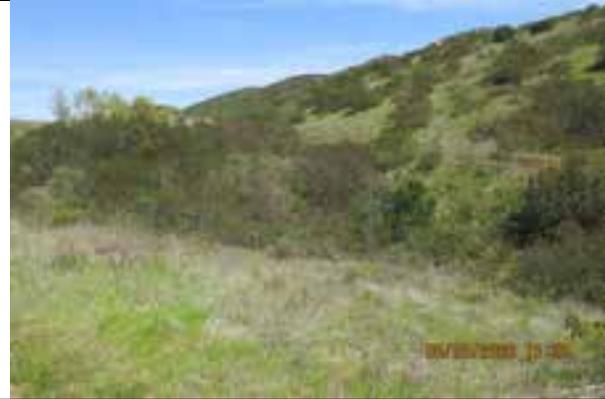
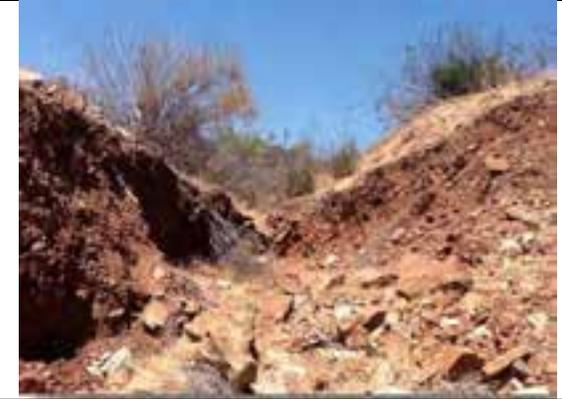
Photo/Observation ID:	MT09		
Date:	05 March 2020		
Latitude:	32.84844444		
Longitude:	-117.0735		
Bearing (degrees):	90		
Project Area:	Mission Trails		
Description:	<p>Located in Shepherd Canyon.</p> <p>Heavily vegetated hillside. Some erosion noted on slopes of drainage ditch.</p>

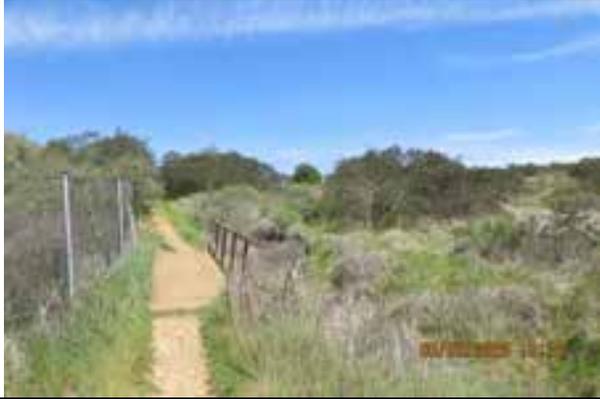
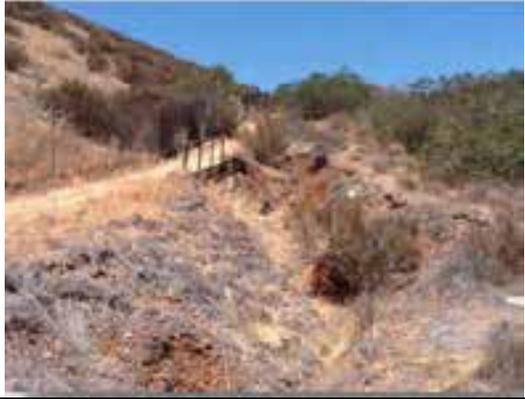
Photo/Observation ID:	MT10		
Date:	05 March 2020		
Latitude:	32.84841667		
Longitude:	-117.0730833		
Bearing (degrees):	0		
Project Area:	Mission Trails		
Description:	<p>Observation collected from trail, ~110 feet west from washout shown in previous review with bearing 62°.</p> <p>The drainage way was observed in the distance; improved vegetation overall in area.</p>

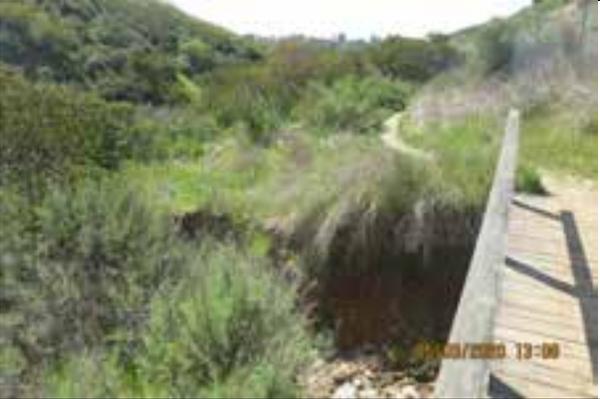
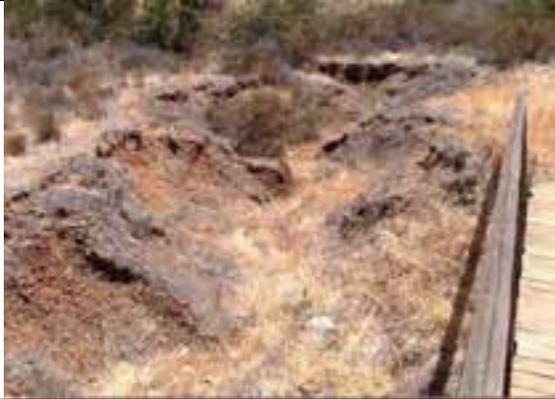
Photo/Observation ID:	MT11		
Date:	05 March 2020		
Latitude:	32.84555556		
Longitude:	-117.0781944		
Bearing (degrees):	40		
Project Area:	Mission Trails		
Description:	<p>Observation collected from trail looking towards foot/bike bridge with a bearing of 62°.</p> <p>Improved vegetation in drainage way and surrounding area.</p>

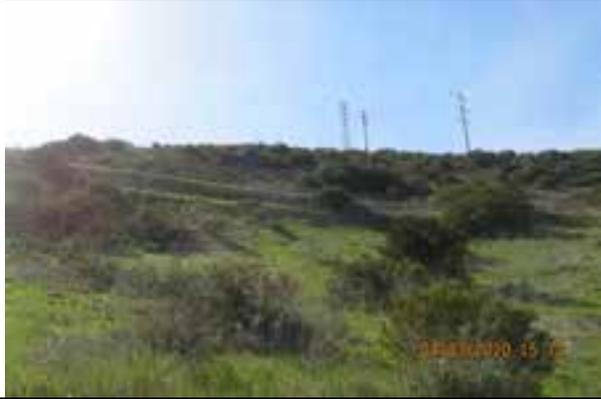
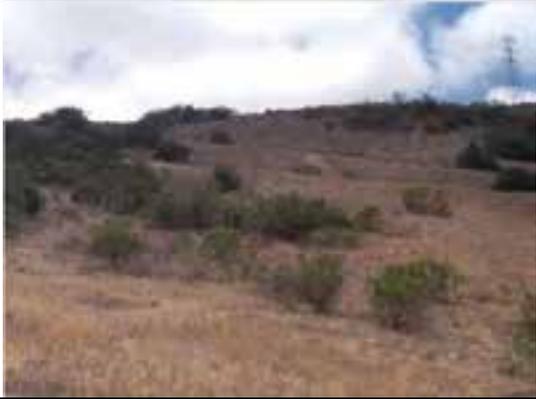
Photo/Observation ID:	MT12		
Date:	05 March 2020		
Latitude:	32.84522222		
Longitude:	-117.0788056		
Bearing (degrees):	135		
Project Area:	Mission Trails		
Description:	<p>Alternate view of MT11 at a bearing of 205°.</p> <p>Drainage way with improved vegetation in area.</p>

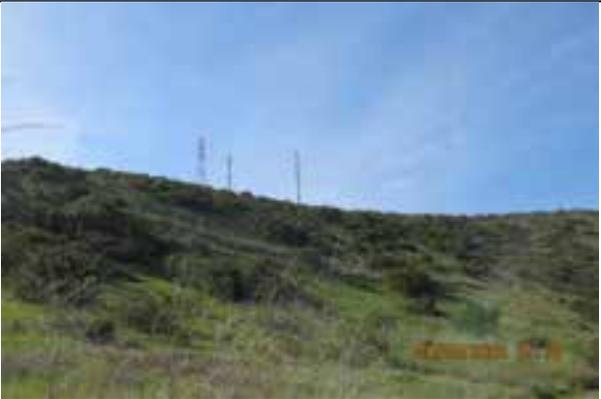
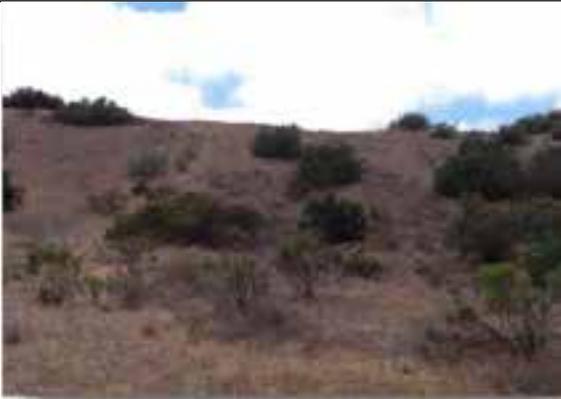
Photo/Observation ID:	MT13		
Date:	04 March 2020		
Latitude:	32.83069444		
Longitude:	-117.0675833		
Bearing (degrees):	270		
Project Area:	Mission Trails		
Description:	No change in terrain and the vegetation appears healthier; no erosion noted.

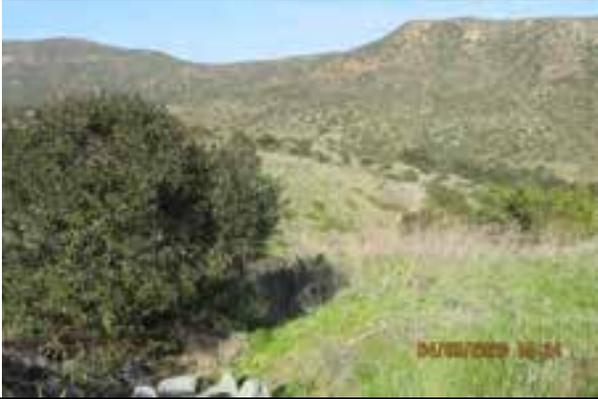
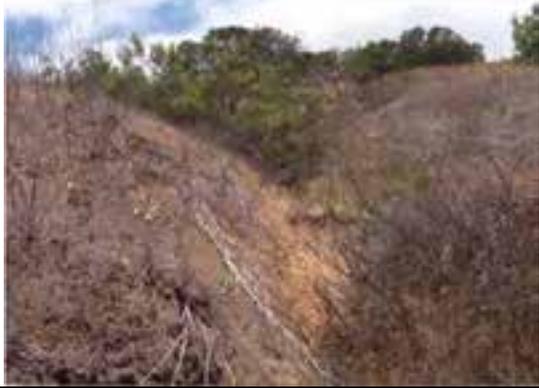
Photo/Observation ID:	MT14		
Date:	04 March 2020		
Latitude:	32.83019444		
Longitude:	-117.0674167		
Bearing (degrees):	270		
Project Area:	Mission Trails		
Description:	No change in terrain and the vegetation appears healthier; no erosion noted.

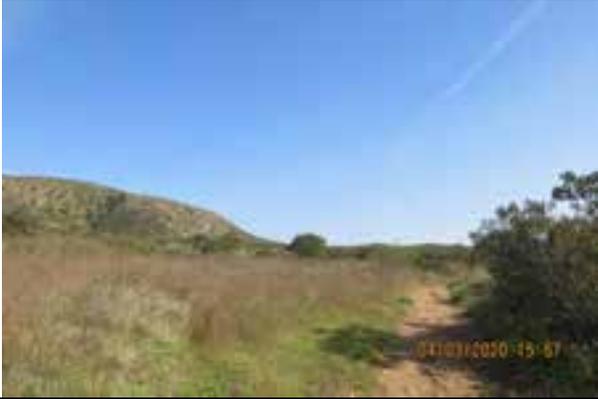
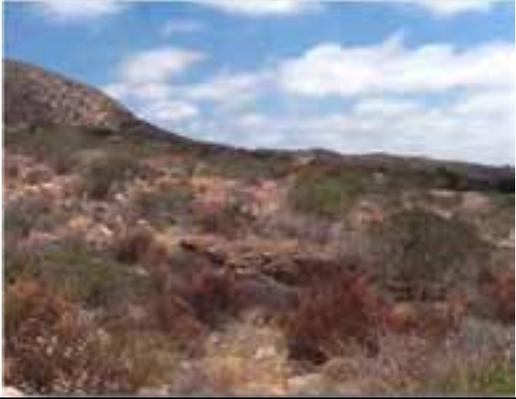
Photo/Observation ID:	MT15		
Date:	04 March 2020		
Latitude:	32.82894444		
Longitude:	-117.0658611		
Bearing (degrees):	270 (40)		
Project Area:	Mission Trails		
Description:	<p>Observation collected from trail at 32.828859, -117.065998 at a bearing of 40° (~40 feet southwest of and looking down at the location from previous review).</p> <p>Sloped area with good vegetation appears healthier; no erosion noted.</p>

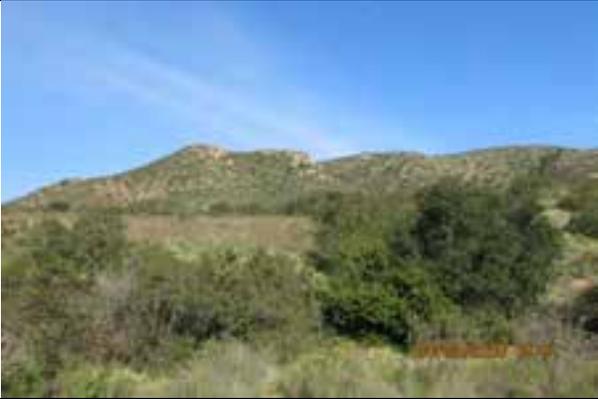
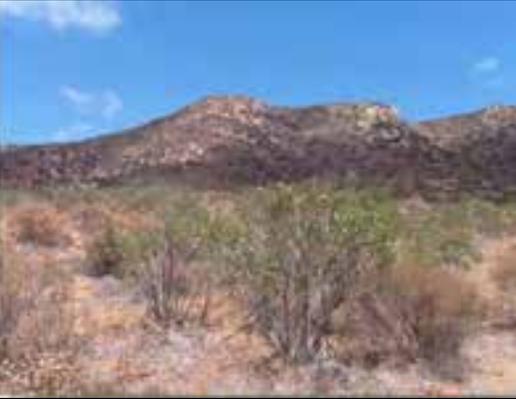
Photo/Observation ID:	MT17		
Date:	04 March 2020		
Latitude:	32.83380556		
Longitude:	-117.0624167		
Bearing (degrees):	135		
Project Area:	Mission Trails		
Description:	Observation collected from trail at 32.833772, -117.063313 (~275 feet west from previous review). Slightly improved vegetation in area; no erosion noted.

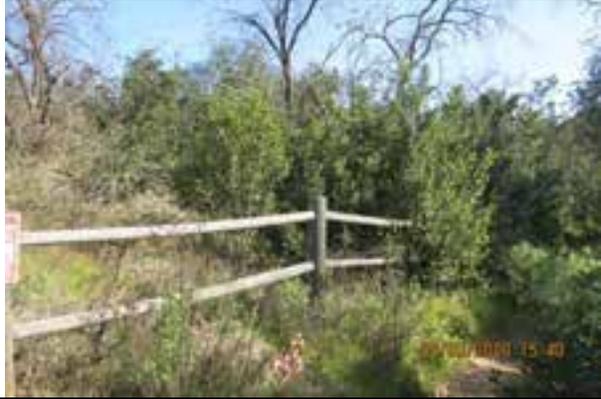
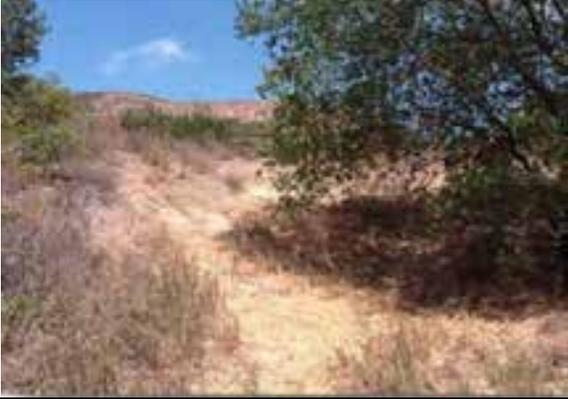
Photo/Observation ID:	MT18		
Date:	04 March 2020		
Latitude:	32.83230556		
Longitude:	-117.0615		
Bearing (degrees):	135		
Project Area:	Mission Trails		
Description:	Observation collected off South Fortuna Trail, ~465 feet west of previous review. Vegetation in area has improved and appears healthier; no erosion or other changes in terrain noted.

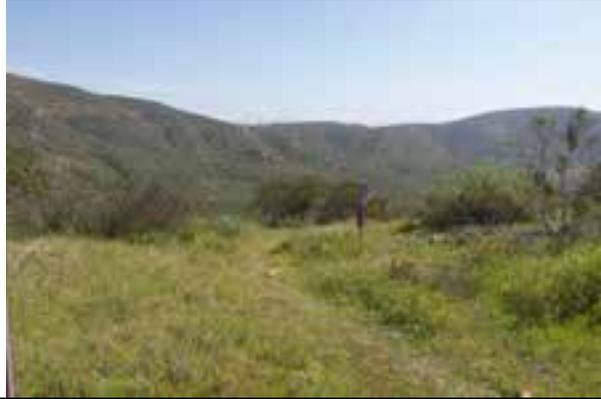
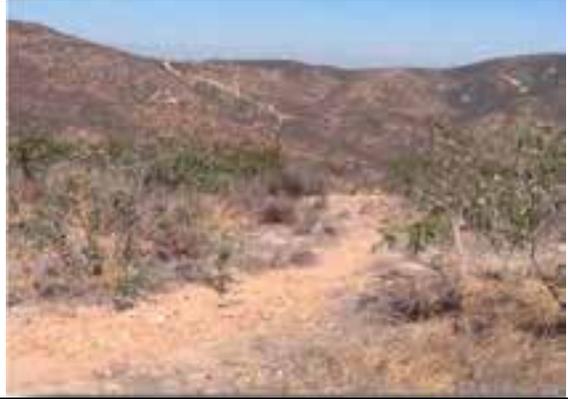
Photo/Observation ID:	MT19		
Date:	04 March 2020		
Latitude:	32.82933333		
Longitude:	-117.0626667		
Bearing (degrees):	135		
Project Area:	Mission Trails		
Description:	<p>Observation collected directly off South Fortuna Trail, approximately 15 feet west of previous five-year review, due to thick vegetation.</p> <p>Improved vegetation in area. Wood fence is visible in previous five-year review.</p>

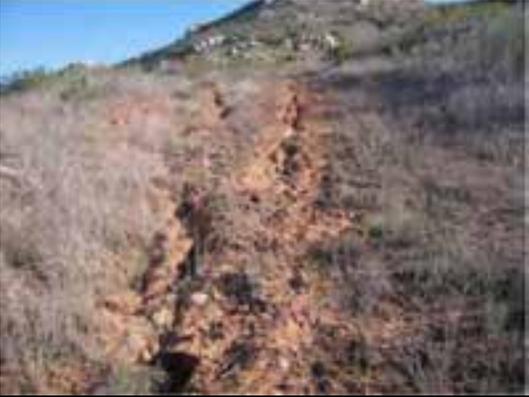
Photo/Observation ID:	MT20		
Date:	04 March 2020		
Latitude:	32.84038889		
Longitude:	-117.0702778		
Bearing (degrees):	105		
Project Area:	Mission Trails		
Description:	<p>Located along the Rim Trail near its intersection with Corte Playa Catalina Trail.</p> <p>View across canyon; much improved vegetation.</p>

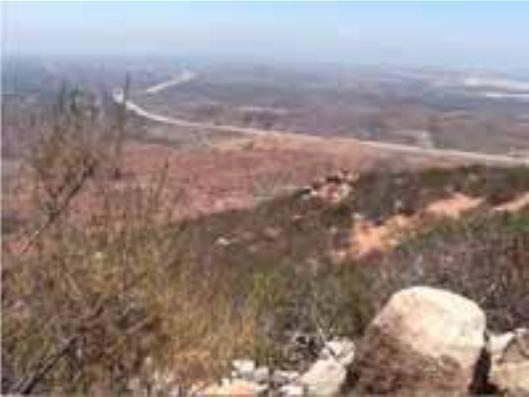
Photo/Observation ID:	MT21
Date:	04 March 2020
Latitude:	32.8486944
Longitude:	-117.066056
Bearing (degrees):	135
Project Area:	Mission Trails
Description:	Due to safety concerns related to heat and terrain, the field team did not visit this observation point. See MT63.

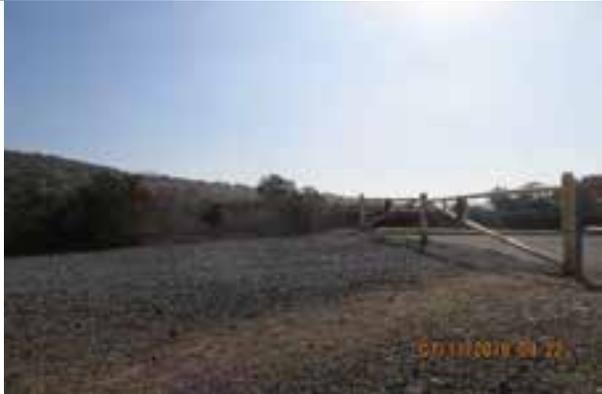
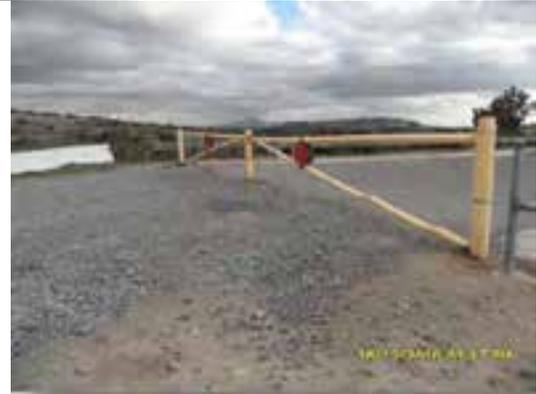
Photo/Observation ID:	MT32
Date:	07 November 2019
Latitude:	32.82080556
Longitude:	-117.0771389
Bearing (degrees):	90
Project Area:	Mission Trails
Description:	Gate to Mission Trails Regional Park at Colina Dorado Drive. Observation is located near sign S-008 / S-093.

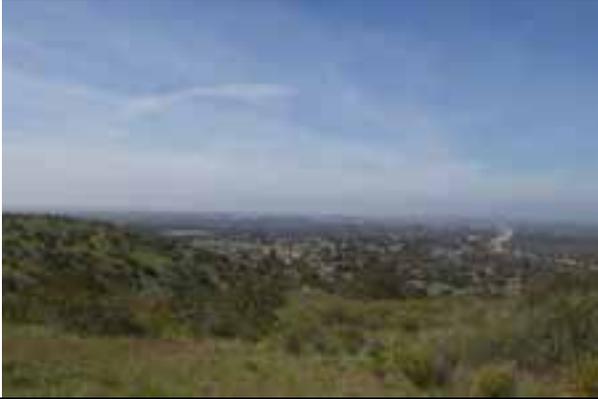
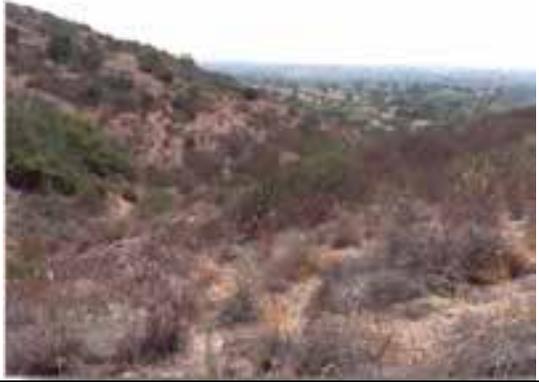
Photo/Observation ID:	MT33		
Date:	04 March 2020		
Latitude:	32.84136111		
Longitude:	-117.0753333		
Bearing (degrees):	225		
Project Area:	Mission Trails		
Description:	<p>Observation collected from the trail, ~500 feet east-northeast from the previous review due to tall grass and slope.</p> <p>Improved vegetation in the area appears healthier; no erosion noted.</p>

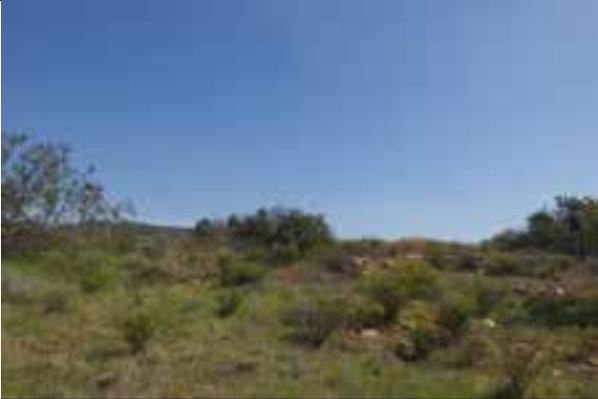
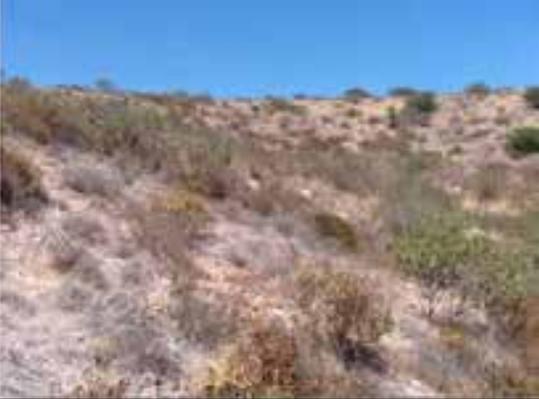
Photo/Observation ID:	MT34		
Date:	04 March 2020		
Latitude:	32.84136111		
Longitude:	-117.0753333		
Bearing (degrees):	60		
Project Area:	Mission Trails		
Description:	<p>Observation collected from the trail, ~500 feet east-northeast from the previous review due to tall grass and slope.</p> <p>Improved vegetation in area appears healthier; no erosion noted.</p>

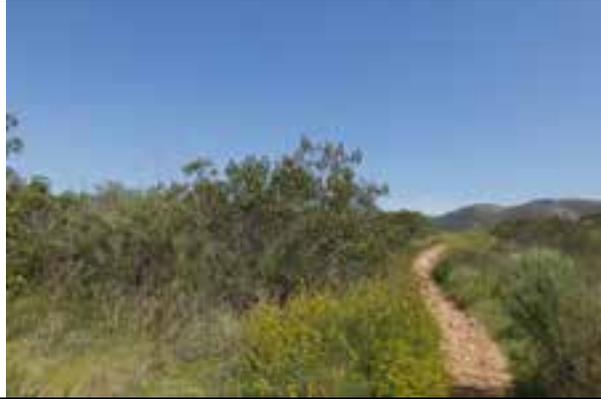
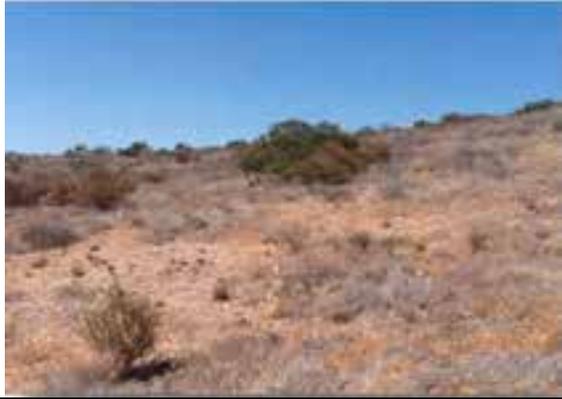
Photo/Observation ID:	MT35		
Date:	04 March 2020		
Latitude:	32.84194444		
Longitude:	-117.0766667		
Bearing (degrees):	35		
Project Area:	Mission Trails		
Description:	<p>Observation collected from the trail, ~450 feet northwest from the previous review due to tall grass and slope.</p> <p>Improved vegetation in the area appears healthier; no erosion noted.</p>

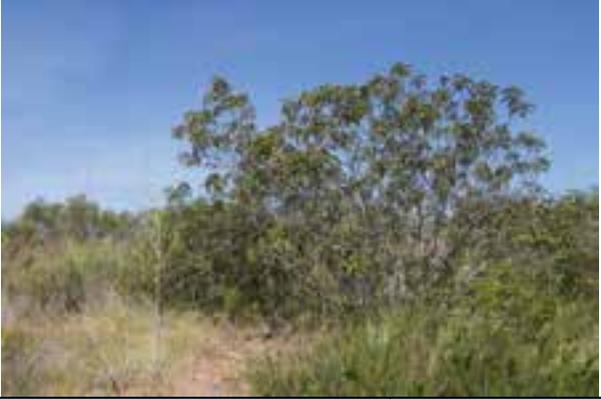
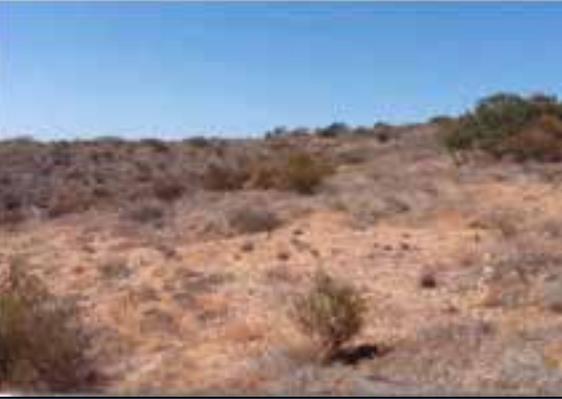
Photo/Observation ID:	MT36		
Date:	04 March 2020		
Latitude:	32.84194444		
Longitude:	-117.0767222		
Bearing (degrees):	350		
Project Area:	Mission Trails		
Description:	<p>Observation collected from the trail, ~450 feet northwest from the previous review due to tall grass and slope.</p> <p>Improved vegetation in area appears healthier; no erosion noted.</p>

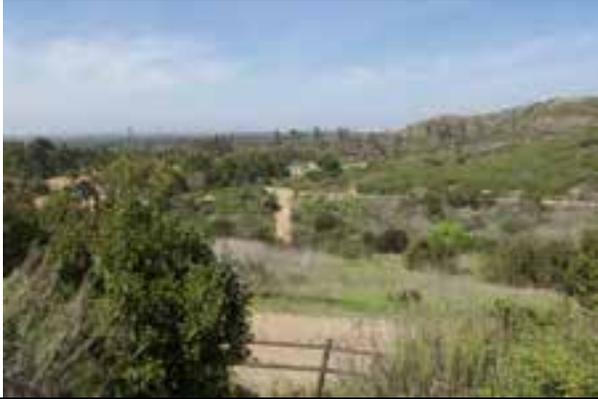
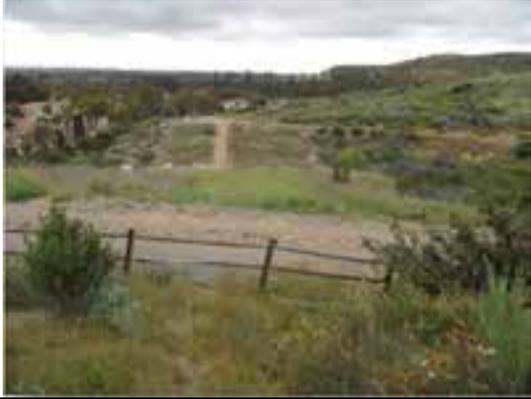
Photo/Observation ID:	MT37		
Date:	04 March 2020		
Latitude:	32.83972222		
Longitude:	-117.0788889		
Bearing (degrees):	310		
Project Area:	Mission Trails		
Description:	Observation collected from sloped area with heavy vegetation; no erosion noted.

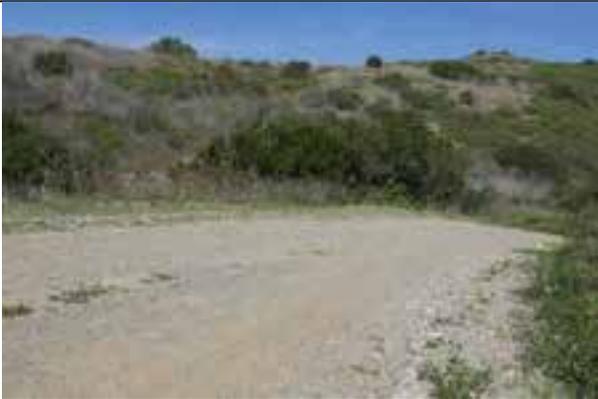
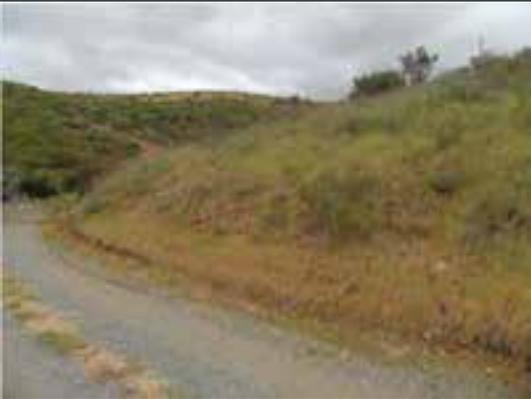
Photo/Observation ID:	MT38		
Date:	04 March 2020		
Latitude:	32.84036111		
Longitude:	-117.079		
Bearing (degrees):	0		
Project Area:	Mission Trails		
Description:	Vegetation has grown since last review; no erosion noted.

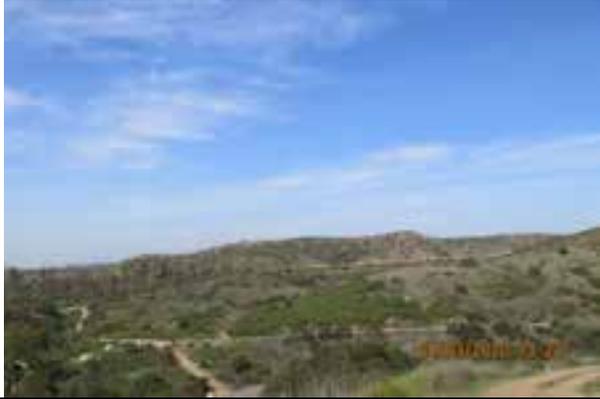
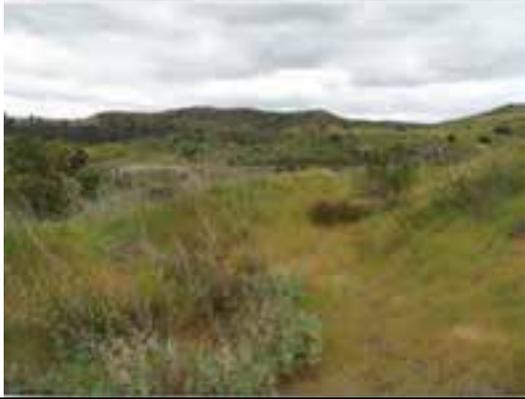
Photo/Observation ID:	MT39		
Date:	04 March 2020		
Latitude:	32.83913889		
Longitude:	-117.0795278		
Bearing (degrees):	340		
Project Area:	Mission Trails		
Description:	<p>Observation collected on the trail, ~75 ft east of the previous review with the same bearing.</p> <p>Heavy vegetation observed on the slope; no erosion noted.</p>

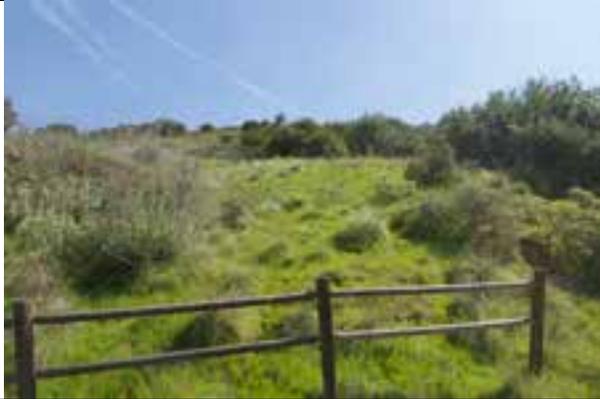
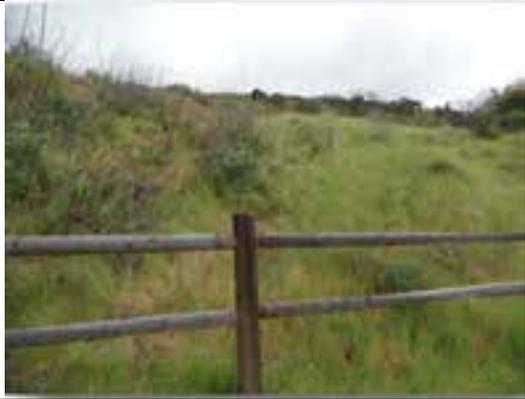
Photo/Observation ID:	MT40		
Date:	04 March 2020		
Latitude:	32.83994444		
Longitude:	-117.079		
Bearing (degrees):	135		
Project Area:	Mission Trails		
Description:	<p>Hillside with good vegetative coverage; no erosion noted. Wood fence present was installed for the protection of the vegetation.</p>

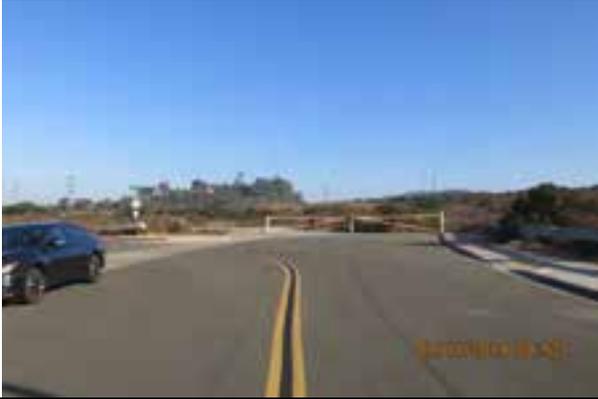
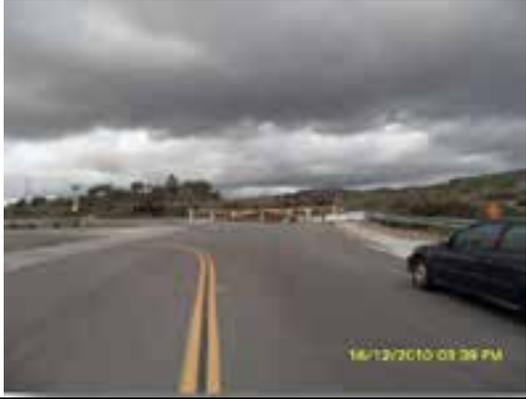
Photo/Observation ID:	MT41		
Date:	07 November 2019		
Latitude:	32.82052778		
Longitude:	-117.07725		
Bearing (degrees):	0		
Project Area:	Mission Trails		
Description:	South Gate to Mission Trails Regional Park at Colina Dorado Drive.

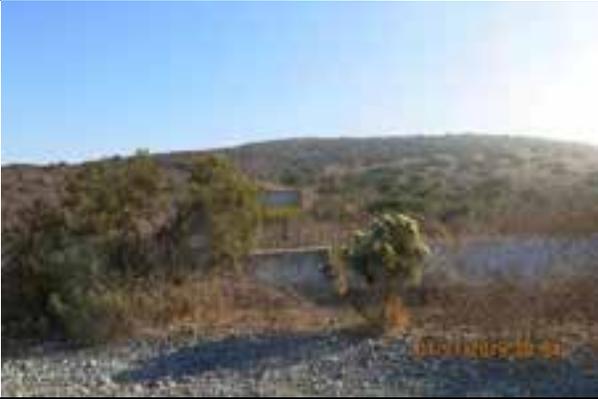
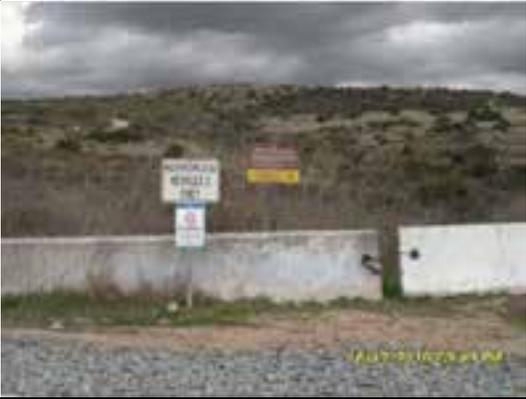
Photo/Observation ID:	MT42		
Date:	07 November 2019		
Latitude:	32.82052778		
Longitude:	-117.07725		
Bearing (degrees):	90		
Project Area:	Mission Trails		
Description:	Sign S-008 / S-093 is faded is located inside of the gate in MT41; location is not very visible.

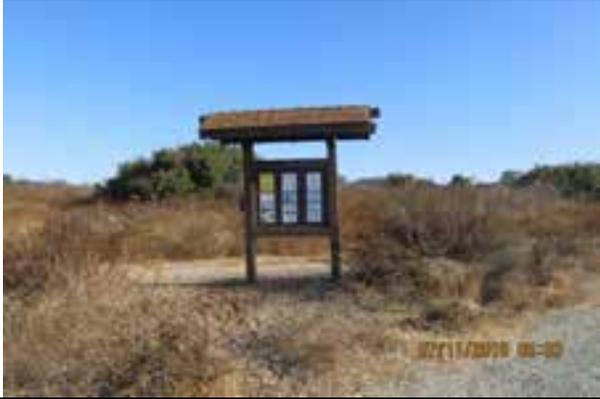
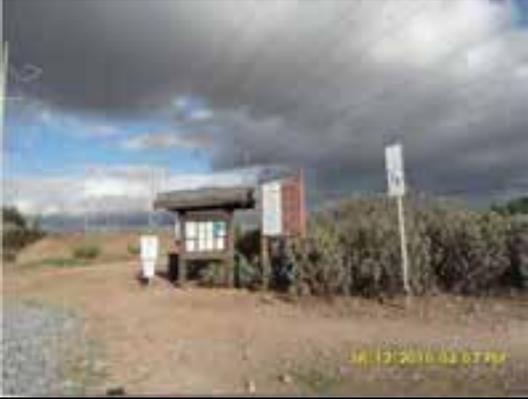
Photo/Observation ID:	MT43		
Date:	07 November 2019		
Latitude:	32.821055		
Longitude:	-117.077197		
Bearing (degrees):	0		
Project Area:	Mission Trails		
Description:	<p>Located just inside of the south gate.</p> <p>The kiosk at the coordinates is no longer present; the field team believes the kiosk was moved up the gravel road to 32.821759, -117.075655 (shown in picture). No MEC information is present on the kiosk. Based on the coordinates provided, the photo in the previous review is incorrect and is the same kiosk shown at MT58.</p>

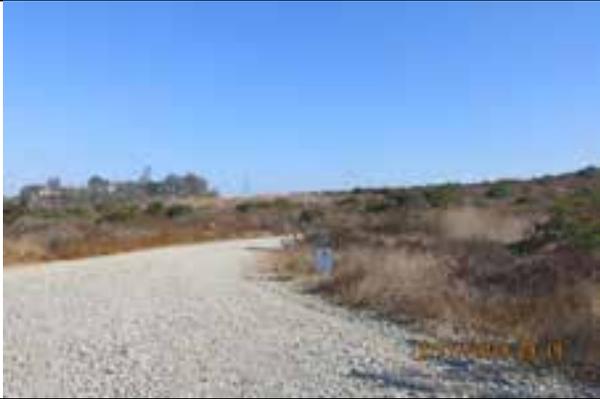
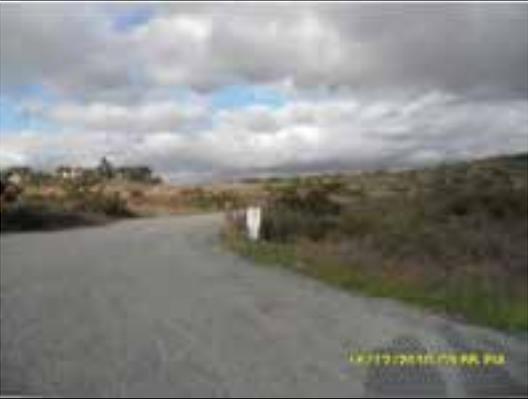
Photo/Observation ID:	MT44		
Date:	07 November 2019		
Latitude:	32.82052778		
Longitude:	-117.07725		
Bearing (degrees):	0		
Project Area:	Mission Trails		
Description:	<p>Observation taken just north of MT41 of gravel service road leading to Mission Trails Regional Park. No MEC warning sign posted.</p>

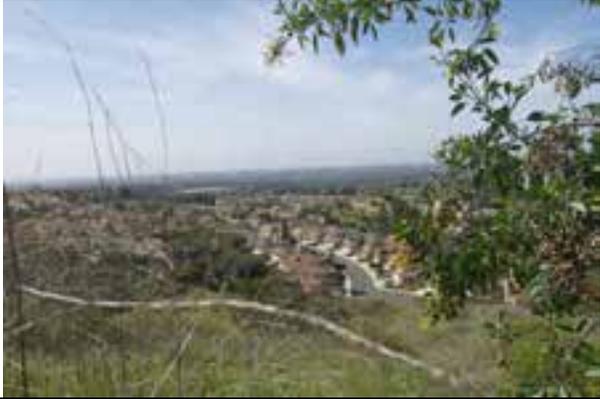
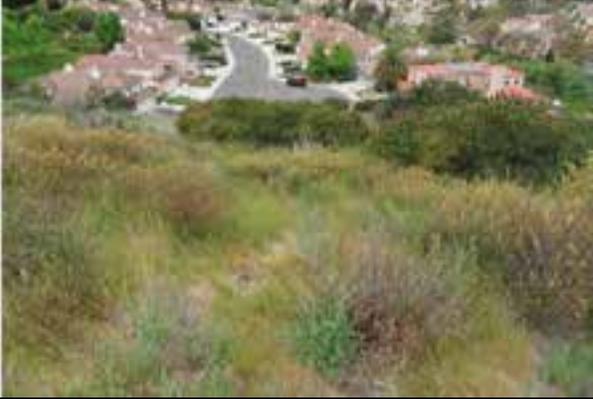
Photo/Observation ID:	MT45		
Date:	04 March 2020		
Latitude:	32.83908333		
Longitude:	-117.0785278		
Bearing (degrees):	240		
Project Area:	Mission Trails		
Description:	View from top of hill down to neighborhood; good vegetation and no erosion observed on hillside.

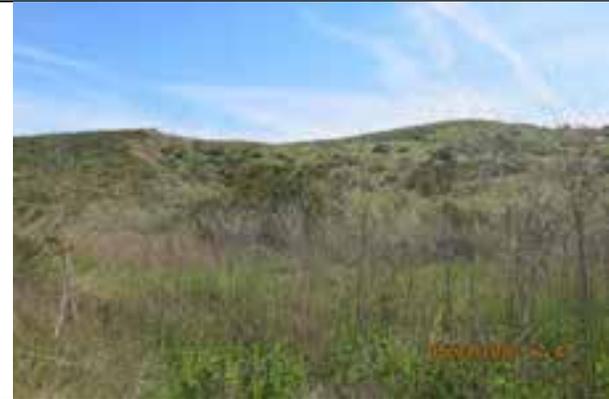
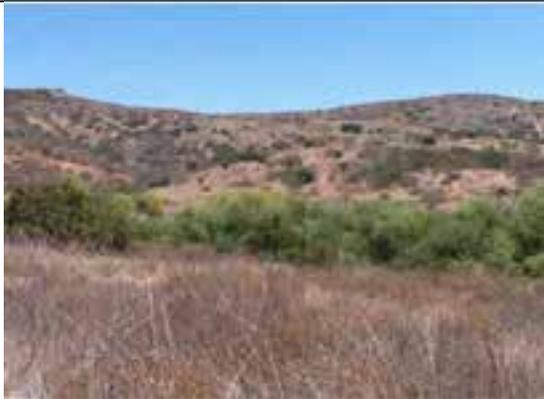
Photo/Observation ID:	MT46		
Date:	05 March 2020		
Latitude:	32.84272222		
Longitude:	-117.0825833		
Bearing (degrees):	60		
Project Area:	Mission Trails		
Description:	Observation collected with a bearing of 100°. Healthy vegetation in the area; no erosion noted.

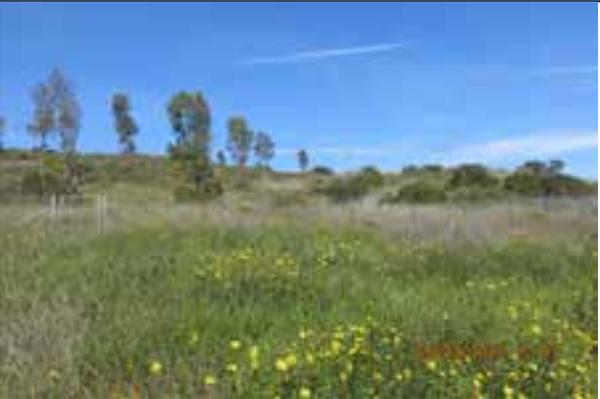
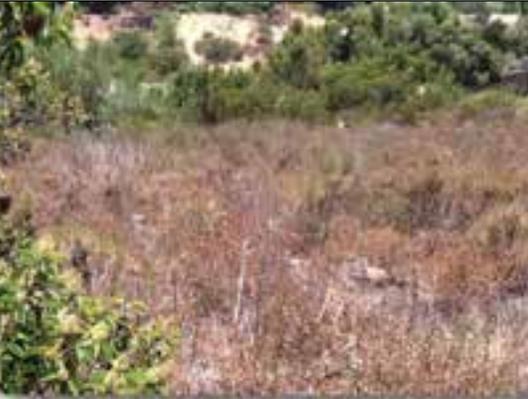
Photo/Observation ID:	MT47		
Date:	05 March 2020		
Latitude:	32.84277778		
Longitude:	-117.0825278		
Bearing (degrees):	40		
Project Area:	Mission Trails		
Description:	Observation collected with a bearing of 100°. Healthy vegetation in the area; no erosion noted.
