Fourth Five-Year Review Report

**Former Camp Elliott-Tierrasanta, Project Number J09CA006701
Former Camp Elliott-Mission Trails, Project Number J09CA006702
San Diego, California**

Date: 7 September 2021

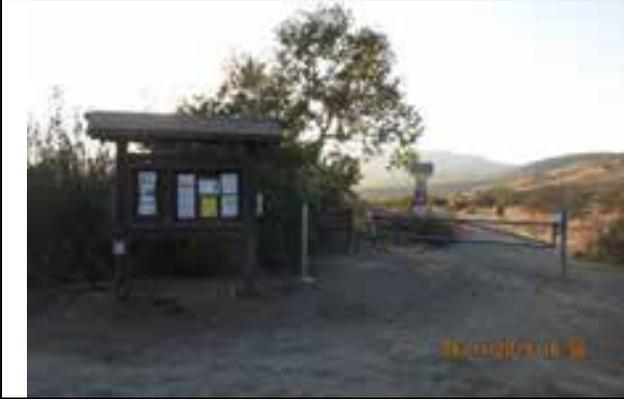
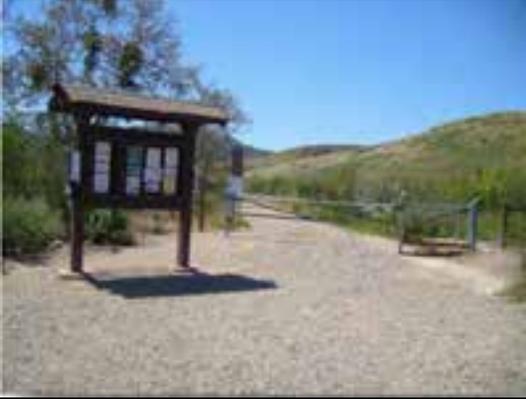
Photo/Observation ID:	MT48		
Date:	05 March 2020		
Latitude:	32.84280556		
Longitude:	-117.0825		
Bearing (degrees):	30		
Project Area:	Mission Trails		
Description:	Vegetation in the area has filled in and appears healthy; no erosion noted. A chain linked fence with a gate is observed in the background. A trail kiosk is located ~50 ft northeast of the observation point with a 3Rs flyer.

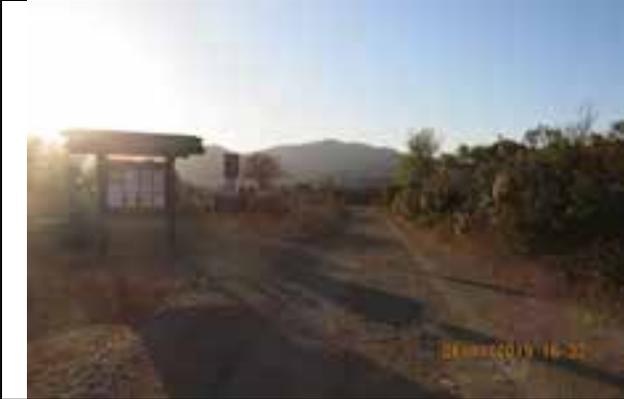
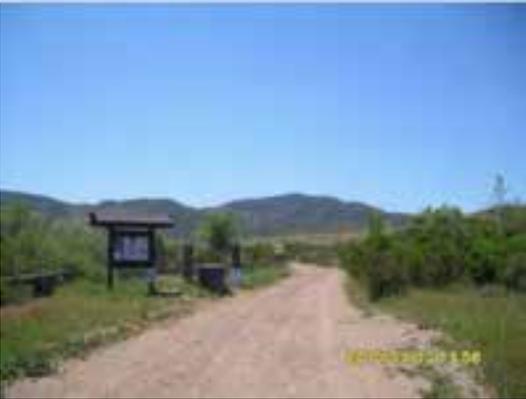
Photo/Observation ID:	MT49		
Date:	06 November 2019		
Latitude:	32.84731389		
Longitude:	-117.0314278		
Bearing (degrees):	90		
Project Area:	Mission Trails		
Description:	<p>Observation located at North Trailhead of the equestrian staging area.</p> <p>Sign S-088 is located just past the kiosk and is in very good condition. No additional 3Rs information was found on the kiosk.</p>

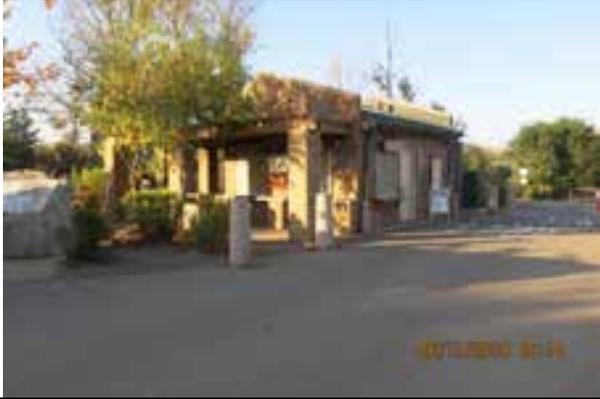
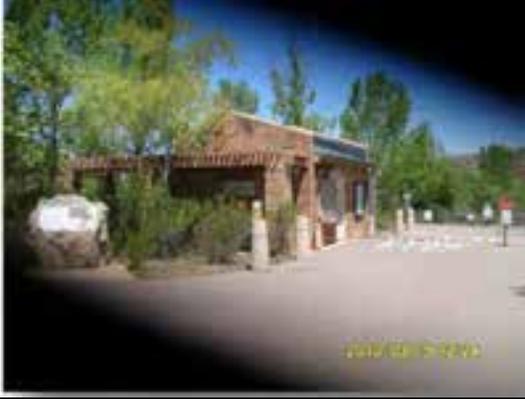
Photo/Observation ID:	MT50		
Date:	06 November 2019		
Latitude:	32.84590833		
Longitude:	-117.0304083		
Bearing (degrees):	90		
Project Area:	Mission Trails		
Description:	<p>Observation located at South Trailhead of the equestrian staging area.</p> <p>Sign S-089 is present and in very good condition. No additional 3Rs information was found on the kiosk.</p>

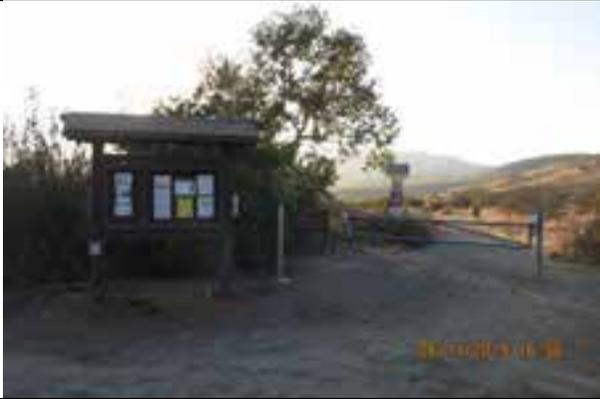
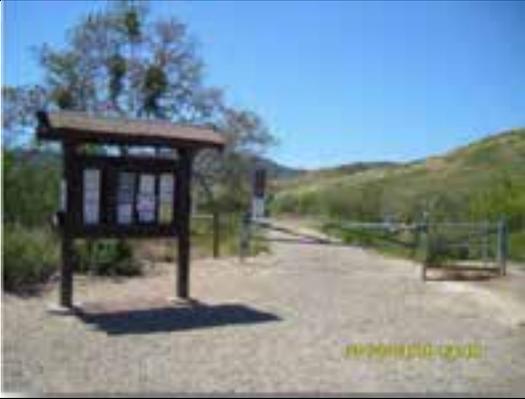
Photo/Observation ID:	MT51		
Date:	06 November 2019		
Latitude:	32.83958611		
Longitude:	-117.0333111		
Bearing (degrees):	0		
Project Area:	Mission Trails		
Description:	<p>Observation located at the entrance to Kumeyaay Campground.</p> <p>No MEC warning sign or information posted on the kiosk.</p>

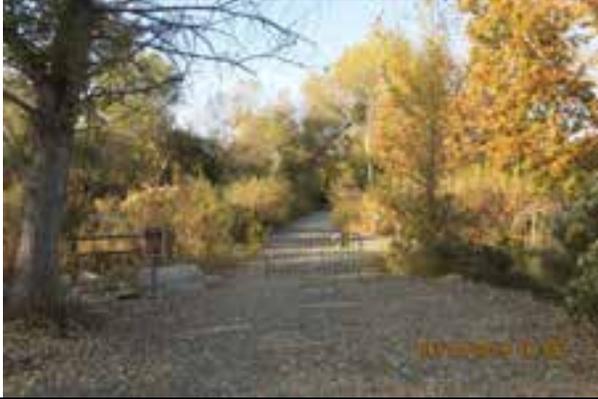
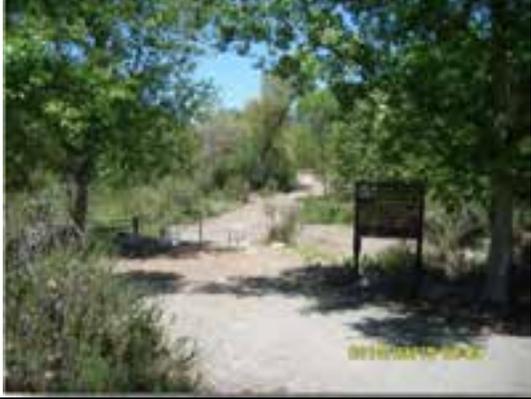
Photo/Observation ID:	MT52		
Date:	06 November 2019		
Latitude:	32.84731389		
Longitude:	-117.0314278		
Bearing (degrees):	90		
Project Area:	Mission Trails		
Description:	<p>Observation located at North Trailhead of the equestrian staging area. Duplicate of MT49.</p> <p>Sign S-088 is located just past the kiosk and is in very good condition. No additional 3Rs information was found on the kiosk.</p>

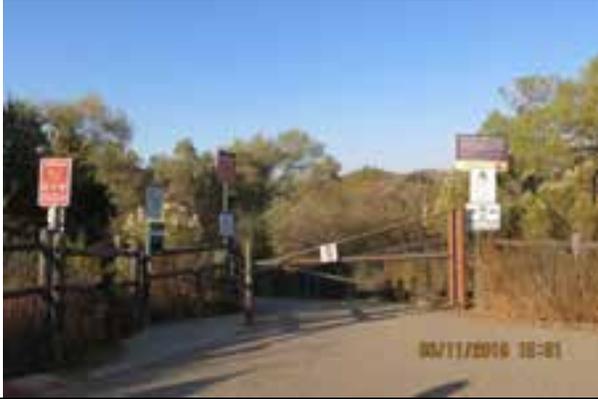
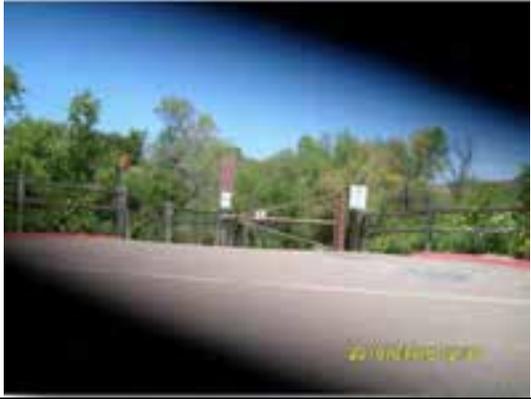
Photo/Observation ID:	MT53		
Date:	06 November 2019		
Latitude:	32.84071389		
Longitude:	-117.0344194		
Bearing (degrees):	0		
Project Area:	Mission Trails		
Description:	<p>Observation located in Kumeyaay Campground, at the west entrance to Kumeyaay Nature Trail and amphitheater.</p> <p>No MEC warning sign and the welcome sign has been removed. No erosion noted.</p>

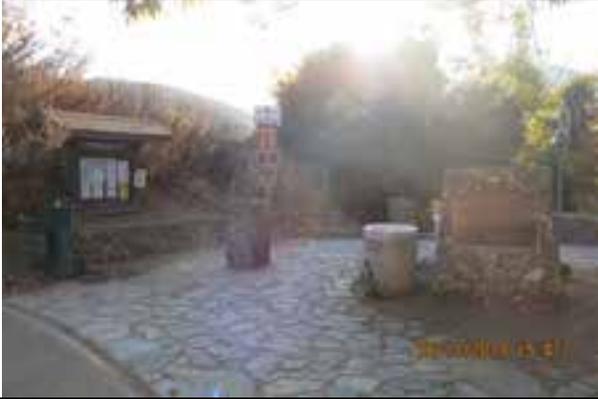
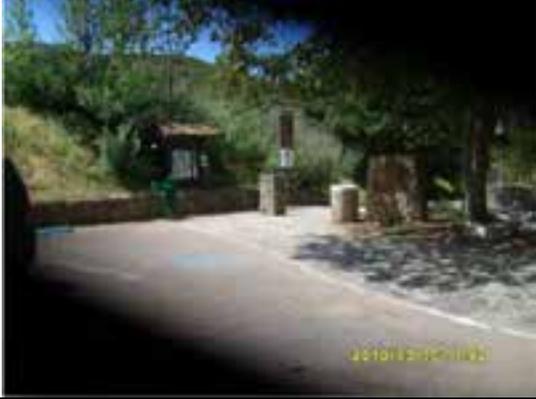
Photo/Observation ID:	MT54		
Date:	06 November 2019		
Latitude:	32.84054444		
Longitude:	-117.0378333		
Bearing (degrees):	0		
Project Area:	Mission Trails		
Description:	<p>Observation located at the trailhead for Grasslands Crossing Trail off of Father Junipero Serra Trail.</p> <p>Sign S-091 has been added of which the last line of text is covered by a mountain lion sign.</p>

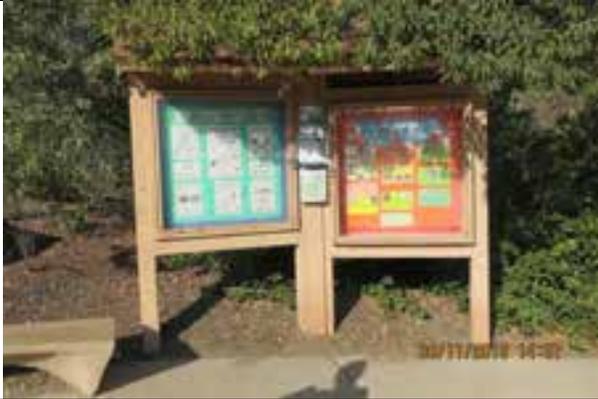
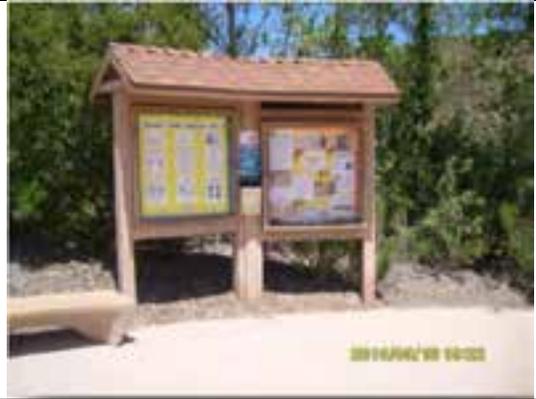
Photo/Observation ID:	MT55		
Date:	06 November 2019		
Latitude:	32.83967222		
Longitude:	-117.041875		
Bearing (degrees):	90		
Project Area:	Mission Trails		
Description:	Observation located at the trailhead to Old Mission Dam off Father Junipero Serra Trail. No MEC warning sign or information available on the kiosk.

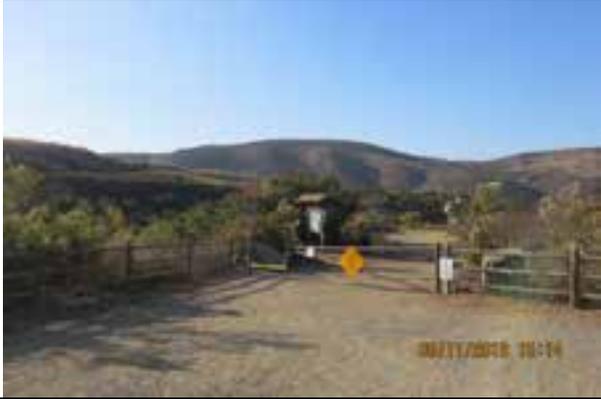
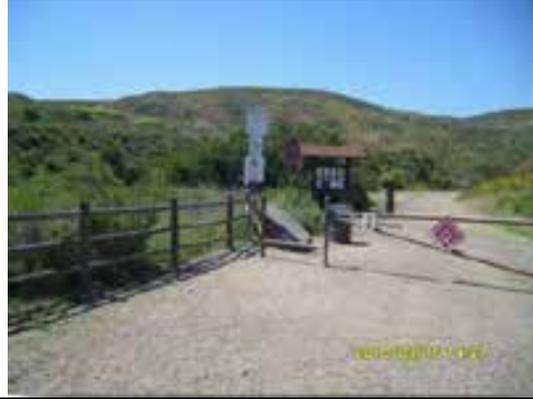
Photo/Observation ID:	MT56		
Date:	06 November 2019		
Latitude:	32.81972222		
Longitude:	-117.0563333		
Bearing (degrees):	0		
Project Area:	Mission Trails		
Description:	Kiosk located at the entrance path to the Visitor Center for Mission Trails Regional Park. No MEC information is provided on the kiosk.

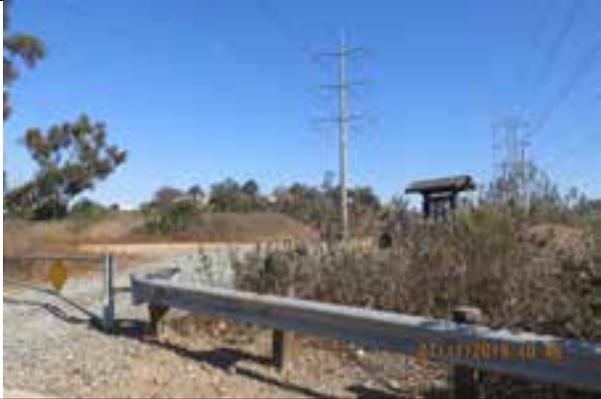
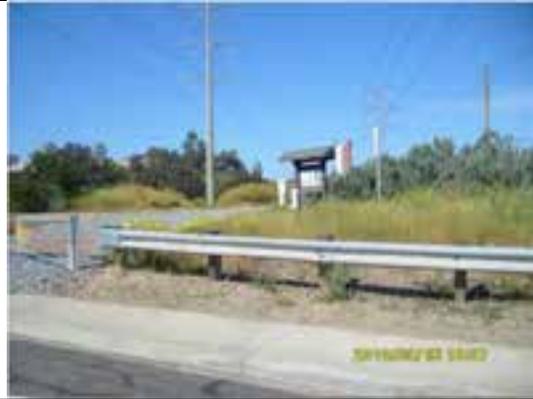
Photo/Observation ID:	MT57
Date:	06 November 2019
Latitude:	32.81788889
Longitude:	-117.0600833
Bearing (degrees):	315
Project Area:	Mission Trails
Description:	<p>Observation located at the trailhead for the South Fortuna Mountain Trail and Sycott Wash.</p> <p>No MEC sign and no information provided on the kiosk.</p>

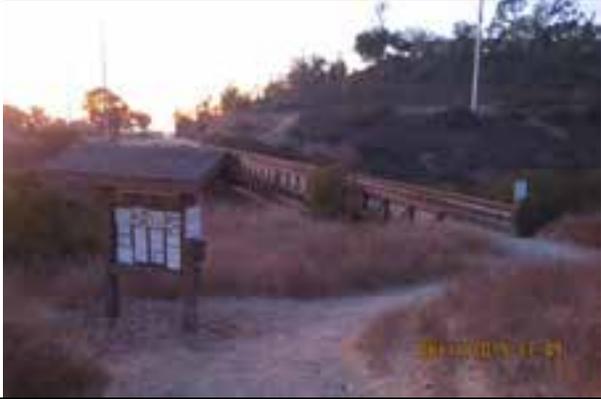
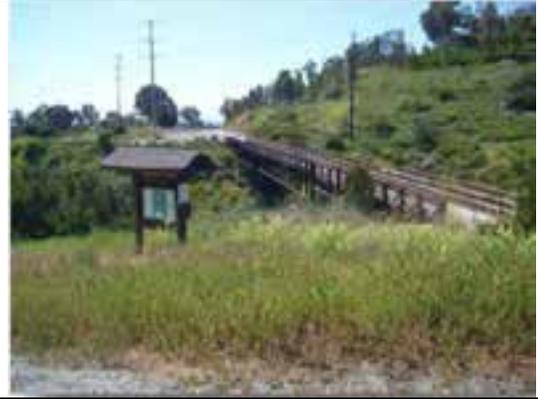
Photo/Observation ID:	MT58
Date:	07 November 2019
Latitude:	32.8227767
Longitude:	-117.079185
Bearing (degrees):	15
Project Area:	Mission Trails
Description:	<p>Observation located at the trailhead off of Calle De Vida beneath overhead power lines.</p> <p>Sign S-077 / S-094 is located directly off the sidewalk.</p>

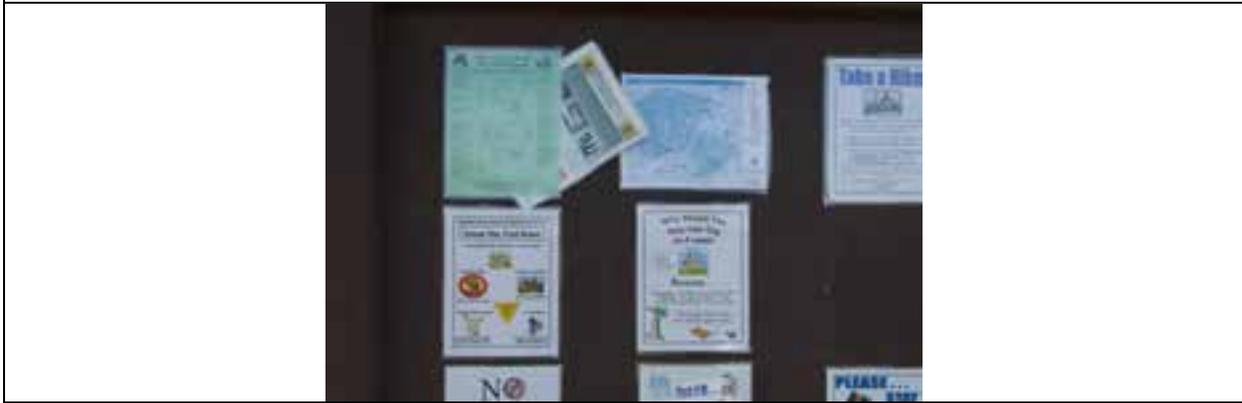
Photo/Observation ID:	MT60
Date:	04 March 2020
Latitude:	32.83744167
Longitude:	-117.0768639
Bearing (degrees):	340
Project Area:	Mission Trails
Description:	<p>Observation located at the entrance to the Mission Trails Regional Park from Corte Playa Catalina.</p> <p>No MEC warning sign present and the nearby kiosk has the 3Rs flyer which was found on the ground (see MT61).</p>

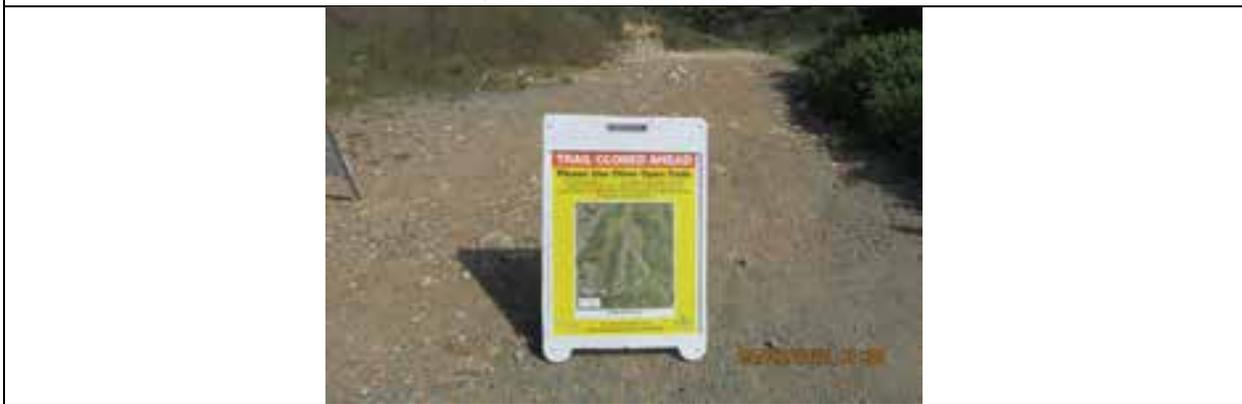
Photo/Observation ID:	MT61
Date:	04 March 2020
Latitude:	32.838008
Longitude:	-117.076714
Bearing (degrees):	-
Project Area:	Mission Trails
Description:	New observation collected to show the first 3Rs flyer to be observed. Kiosk is located near MT60. The 3Rs flyer was found on the ground.

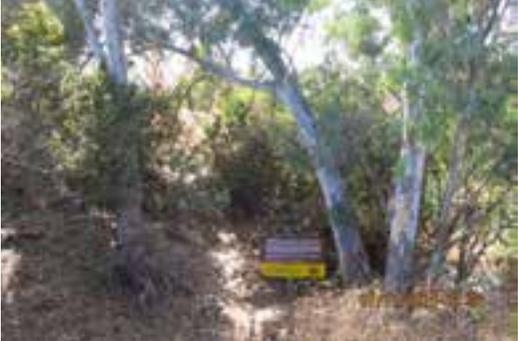
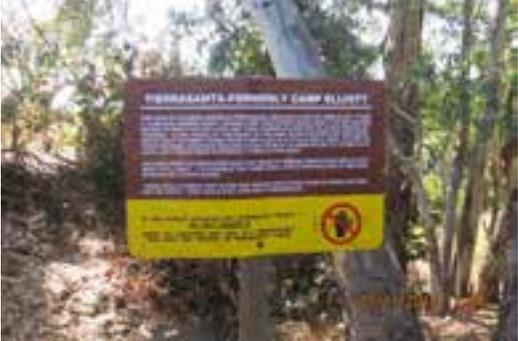
Sign ID	Coordinates		Photo	Description	Recommendation
	Latitude	Longitude			
S-002	32.81856	-117.10086	<p>TS02 S-002.jpg</p>

<p>Located at the north end of Roadrunner Park (near school fence near trees and brush); See also TS02 and TS85.</p> <p>The sign is bent but legible and visible.</p>	None.

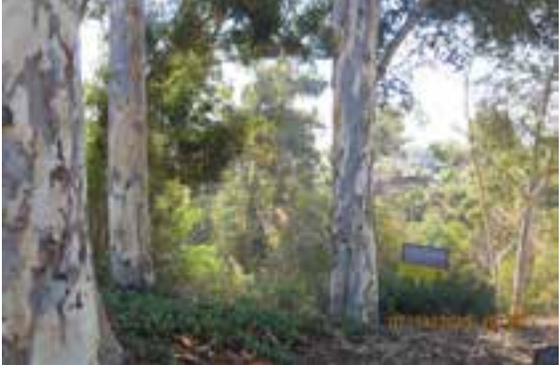
Sign ID	Coordinates		Photo	Description	Recommendation
	Latitude	Longitude			
S-003	32.82244	-117.08456	TS03 S-003 S-069.jpg

Located on Rueda Drive, between Temprano and Zorita Court; See also TS03. Duplicate of S-069. Sign is in good condition.	None.

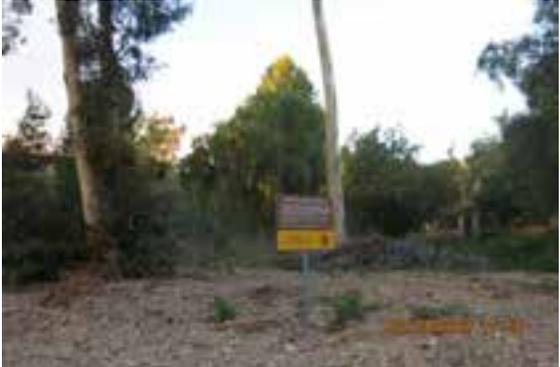
Sign ID	Coordinates		Photo	Description	Recommendation
	Latitude	Longitude			
S-004	32.81814	-117.09153	TS04 S-004.jpg

On Tierrasanta Blvd, west of Tambor Court; See also TS04. Sign is in good condition.	None.

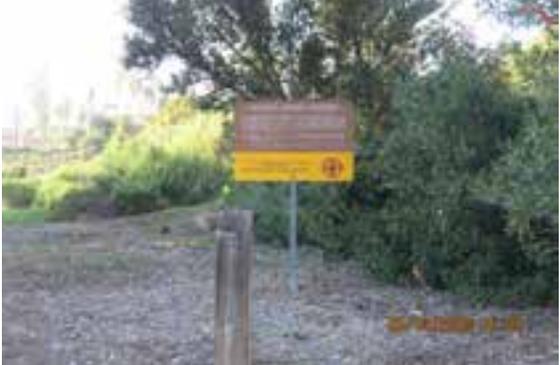
Sign ID	Coordinates		Photo	Description	Recommendation
	Latitude	Longitude			
S-006	32.81611	-117.08403	S-006.jpg

Located on Pediente Ct. at a trailhead. Description of project area provided on sign is fading.	Replace sign.

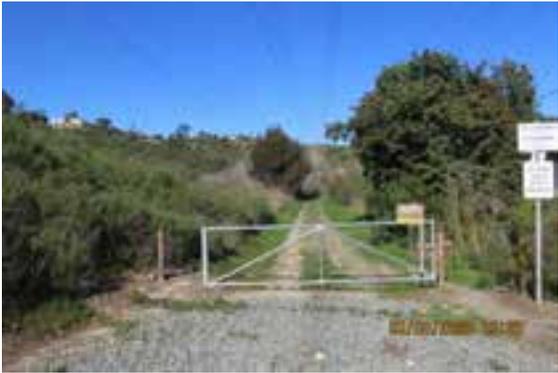
Sign ID	Coordinates		Photo	Description	Recommendation
	Latitude	Longitude			
S-007	32.81578	-117.08697	TS42 S-007.jpg

Located on the north side of Tierrasanta Blvd between Tambor Rd and Colina Dorado Dr, behind a San Diego Gas & Electric (SDG&E) gate. Sign is in a visible location. It has been graffitied but is still legible.	None.

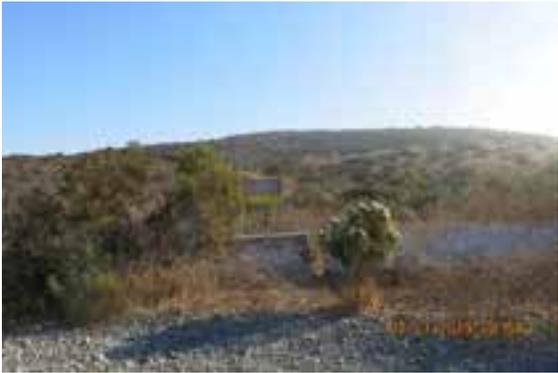
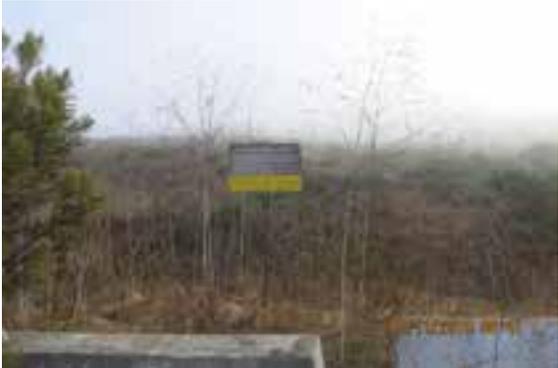
Sign ID	Coordinates		Photo	Description	Recommendation
	Latitude	Longitude			
S-008	32.82083	-117.07706	<p>MT42 S-008 S-093.jpg</p>

<p>Located inside of the south gate to Mission Trails Regional Park at Colina Dorado Drive; See also MT42 and TS36.</p> <p>Description of project area is still legible on the sign, but the bottom yellow portion, which contains instructions if MEC item is found, is completely faded. The sign is not in a very visible location. Duplicate of S-093.</p>	<p>Recommend replacing sign and moving to a more visible location, such as MT44.</p>

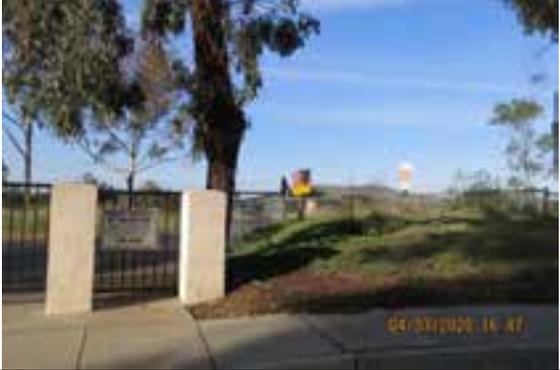
Sign ID	Coordinates		Photo	Description	Recommendation
	Latitude	Longitude			
S-009	32.82897	-117.07653	S-009 S-096.jpg

<p>Located just outside of a fenced area, near a trailhead.</p> <p>Sign is legible and in a very visible location. Duplicate of S-096.</p>	None.

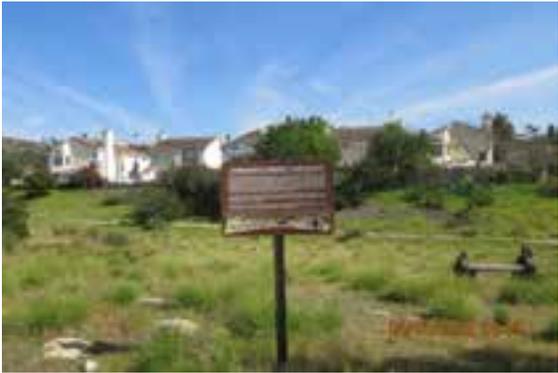
Sign ID	Coordinates		Photo	Description	Recommendation
	Latitude	Longitude			
S-014	32.83731	-117.08450	S-014.jpg

<p>Located at trailhead, accessed from Avenida Playa Cancun.</p> <p>Sign is legible and is in a very visible location. The bottom yellow portion of sign, which contains instructions if MEC item is found, is beginning to peel.</p>	Replace sign.

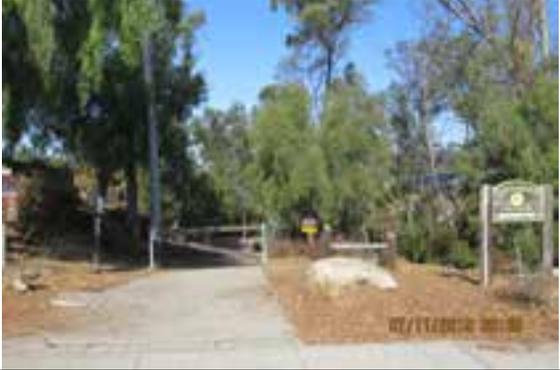
Sign ID	Coordinates		Photo	Description	Recommendation
	Latitude	Longitude			
S-016	32.82414	-117.08007	S-016.jpg

Located off of Rueda Drive, opposite Palabra Circle, at the trailhead for Seda Nature Trail. Sign is in good condition and legible.	None.

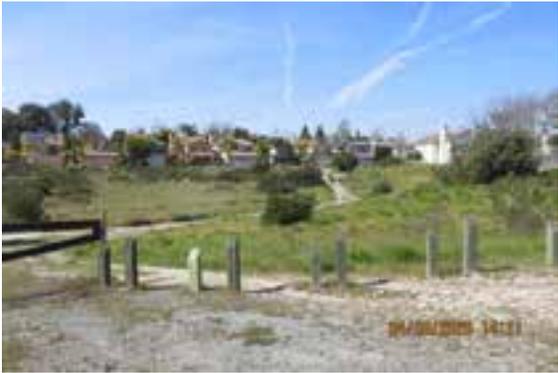
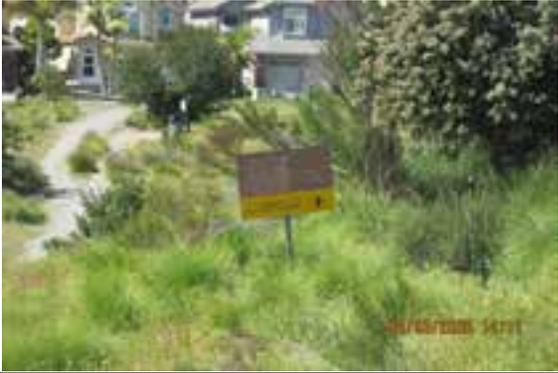
Sign ID	Coordinates		Photo	Description	Recommendation
	Latitude	Longitude			
S-018	32.83664	-117.08397	<p>S-018a.jpg</p>

<p>Located approximately 60 feet off the trail, accessed from Via Playa De Cortes. Sign is difficult to read due to worn condition and location.</p>	<p>Replace sign and relocate to trailhead.</p>

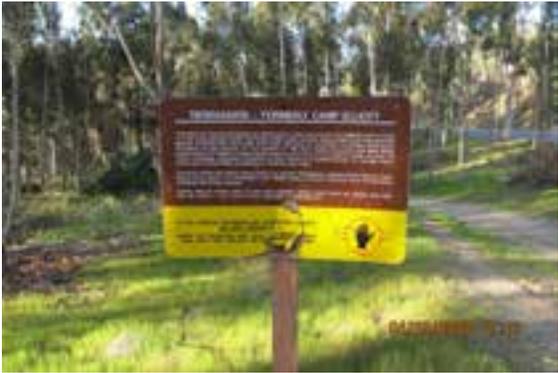
Sign ID	Coordinates		Photo	Description	Recommendation
	Latitude	Longitude			
S-021	32.82987	-117.08331	S-021a.jpg

<p>Sign is near trailhead for East Shephard Canyon, located on the west side of Via Valarta.</p> <p>Project area description is legible but the bottom yellow portion, which contains instructions if MEC item is found, is beginning to peel. Coordinates have been updated with actual location of sign (~100 feet from coordinates provided).</p>	Replace sign.

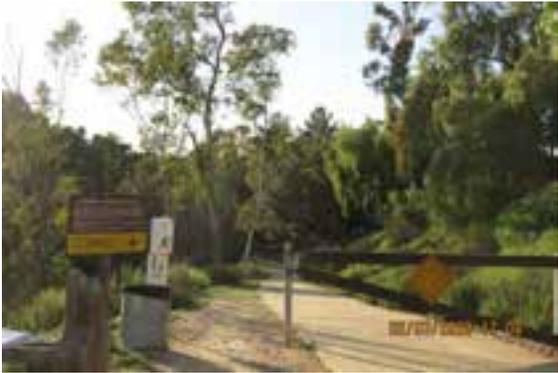
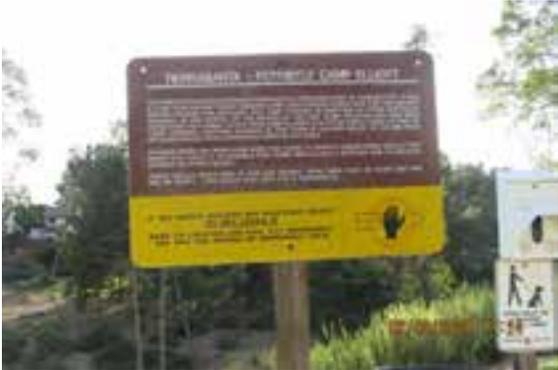
Sign ID	Coordinates		Photo	Description	Recommendation
	Latitude	Longitude			
S-022	32.82583	-117.08228	<p>TS09 S-022.jpg</p>

<p>Located on the west side of Seda Drive, between Clairemont Mesa Blvd and Calle de Vida; See also TS09 and TS10.</p> <p>Sign is legible and in good condition.</p>	None.

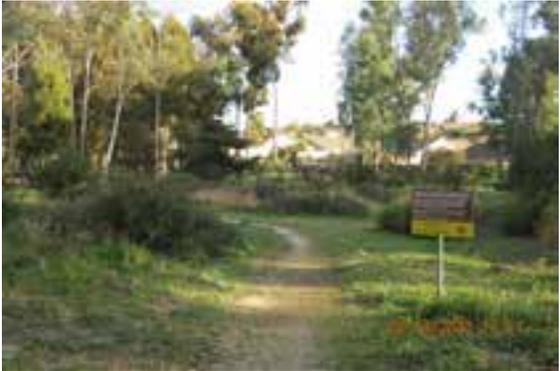
Sign ID	Coordinates		Photo	Description	Recommendation
	Latitude	Longitude			
S-023	32.82564	-117.08206	TS11 S-023.jpg

<p>Located on the east side of Seda Drive, between Clairemont Mesa Blvd and Calle de Vida; see also TS11.</p> <p>Sign is legible and in good condition.</p>	None.

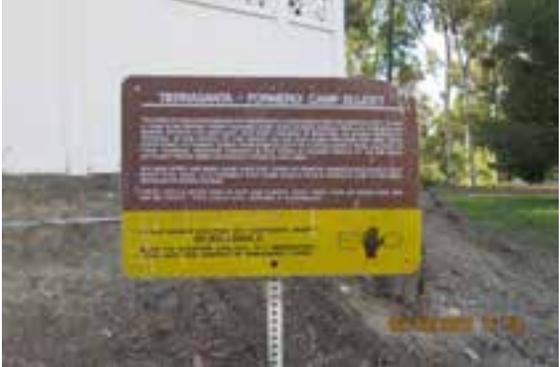
Sign ID	Coordinates		Photo	Description	Recommendation
	Latitude	Longitude			
S-024	32.82664	-117.08645	S-024.jpg

<p>Located off of Calle de Vida near home at 4474 Calle de Vida, on a trail.</p> <p>Sign is legible but starting to show signs of age.</p>	Monitor condition of sign; may need to be replaced prior to next review.

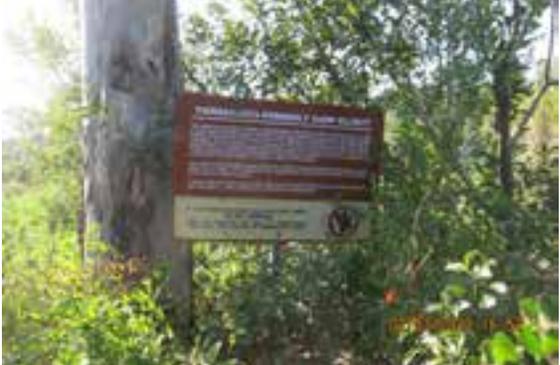
Sign ID	Coordinates		Photo	Description	Recommendation
	Latitude	Longitude			
S-026	32.82556	-117.09044	S-026.jpg

Located at the end of Vivaracho Way, on a trail between two homes. Sign is legible but partially obscured by vegetation.	Trim vegetation around the sign.

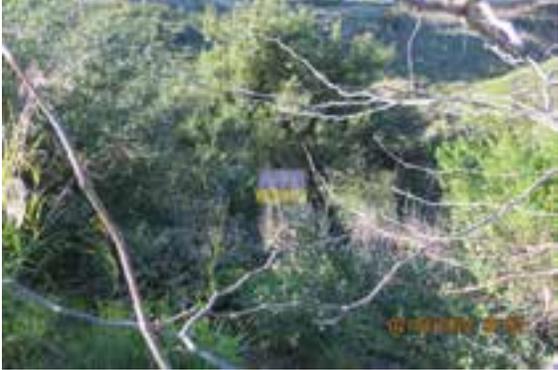
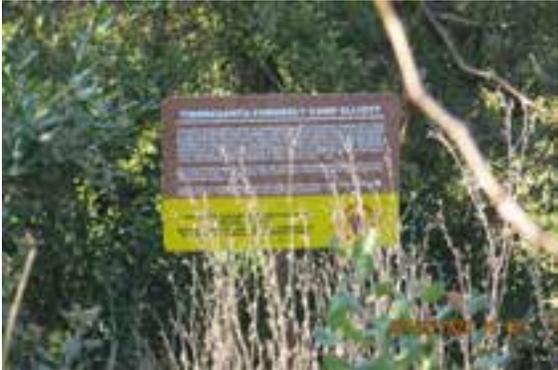
Sign ID	Coordinates		Photo	Description	Recommendation
	Latitude	Longitude			
S-027	32.82639	-117.08920	<p>S-027a.jpg</p>

<p>Located at the north end of Vivaracho Ct.</p> <p>Sign is in good condition and is legible but partially obscured by vegetation.</p>	<p>Trim vegetation around the sign.</p>

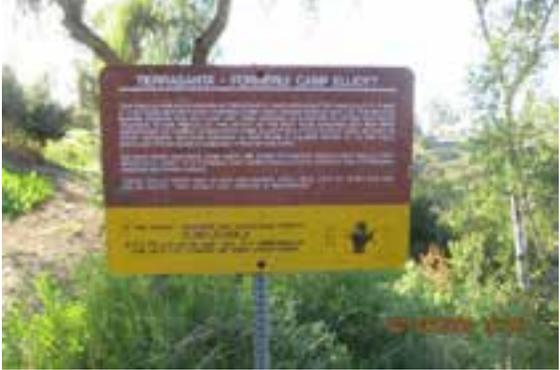
Sign ID	Coordinates		Photo	Description	Recommendation
	Latitude	Longitude			
S-028	32.82397	-117.09064	S-028 S-076.jpg

<p>Located at the end of Cartulina Road.</p> <p>Project area description is legible on sign but the bottom yellow portion, which contains instructions if MEC item is found, is beginning to fade. Duplicate of S-076.</p>	Monitor condition of sign; may need to be replaced prior to next review.

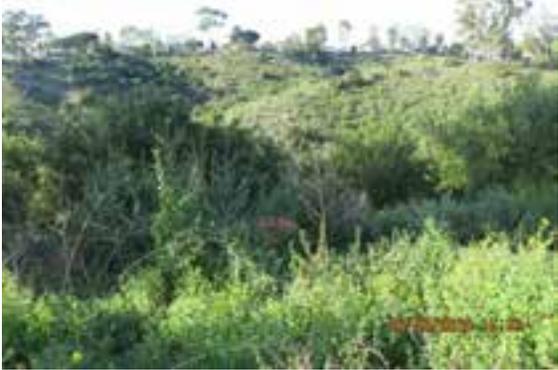
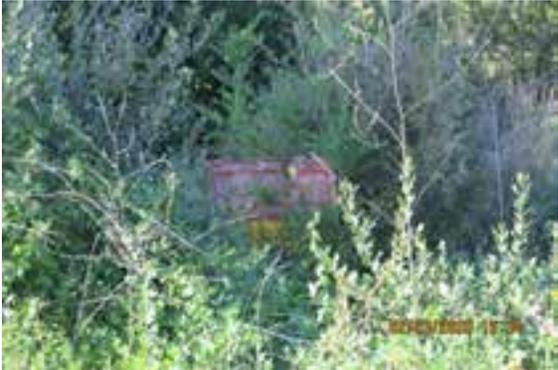
Sign ID	Coordinates		Photo	Description	Recommendation
	Latitude	Longitude			
S-029	32.82376	-117.09162	<p>S-029a.jpg</p>

<p>Located at the end of Via del Cosira on a canyon slope.</p> <p>Sign is partially obscured by vegetation and is very faded.</p>	<p>Replace sign and trim vegetation in area; consider moving the sign up slope of canyon.</p>

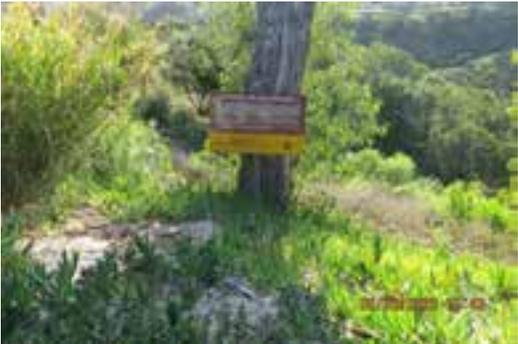
Sign ID	Coordinates		Photo	Description	Recommendation
	Latitude	Longitude			
S-030	32.82301	-117.09158	S-030.jpg

<p>Located at the end of Cosira Ct.</p> <p>Sign is fading and has patches of illegible text.</p>	Replace sign.

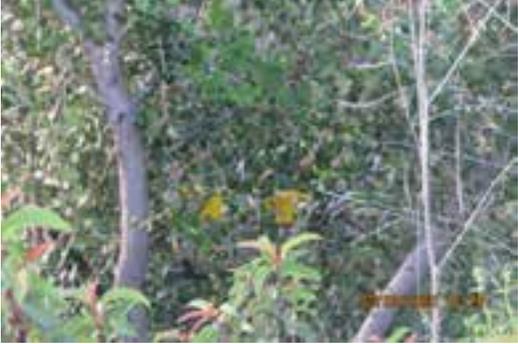
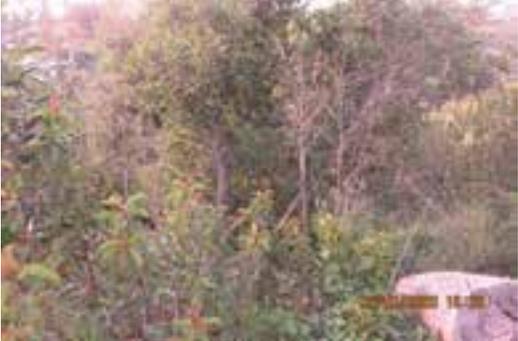
Sign ID	Coordinates		Photo	Description	Recommendation
	Latitude	Longitude			
S-031	32.82239	-117.09192	<p>S-031a.jpg</p>

<p>Located at the end of Cascajo Court on canyon slope.</p> <p>Sign is completely obscured by vegetation and is upside down.</p>	<p>It is possible the sign needs to be replaced, but the condition of the sign could not be assessed because of the vegetation around it. Trim vegetation around the sign, and re-install with correct orientation; consider moving up slope of canyon.</p>

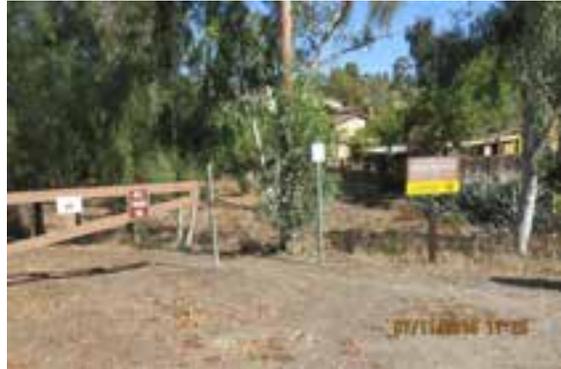
Sign ID	Coordinates		Photo	Description	Recommendation
	Latitude	Longitude			
S-035	32.81819	-117.09456	<p>S-035.jpg</p>

<p>Located on the north side of Tierrasanta Blvd, between Ducos Pl and Rueda Dr, at a trailhead for Canyon Trail.</p> <p>Sign is in good condition.</p>	None.

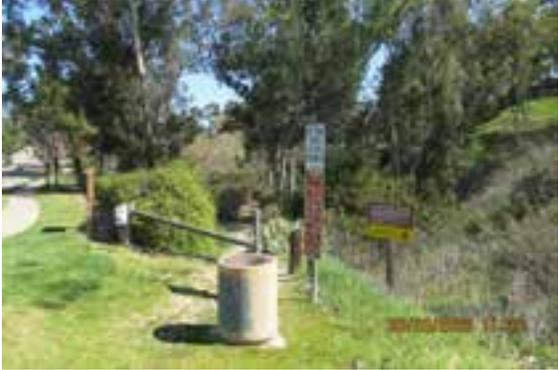
Sign ID	Coordinates		Photo	Description	Recommendation
	Latitude	Longitude			
S-036	32.83161	-117.10225	TS67 S-036.jpg

Located on the east side of Santo Rd, between Antigua Blvd and Clairemont Mesa Blvd, at a trailhead for East Shephard Canyon; see also TS67. Sign in good condition and visible at its current location.	None.

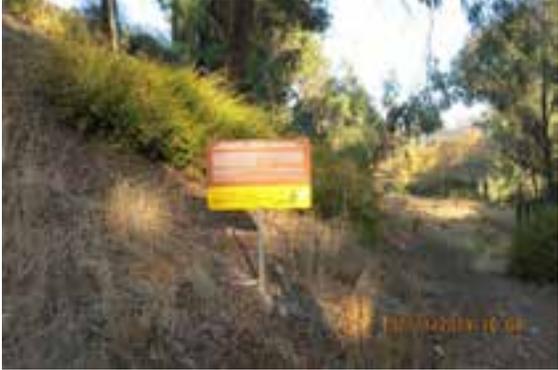
Sign ID	Coordinates		Photo	Description	Recommendation
	Latitude	Longitude			
S-038	32.83092	-117.10747	S-038.jpg

<p>Located on the north side of Clairemont Mesa Blvd, at a trailhead for West Shepard Canyon.</p> <p>Sign has some illegible text with graffiti. Bottom yellow portion, which contains instructions if MEC item is found, is beginning to fade.</p>	Replace sign.

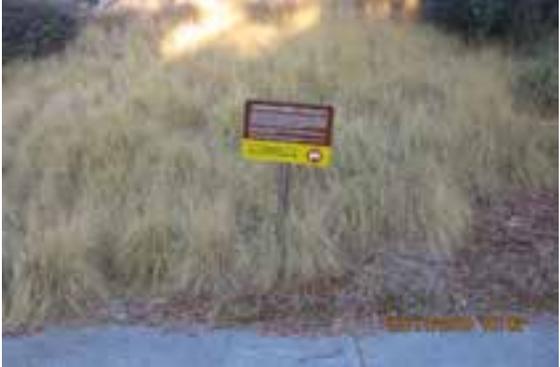
Sign ID	Coordinates		Photo	Description	Recommendation
	Latitude	Longitude			
S-041	32.83258	-117.10522	S-041.jpg

Located off of a paved trail between Totuga Ct and Veracruz Ct. Sign is visible and in good condition.	None.

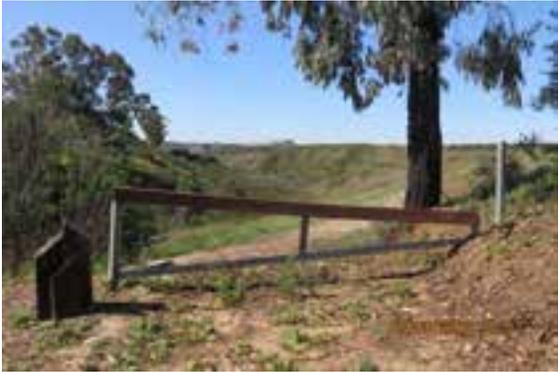
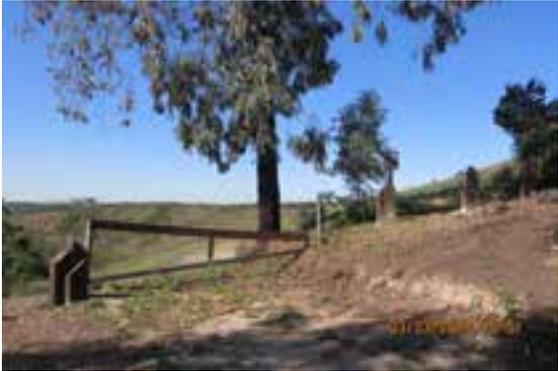
Sign ID	Coordinates		Photo	Description	Recommendation
	Latitude	Longitude			
S-051	32.83894	-117.10592	<p>S-051a.jpg</p>

<p>Located at the end of the cul de sac at La Morada Dr.</p> <p>No sign is present, but location is at a trailhead.</p>	<p>Add a sign to the gate.</p>

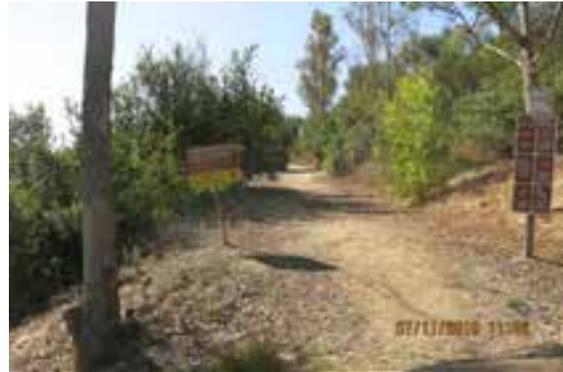
Sign ID	Coordinates		Photo	Description	Recommendation
	Latitude	Longitude			
S-054	32.81856	-117.09600	S-054.jpg

<p>Located on the south side of Tierrasanta Blvd, between Rueda Dr and Ducos Pl, at a trailhead.</p> <p>Sign is in good condition and location is very visible.</p>	None.

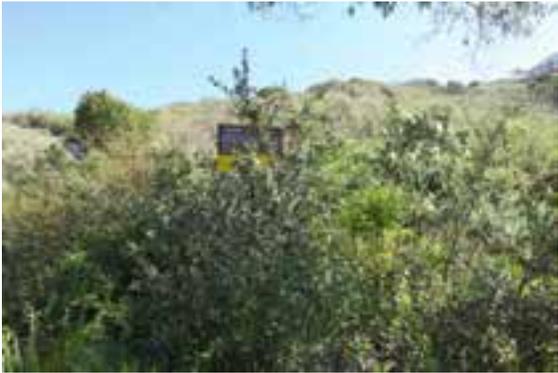
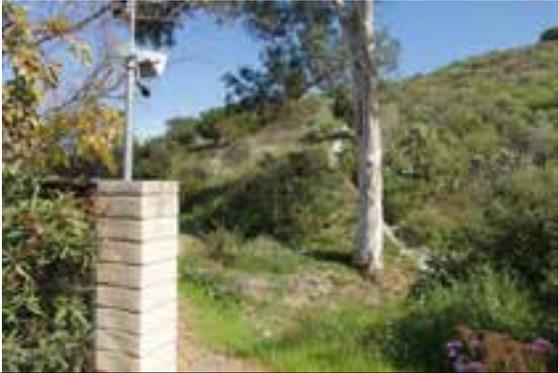
Sign ID	Coordinates		Photo	Description	Recommendation
	Latitude	Longitude			
S-060	32.83694	-117.07958	<p>S-060a.jpg</p>

<p>Located at the end of Callejon Quintana.</p> <p>Sign is partially obscured by vegetation but is in good condition. Location is near what appears to be a social trail that runs behind the homes.</p>	<p>Trim vegetation around sign at current location or move closer to sidewalk.</p>

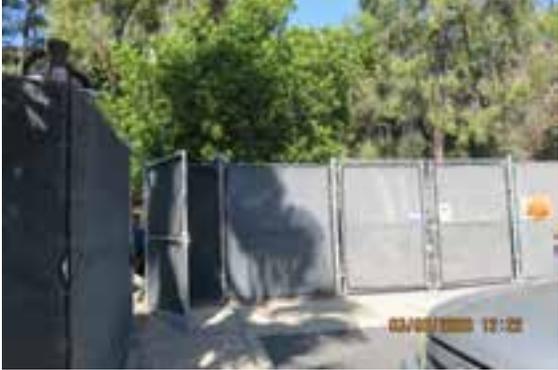
Sign ID	Coordinates		Photo	Description	Recommendation
	Latitude	Longitude			
S-067	32.83936	-117.09614	S-067.jpg

<p>Located at the pocket park off of Portobelo Dr.</p> <p>No sign is present. The coordinates provided are for a location behind a fenced area. A worker was asked about the presence of a sign; he has never seen a warning sign at the location in 20 years.</p>	None.

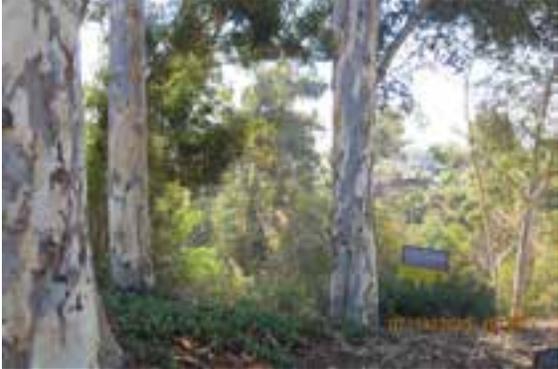
Sign ID	Coordinates		Photo	Description	Recommendation
	Latitude	Longitude			
S-069	32.82239	-117.08453	TS03 S-003 S-069.jpg

<p>Located on the south side of Rueda Drive, opposite Zorita Ct; see also TS03.</p> <p>Sign is in good condition. Duplicate of S-003.</p>	None.

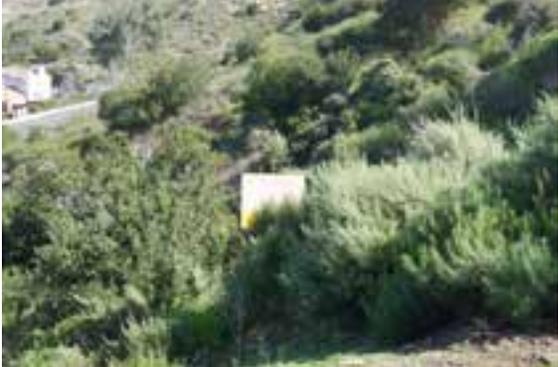
Sign ID	Coordinates		Photo	Description	Recommendation
	Latitude	Longitude			
S-070	32.83606	-117.08039	S-070.jpg

<p>Located at the end of Terraza Playa Catalina.</p> <p>Sign is very faded and not legible and obscured by vegetation. Should be moved and replaced.</p>	Replace sign and relocate closer to the end of the road.

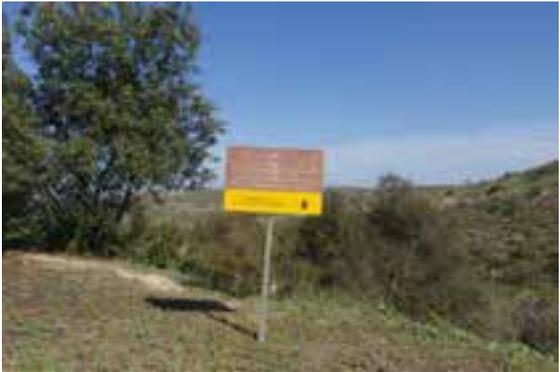
Sign ID	Coordinates		Photo	Description	Recommendation
	Latitude	Longitude			
S-071	32.83619	-117.07978	S-071.jpg

<p>Located at the end of Playa Catalina.</p> <p>Sign is faded and description of project area is no longer legible. Location is very visible.</p>	Replace sign.

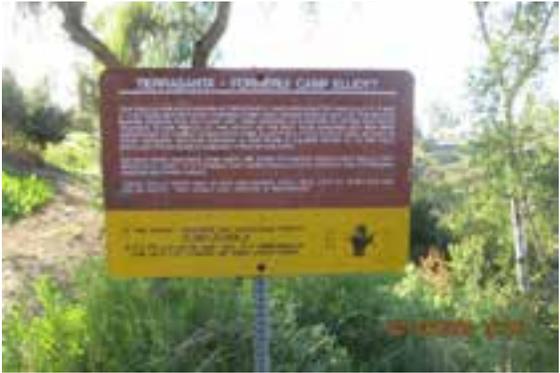
Sign ID	Coordinates		Photo	Description	Recommendation
	Latitude	Longitude			
S-076	32.82397	-117.09064	<p>S-028 S-076.jpg</p>

<p>Located at the end of Cartulina Road.</p> <p>Project area description is legible on sign but the bottom yellow portion, which contains instructions if MEC item is found, is beginning to fade. Duplicate of S-028.</p>	<p>Monitor condition of sign; may need to be replaced prior to next review.</p>

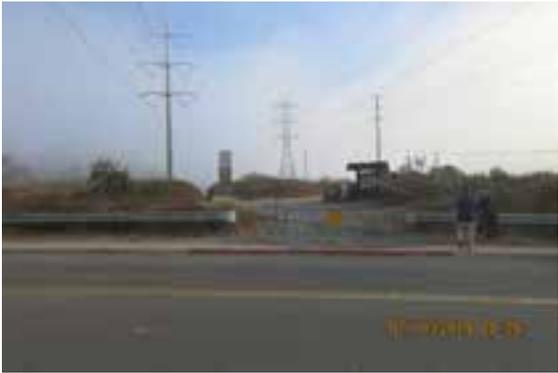
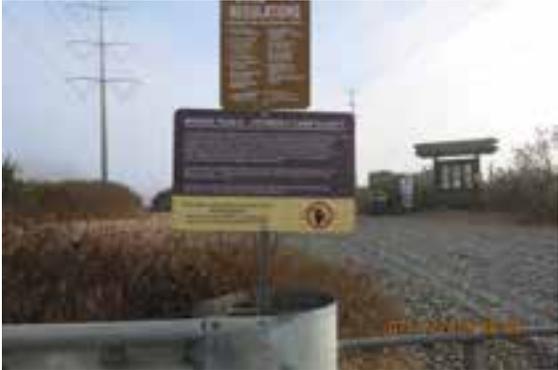
Sign ID	Coordinates		Photo	Description	Recommendation
	Latitude	Longitude			
S-077	32.82294	-117.07899	<p>S-077 S-094 a.jpg</p>

<p>Located on the north side of Calle de Vida at an entrance to Mission Trails Regional Park; See also MT58.</p> <p>Sign is in good condition, and the location is very visible. Duplicate of S-094.</p>	None.

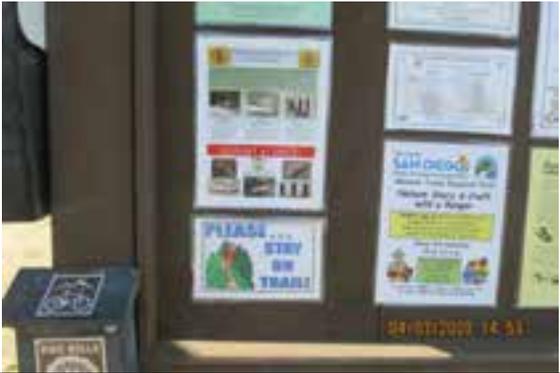
Sign ID	Coordinates		Photo	Description	Recommendation
	Latitude	Longitude			
S-078	32.82528	-117.07444	S-078.jpg

<p>Located at a major intersection near the entrance to Mission Trails Regional Park from Clairemont Mesa Blvd.</p> <p>No sign is present, but a 3Rs flyer is posted on the kiosk.</p>	None. Sign is located at the entrance to Mission Trails Regional Park from Clairemont Mesa Blvd, at the end of the wood bridge (see S-095).

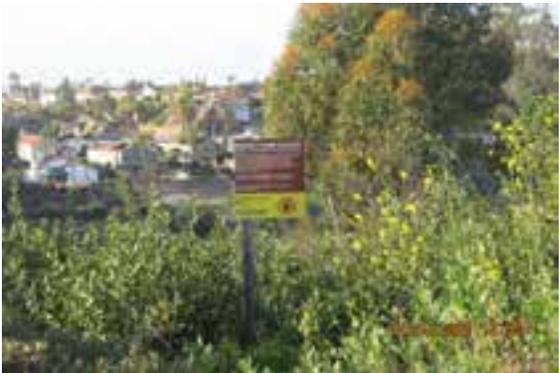
Sign ID	Coordinates		Photo	Description	Recommendation
	Latitude	Longitude			
S-079	32.82971	-117.07826	S-079.jpg

<p>Located at the end of Valdina Way, at the top of a steep slope.</p> <p>Only half of the sign is present.</p>	Replace sign.

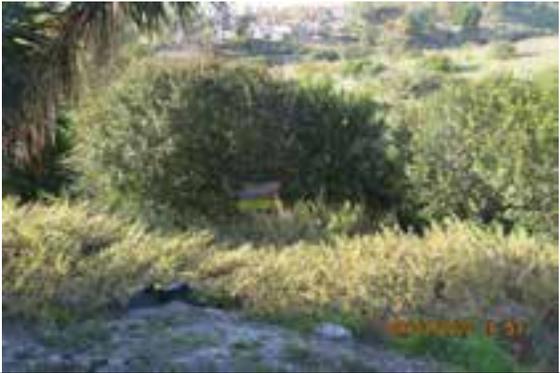
Sign ID	Coordinates		Photo	Description	Recommendation
	Latitude	Longitude			
S-080	32.82997	-117.07879	S-080.jpg

<p>Located at the end of Tinasa Way, down a steep slope.</p> <p>Sign is in very good condition and visible but is becoming obscured by vegetation.</p>	<p>Trim vegetation around the sign.</p> <p>Consider moving to the top of the slope.</p>

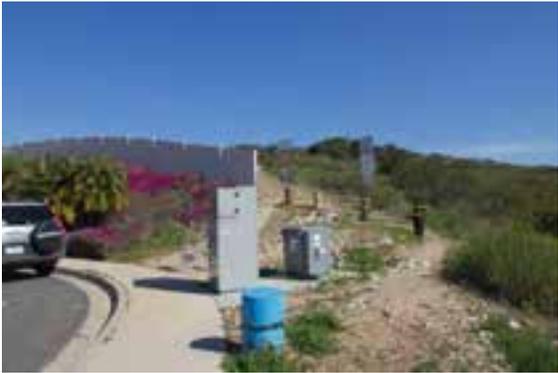
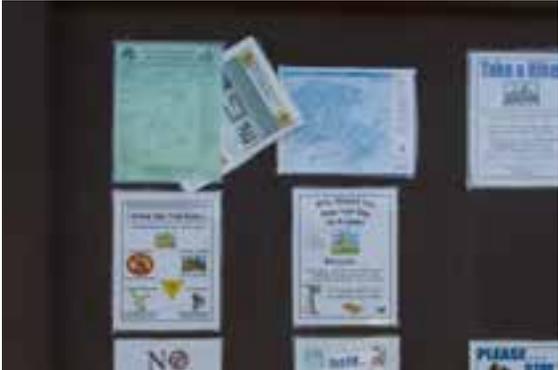
Sign ID	Coordinates		Photo	Description	Recommendation
	Latitude	Longitude			
S-081	32.83744	-117.07686	<p>MT60 S-081 S-097.jpg</p>

<p>Located at the end of Corte Playa Catalina, at a trailhead to Mission Trails Regional Park; see also MT60 and MT61.</p> <p>The 3Rs flyer was not attached to the kiosk.</p> <p>No sign is present. Duplicate of S-097.</p>	<p>Reattach 3Rs flyer to kiosk or add sign to kiosk at MT61.</p>

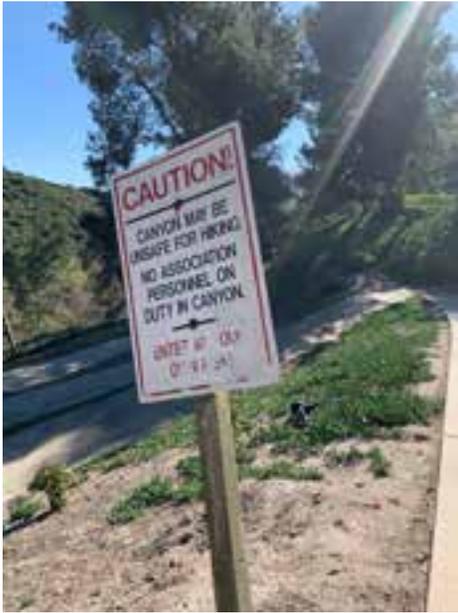
Sign ID	Coordinates		Photo	Description	Recommendation
	Latitude	Longitude			
S-087	32.82772	-117.11208	<p>S-087.jpg</p>

<p>Located at a trail junction between Park Crest Ln and Lemonwood Ln.</p> <p>General warning sign at coordinates provided. MEC warning sign located at S- 108, ~600 feet down trail.</p>	None.

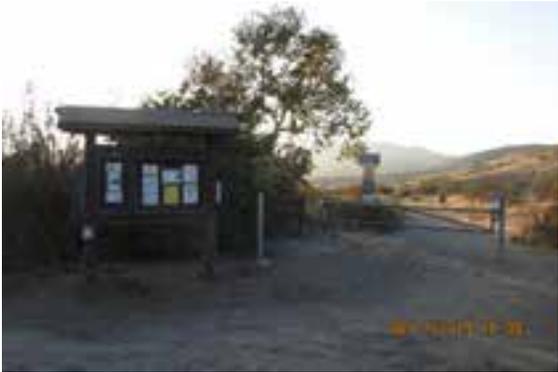
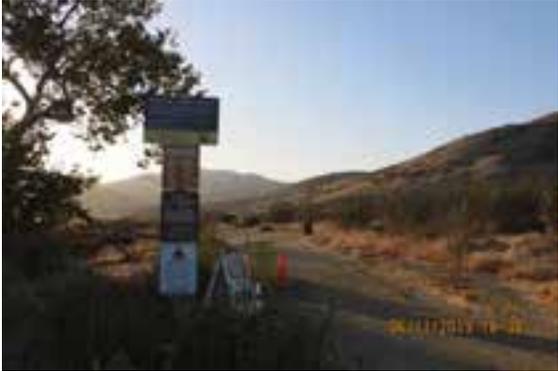
Sign ID	Coordinates		Photo	Description	Recommendation
	Latitude	Longitude			
S-088	32.84728	-117.03141	<p>MT49a S-088.jpg</p>

<p>Located at the trailhead of the equestrian center; see also MT49.</p> <p>Sign is in very good condition and the location is very visible.</p>	None.

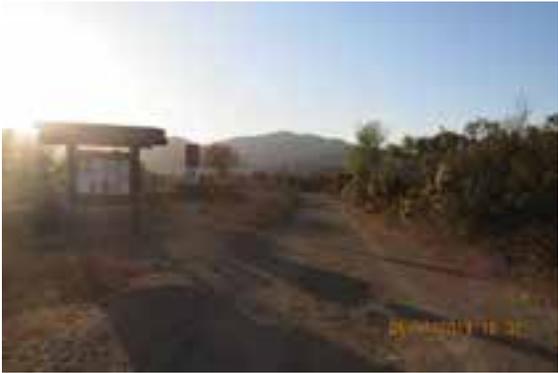
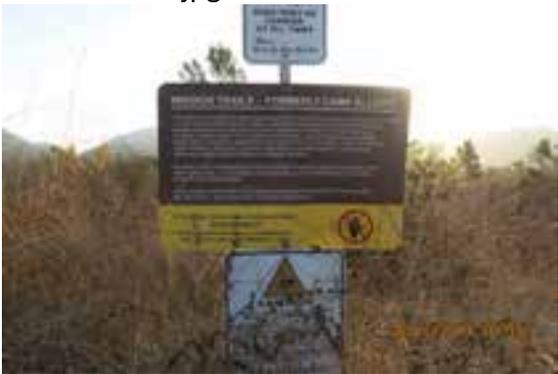
Sign ID	Coordinates		Photo	Description	Recommendation
	Latitude	Longitude			
S-089	32.84591	-117.03056	<p>MT50a S-089.jpg</p>

<p>Located at the trailhead of the equestrian center; see also MT50.</p> <p>Sign is in very good condition and the location is very visible.</p>	None.

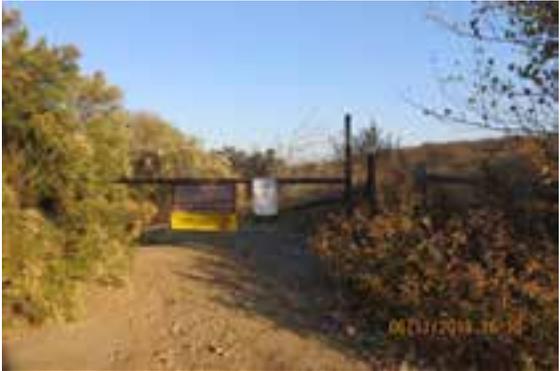
Sign ID	Coordinates		Photo	Description	Recommendation
	Latitude	Longitude			
S-090	32.84060	-117.03290	S-090.jpg

Located in Kumeyaay Camground. Sign is in good condition and in a very visible location.	None.

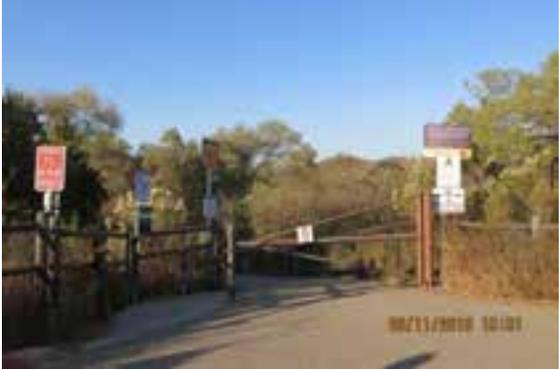
Sign ID	Coordinates		Photo	Description	Recommendation
	Latitude	Longitude			
S-091	32.84054	-117.03786	MT54 S-091.jpg

Located off of Father Junipero Serra Trail at the trailhead for Grasslands Crossing; see also MT54. Sign is in very good condition and is very visible. The last line of text on the sign is covered by mountain lion warning sign.	Move sign to another post so all of it is visible.

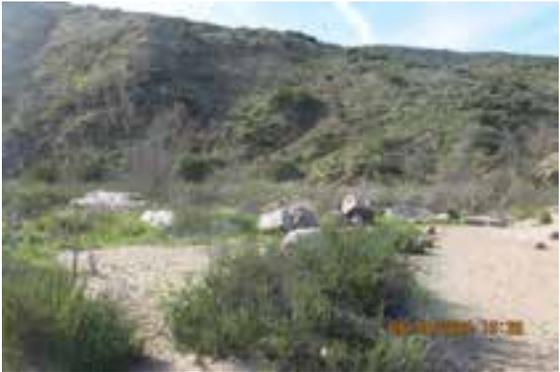
Sign ID	Coordinates		Photo	Description	Recommendation
	Latitude	Longitude			
S-092	32.83882	-117.04538	S-092.jpg

Located down Oak Canyon Trail. No sign located at coordinates provided or in the vicinity (walked ~200 feet past location). "Area Closed" signs at this location.	Add sign or include 3Rs flyer on trail kiosk.
