Fourth Five-Year Review Report

**Former Camp Elliott-Tierrasanta, Project Number J09CA006701
Former Camp Elliott-Mission Trails, Project Number J09CA006702
San Diego, California**

Date: 7 September 2021

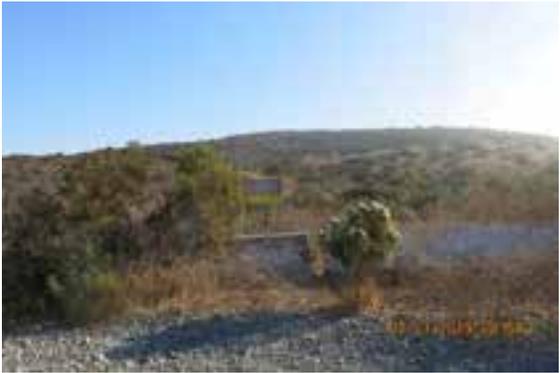
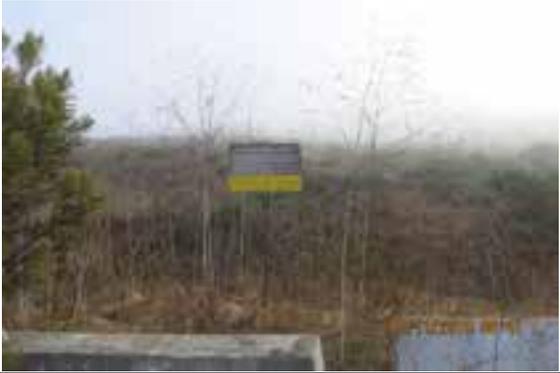
Sign ID	Coordinates		Photo	Description	Recommendation
	Latitude	Longitude			
S-093	32.82085	-117.07706	<p>MT42 S-008 S-093.jpg</p>

<p>Located inside of the south gate to Mission Trails Regional Park at Colina Dorado Drive; see also MT42 and TS36.</p> <p>Description of project area is still legible on the sign, but the bottom yellow portion is completely faded. The sign is not in a very visible location. Duplcate of S-008.</p>	<p>Recommned replacing sign and moving to a more visible location, such as MT44.</p>

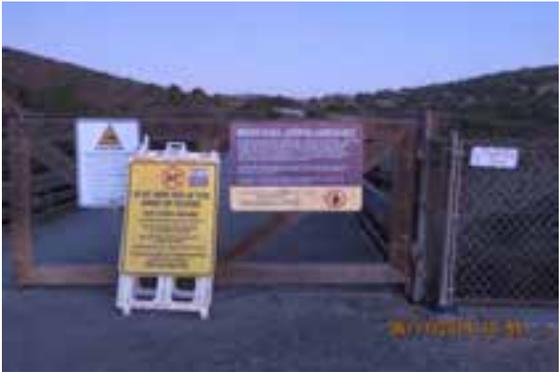
Sign ID	Coordinates		Photo	Description	Recommendation
	Latitude	Longitude			
S-095	32.82534	-117.07573	S-095.jpg

<p>Located on the east end of a wood bridge at Mission Trails Regional Park entrance off of Clairemont Mesa Blvd.</p> <p>Sign is in good condition and location is very visible.</p>	None.

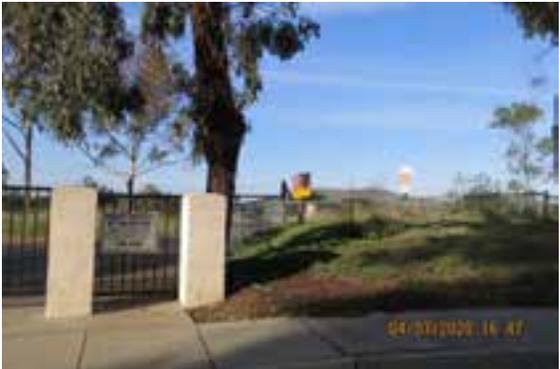
Sign ID	Coordinates		Photo	Description	Recommendation
	Latitude	Longitude			
S-096	32.82902	-117.07648	S-009 S-096.jpg

<p>Located just outside of a fenced area, near a trailhead.</p> <p>Sign is legible and in a very visible location. Duplicate of S-009.</p>	None.

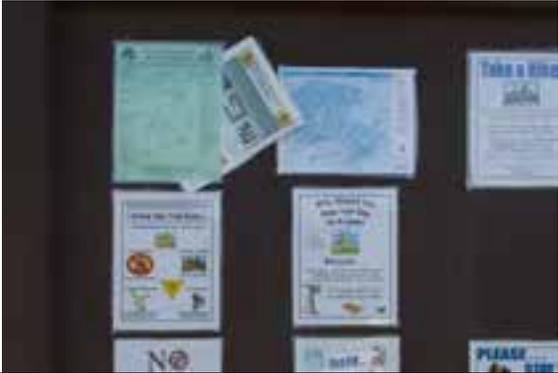
<p>MT61.jpg</p>

<p>Located at the end of Corte Playa Catalina, at a trailhead to Mission Trails Regional Park; see also MT60 and MT61.</p> <p>The 3Rs flyer is not attached to the kiosk.</p> <p>No sign is present. Duplicate of S-081.</p>	<p>Reattach 3Rs flyer to kiosk or add sign to kiosk at MT61.</p>

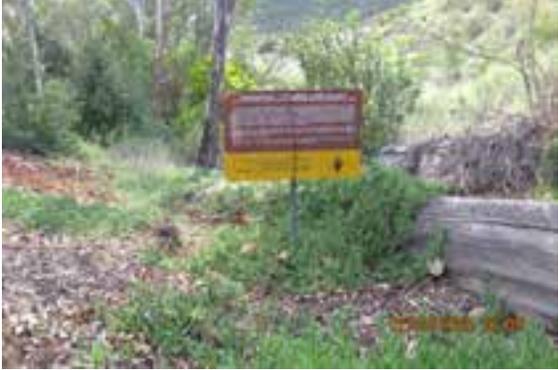
Sign ID	Coordinates		Photo	Description	Recommendation
	Latitude	Longitude			
S-099	32.81596	-117.09971	S-099.jpg

Located on the west side of La Cuenta Drive, between Baroque Lane and Valldemosa Lane. Description of project area is legible, but yellow portion, which contains instructions if MEC item is found, is faded.	Monitor condition of sign; may need to be replaced prior to next review.

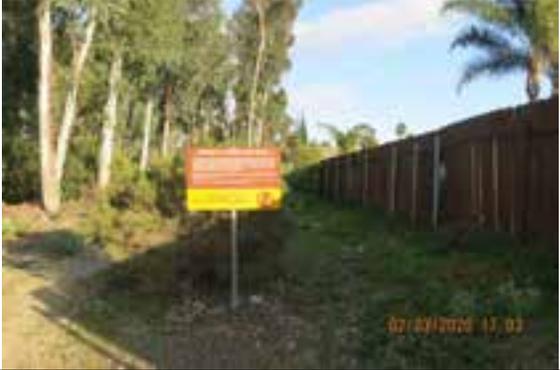
Sign ID	Coordinates		Photo	Description	Recommendation
	Latitude	Longitude			
S-100	32.82512	-117.08240	S-100.jpg

<p>Located on west side of Seda Drive, between Promesa Dr and Calle De Vida, at a trailhead.</p> <p>Sign is in very good condition.</p>	None.

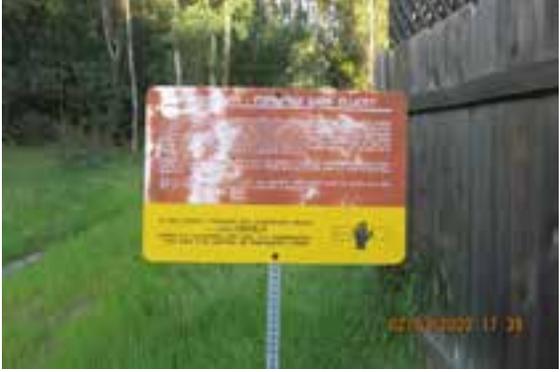
Sign ID	Coordinates		Photo	Description	Recommendation
	Latitude	Longitude			
S-101	32.82184	-117.08552	S-101.jpg

<p>Located at the end of Tambor Ct, on the side of the home at 4296 Tambor Ct and along a concrete stormwater drain.</p> <p>Sign is very faded. Location is ~150 feet from S-034 (where there is no sign).</p>	Replace sign and consider relocating to coordinates provided for S-034.

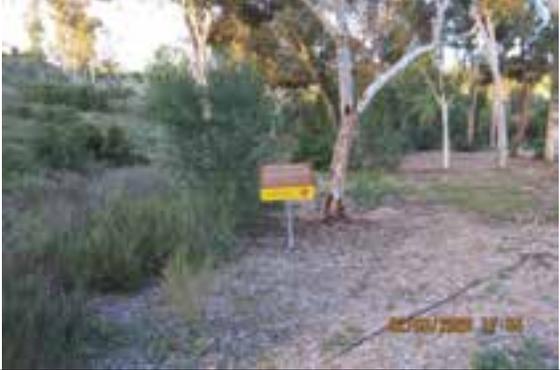
Sign ID	Coordinates		Photo	Description	Recommendation
	Latitude	Longitude			
S-102	32.81801	-117.09200	S-102.jpg

<p>Located on the north side of Tierrasanta Blvd, between Rueda Dr and Tambor Rd.</p> <p>Sign is legible and visible.</p>	None.

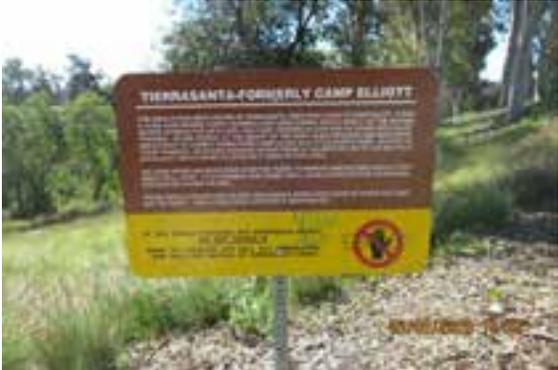
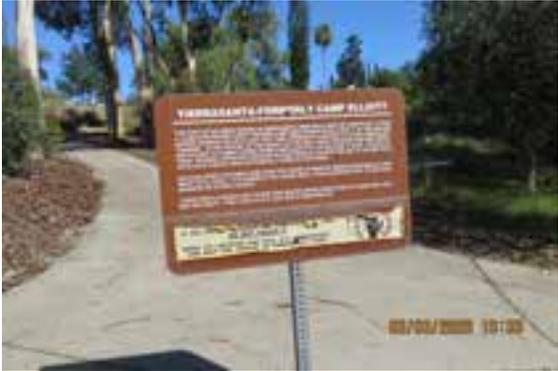
Sign ID	Coordinates		Photo	Description	Recommendation
	Latitude	Longitude			
S-103	32.83414	-117.10566	<p>S-103a.jpg (bearing = 335°)</p>

<p>Double sided sign along paved trail.</p> <p>Sign at bearing 335° has a small amount of graffiti but is in very good condition. Yellow portion of sign at bearing 145° is peeling but is still completely legible.</p>	<p>Monitor condition of sign; may need to be replaced prior to next review.</p>

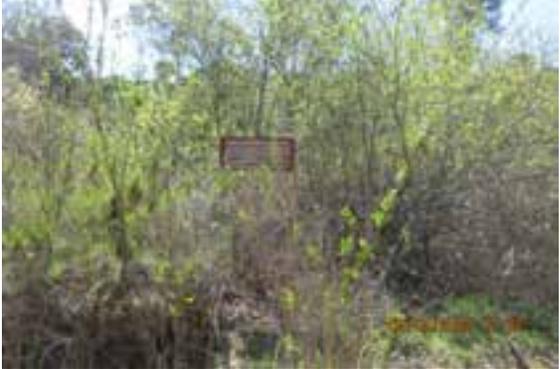
Sign ID	Coordinates		Photo	Description	Recommendation
	Latitude	Longitude			
S-104	32.83263	-117.09963	S-104.jpg

<p>Located on a trail in Shephard Canyon.</p> <p>Sign is legible but is partially obscured by vegetation.</p>	Trim vegetation around the sign.

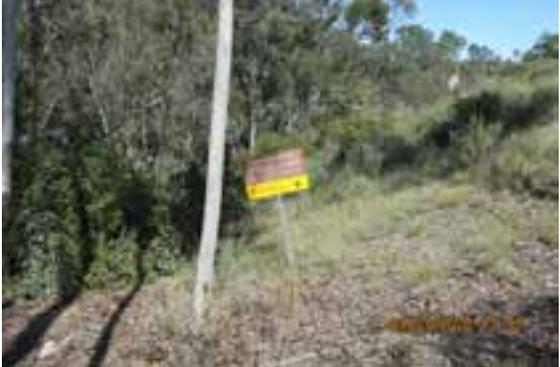
Sign ID	Coordinates		Photo	Description	Recommendation
	Latitude	Longitude			
S-105	32.83316	-117.09427	S-105.jpg

<p>Located on the north side of Villaricca Way.</p> <p>Description of project area is very faded but yellow portion, which contains instructions if MEC item is found, is in good condition.</p>	Replace sign.

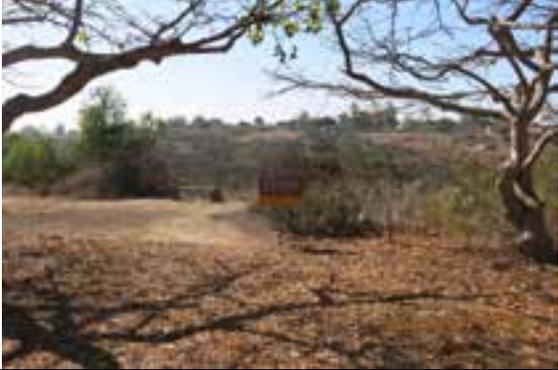
Sign ID	Coordinates		Photo	Description	Recommendation
	Latitude	Longitude			
S-110	32.81786	-117.10059	S-110.jpg

MEC warning sign observed at Roadrunner Park, at the top of the canyon. Sign is in good condition and is in a visible location.	None.

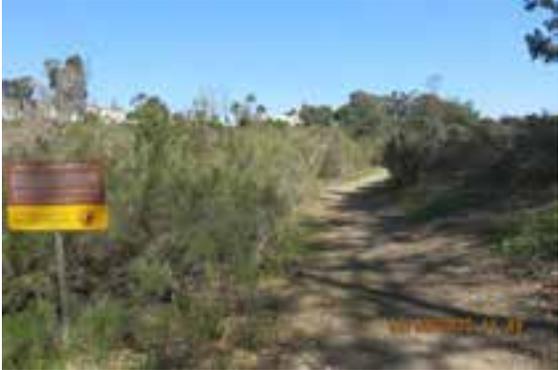
Sign ID	Coordinates		Photo	Description	Recommendation
	Latitude	Longitude			
S-112	32.83347222	-117.09975	<p>TS69 S-112.jpg</p>

<p>Located at a trailhead for Lower North Shepherd Canyon Trail, next to a Villa Colina housing complex; see also TS69.</p> <p>Project description is fading on sign and the location is very visible.</p>	Monitor condition of sign; may need to be replaced prior to next review.

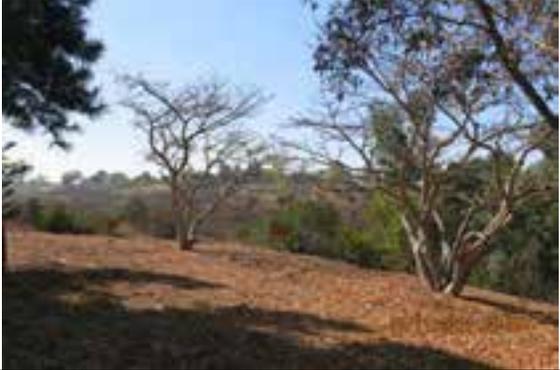
Sign ID	Coordinates		Photo	Description	Recommendation
	Latitude	Longitude			
S-113	32.81844	-117.10072	S-113.jpg

<p>Located at Roadrunner Park, at the top of the canyon slope.</p> <p>Sign is in good condition and is in a visible location.</p>	None.

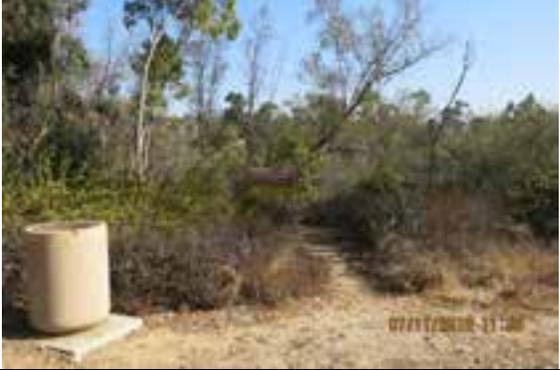
Sign ID	Coordinates		Photo	Description	Recommendation
	Latitude	Longitude			
S-114	32.81916	-117.09612	S-114.jpg

<p>Located on the north side of Tierrasanta Blvd, between Ducos Pl and Rueda Dr, at a trailhead.</p> <p>Sign is in good condition and is visible.</p>	None.

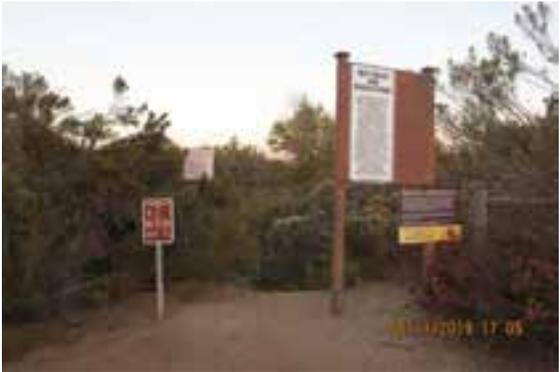
Sign ID	Coordinates		Photo	Description	Recommendation
	Latitude	Longitude			
S-115	32.84056	-117.03612	S-115.jpg

Located in Kumeyaay Campground. Sign is in good condition and is in a visible location.	None.

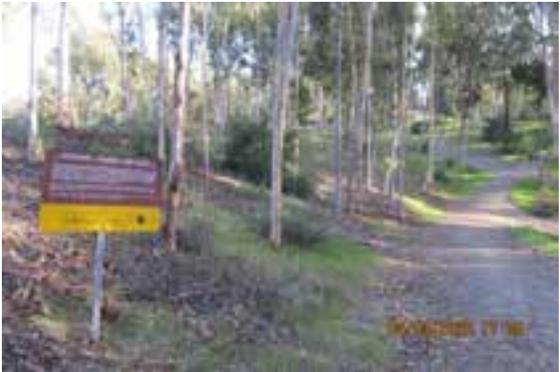
Sign ID	Coordinates		Photo	Description	Recommendation
	Latitude	Longitude			
S-116	32.83080	-117.08337	S-116.jpg

Located on the west side of Via Valarta. Sign is at a trailhead for East Shephard Canyon. Project area description is legible but the bottom yellow portion, which contains instructions if MEC item is found, is faded.	Replace sign.

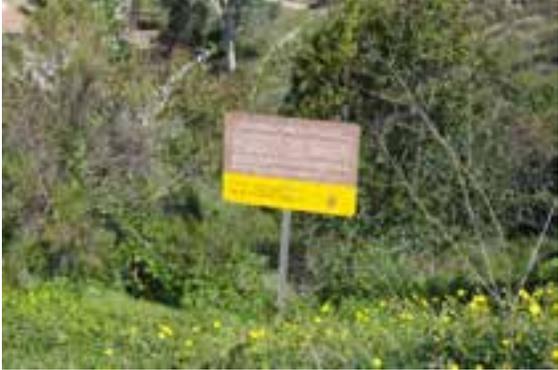
Sign ID	Coordinates		Photo	Description	Recommendation
	Latitude	Longitude			
S-117	32.83622	-117.07926	<p>S-117.jpg</p>

<p>Located off of Via Playa Los Santos.</p> <p>Sign is located next to a home at 5092 Via Playa Los Santos, ~115 feet southwest of S-072.</p> <p>Sign is visible and legible, but is beginning to show signs of wear.</p>	<p>Monitor condition of sign; may need to be replaced prior to next review. Consider moving to intended location (S-072).</p>
