**EAST TWIN CREEK 2 LEVEE SYSTEM**  
**SAN BERNARDINO COUNTY, CALIFORNIA**  
**NLD SYSTEM ID # 3805010079**

**PERIODIC INSPECTION REPORT NO 1**  
**GENERALIZED EXECUTIVE SUMMARY**

**FINAL SYSTEM RATING: MINIMALLY ACCEPTABLE**  
**FINAL RATING DATE: SEPTEMBER 23, 2013**

PERIODIC INSPECTION REPORT PREPARED BY TETRA TECH  
FOR THE U.S. ARMY CORPS OF ENGINEERS, LOS ANGELES DISTRICT

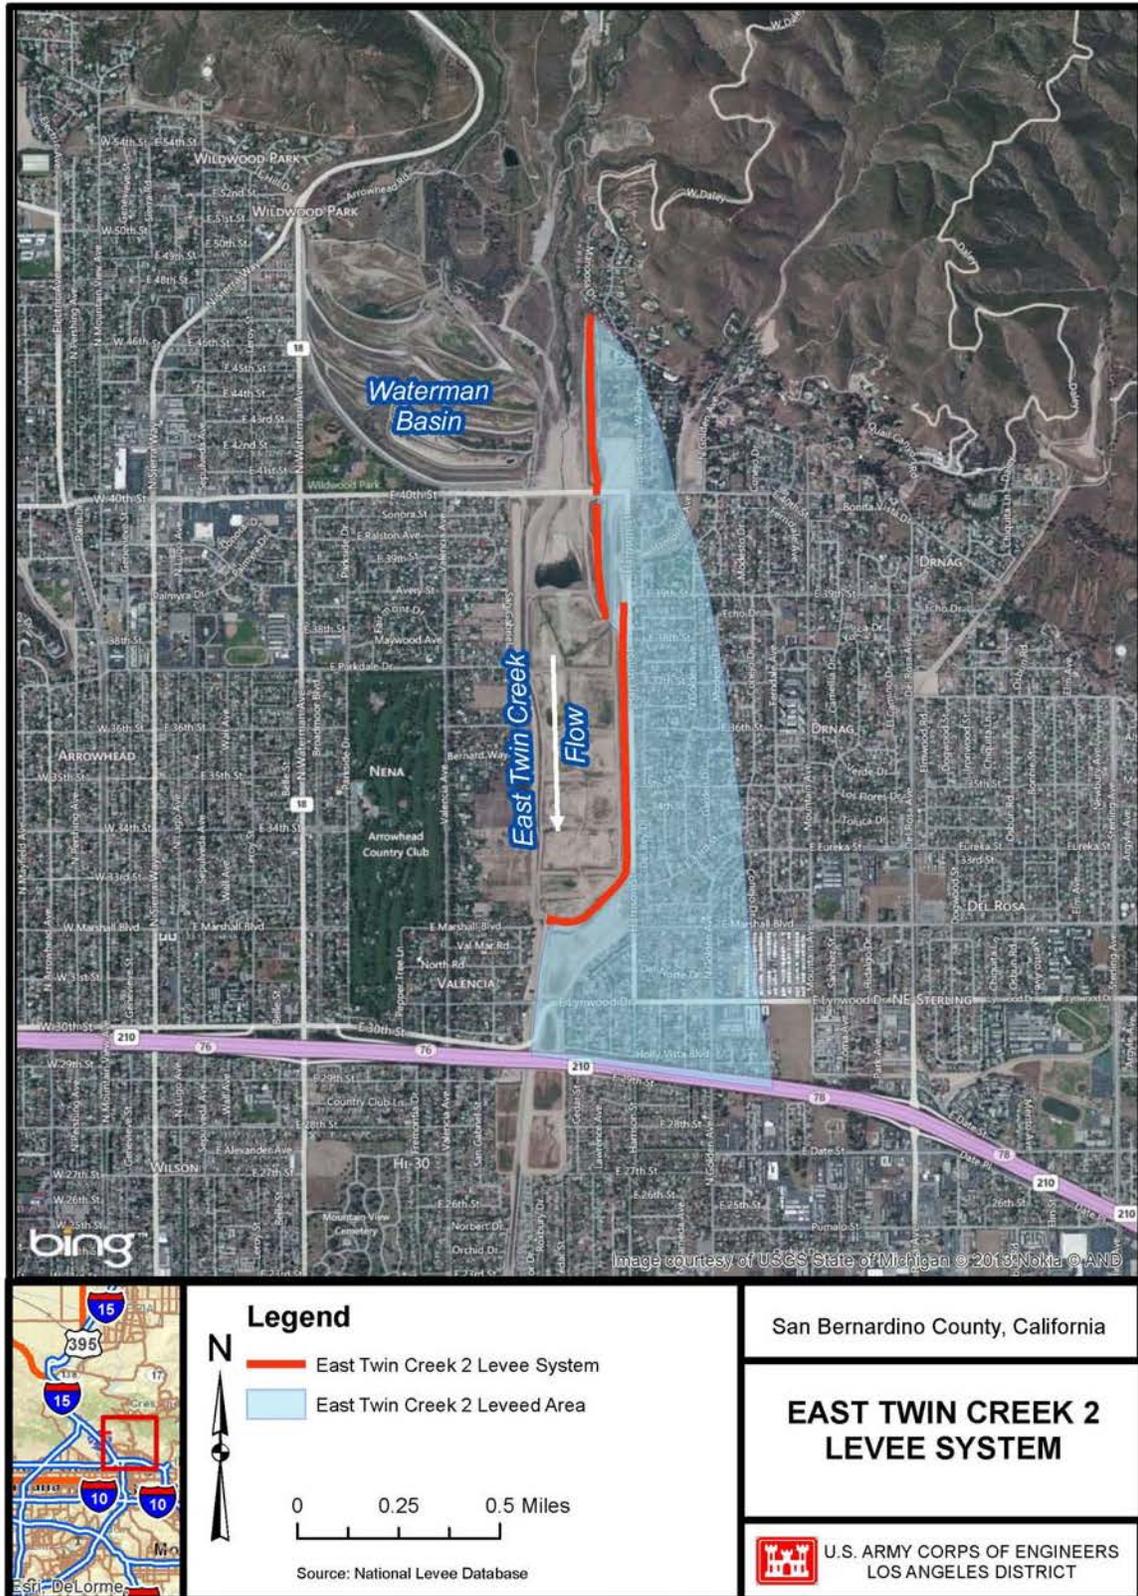
Figure 1: East Twin Creek 1 Levee System

Note: This NLD Leveed Area supersedes the leaved area shown in the PI Report.

East Twin Creek 2 Levee System is located in the City of San Bernardino, in the County of San Bernardino, in the State of California. East Twin Creek 2 Levee System is located along the left/east bank of East Twin Creek (Figure 1). East Twin Creek 2 Levee System originally constructed by local interests but later improved by the United States Army Corps of Engineers (USACE). The East Twin Creek 2 Levee System levee embankment extends from approximately 3,074 feet upstream of 40th Street to the East Twin Creek Channel inlet structure at Marshall Boulevard, a distance of 8,670 feet. East Twin Creek 2 Levee System also includes a total of 127 feet of channel at its downstream limit along the left/east bank of East Twin Creek Channel. East Twin Creek 2 Levee System is locally operated and maintained by the San Bernardino County Flood Control District (hereafter the "County"). The National Levee Database (NLD) System ID Number for East Twin Creek 2 Levee System is 3805010079.

On June 13, 2013, the leveed area was revised per signature of the Levee Safety Officer and is shown on Figure 1. This leveed area supersedes the leveed area in the Periodic Inspection Report No. 1.
