**LOS ANGELES RIVER/COMPTON
CREEK 2 LEVEE SYSTEM
LOS ANGELES COUNTY, CALIFORNIA
NLD SYSTEM ID # 3805010033**

**PERIODIC INSPECTION REPORT NO 1
GENERALIZED EXECUTIVE SUMMARY**

**FINAL SYSTEM RATING: UNACCEPTABLE
FINAL RATING DATE: MARCH 20, 2013**

PERIODIC INSPECTION REPORT PREPARED BY URS GROUP, INC.
FOR THE U.S. ARMY CORPS OF ENGINEERS, LOS ANGELES DISTRICT

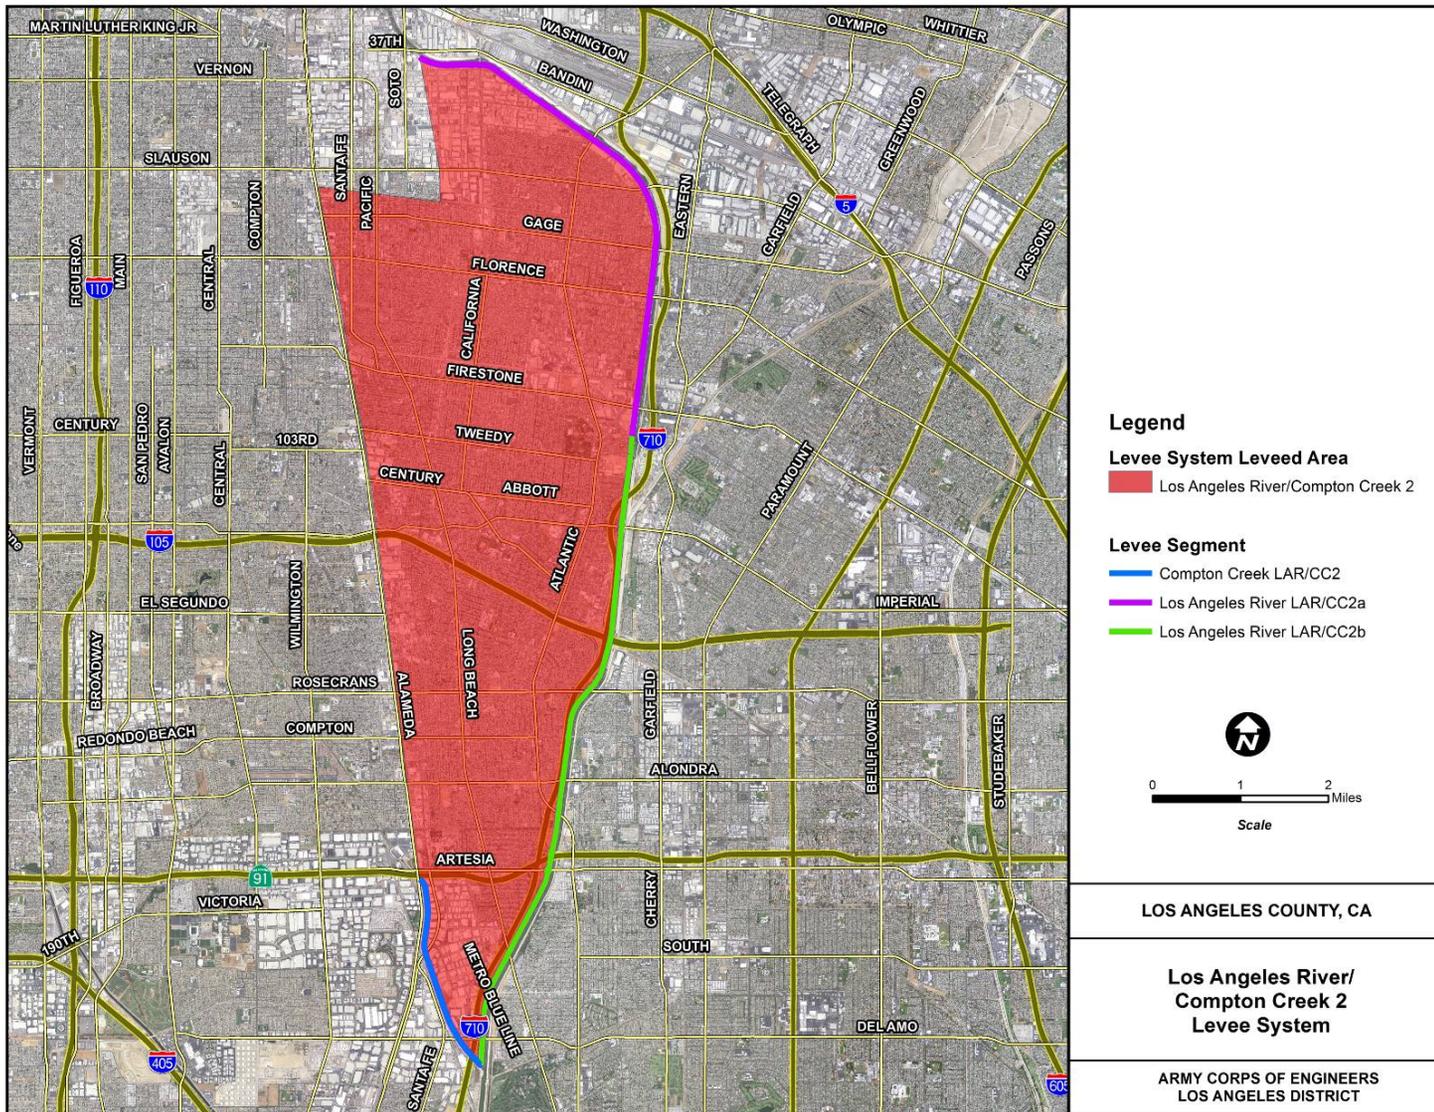
Figure 1. Los Angeles River/Compton Creek 2 Levee System

The LAR/CC2 Levee System, shown on Figure 1, is located in the County of Los Angeles, California and is in the Los Angeles County Drainage Area (LACDA).
