# **LOS ANGELES RIVER 7 LEVEE SYSTEM**

## **LOS ANGELES COUNTY, CALIFORNIA**

**PERIODIC INSPECTION REPORT NO 1**  
**GENERALIZED EXECUTIVE SUMMARY**

PERIODIC INSPECTION REPORT PREPARED BY  
URS GROUP, INC.  
FOR THE U.S. ARMY CORPS OF ENGINEERS, LOS ANGELES DISTRICT

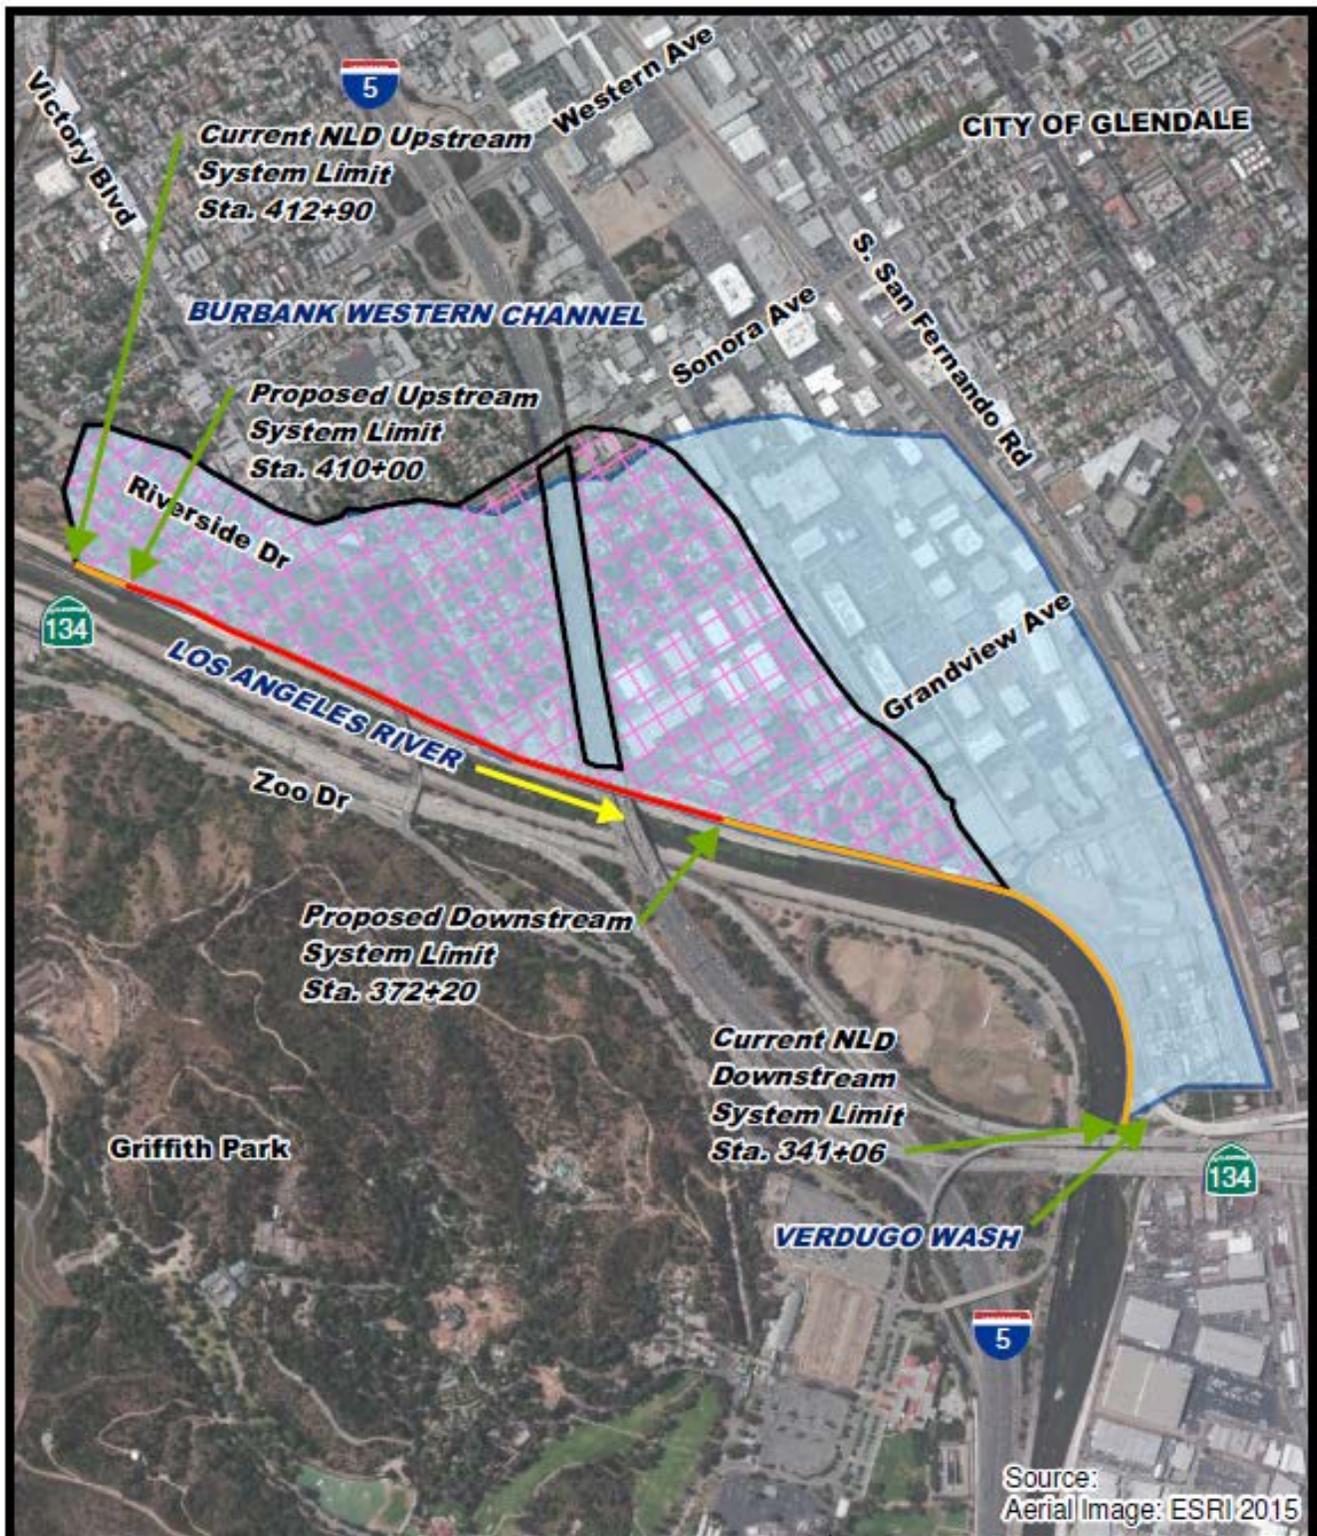
## LOCATION AND LEAVED AREA MAP

URS also reviewed the leveed area in the NLD and proposed a modified leveed area based on the revised extent of the LAR7 Levee System recommended by this PI. After discussions with USACE-SPL, it was decided to revise the leveed area as shown in the Location and Leveed Area Map (Figure 1), which also shows the version that was in the NLD at the outset of this PI.
