RIO HONDO UPPER 2 LEVEE SYSTEM

LOS ANGELES COUNTY, CALIFORNIA NLD SYSTEM ID # 3805010101

PERIODIC INSPECTION REPORT NO 1
GENERALIZED EXECUTIVE SUMMARY

PERIODIC INSPECTION REPORT PREPARED BY PRAAD/GENTERRA/TABER, LLC FOR THE U.S. ARMY CORPS OF ENGINEERS, LOS ANGELES DISTRICT

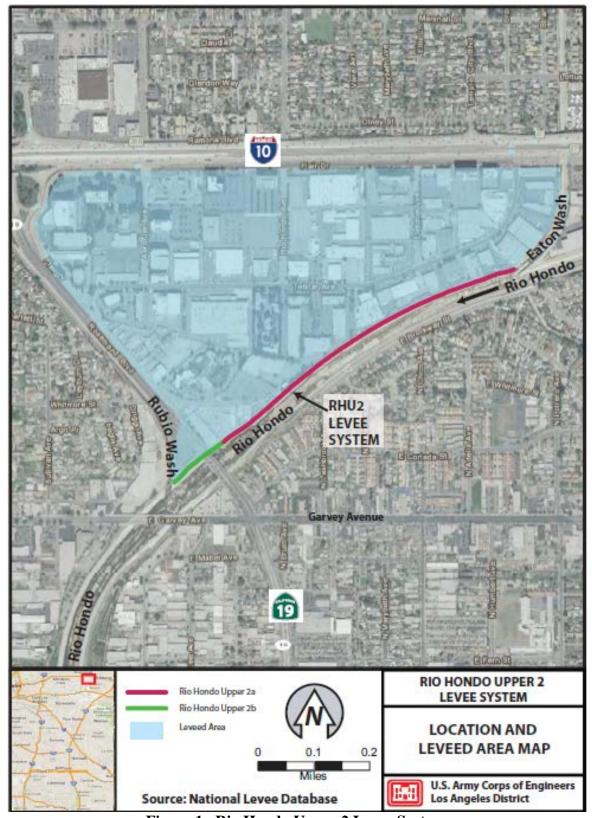
Figure 1. Rio Hondo Upper 2 Levee System

The RHU2 is located in the cities of El Monte and South El Monte, in Los Angeles County, in the State of California. The National Levee Database (NLD) shows the RHU2 along the right (west) bank of the Rio Hondo, from approximate STA. 671+00 (junction with Eaton Wash) to STA. 632+40 (junction with Rubio Wash), with a total length of about 0.73 miles (about 3,840 feet). The NLD System ID Number is 3805010101. Figure 1 shows the extent of and leveed area for the RHU2.
