SAN GABRIEL RIVER/COYOTE CREEK 1 LEVEE SYSTEM

**LOS ANGELES COUNTY, CALIFORNIA
NLD SYSTEM ID # 3805010018**

**PERIODIC INSPECTION REPORT NO 1
GENERALIZED EXECUTIVE SUMMARY**

**FINAL SYSTEM RATING: MINIMALLY ACCEPTABLE
FINAL RATING DATE: JUNE 25, 2015**

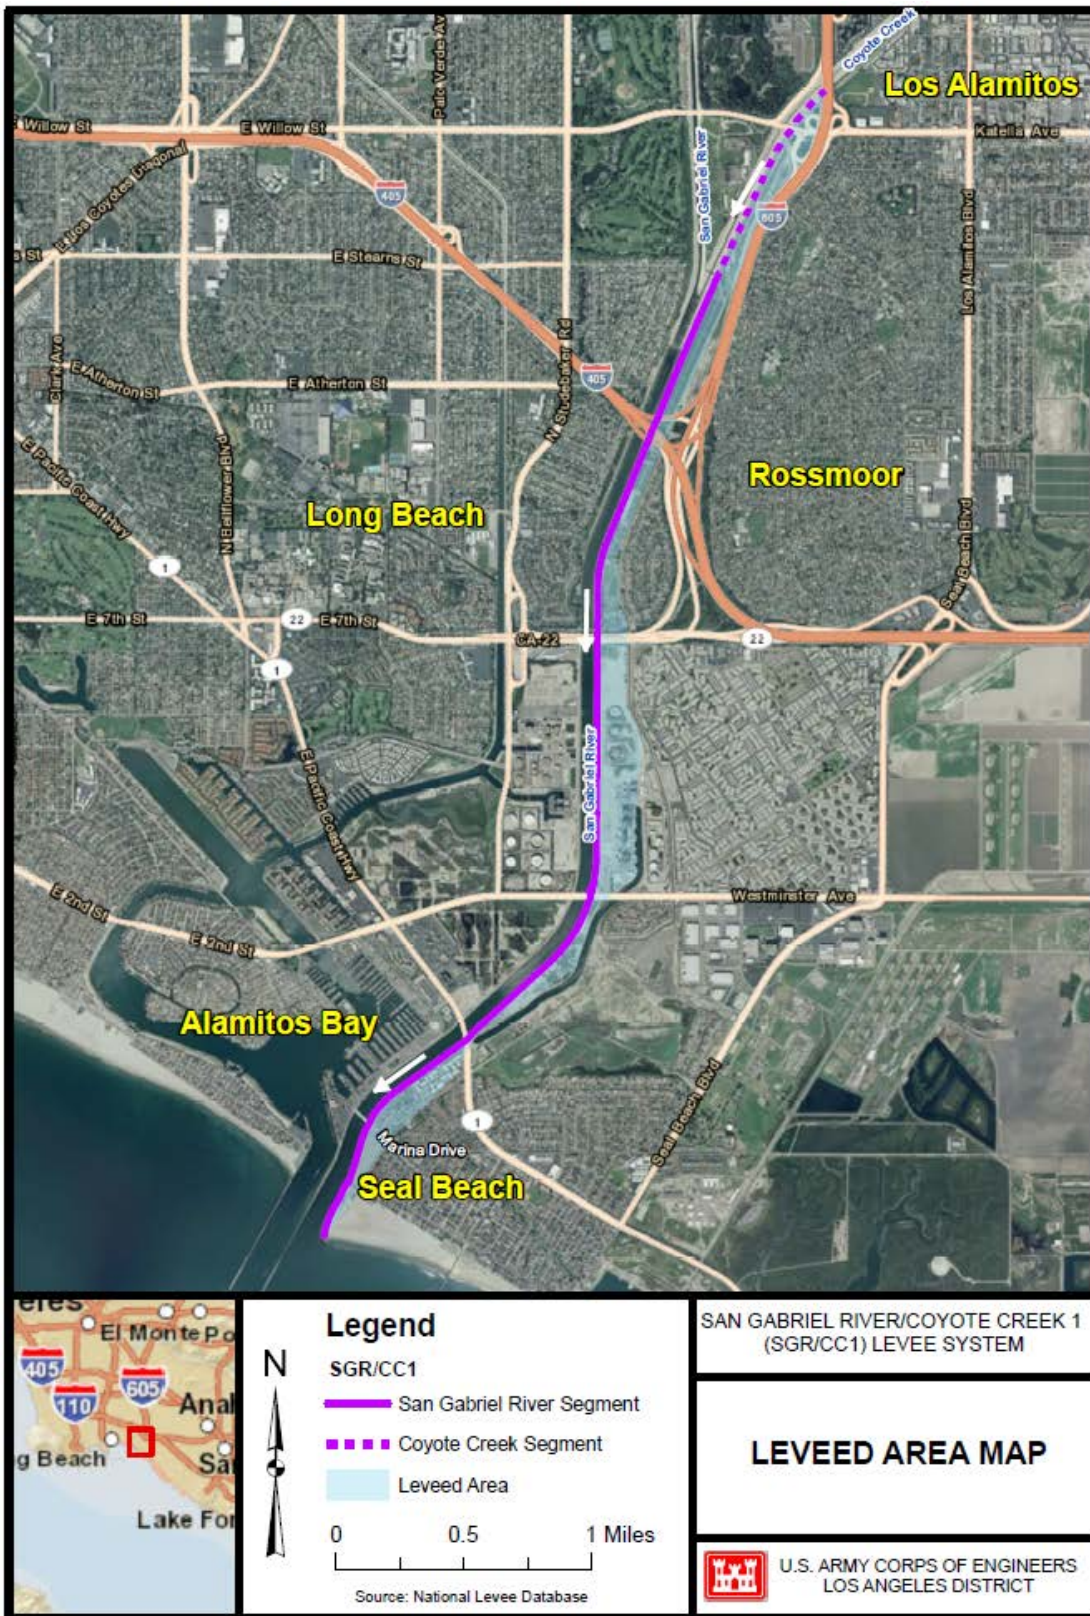
Figure 1. San Gabriel River – Coyote Creek 1 Levee System

The SGR/CC1 Levee System is located in the Cities of Los Alamitos, Seal Beach, and Long Beach, along the Los Angeles County and Orange County boundary, California. The total length of the system is about 27,249 feet (5.16 miles). Figure 1 below shows the extent of the SGR/CC1 Levee System.
