**LYTLE CREEK (MUSCOY)
LEVEE SYSTEM
SAN BERNARDINO COUNTY, CALIFORNIA
NLD SYSTEM ID # 3805010071**

**PERIODIC INSPECTION REPORT NO 1
GENERALIZED EXECUTIVE SUMMARY**

**FINAL SYSTEM RATING: MINIMALLY ACCEPTABLE
FINAL RATING DATE: OCTOBER 17, 2013**

PERIODIC INSPECTION REPORT PREPARED BY TETRA TECH
FOR THE U.S. ARMY CORPS OF ENGINEERS, LOS ANGELES DISTRICT

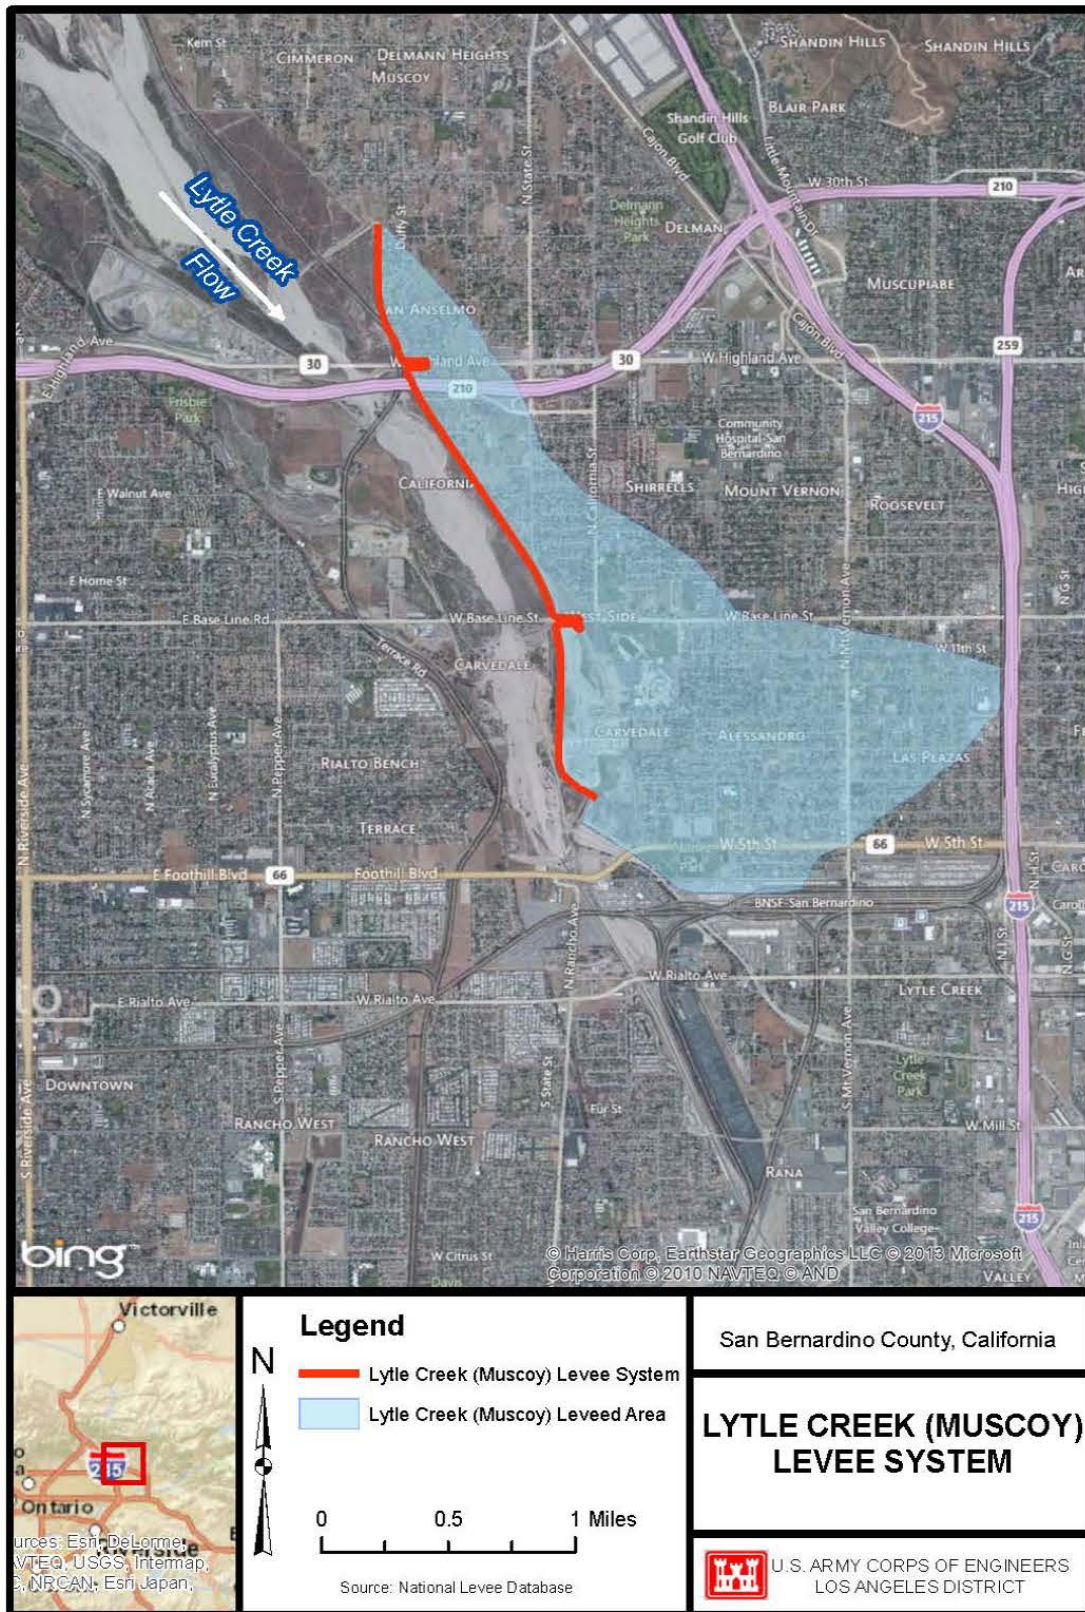
Figure 1: Lytle Creek (Muscoy) Levee System

Note: This NLD Leveed Area supersedes the leveed area shown in the PI Report.

Lytle Creek (Muscoy) Levee System is located in the City of San Bernardino, in the County of San Bernardino, in the State of California. It is crossed by the Southern Pacific railroad (SPRR), Highland Avenue, State Route 210 (SR 210), and Base Line Road (See Figure 1). Lytle Creek (Muscoy) Levee System is a flood-control improvement located along the eastern/left (looking downstream) bank of Lytle Creek. The portion of earthen levee with grouted rock revetment on the riverward slope starts about one mile downstream from Muscoy Groin No. 4, and extends downstream a distance of 13,085 feet. At that location the grouted rock revetment on the riverward slope changes into concrete revetment. The concrete revetment on the riverward slope extends downstream a distance of 151 feet. At that location the riverward slope, levee crown, and landward slope of the levee are all faced with concrete. This portion of the levee is known as the bypass structure. A floodwall stands on top of the crown of the bypass structure. Lytle Creek (Muscoy) Levee System was federally authorized and subsequently constructed by the United States Army Corps of Engineers (USACE). It is now entirely operated and maintained by the San Bernardino County Flood Control District (SBCFCD). The National Levee Database Number (NLD No.) for Lytle Creek (Muscoy) Levee System is 3805010071.

On June 13, 2013, the leveed area was revised per signature of the Levee Safety Officer and is shown on Figure 1. This leveed area supersedes the leveed area in the Periodic Inspection Report No. 1.
