RIO HONDO UPPER 4 LEVEE SYSTEM
LOS ANGELES COUNTY, CALIFORNIA
NLD SYSTEM ID # 3805010104

PERIODIC INSPECTION REPORT NO 1
GENERALIZED EXECUTIVE SUMMARY

FINAL SYSTEM RATING: MINIMALLY ACCEPTABLE
FINAL RATING DATE: JANUARY 23, 2014

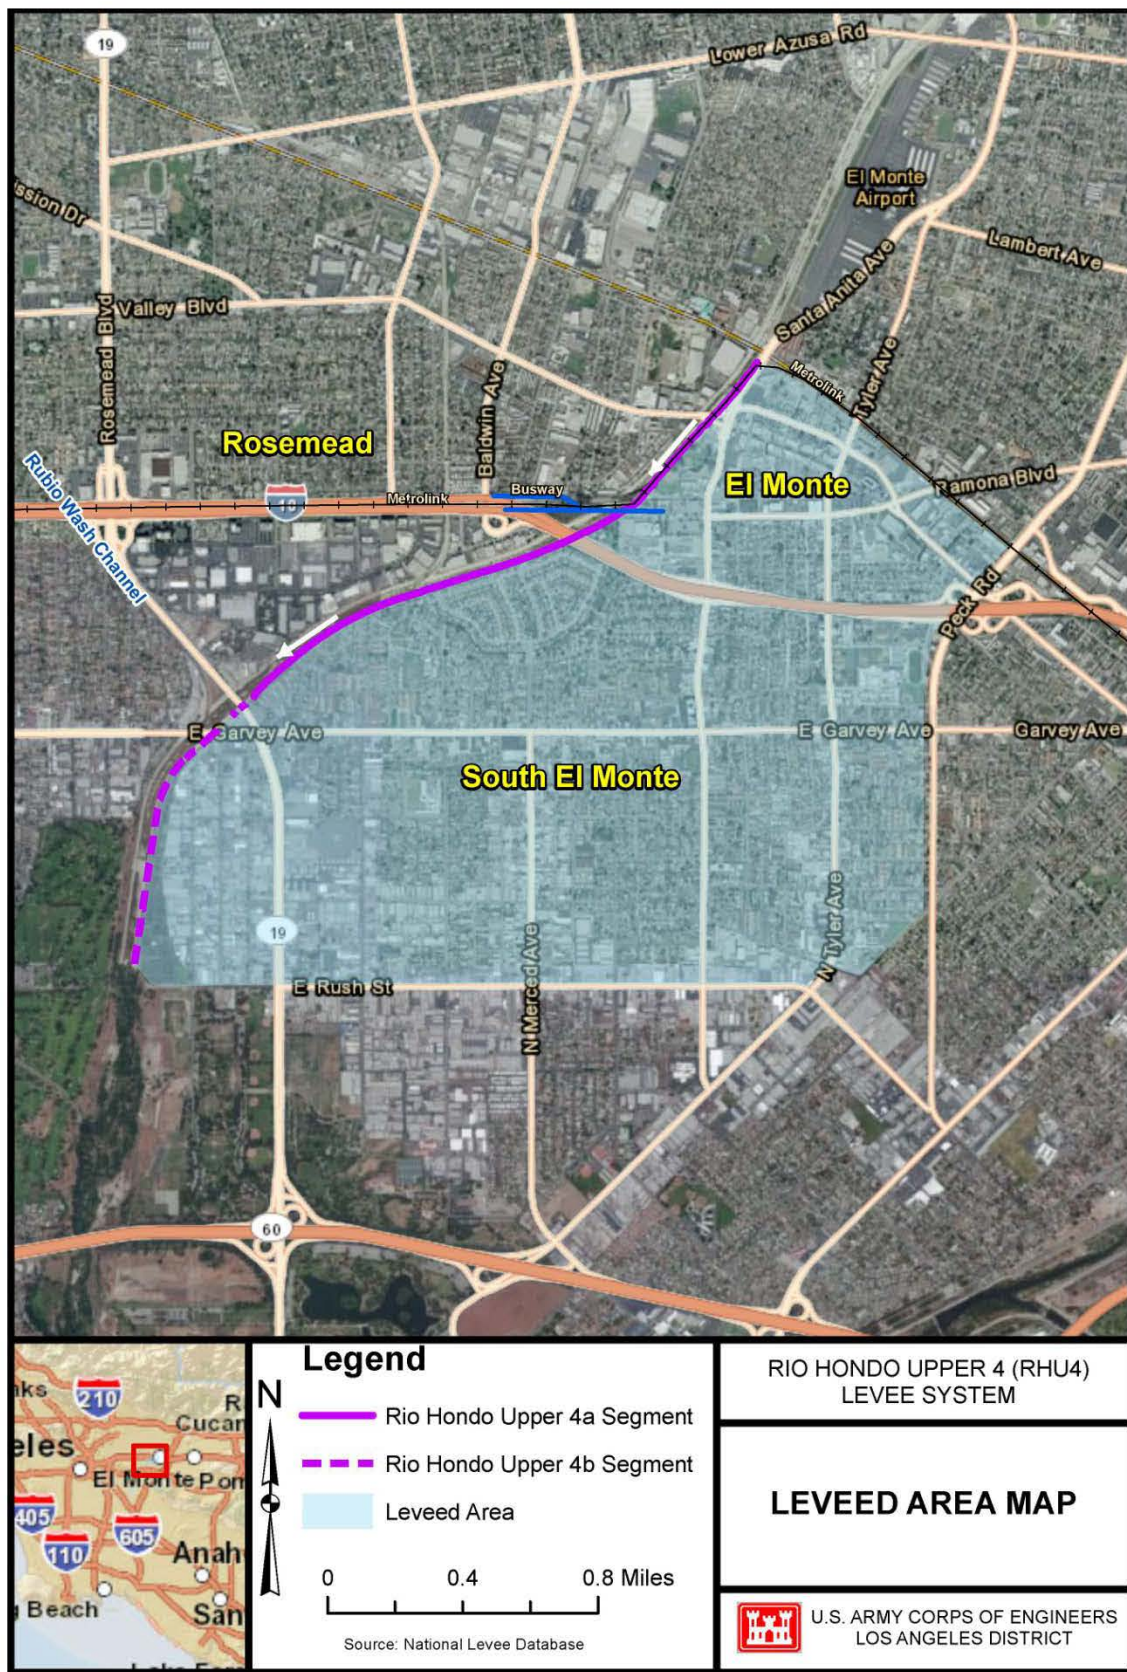
Figure 1. Rio Hondo Upper 4 Levee System

The RHU4 Levee System is a concrete-lined, trapezoidal channel with a subdrainage system below the invert. According to as-built plans, the RHU4 Levee System includes 6 bridge crossings, and 11 culverts (8 side-drainage structures) that penetrate through the levee and outlet into the upper Rio Hondo channel. Five additional culverts (5 side-drainage structures) and 3 floodwalls were observed during the field inspection.
