Riparian Ecosystem Restoration Plan for the Otay River Watershed: General Design Criteria and Site Selection

**Prepared for:
U. S. Army Corps of Engineers, Los Angeles District, Regulatory Branch**

**R. Daniel Smith and Charles V. Klimas
U.S. Army Engineer Research and Development Center,
Waterways Experiment Station**

December 2006

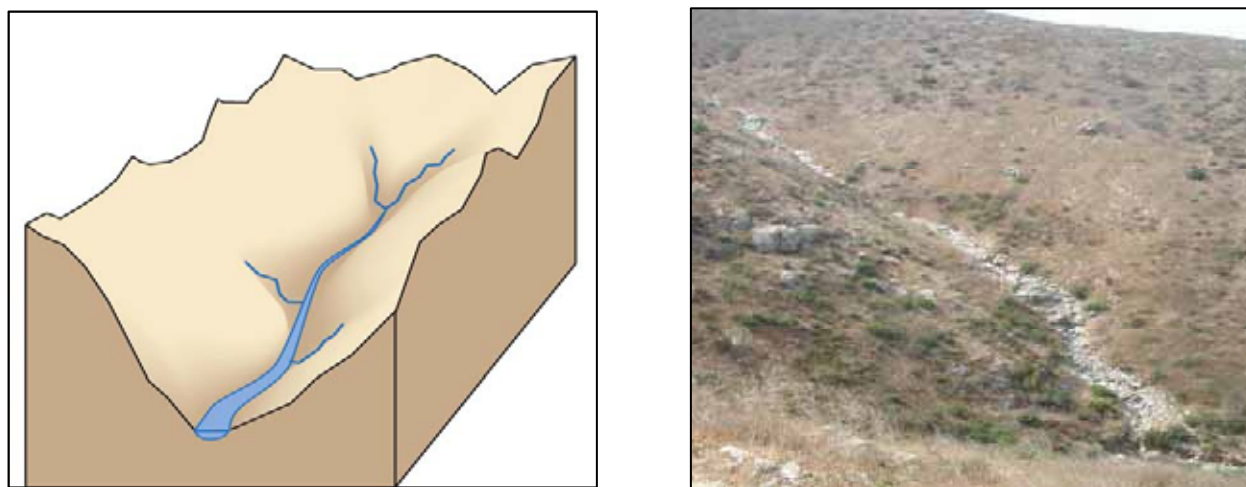
Figure 5. General form of Geomorphic Zone 1 and view of typical reach.

Stream channels in Geomorphic Zone 1 (Figure 5) are primarily high-gradient systems within the mountains, and first-order streams in the foothills. Soil and geologic mapping (Bowman 1973, Strand 1962) usually indicate no Quaternary alluvial deposits, although small terrace fragments may be present. Generally, streambanks are carved directly into adjacent hillslopes, and riparian vegetation is restricted to the channel edges and banks. Hillslope vegetation, usually coastal sage scrub, extends to the top of the bank. Riparian vegetation has been grazed heavily along many Zone 1 streams, but channel incision is generally minimal due to bedrock control.

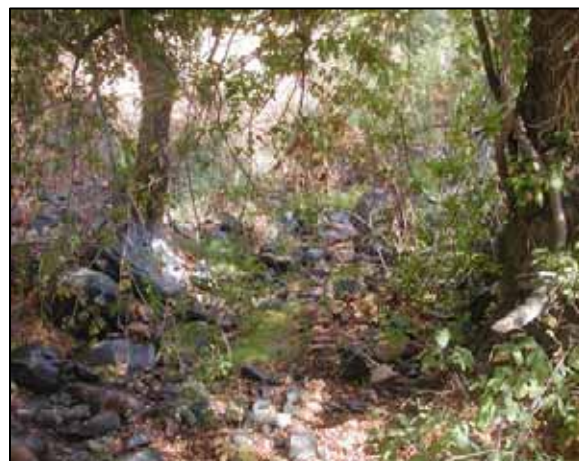
Figure 6. General form of Geomorphic Zone 2 and view of typical reach

Stream channels in Geomorphic Zone 2 (Figure 6) have a sinuous, meandering appearance on topographic maps and aerial photos, but in fact are winding between alternating fan, colluvium, or boulder bar deposits. Streams in this zone have narrow floodplains, and narrow, discontinuous terraces. Riparian vegetation dominated by sycamore, willows, and mulefat is restricted to the floodplains and terraces, usually forming narrow strips along the channel through fan and colluvial sections. In sheltered locations, the adjacent colluvial slopes and fans may be occupied by oak woodlands, but in most locations the alluvial zone is directly bordered by the predominant upland vegetation type (most commonly coastal sage-scrub or chaparral). On many streams, particularly within the mountains and deep canyons, large boulder bars occur at intervals along the channel, and often appear to be the result of landslides immediately upslope. These bars may develop thin soils, and have the appearance of terraces more typical of meandering-stream segments. However, the boulder-bar terraces are relatively unsorted material, with uneven, hummocky surfaces. The boulder-bars are typically well-drained, and support a mix of riparian and upland plant species.

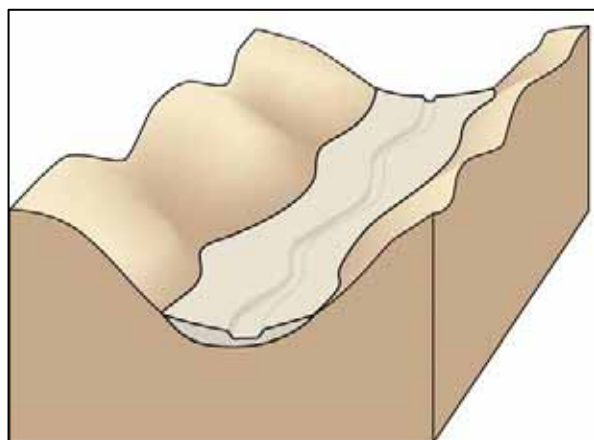
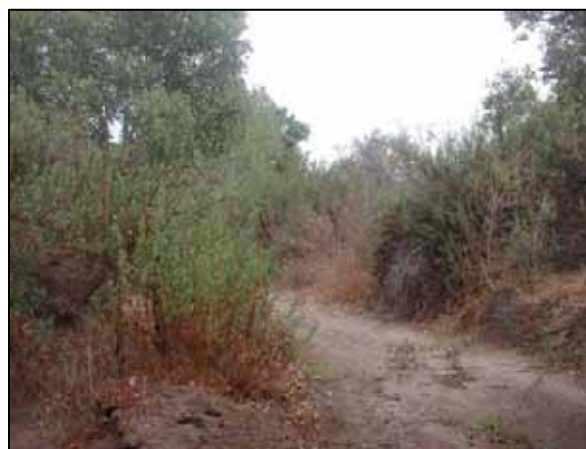
Figure 11. General form of Geomorphic Zone 7 and view of typical reach

A distinctive sandy wash channel type occurs in a limited number of small valley settings in the foothills. In the Otay watershed, this type exists only as short segments within reaches designated as predominantly other geomorphic zones. The type consists of a relatively narrow, flat-bottomed channel with low, distinct banks that give way to gently sloping alluvial and/or colluvial deposits (Figure 11). The alluvial deposits flanking the channel do not include any

significant terrace systems, but instead are occupied by upland vegetation. The form of the valleys where these systems occur suggests that the coarse alluvial deposits are not deep. Riparian vegetation consists mostly of scattered, sparse stands of mulefat within the channel, but occasional isolated oaks, cottonwoods, and sycamores indicate that a relatively continuous riparian corridor might be re-established within Zone 7 reaches through land use changes and light planting. The distinctive channel, with well-established banklines, the sloping deposits flanking the channel, and the apparent frequent (but brief) occurrence of surface flows distinguish this Zone from the valley fill type (Zone 6), where identification of shallow groundwater areas is a more critical restoration factor.
