Riparian Ecosystem Restoration Plan for the Santa Margarita River Watershed: General Design Criteria and Site Selection

**Prepared for:
U. S. Army Corps of Engineers, Los Angeles District, Regulatory Branch**

**R. Daniel Smith and Charles V. Klimas
U.S. Army Engineer Research and Development Center,
Waterways Experiment Station**

November 2006

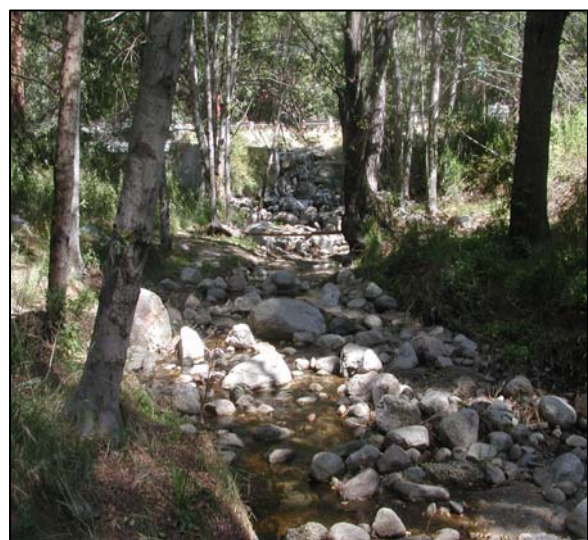
Figure 6. General form of Geomorphic Zone 2 and view of typical reach

Stream channels in Geomorphic Zone 2 (Figure 6) have a sinuous, meandering appearance on topographic maps and aerial photos, but in fact are winding between alternating fan, colluvium, or boulder bar deposits. Streams in this zone are confined by colluvium, boulder bar deposits, or bedrock, and have narrow floodplains, and narrow, discontinuous terraces. Riparian vegetation dominated by sycamore, willows, and mulefat is restricted to the floodplains and terraces, usually forming narrow strips along the channel through fan and colluvial sections. In sheltered locations, the adjacent colluvial slopes and fans may be occupied by oak woodlands, but in most locations the alluvial zone is directly bordered by the predominant upland vegetation type (most commonly chaparral). On many streams, particularly within the mountains and deep canyons, large boulder bars occur at intervals along the channel, and often appear to be the result of landslides immediately upslope. These bars may develop thin soils, and have the appearance of terraces more typical of meandering-stream segments. However, the boulder-bar terraces are relatively unsorted material, with uneven, hummocky surfaces. The boulder-bars are typically well-drained, and support various riparian species including alders, oaks, sycamores, or other species, depending on elevation, position in the watershed, age and activity of the deposit, and other relevant factors. Because the boulder bars, colluvial deposits, and fans that characterize Zone 2 occur as relatively large and variable units (rather than narrow streamside strips), and because extensive oak woodlands are generally part of the lower-slope community, these tend to

be among the most structurally and compositionally diverse riparian systems within the study area. In the foothills, Zone 2 channels are less diverse. Boulder bars are less prominent features than colluvial material, and oak woodland communities may be fairly restricted in distribution.

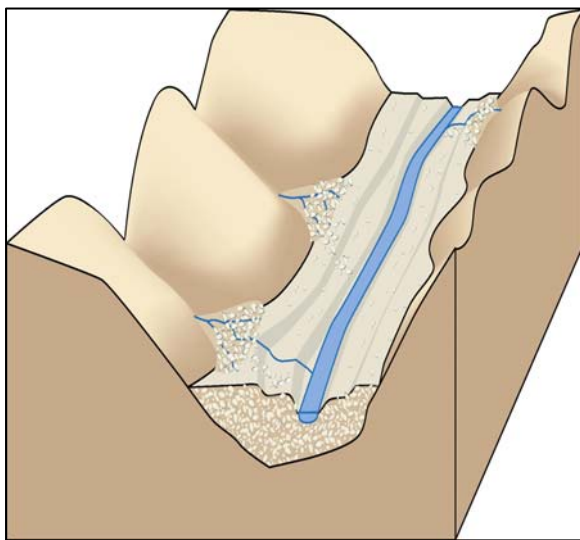
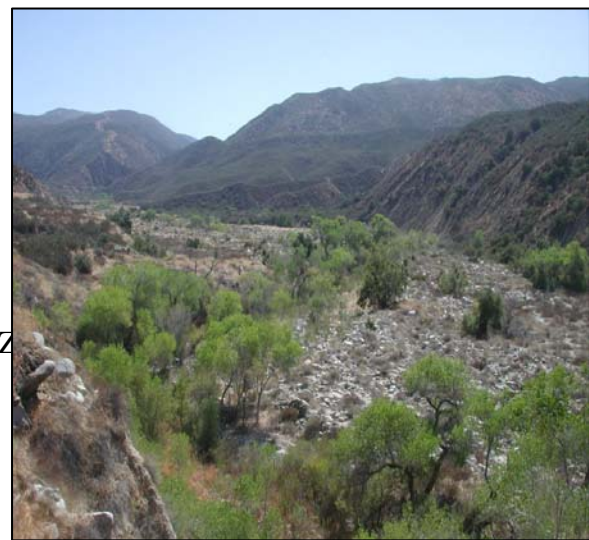
Figure 7. General form of Geomorphic Zone 3 and view of typical reach.

Geomorphic Zone 3 (Figure 7) is characterized by deep, extensive accumulations of boulders and cobble that extend from valley wall to valley wall (as opposed to the discontinuous boulder bars that occur in Geomorphic Zone 2). These areas usually are mapped as Quaternary Alluvium (Rogers 1965). This type was identified in a reconnaissance of the San Jacinto watershed, where it occurs primarily as a series of high, uneven terraces flanking a single-thread channel. It is not common in the San Jacinto basin, and was not mapped by us anywhere in the Santa Margarita watershed, but is included here because some Zone 2 boulder accumulations may be extensive enough to be regarded as transitional to the Zone 3 type.

Zone 3 reaches appear to be the result of large landslides. The materials filling the valley are generally unsorted, and may include very large boulders. The stream channel has incised through the debris, leaving a series of rough, high terraces. Because the terraces consist of very coarse material, and usually are elevated well above the active stream channel, they are dominated by upland shrub communities composed of species such as sagebrush and buckwheat. Oaks and sycamores may occur as scattered individuals, presumably in places where water from

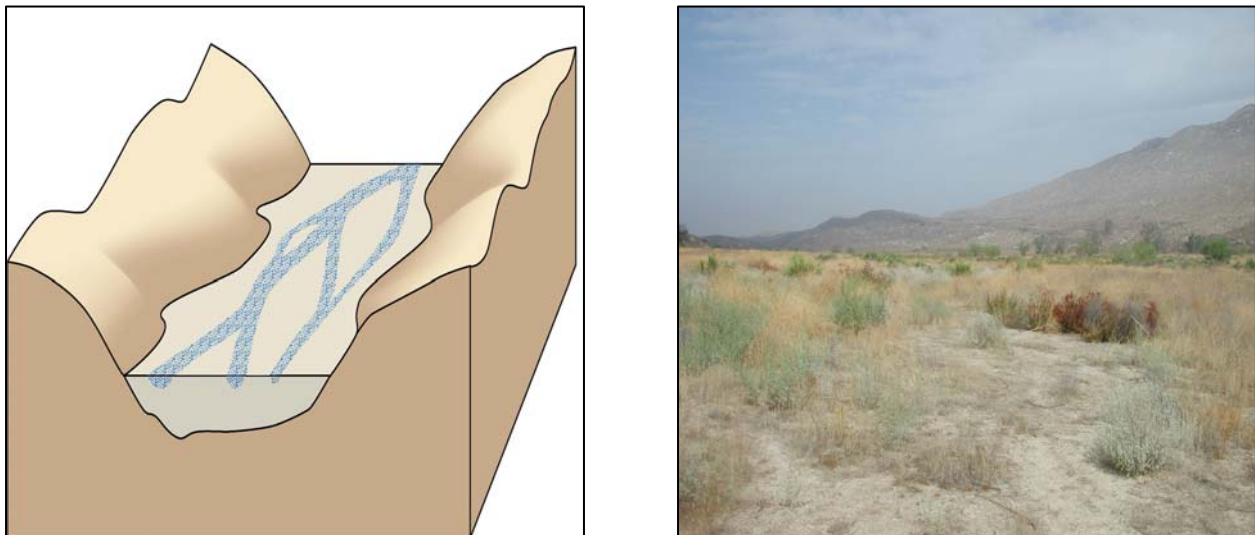
Figure 10. General form of Geomorphic Zone 6 and view of typical reach.

Some reaches of the major stream valleys have been filled with deep, well-drained sediments that show only trace channel systems and little or no terrace development (Figure 10). These areas may slope somewhat toward the valley walls, but do not appear to be created by distinctive lateral fans such as those characteristic of Zones 4, and sometimes present in Zone 5. Rather, the valley fill material in Zone 6 has the appearance of having originated higher in the main valley, and was likely deposited in a braided or highly meandering flow environment. As a result, the valley floor is relatively flat, and lacks distinctive continuous terraces. Most flows evidently pass through these reaches subsurface. Where farming or grazing occurs, the channel system may be obliterated completely. However, remnant strips of riparian species (cottonwood, mulefat) suggest that, where subsurface water is available, riparian communities can be

established. Re-establishment of a channel system, with particular attention to springs and shallow groundwater areas, may allow restoration of fairly continuous riparian corridors through Zone 6 reaches.
