SAN GABRIEL RIVER 4 LEVEE SYSTEM

LOS ANGELES COUNTY, CALIFORNIA
NLD SYSTEM ID # 3805010051

PERIODIC INSPECTION REPORT NO 1 **GENERALIZED EXECUTIVE SUMMARY**

FINAL SYSTEM RATING: UNACCEPTABLE

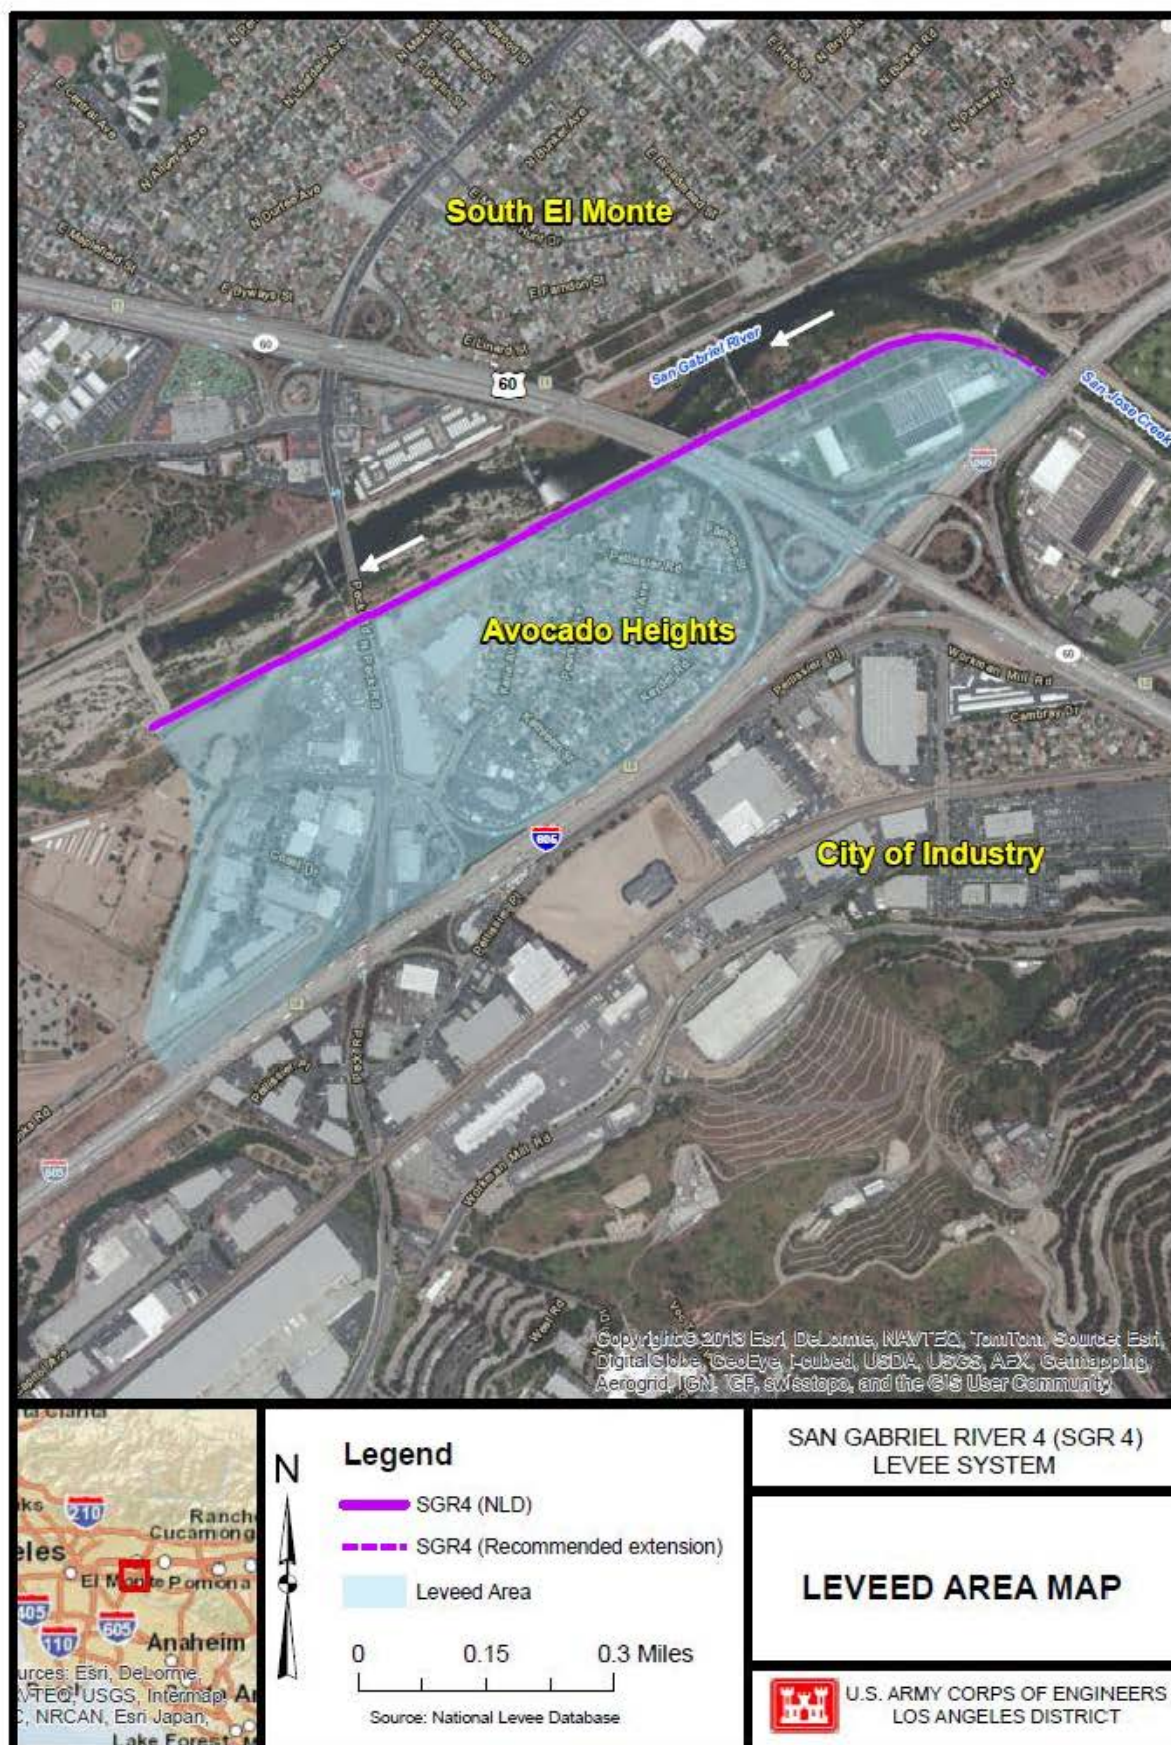
The SGR4 Levee System is located in the City of Industry, Avocado Heights, and an unincorporated area, within Los Angeles County, in the State of California. According to the National Levee Database (NLD), the SGR4 Levee System runs along the left (east) bank (looking downstream) of San Gabriel River (SGR), beginning at the confluence with the San Jose Creek (SJC) Diversion Channel at approximate Station 1230+80 (Station SJ 32+70) and terminating at the Whittier Narrows Dam Flood Control (F.C.) Basin at Station 1172+00. The levee system is composed of a single levee segment. Figure 1 shows the extent of the levee system and leveed area.
