SECTION 10- APPENDICES

**Port San Luis Breakwater Repair Subtidal
Habitat Survey Report For Displaced
Morro Rock Stone Relocation**

PORT SAN LUIS BREAKWATER REPAIR
MODIFIED UNDERTAKING
San Luis Obispo County, California

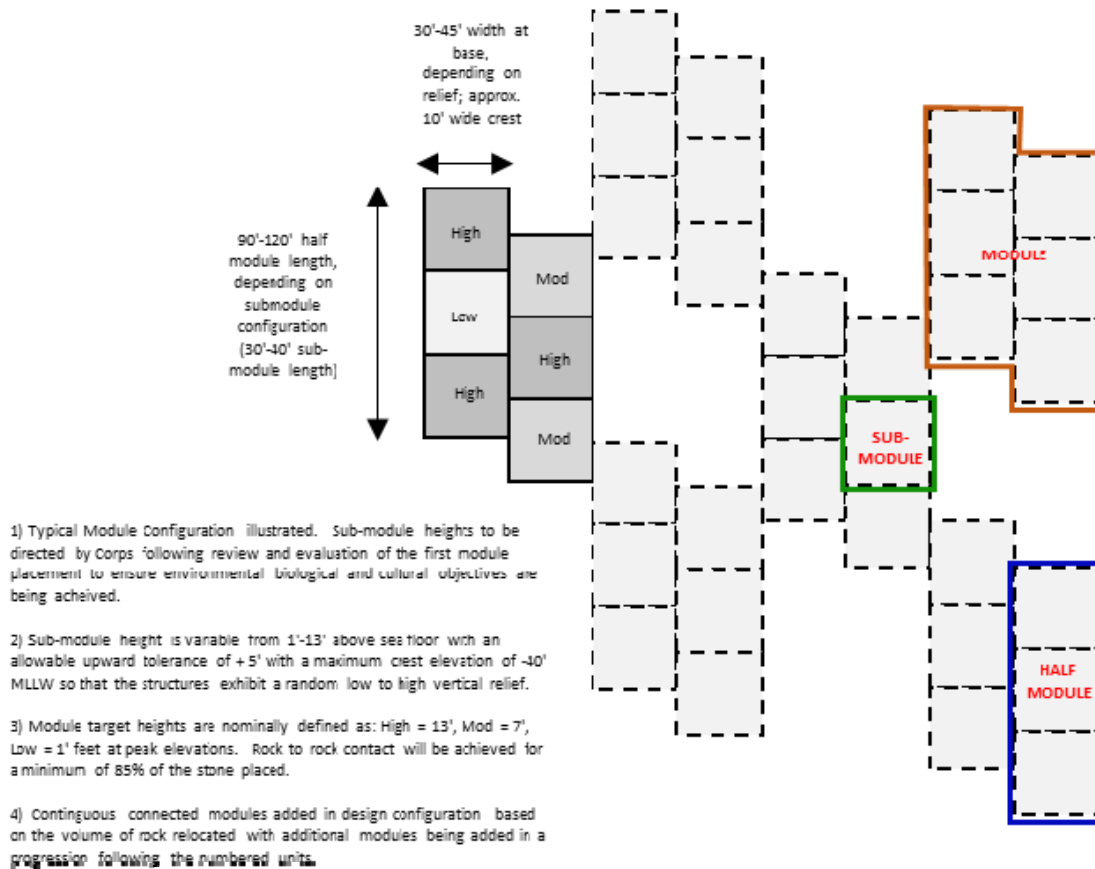
Port San Luis Breakwater Stone Relocation Configuration

Figure 4. Conceptual layout for cultural repatriation reef

Because the actual total amount of the undersized stone remains unknown and will not be known until the breakwater repair is completed, the design of the cultural reef has been made module, such that each new load of stone placed would add to prior rock in a manner that retains goals for a vertically variable reef configuration, following designs that have contributed to high fishery value, particularly for rockfish species. The contemplated conceptual design of the reef is illustrated in Figure 4.

Each module of the reef consists of two half-modules that are based on a volume reflected by a single scow load of rock. The half modules are made up of sub-modules that are placed as rock mounds of variable height from 1 foot to 15 feet above the seafloor (Figure 4). The submodules are positioned to provide rock to rock contact with adjacent submodules to create a unified reef structure. As additional stone is displaced, it would be placed in adjacent areas of the bottom creating a rock-to-rock contact array that also provides integrated retention of sandy bottom habitat. The elevation of the rocky reef to be developed has been kept in waters between -50 and -65 feet MLLW to ensure that the reef can be safely constructed and that the highest reef crests remain at depths at or below -40 feet to avoid any potential for the reef to interfere with natural wave environments or sediment transport conditions along the shoreline.

While it is technically feasible to fit the full reef configuration illustrated in Figure 4 within soft bottom of the Point San Luis Study Area, and within the tidelands grant boundary, it is unlikely that a reef could be readily constructed in this area without some potential to damage rocky reef habitat in proximity through anchor placement and cable drags. Such effects may result in significant damage to marine resources, particularly because dragging of anchor cables may be expected to shear many vertical sessile organisms and clear overstory and understory kelp from rock. As a result, should this site be selected additional analysis working in concert with the breakwater contractor would be necessary to determine if potential exists to avoid risk of significant temporary impact to marine resources. Construction of a reef within the open sand bottom of the Morro Rock Study Area does not have similar inherent risk of damage to an HAPC due to the absence of reefs in the area.

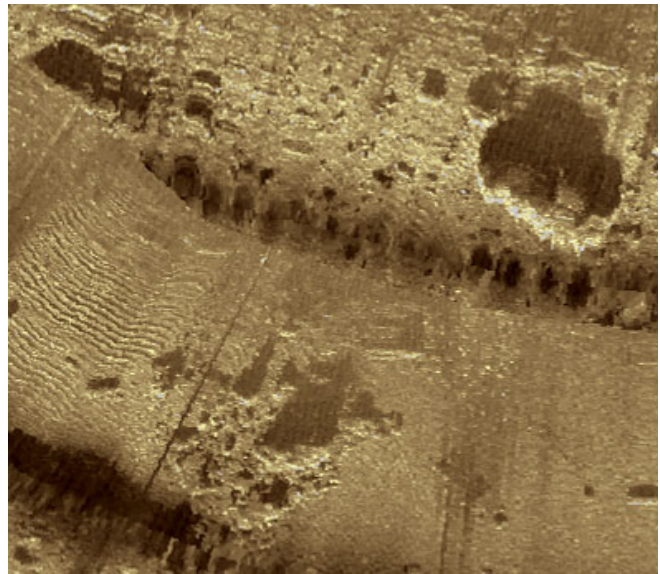
Example interferometric sidescan image of the bottom within the Point San Luis Survey Area. The image illustrates rock bottom habitat of low and high relief reef along with sand bottom and energy influenced sand bottom, represented by the sand ripples.

Survey Methodology Habitat distribution and anthropogenic debris data were collected using an interferometric sidescan sonar (ISS) operating at 468 kHz scanning out 50 meters on both the starboard and port channels for a 100-m wide swath. The survey was conducted by running parallel tracklines that were spaced to allow for overlap between adjoining sidescan swaths. Parallel tracklines were surveyed until the entirety of the survey area was covered. The ISS is ideally suited to support surveys for both marine habitats and anthropogenic features due to the integrated collection of both high resolution sidescan along with bottom relief data that further enhances detectability and characterization of features with vertical relief elements such as reefs and shipwrecks.

The swath sonographic surveys allowed for mapping and characterization of different habitats present within the survey areas based on differences in backscatter reflectance, rugosity, bottom topology, and acoustic shadow characteristics. In addition to separation of substrate habitat features (e.g., rock and sand bottom), the survey methods also allowed for the mapping of energy influenced sand, based on sand rippling of the bottom. Biotic features that are readily mappable from the sidescan sonar, including eelgrass was mapped during the habitat inventory. Following completion of the survey, interferometric sidescan sonar traces were mosaicked into a spatially rectified image and transferred to geographic information systems (GIS) software to support mapping. Bathymetry was also a derived product of the interferometric swath survey.
