**RIO HONDO UPPER 3 LEVEE SYSTEM**  
**LOS ANGELES COUNTY, CALIFORNIA**  
**NLD SYSTEM ID # 3805010102**

**PERIODIC INSPECTION REPORT NO 1**  
**GENERALIZED EXECUTIVE SUMMARY**

**FINAL SYSTEM RATING: MINIMALLY ACCEPTABLE**  
**FINAL RATING DATE: JANUARY 23, 2014**

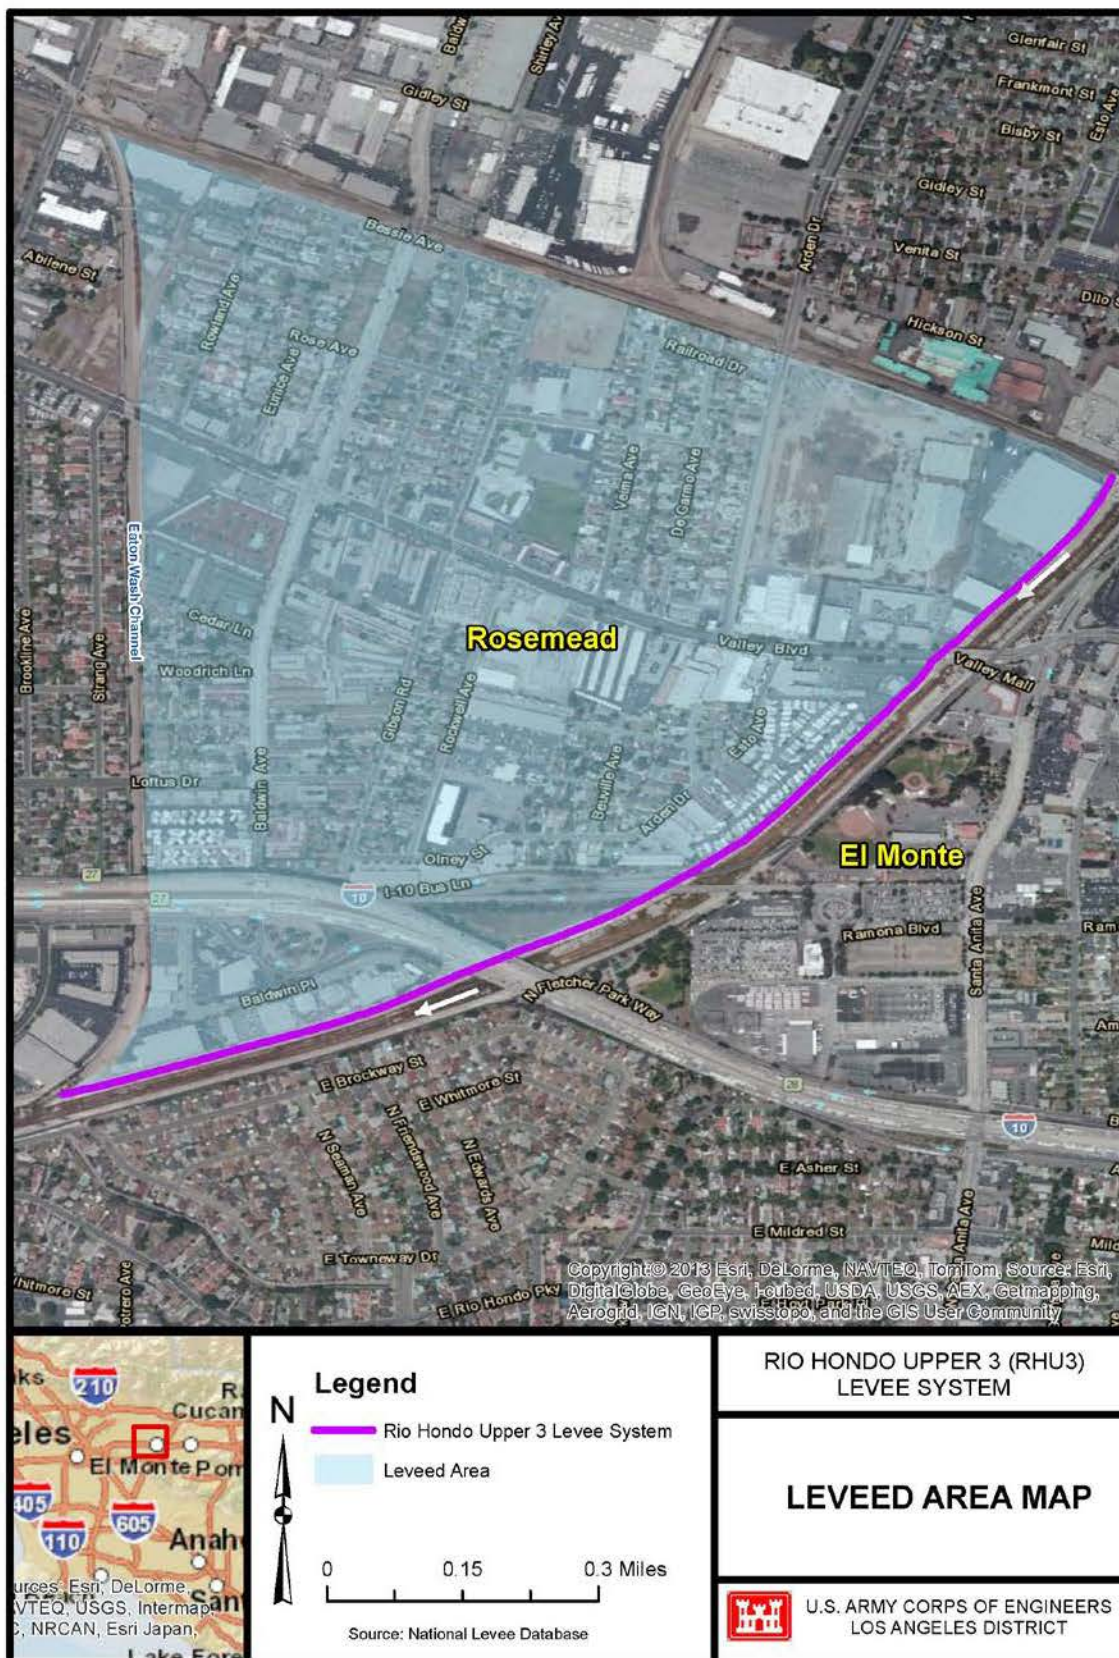
Figure 1. Rio Hondo Upper 3 Levee System

The Rio Hondo channels are a unit of the Los Angeles County Drainage Area project (LACDA). The RHU3 Levee System, shown in Figure 1, is a portion of the Rio Hondo channels and is contained within the Cities of El Monte and Rosemead, Los Angeles County, California. The length of the system is 6,469 feet (1.23 miles).

The RHU3 Levee System is a reinforced-concrete-lined trapezoidal channel and levee. The levee is located along the right embankment (looking downstream) of the Rio Hondo Upper Channel beginning downstream of the Union Pacific Railway bridge at Station 735+45 and extending down to the Eaton Wash confluence at Station 670+76. Features include a floodwall, side drainage structures, retaining walls, and bridge crossings.
